19801 Darnestown Road, Beallsville

HPC Case No. 17/01-09A

Beallsville Historic District

SUBJECT: Historic Area Work Permit #^{513027 JS 3/9/11}506356, building stabilization

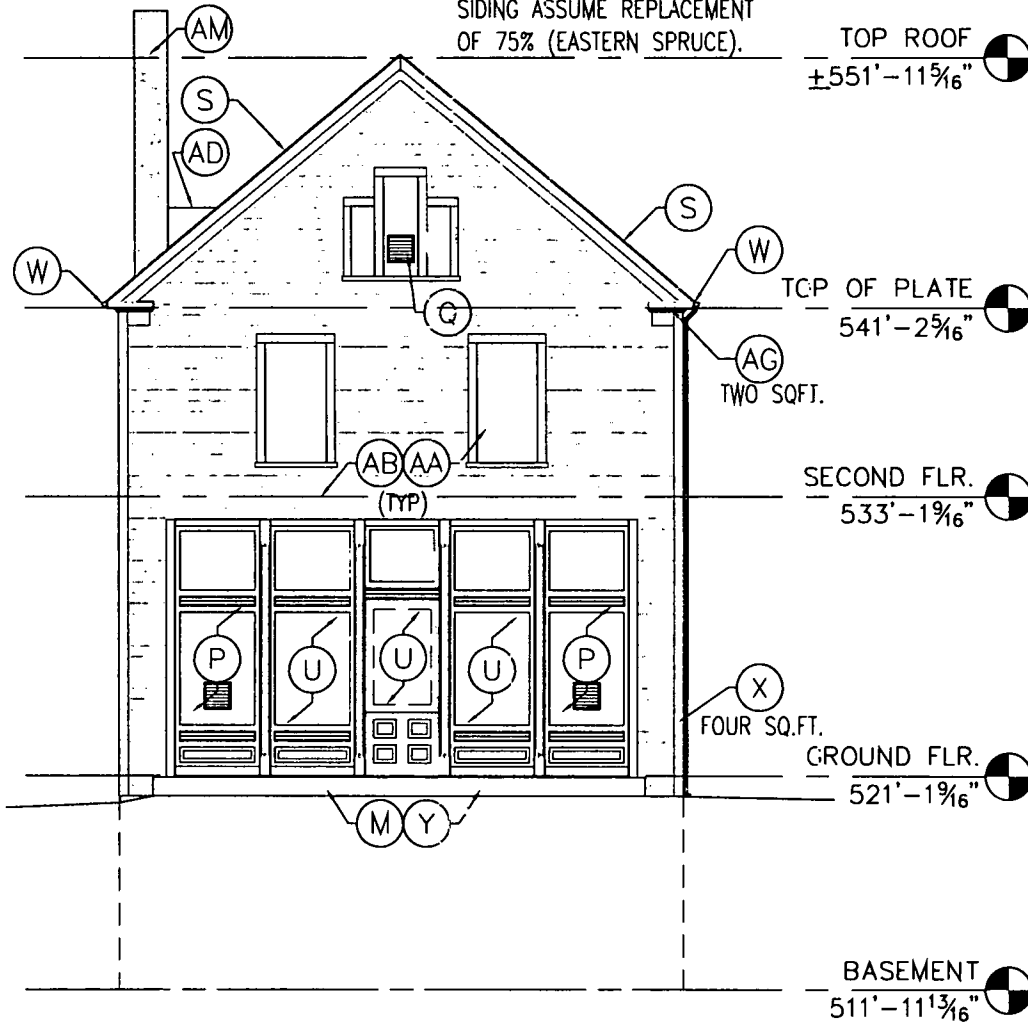
Proposed South Elevation

SOUTH FACADE GENERAL NOTE:
REPLACE DAMAGED/MSSING SIDING ASSUME REPLACEMENT OF 75% (EASTERN SPRUCE).

- (S) AFTER BLDG. RELOCATION CAREFULLY REMOVE & SALVAGE WHOLE MTL. SHINGLES. REPLACE SHINGLES WITH NEW TO MATCH EXIST. DIM. AND PROFILE.
- (U) REMOVE EXIST. WDW. PLY'WD. PROTECTION FROM INTERIOR AND REATTACH TO THE EXT. OF STORE FRONT LOWER WINDOWS.

- (W) NEW 4" GALVANIZED MTL. GUTTERS & DOWNSPOUTS AFTER BLDG. RELOCATION.
- (X) REPAIR WD. CORNER BOARD AS NEEDED WITH MAT'L OF SAME DIM (EASTERN SPRUCE).

- (Y) ASSUME 50% OF SILLPLATE TO BE REPLACED.
- (AA) REPLACE EXIST. ROTTED WD. DIAGONAL WALL SHEATHING AS NEEDED.
- (AB) REMOVE ALL EASTERN SPRUCE SIDING FOR DIAGONAL WALL SHEATHING INSPECTION. SALVAGE & CATALOG WD. SIDING FOR REINSTALLATION AFTER BLDG. RELOCATION.

- (AD) INSTALL ROOF CRICKET AT CHIMNEY AFTER BLDG. RELOCATION
- (AG) SEAL DETERIORATING SOFFIT FROM EXT ELEMENTS AS INDICATED ON ELEV.
- (AM) USE ON-SITE SALVAGED BRICK TO EXTEND CHIMNEY TO 24" ABOVE ROOF RIDGE AFTER BLDG. RELOCATION.

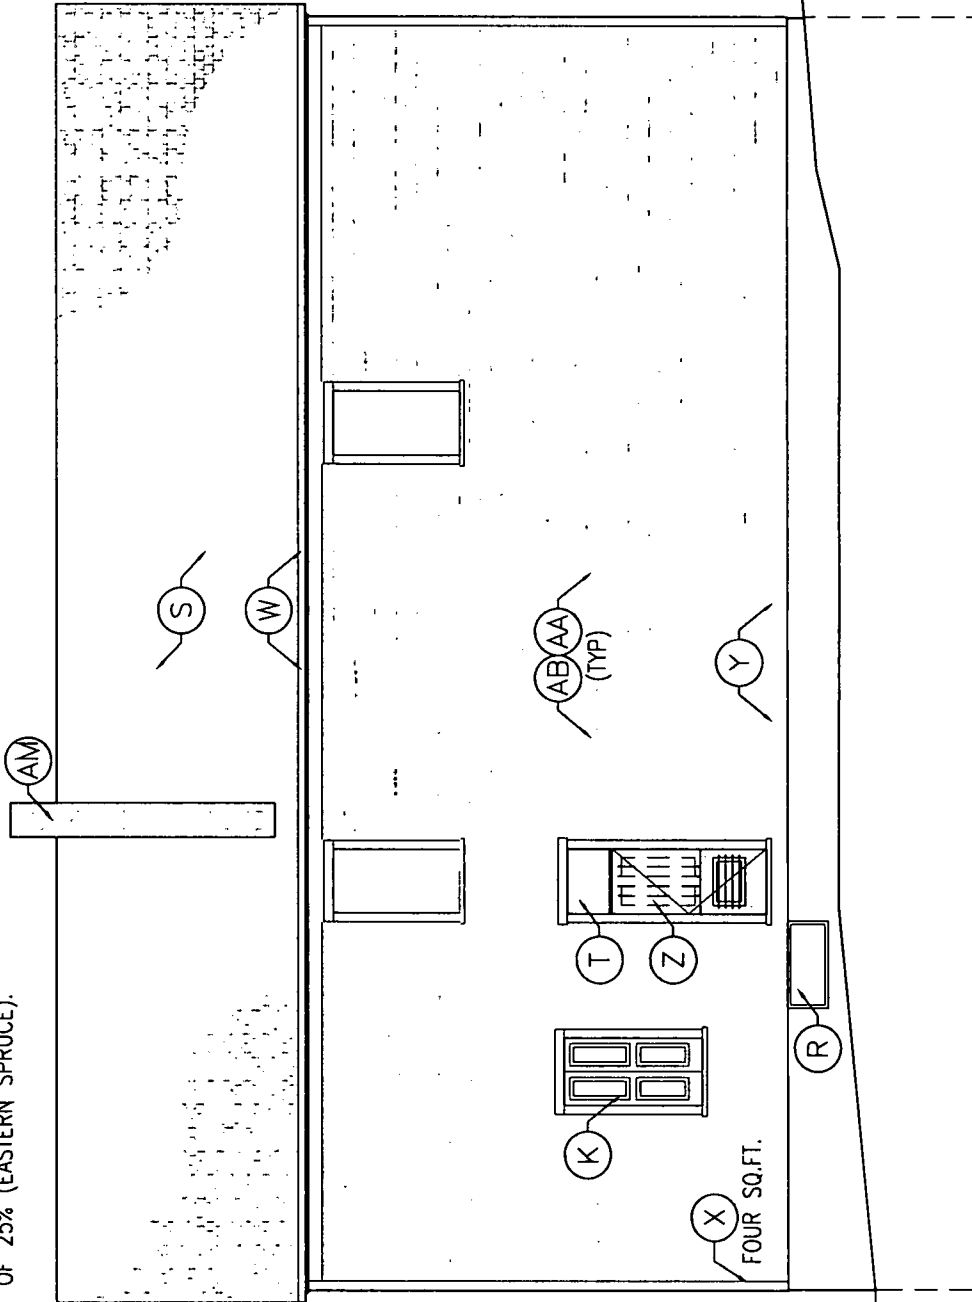
Proposed West Elevation

WEST FACADE GENERAL NOTE:
REPLACE DAMAGED/MISSING SIDING ASSUME REPLACEMENT OF 25% (EASTERN SPRUCE).

- (K) EXIST. WD. WDW. SHUTTERS TO REMAIN, PAINT ALL EXTERIOR SURFACES.
- (R) ACTIVE SOLAR POWERED VENTILATION IN SASH OF EXIST. BASEMENT WINDOW.
- (S) AFTER BLDG. RELOCATION CAREFULLY REMOVE & SALVAGE WHOLE MTL. SHINGLES. REPLACE SHINGLES W/ NEW TO MATCH EXIST. DIM. & PROFILE.

- (W) NEW 4" GALVANIZED MTL. GUTTERS & DOWNSPOUTS AFTER BLDG. RELOCATION.
- (X) REPAIR WD. CORNER BOARD AS NEEDED WITH MAT'L OF SAME DIM (EASTERN SPRUCE).

- (Y) ASSUME 50% OF SILLPLATE TO BE REPLACED.
- (T) COVER EXIST. TRANSOM WINDOW FROM EXTERIOR W/ PLYWOOD SCREWED TO THE FRAME - PAINT.
- (Z) COVER EXIST. GLAZED DOOR OPENING WITH PLYWOOD FROM EXTERIOR & PAINT PER SPEC.

- (AA) REPLACE EXIST. ROTTED WD. DIAGONAL WALL SHEATHING AS NEEDED.
- (AB) REMOVE ALL EASTERN SPRUCE SIDING FOR DIAGONAL WALL SHEATHING INSPECTION. SALVAGE & CATALOG WD. SIDING FOR REINSTALLATION AFTER BLDG. RELOCATION.

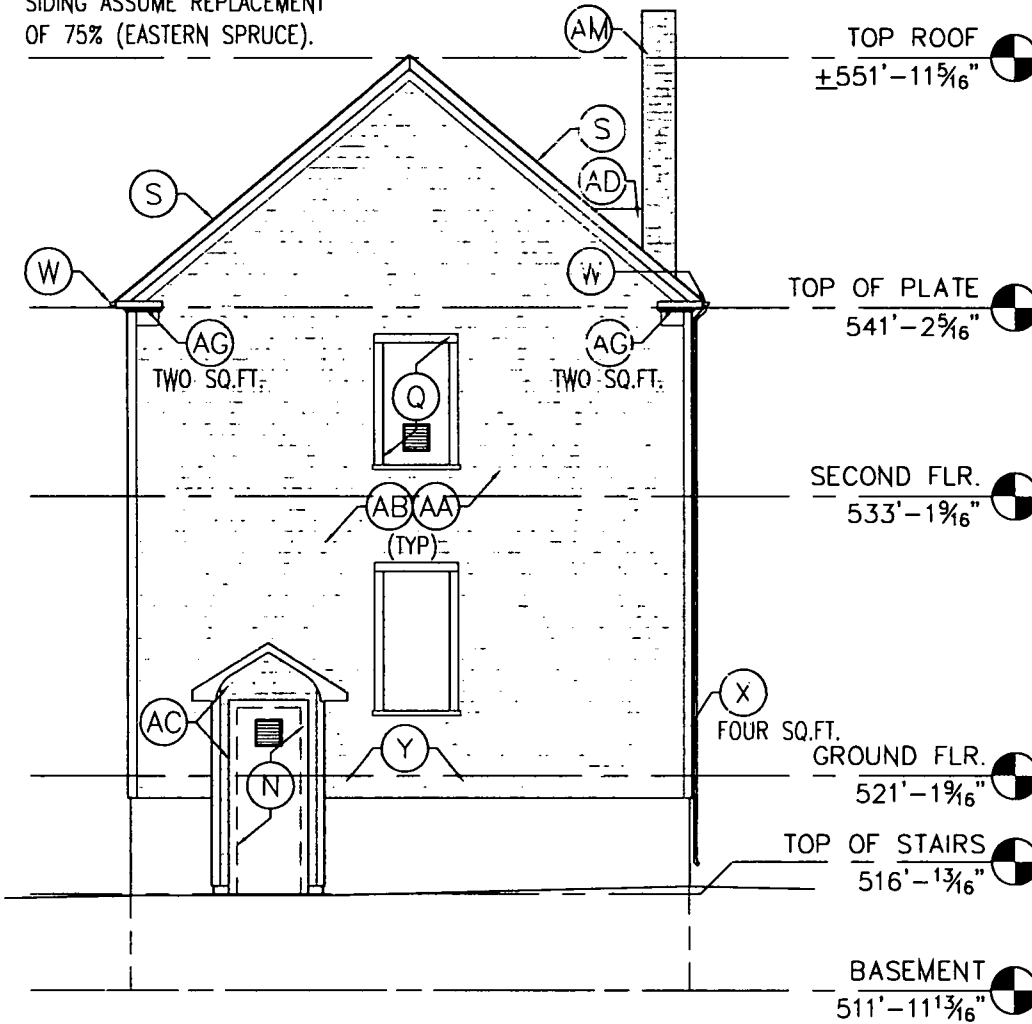
Proposed North Elevation

NORTH FACADE GENERAL NOTE:
REPLACE DAMAGED/MISSING SIDING ASSUME REPLACEMENT OF 75% (EASTERN SPRUCE).

- (N) PASSIVE VENTILATION LOUVER IN EXIST. DR. OPENING.
- (S) AFTER BLDG. RELOCATION CAREFULLY REMOVE & SALVAGE WHOLE MTL. SHINGLES. REPLACE SHINGLES WITH NEW TO MATCH EXIST. DIM. AND PROFILE.

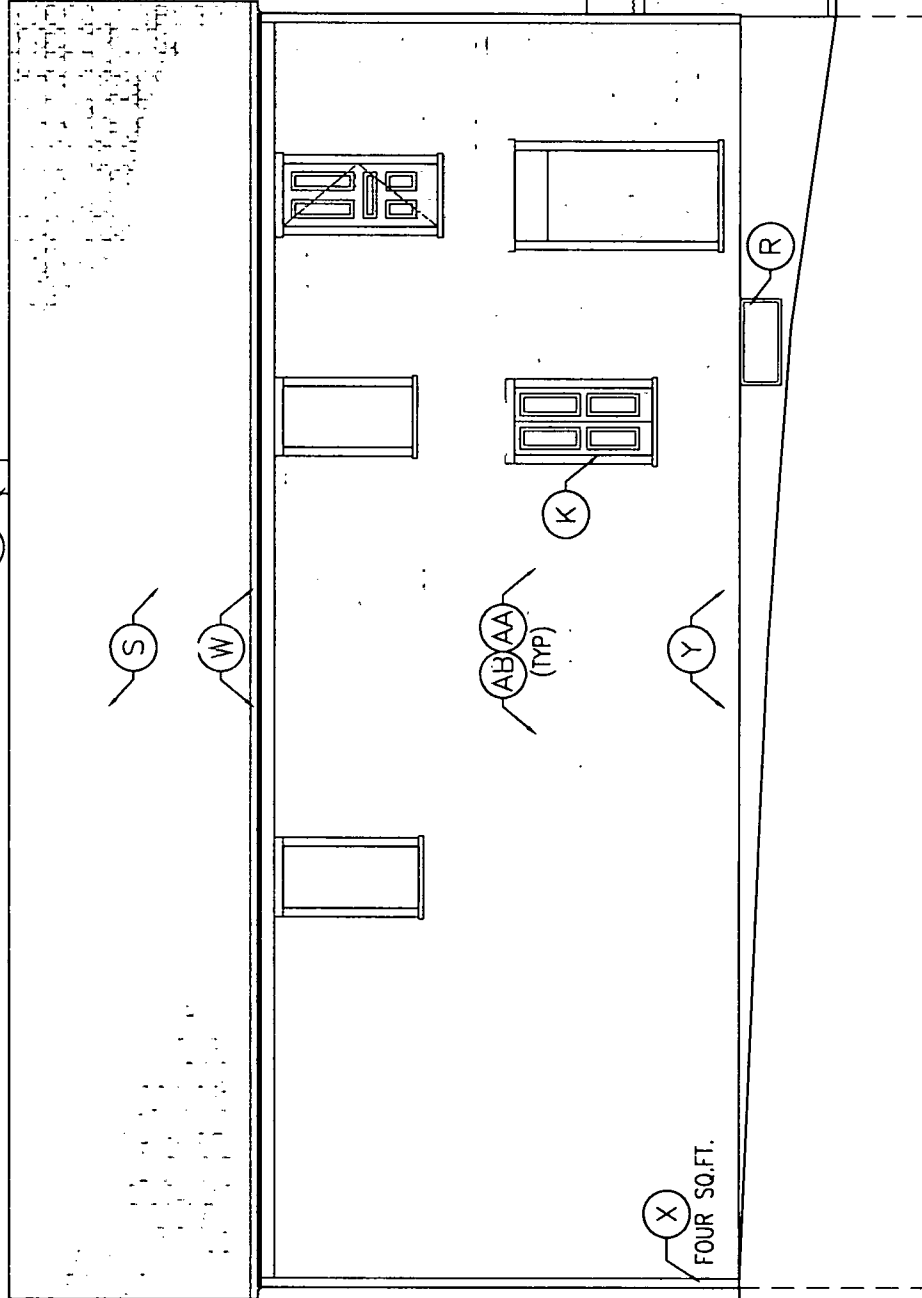
EAST FACADE GENERAL NOTE:
REPLACE DAMAGED/MISSING
SIDING ASSUME REPLACEMENT
OF 75% (EASTERN SPRUCE).

- (K) EXIST. WD. SHUTTERS TO REMAIN. PAINT ALL EXTERIOR SURFACES.
- (M) REMOVE & DISPOSE OF EXIST. WD. FRONT PORCH
- (R) ACTIVE SOLAR POWERED VENTILATION IN SASH OF EXIST. BASEMENT WINDOW.

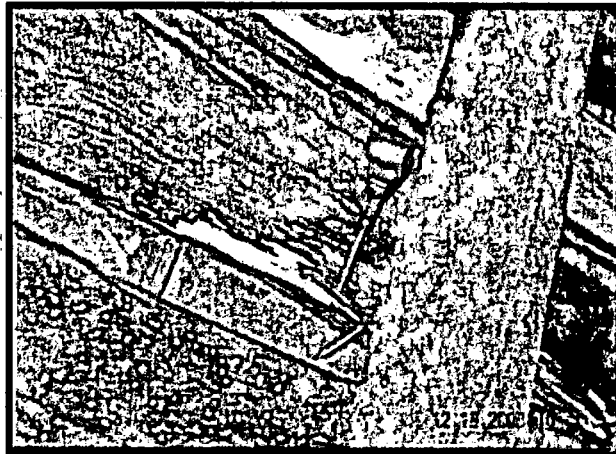
The roof framing in the Store consists of dimension-lumber rafters (2 inches by 6 inches, spaced 24 inches on center) covered with open board sheathing (the boards are not tight against one another), vertical ties composed of miscellaneous boards that vary in width, and dimension-lumber horizontal tie beams (2 inches by 6 inches) (Figure 8). No ridge board or beam is used at the peak of the roof, and a single 2-inch by 4-inch member on top of the studs forms the top plate over which the rafters are notched. The roof sheathing is in poor condition due to extensive wood decay (Figure 9).

Figure 9. Decayed roof sheathing.

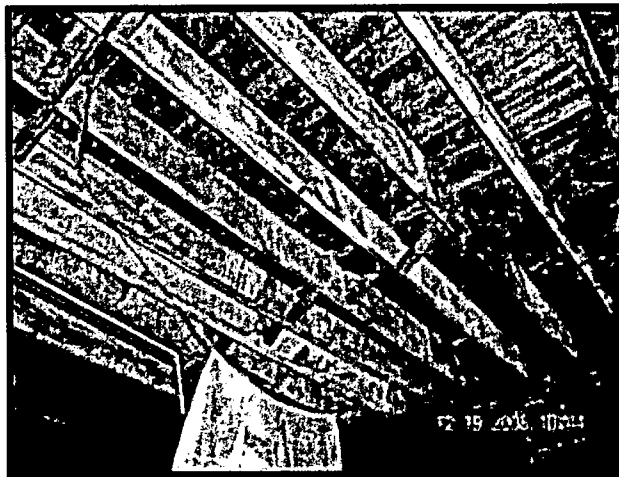
The floor joists for the second floor have some minor moisture staining (Figure 14). One joist near the top of the stairs has extensive decay (Figure 15). Areas of deterioration along the tops of some of the joists were visible from the second floor and correspond to areas of moisture penetration due to roof leaks. Resistance drilling of a few joists beyond the perimeter of the area of the roof leaks confirmed that the joists were in good condition along the span. Moisture contents for the second floor joists are well below the threshold for active wood decay.

Figure 14. The second floor joists exhibit minor staining but otherwise appear to be in good condition along the span, except where noted above.

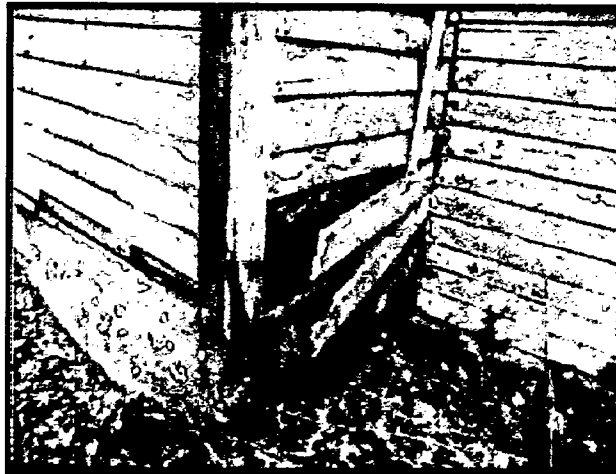
Figure 23. Northeast corner on the north elevation with termite damage in the sheathing and sill.

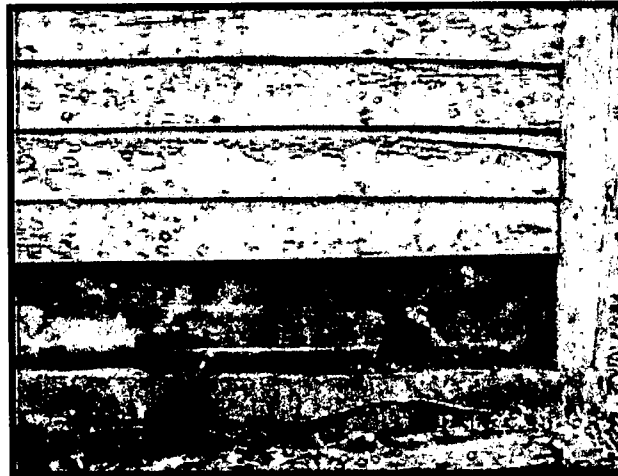
Figure 25. Location of resistance drillings D1 through D4. Note the sill repair block under the trim board.

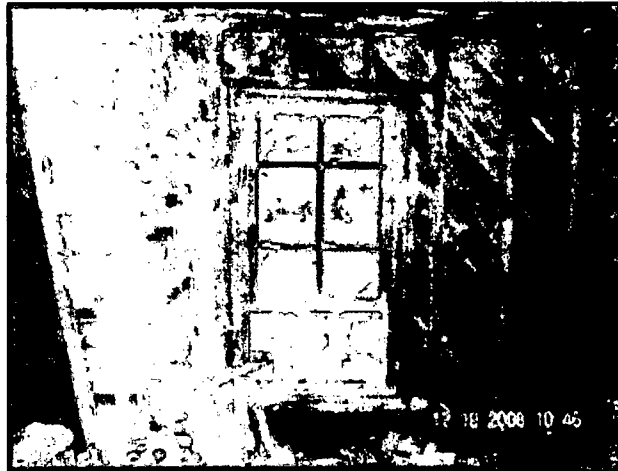
Figure 28. Window on west elevation of the second floor. It is in good condition, as are all the windows, except for minor deterioration to the exterior trim.
