Mount Carmel
MP site 12/22

From: Fothergill, Anne
Sent: Wednesday, May 11, 2011 2:36 PM
Subject: 5/11 staff item #3

SUBJECT: Historic Area Work Permit #554485—roof replacement, garage construction, barn demolition,
and other alterations

**HISTORIC PRESERVATION FOR:
 MOUNT CARMEL
 DICKERSON, MD 20842**

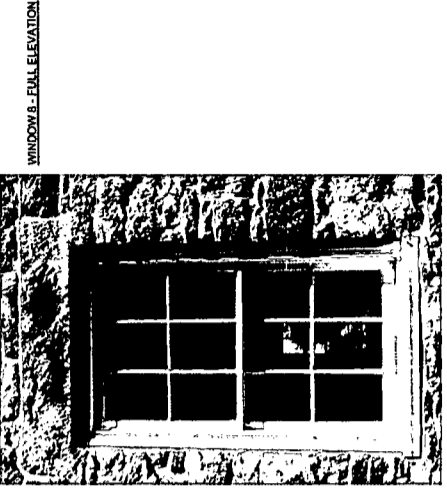
CONNECTION PINS IN WINDOW SASH CAN BE SEEN COMING LOOSE. REPAIR AS REQUIRED @ THIS WINDOW AS WELL AS ANY OTHER WHERE THIS CONDITION OCCURS.

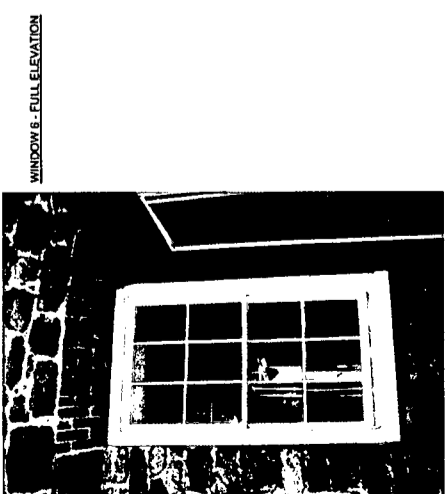
CONNECTION PINS IN WINDOW SASH CAN BE SEEN COMING LOOSE. REPAIR AS REQUIRED @ THIS WINDOW AS WELL AS ANY OTHER WHERE THIS CONDITION OCCURS.

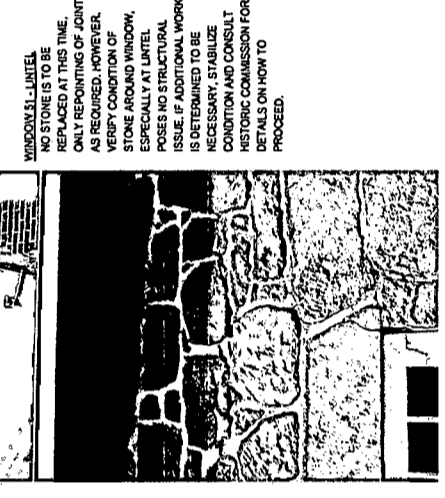
WINDOW 51 - LINTEL
 NO STONE IS TO BE REPLACED AT THIS TIME. ONLY REPOINTING OF JOINTS AS REQUIRED. HOWEVER, VERIFY CONDITION OF STONE AROUND WINDOW, ESPECIALLY AT LINTEL. POSSES NO STRUCTURAL ISSUE. IF ADDITIONAL WORK IS DETERMINED TO BE NECESSARY, STABILIZE CONDITION AND CONSULT HISTORIC COMMISSION FOR DETAILS ON HOW TO PROCEED.

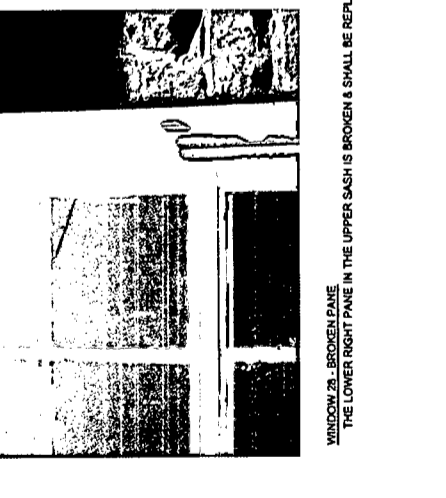
WINDOW 28 - BROKEN PANE
 THE LOWER RIGHT PANE IN THE UPPER SASH IS BROKEN & SHALL BE REPLACED.
