APPLICATION FOR HISTORIC AREA WORK PERMIT
HISTORIC PRESERVATION COMMISSION
301.563.3400

Our proposed work will restore and repair our property's two-story front porch.

**Representative Name:** Roxanne Fulcher Roxy@pheared.net 301-270-5151  
**Location of Project:** 7102-04 Maple Avenue  
**Proposed Scope of Work:** Repair 2-story front porch

Scope of Work Restore two-story front porch.

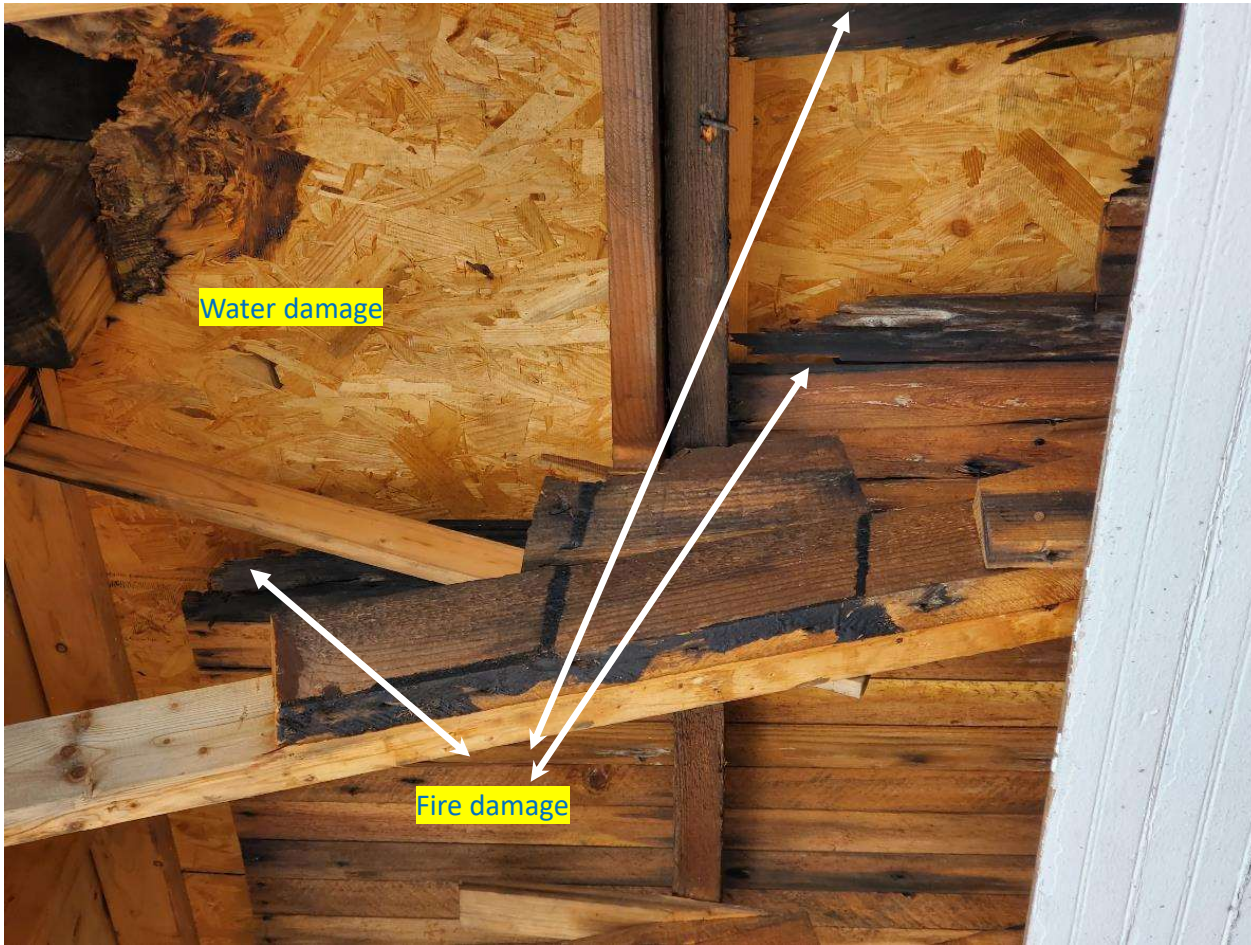
Photo 2 - 7102 Maple Ave – fire damage

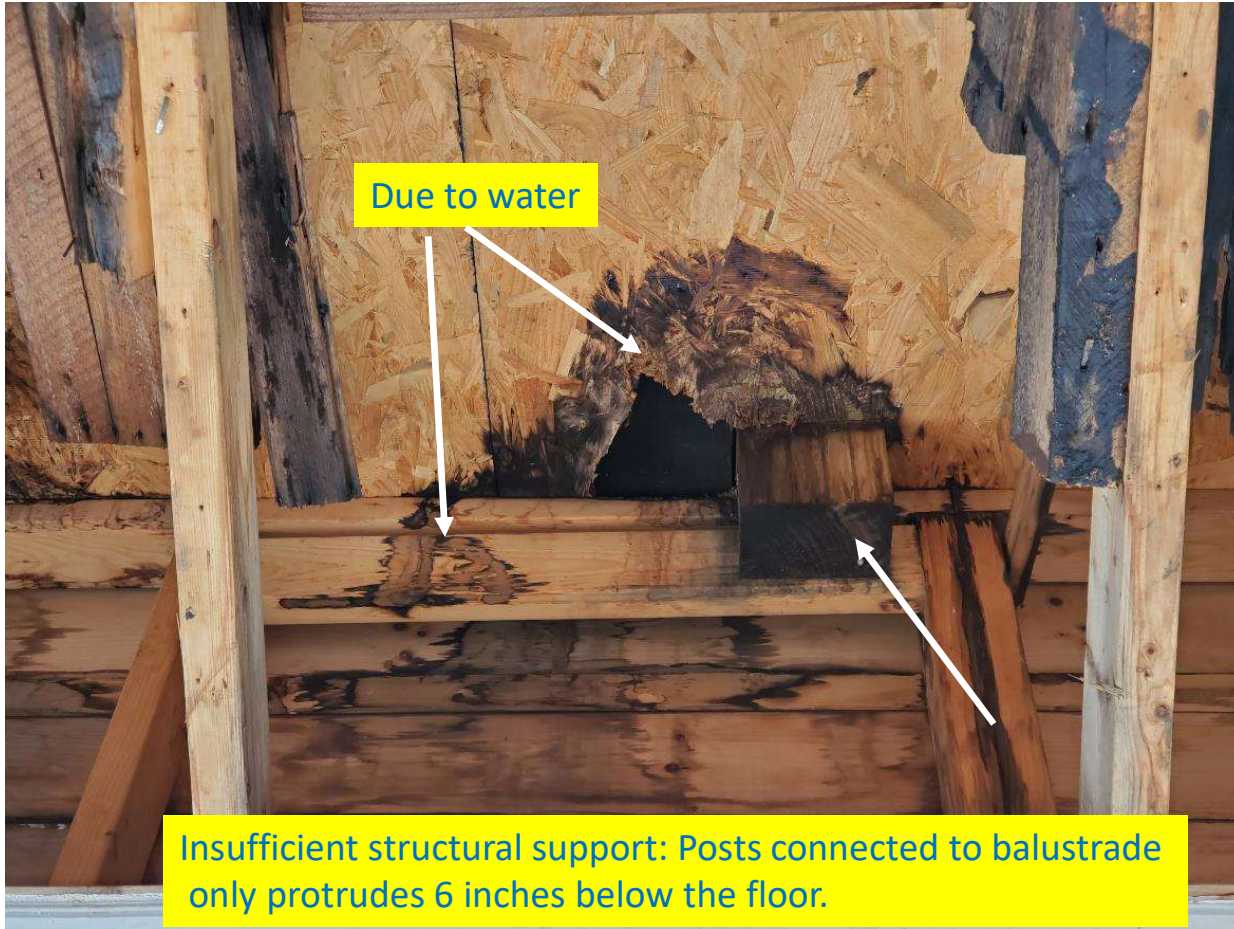
**Photo 3 - 7102 Maple Ave – deteriorated post upper porch**

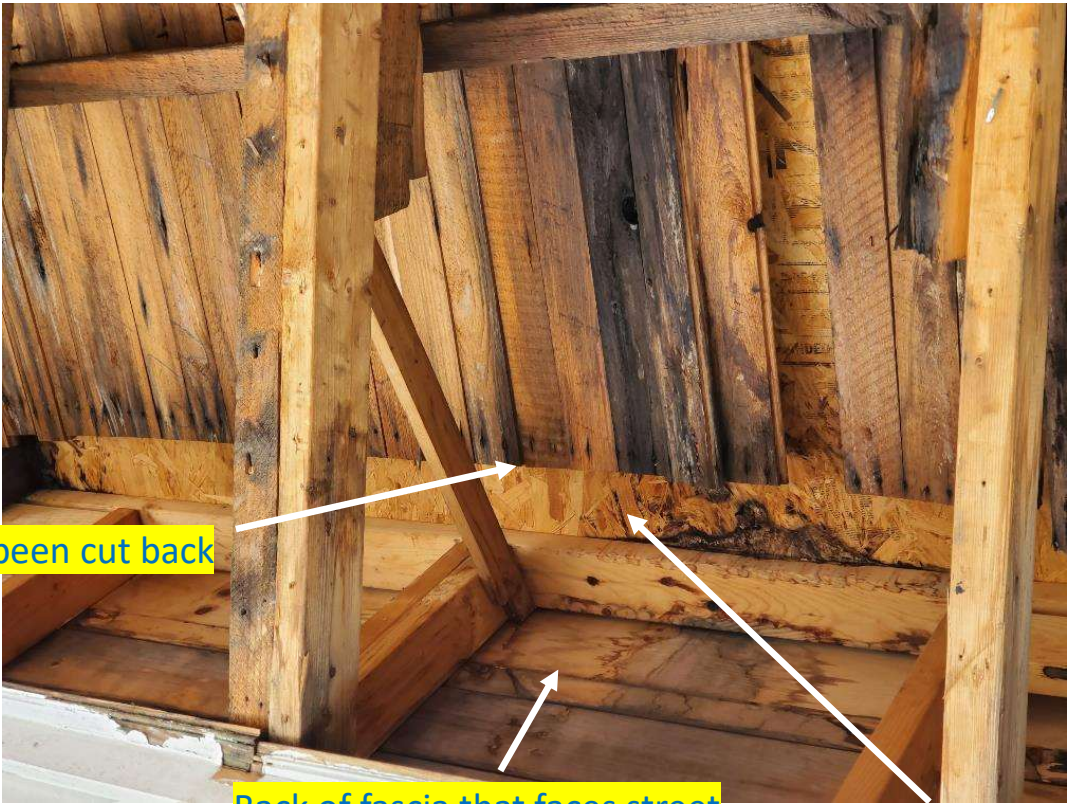
Side 4 - 7102 Maple Ave – OSB flooring and original tongue and groove cut

Original T&G has been cut back

Back of fascia that faces street

OSB

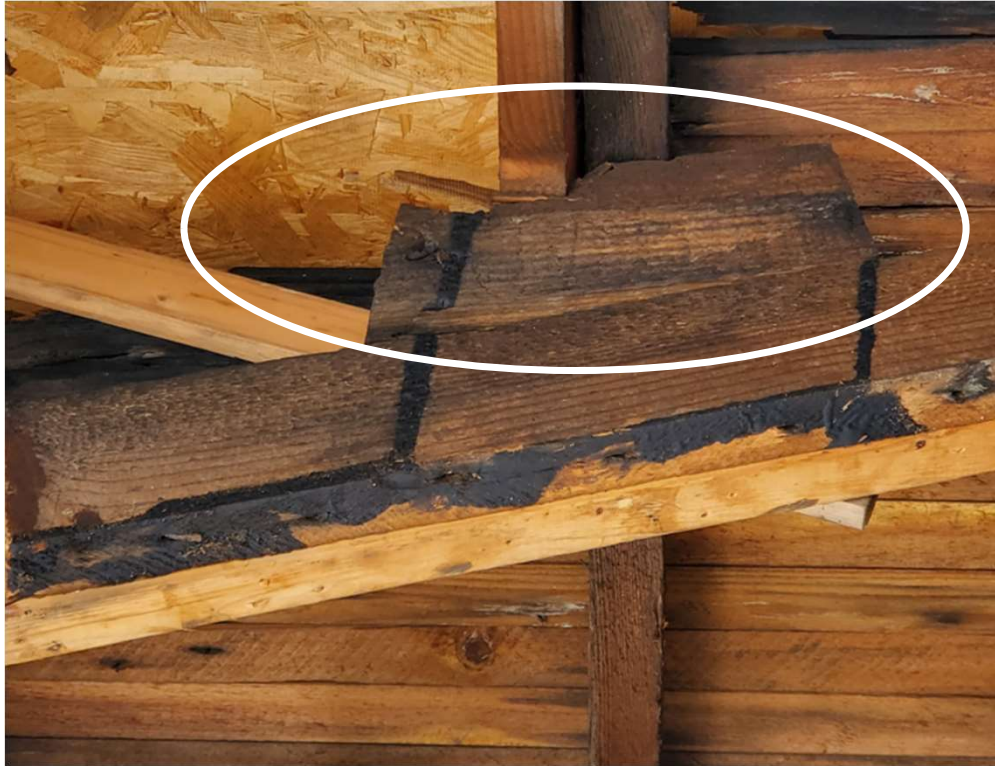
**Photo 5 - 7102 Maple Ave – odd shaped shims holding up 20 Foot long 2x4s**

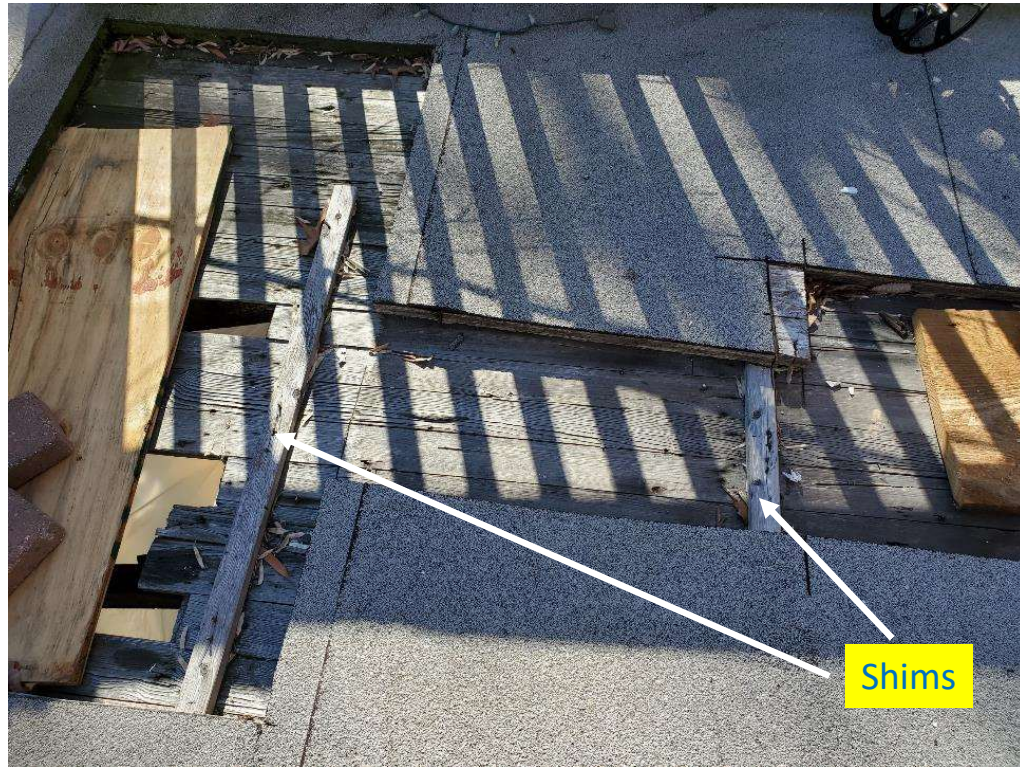
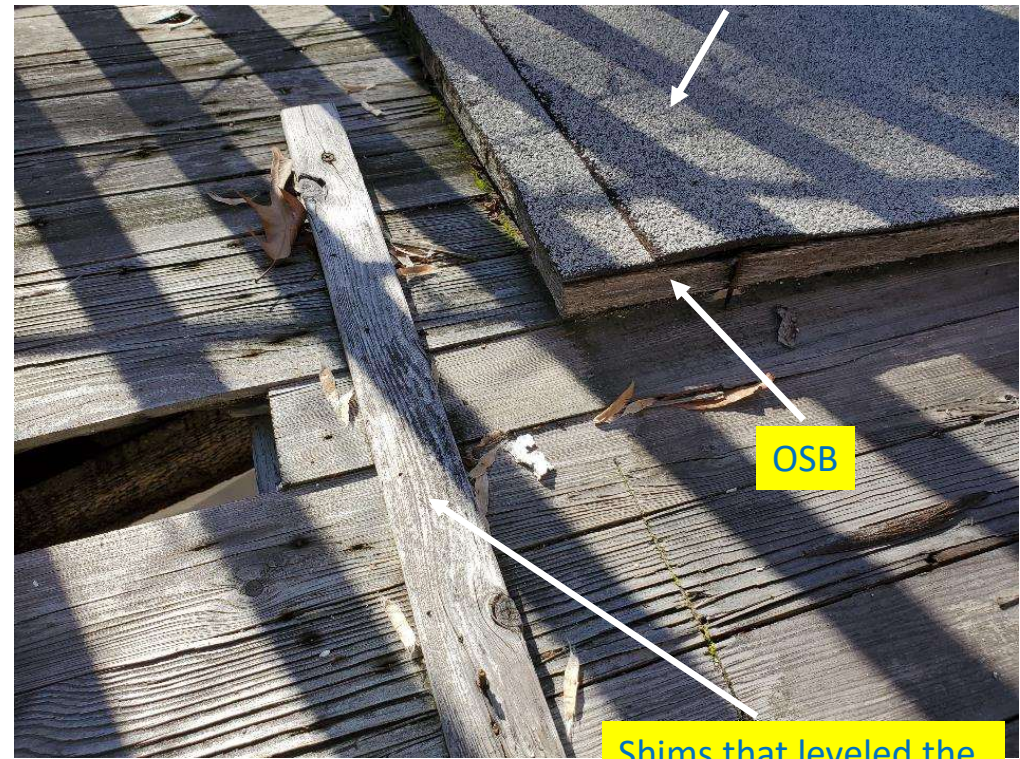
Photo 6 - 7102 Maple Ave – Upper Porch-T&G-OSB-Shims

Asphalt roofing material

OSB

Shims that leveled the altered flooring

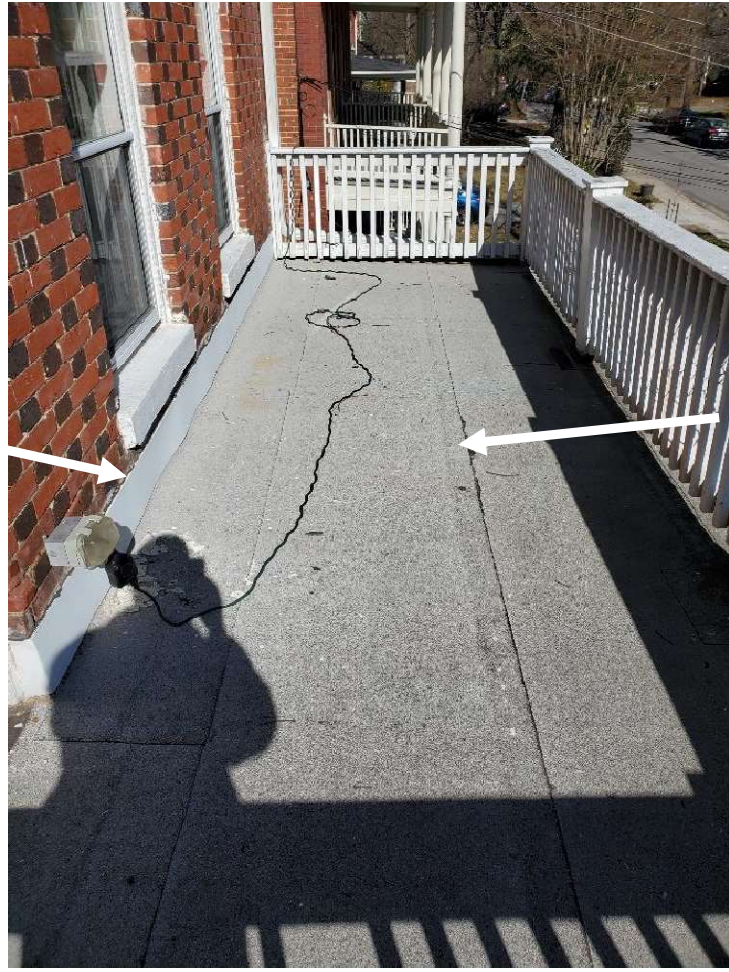
**Photo 7 - 7102 Maple Ave – Asphalt roofing material**

Flashing

Asphalt roofing material  
Unsuitable for foot traffic

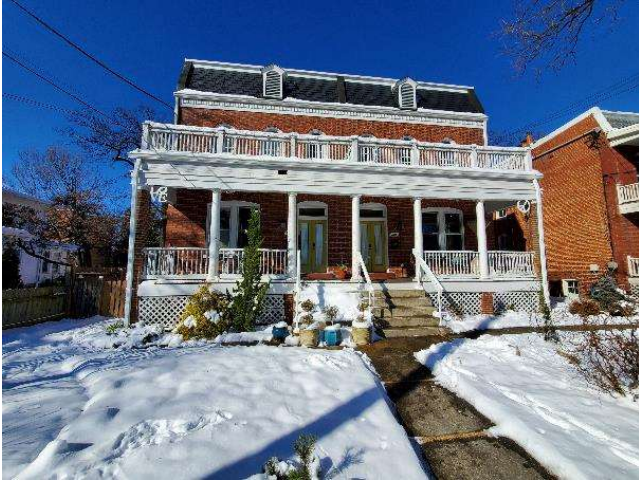
7102-4 Maple Ave – Fascia

1. Fascia @ 7102-04 Maple is more than twice as tall as others.
2. Columns @ 7102-04 Maple are shorter than others.
3. 7102-04 portion of ceiling closest to building is likely original as it is below original joists. Also, brick is below ceiling is clean—no paint to indicate ceiling has been raised.
4. 7106-08 Maple ceiling is shorter but columns are taller than 7102-04 Maple.

## Photo 8 Fascia Comparisons

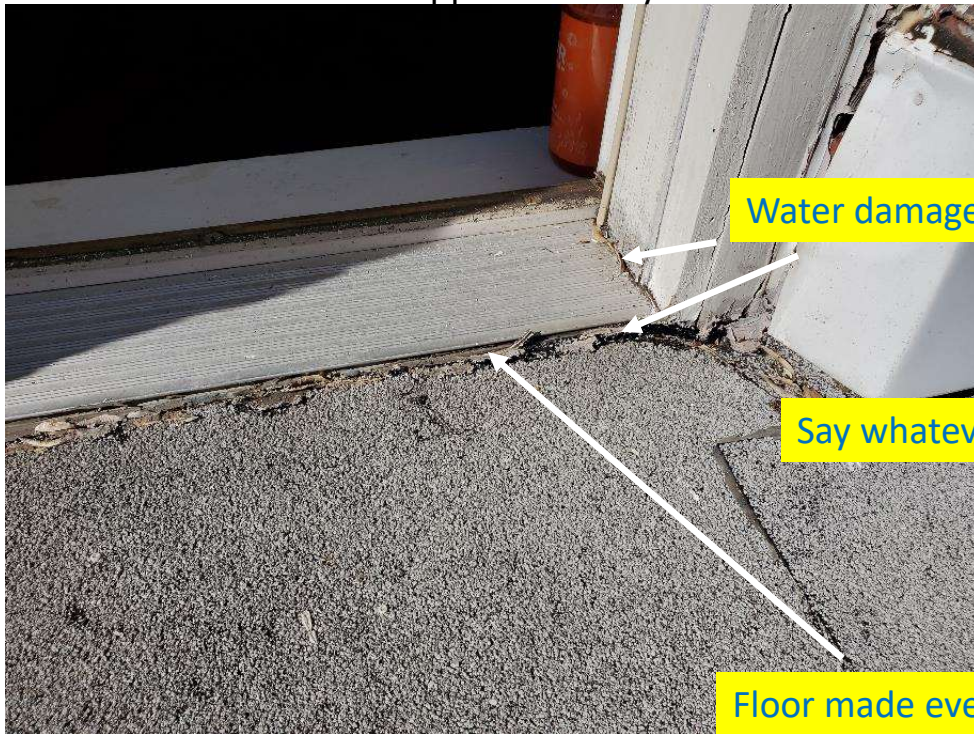
7102 Upper Doorway

- (2) One-inch thick OSB plywood was installed on top of the remaining T&G as well as over the area where T&G was removed.
- (3) An original slope on the upper-floor causing water to move away from the house was eliminated when OSB was installed level with the thresholds of two doors. This alteration resulted in watering puddling on the floor as well as leaking through the doors into the house. (Photo 6,9)

**Photo 9 - 7102 Maple Ave – Upper porch doorways**

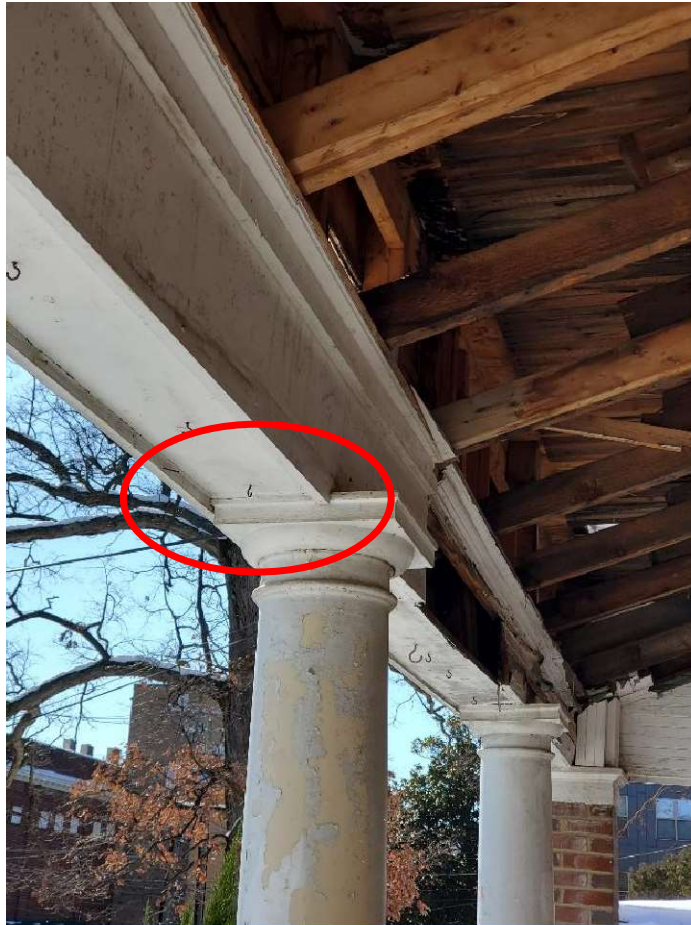
**Photo 10 - 7102 Maple Ave – off center beam**

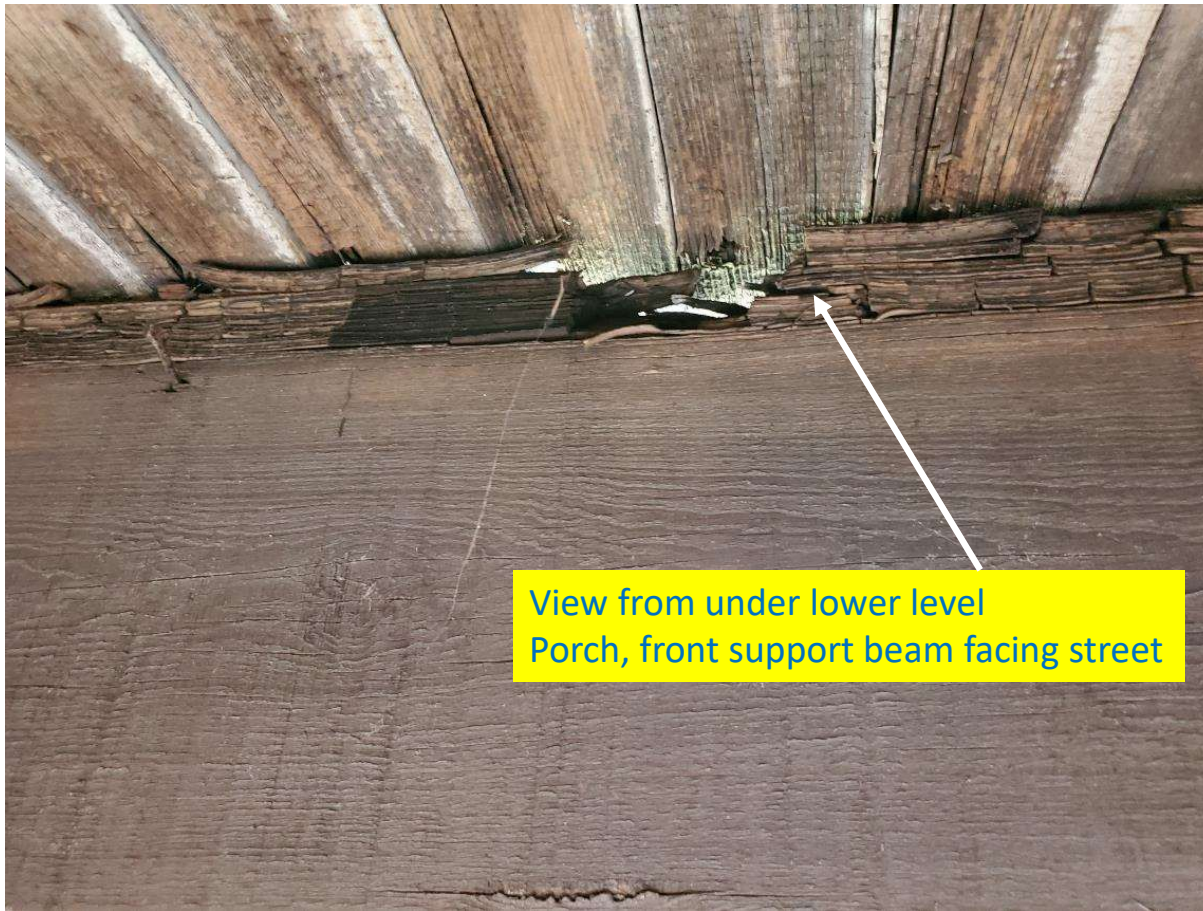
**Photo 11 - 7102 Maple Ave – lower porch floor joist rot**

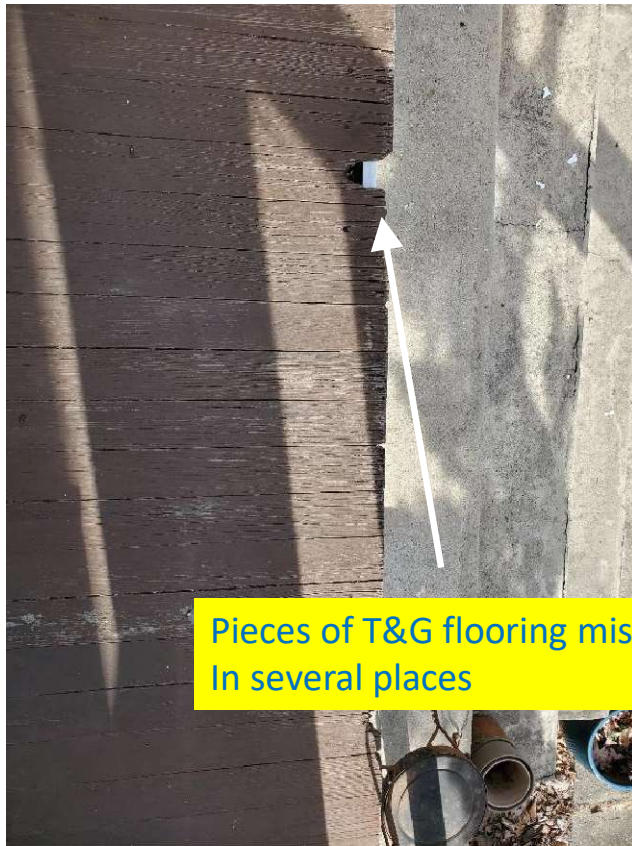
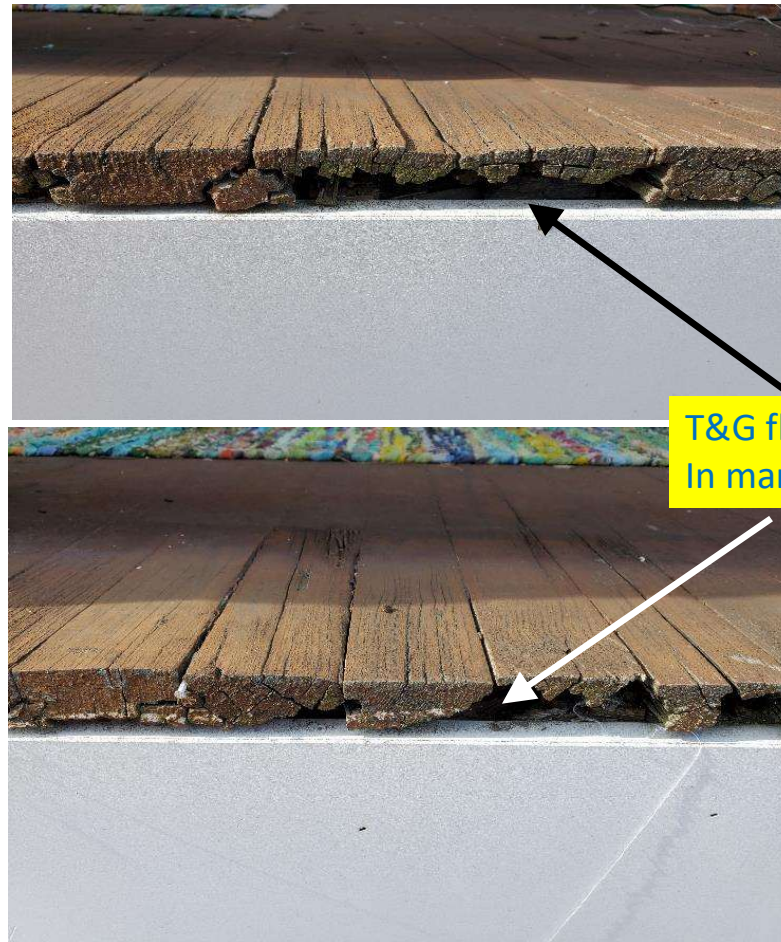
Photo 12 - 7102 Maple Ave – lower porch floor rot

Pieces of T&G flooring missing  
In several places

T&G flooring deteriorating  
In many places

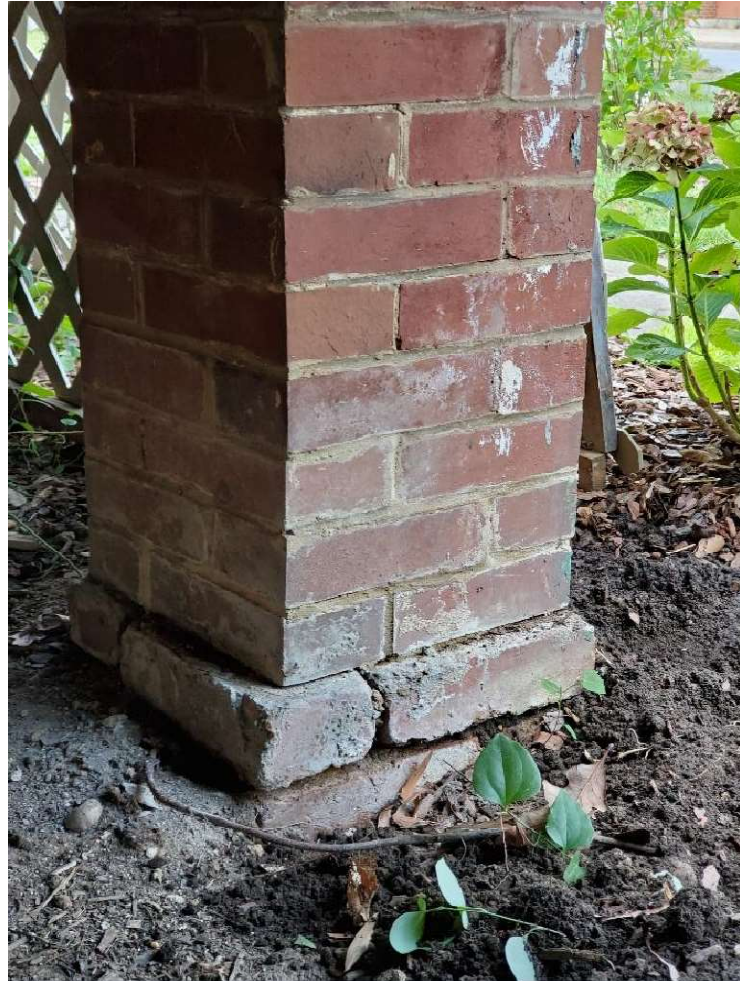
- (1) Brick piers and their foundations (6) are missing mortar or/and brick. (Photo 13,18)
- (2) Wood is deteriorating or missing and paint is peeling on and around doors (4 (2 double)), thresholds, eight windows and trim.
- (3) Railings along steps are unsafe (no fall protection between railing posts). (Photo 14)

**Photo 13 - 7102 Maple Ave – brick pier base**

- (1) Repoint/repair brick piers and their foundations.
- (2) Repair two double doors and windows.
- (3) Repair stair railings to 2024 code.
- (4) Prime and paint (2 coats).

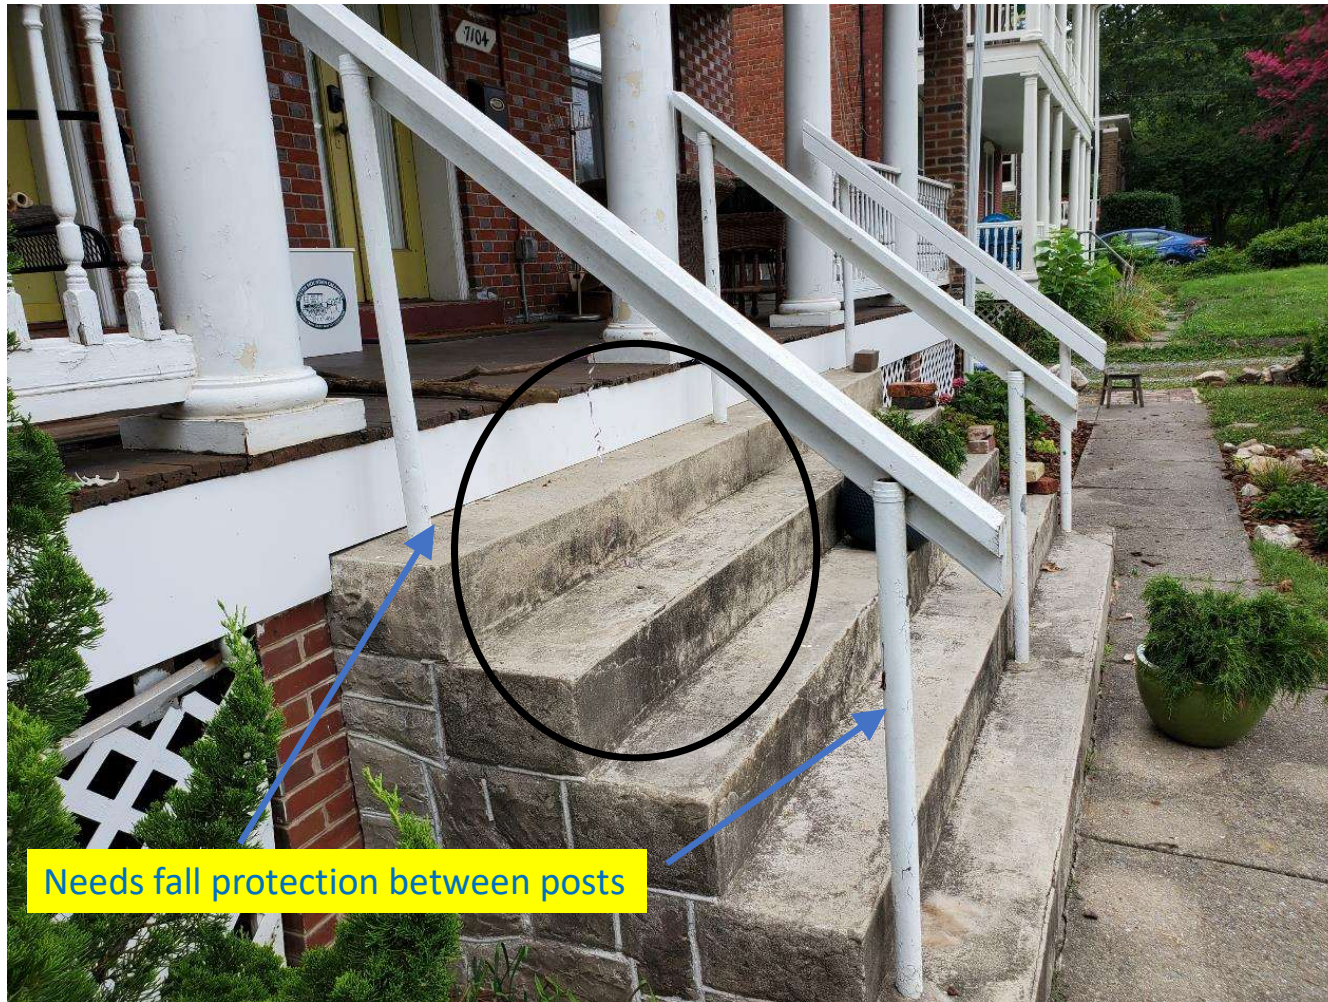
**Photo 14 - 7102 Maple Ave – steps showing no fall protection**

Needs fall protection between posts

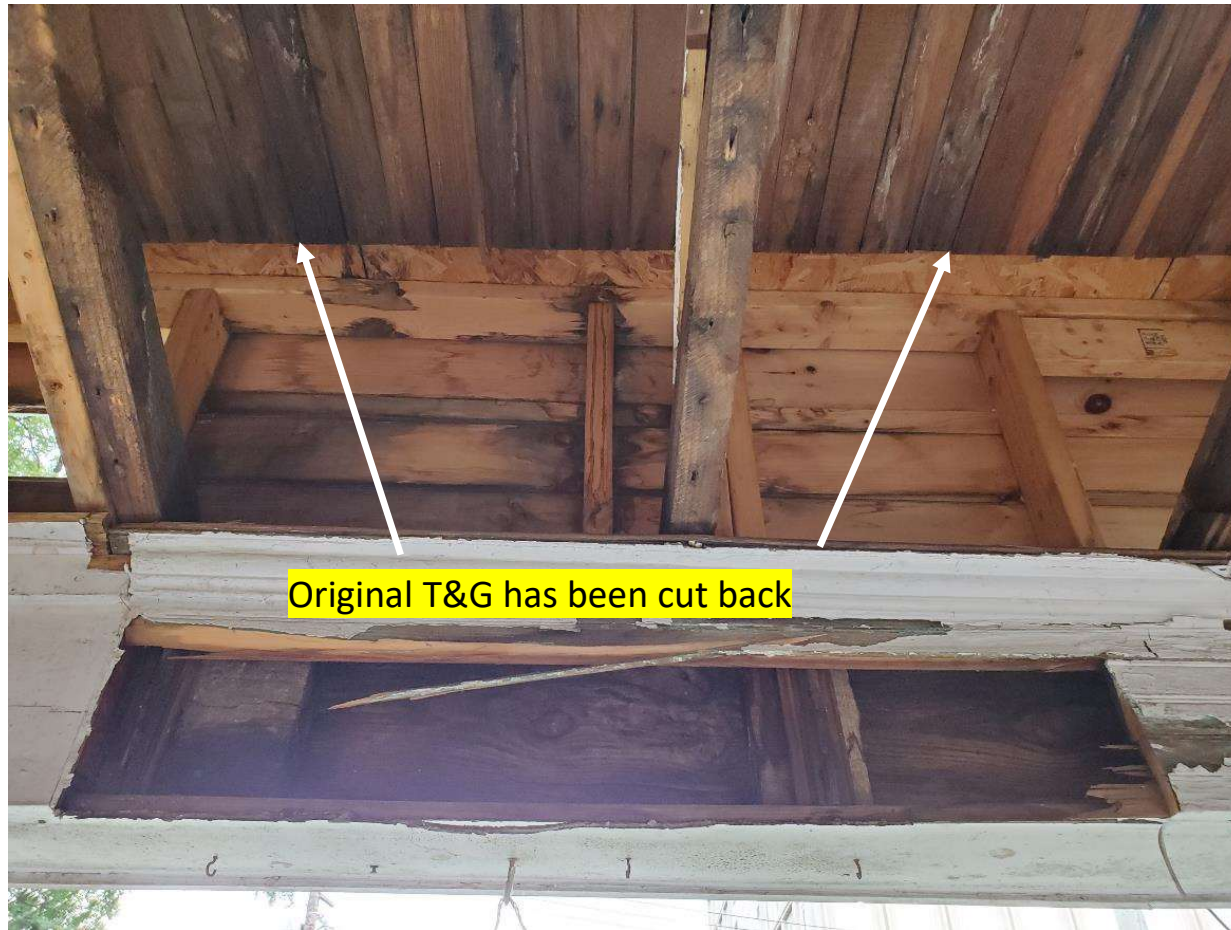
**Photo 16 - 7102 Maple Ave – ‘wall’ above support beam**

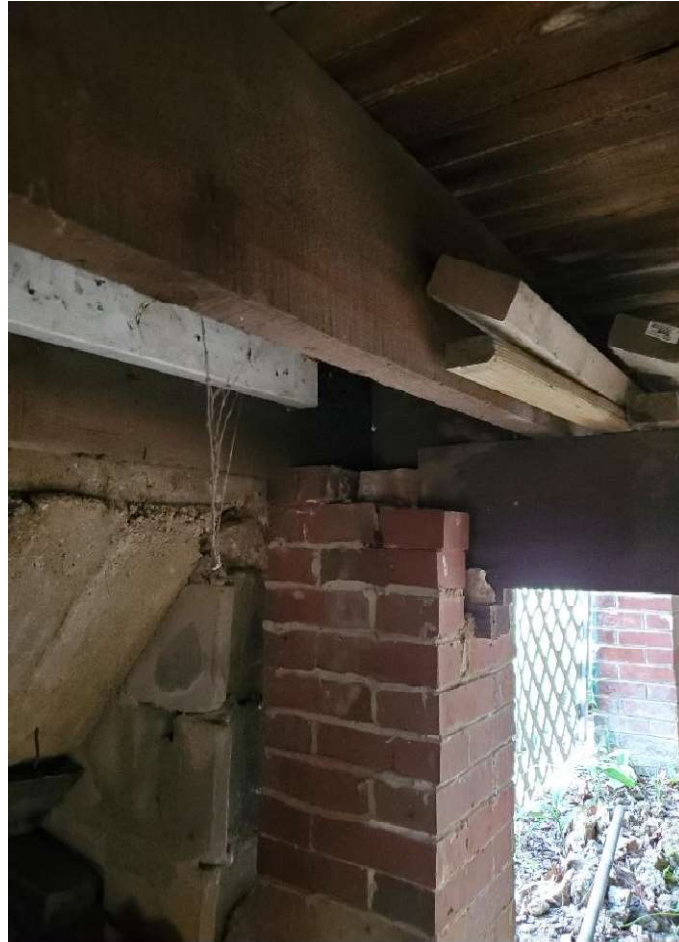
**Photo 18 - 7102 Maple Ave – brick pier**

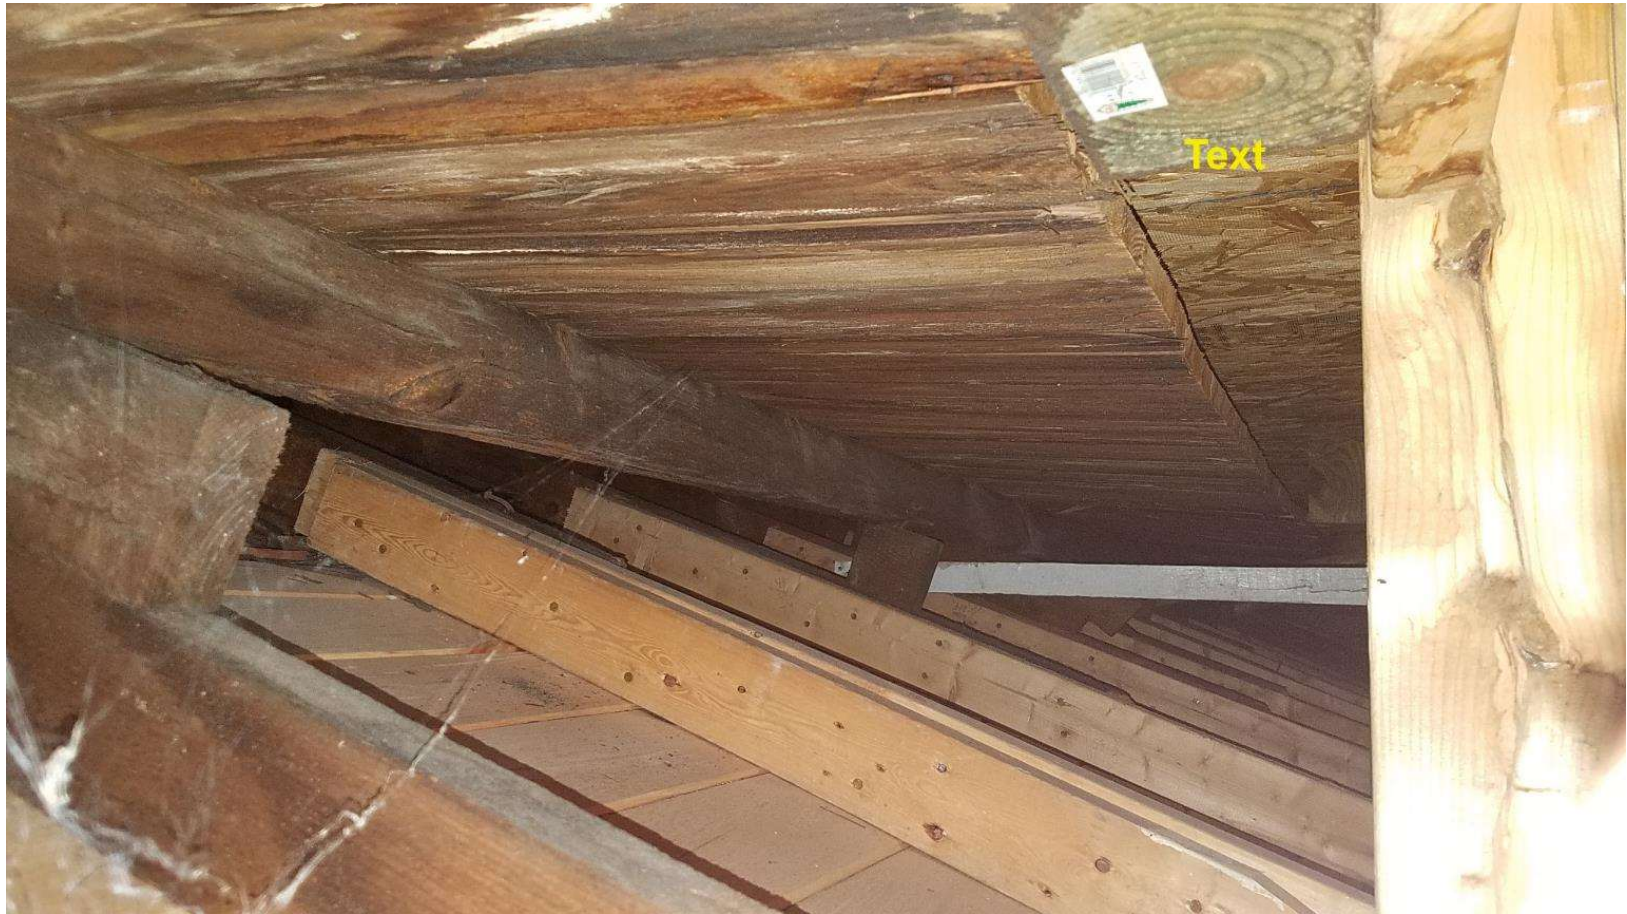
- (5) A beam that would have run lengthwise likely burned, and a 2x4 was installed to replace it. OSB was attached to the 2x4. (Photo6)
- (6) Joist segments (3') cut from original joists were reattached to them at an angle toward the columns. The joists portions were made long enough to reach and be attached to the beam resting on top of the columns by sistering longer 2x4s to them. (Photo19)

Photo 19 - 7102 Maple Ave – Hechinger label, junk wood
