## HISTORIC PRESERVATION COMMISSION

SUBJECT: Historic Area Work Permit #1164669– Masonry restoration, window restoration, door replacement, and trim repairs

Applicant: Town of Brookeville; Andrea Scanlon (Agent)  
Address: 5 High Street, Brookeville

Work Item 1A Brookeville Academy - stone facade

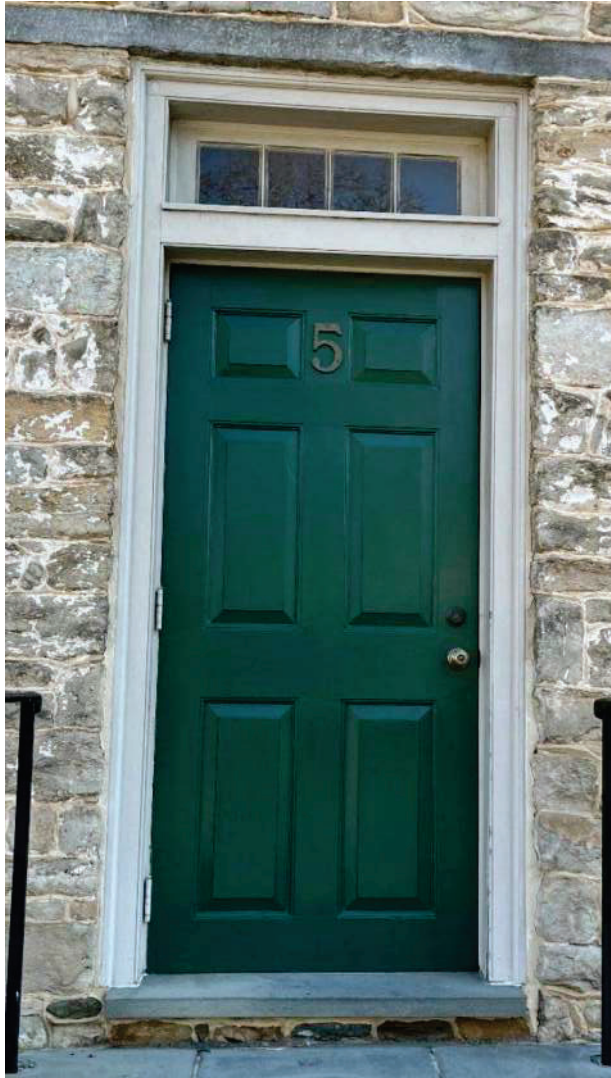
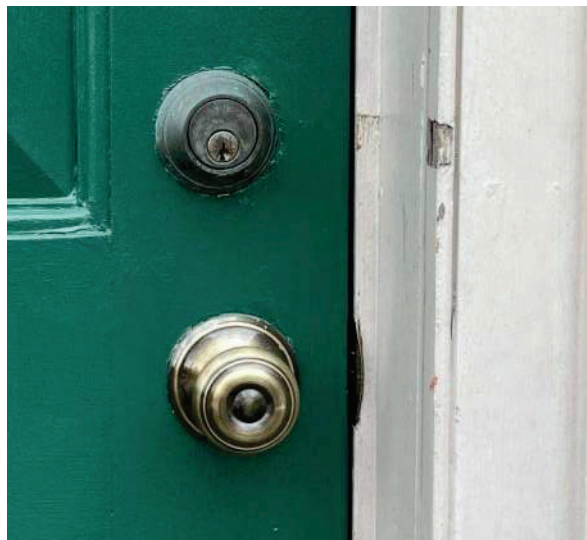
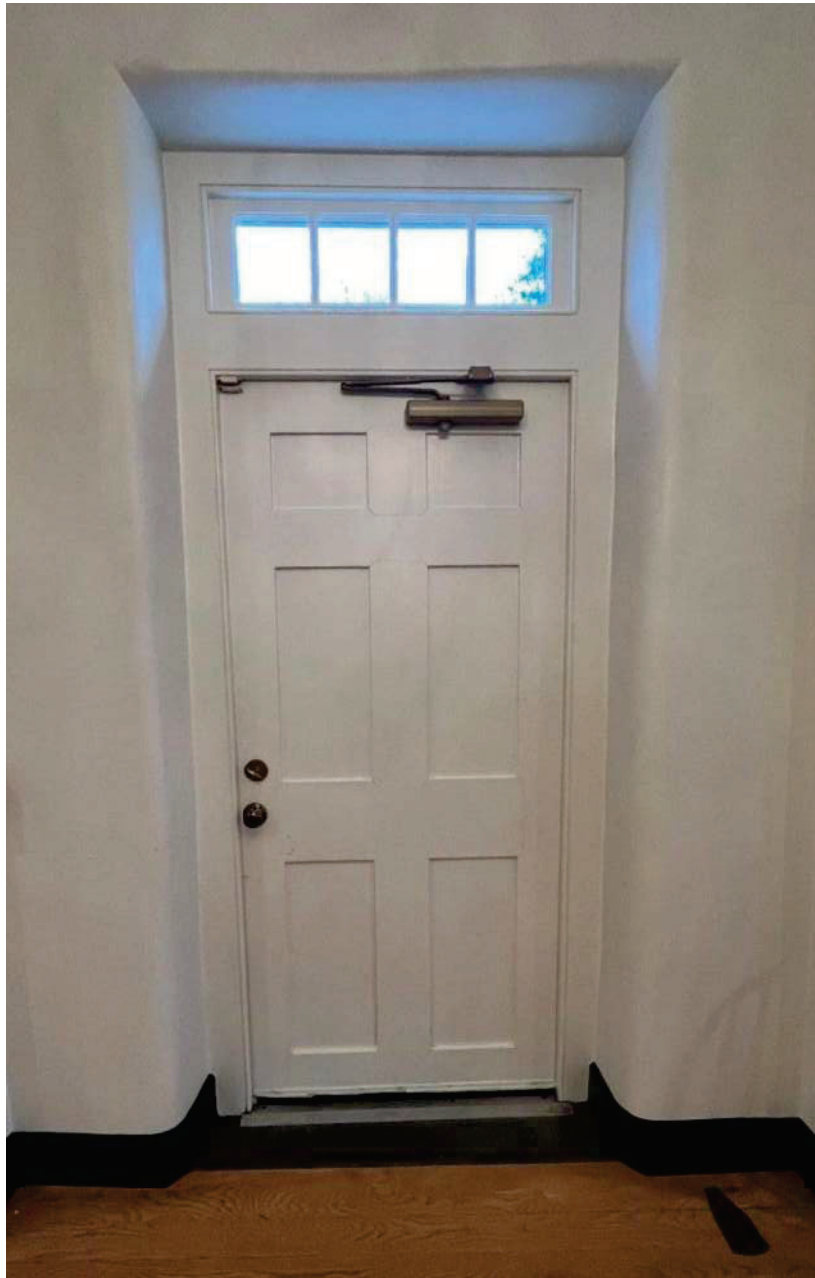
The front door was installed in 1996 with modern brass hardware.

- Replace front door with wooden, period-appropriate door (see attached); the glass lites over the door are to remain
- Replace hardware at front door with period-appropriate hardware (see attached)
- Paint door and trim
- Replace hardware at side door
- Paint door and trim

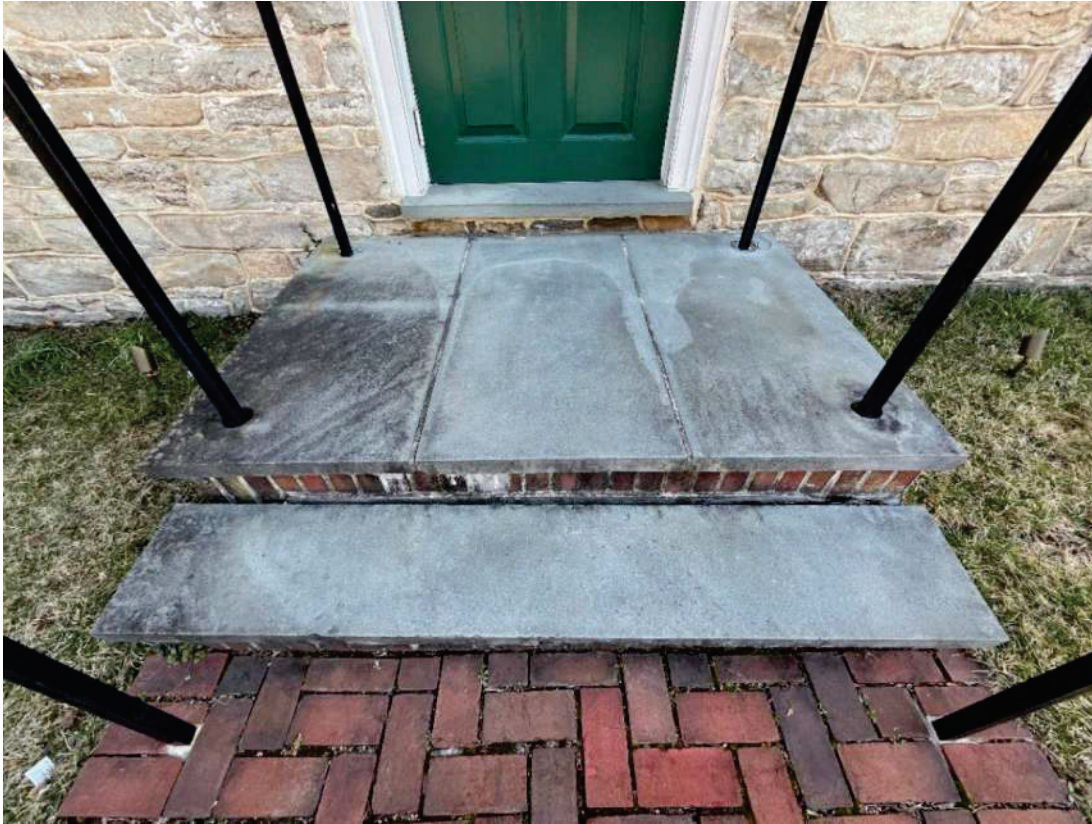
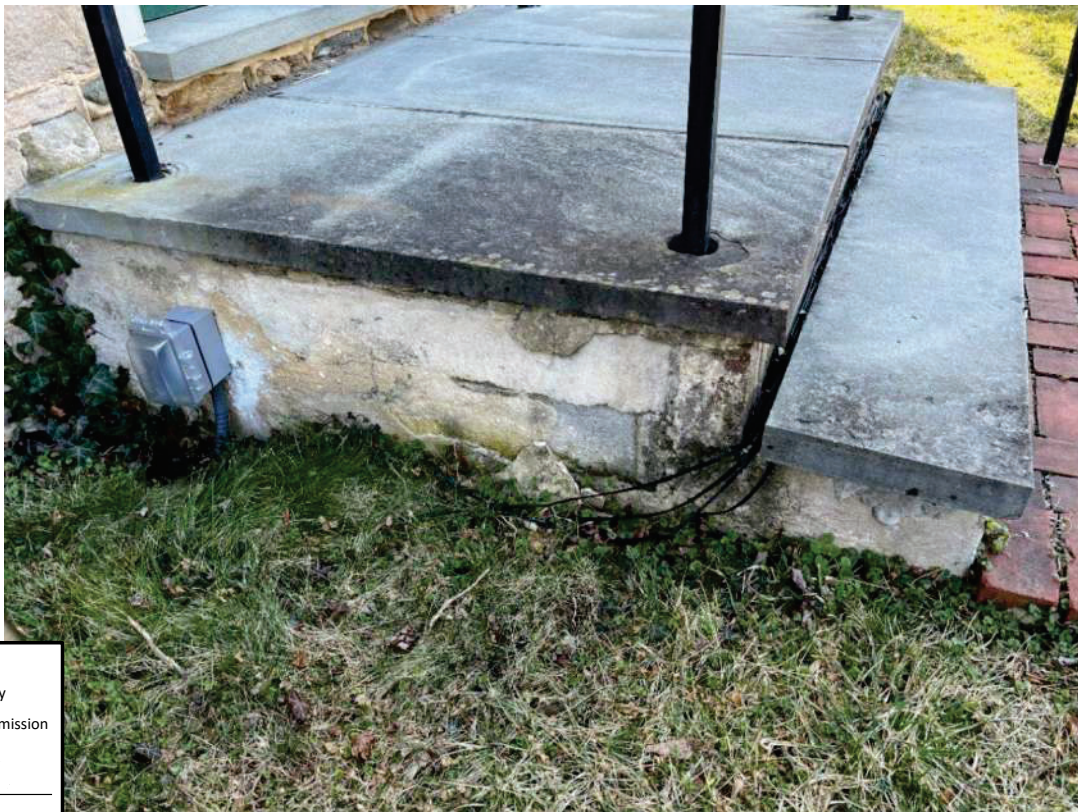
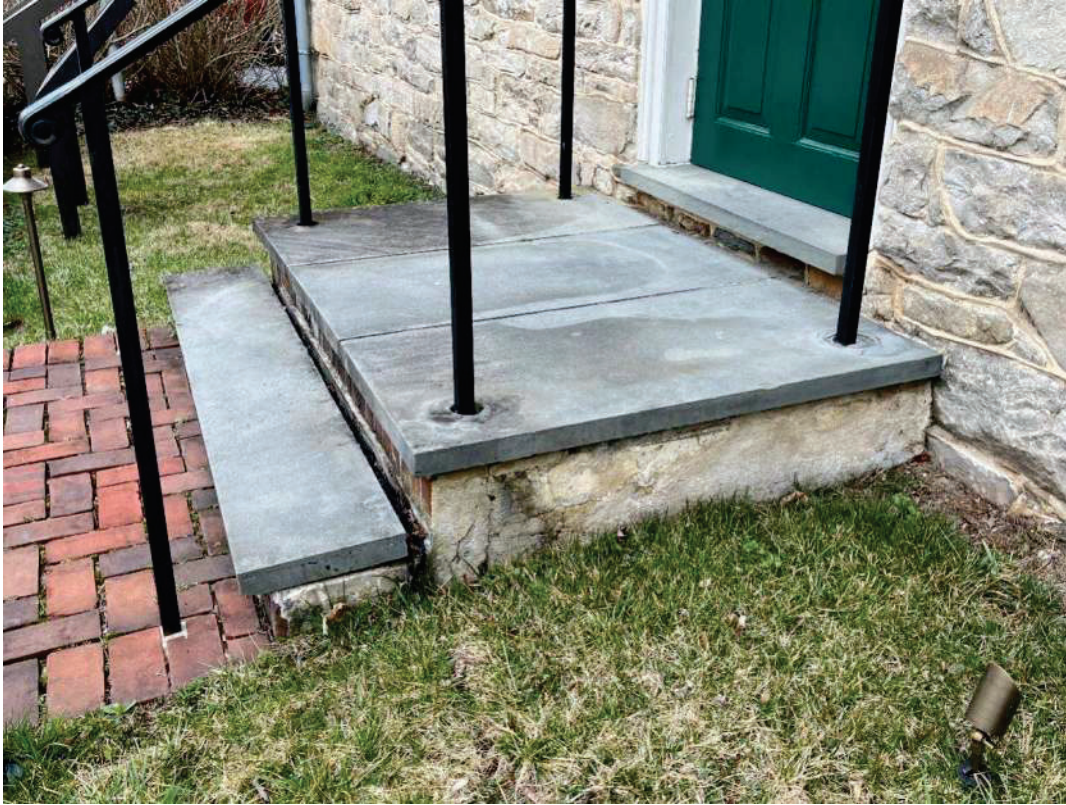
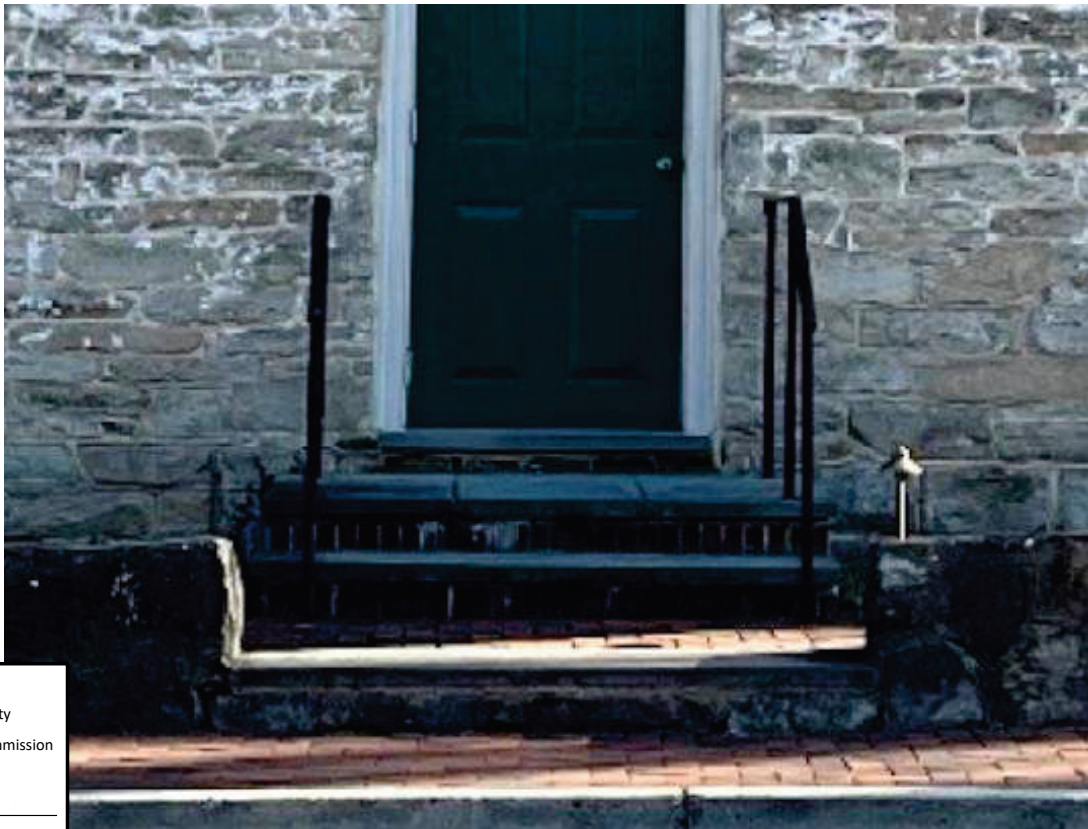
The stone steps and metal railing were installed in 1996. The stone joints have separated and the parging at the side of the steps is failing.

- Re-set stone steps
- Repair or replace parging
- Re-grout railing into stone
- Clean and re-paint railing

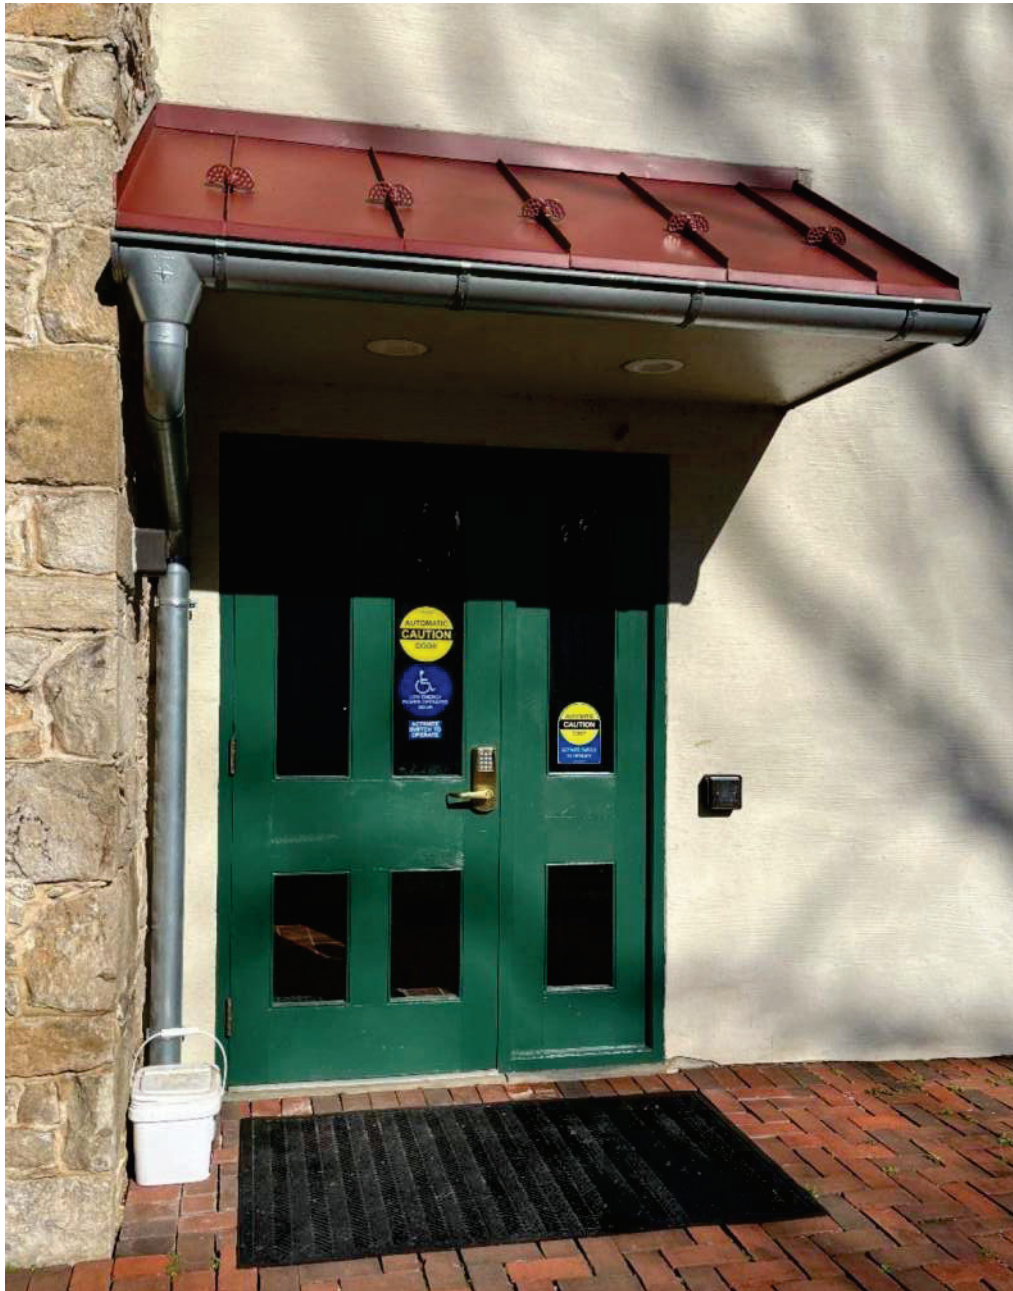
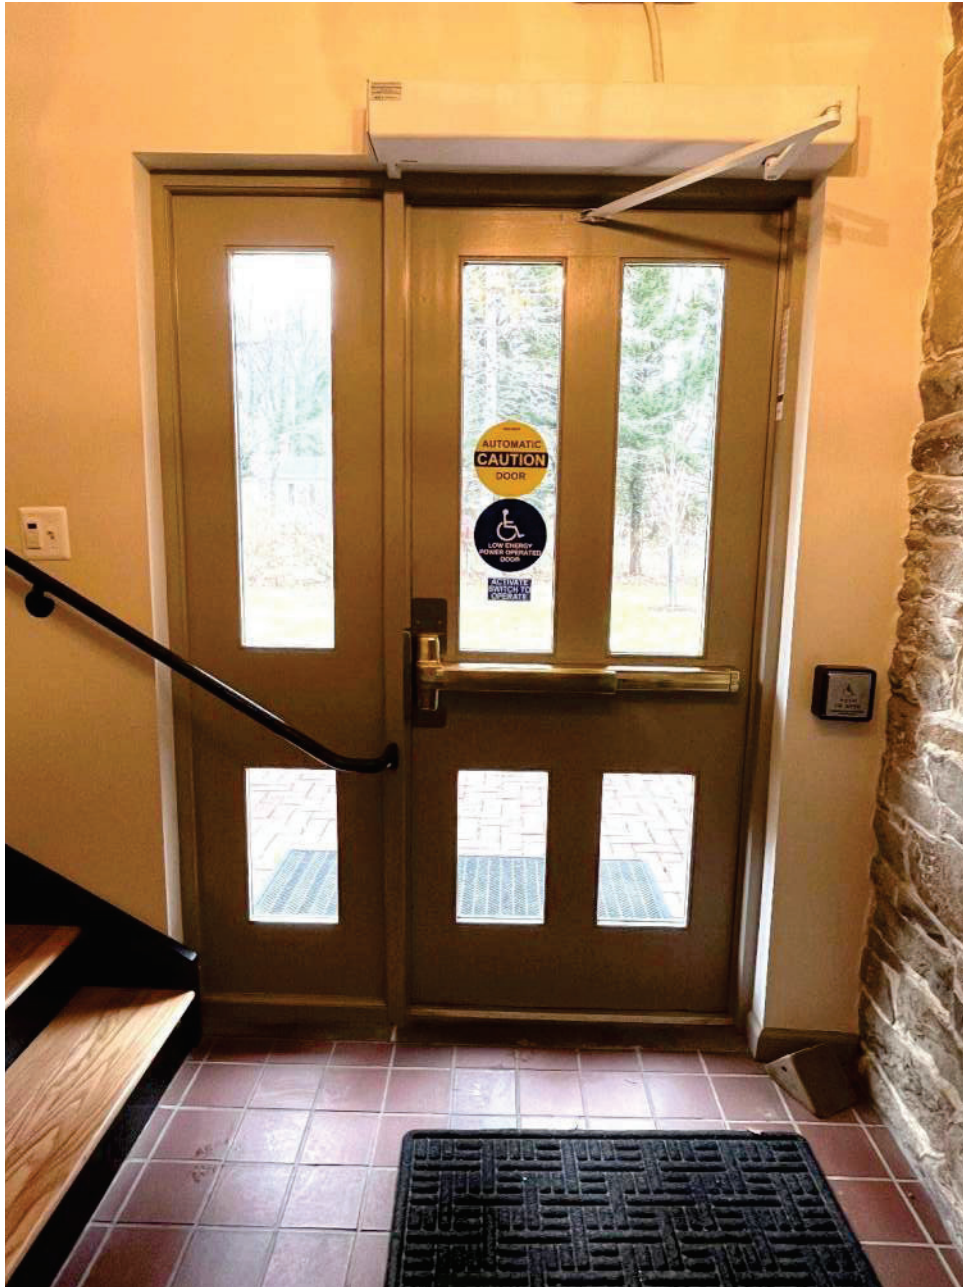
The side door, which was installed in 1996 is a modern door with a glass sidelite and modern brass hardware. An electronic keypad and automatic door operator have been added for accessibility.

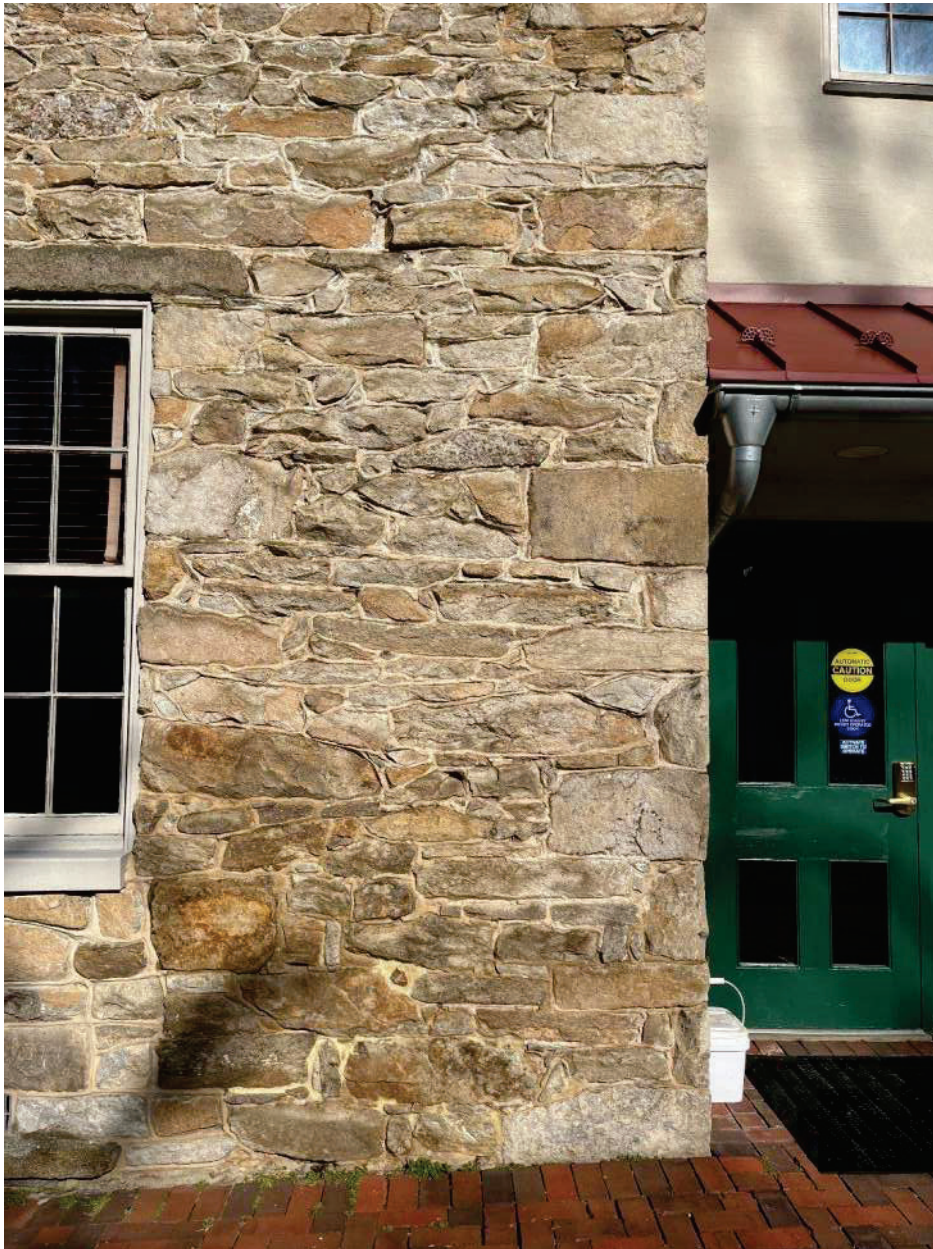
The masonry facade dates back over 210 years, and the last time it was re-pointed was in 1996, when the rear addition was constructed. The failing mortar is allowing moisture to infiltrate the facade, which is collecting at the bottom of the wall. This moisture is causing the interior paint to peel and plaster to fail.

Photo 18 - Masonry Façade Showing Moisture

- Re-point entire masonry facade with appropriate lime based mortar.
- All work is to be performed per the standards in the US Department of the Interiors Standards for the Treatment of Historic Properties.

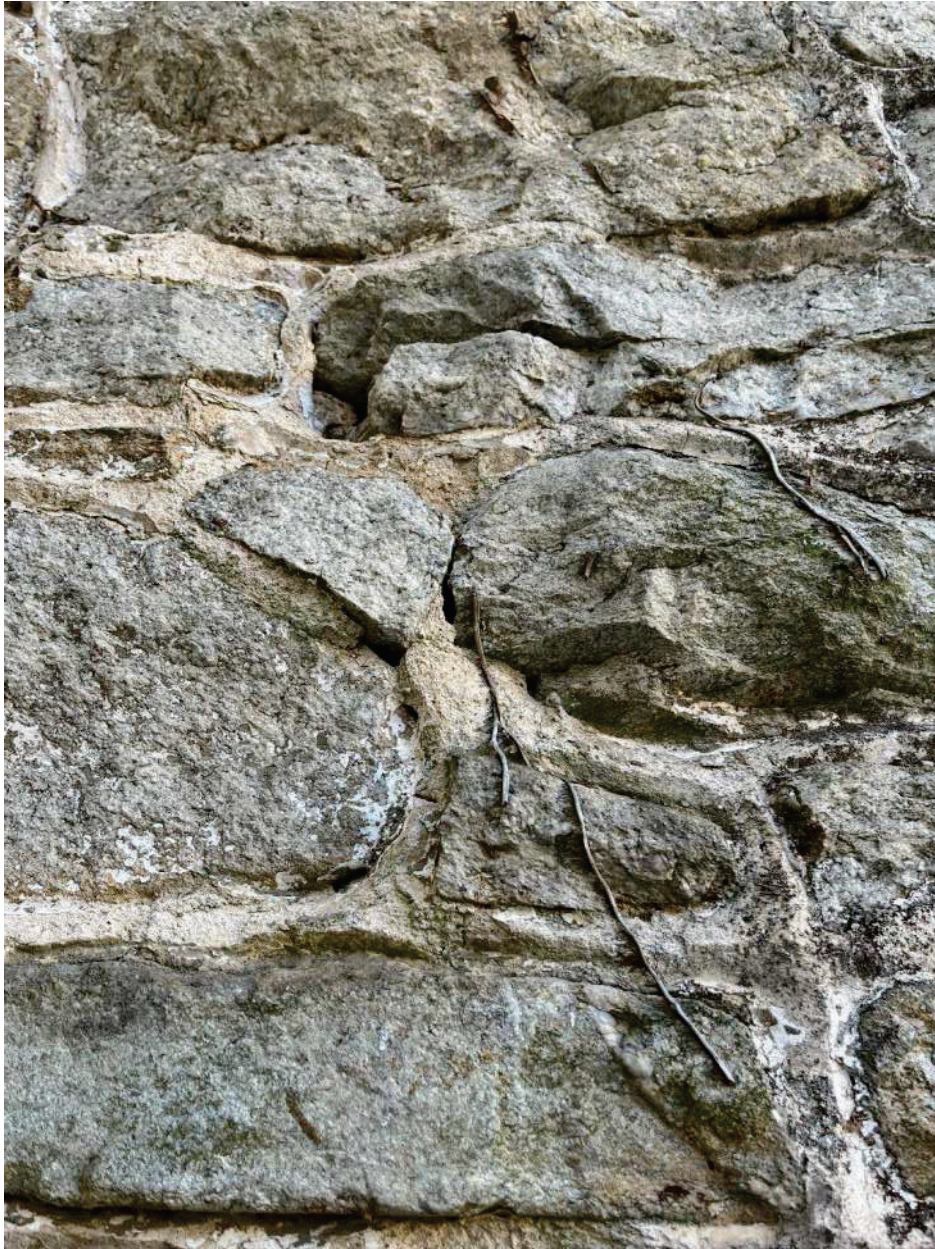
Photo 19 - Masonry Façade Close-Up 1

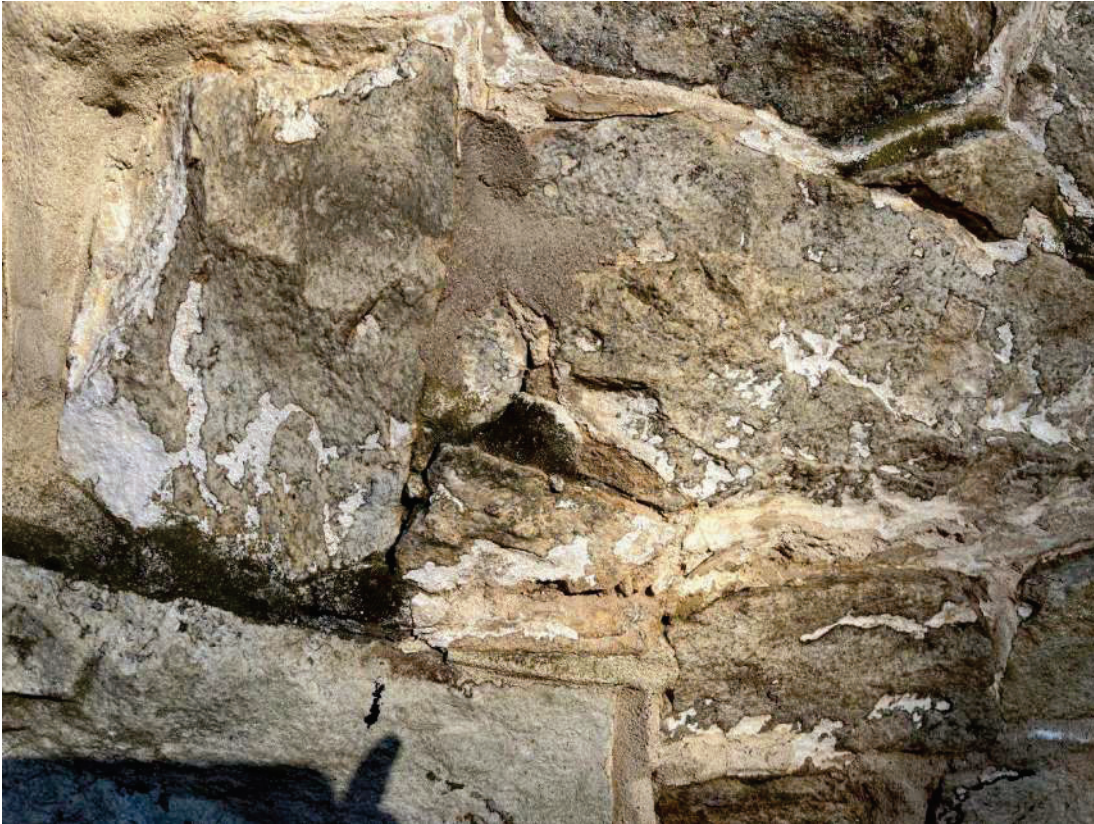
Photo 20 - Masonry Façade Close-Up 2

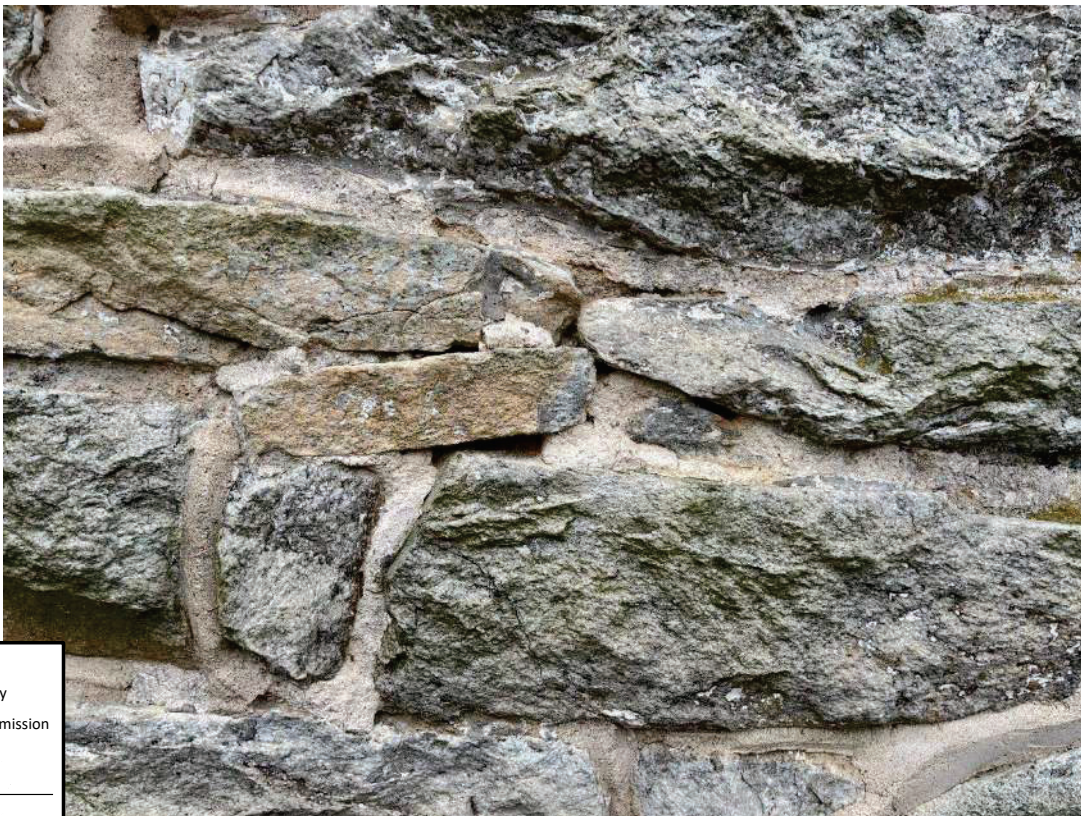
Photo 21 - Masonry Façade Close-Up 3

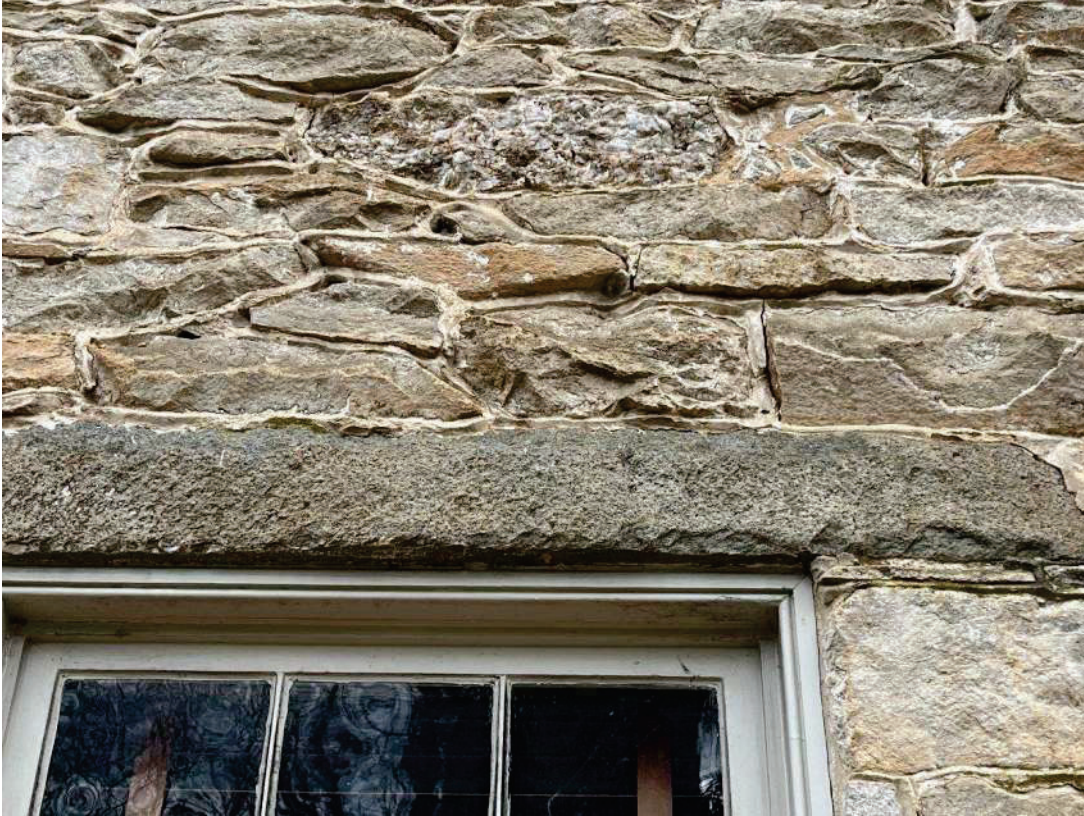
Photo 22 - Masonry Façade Close-Up 4

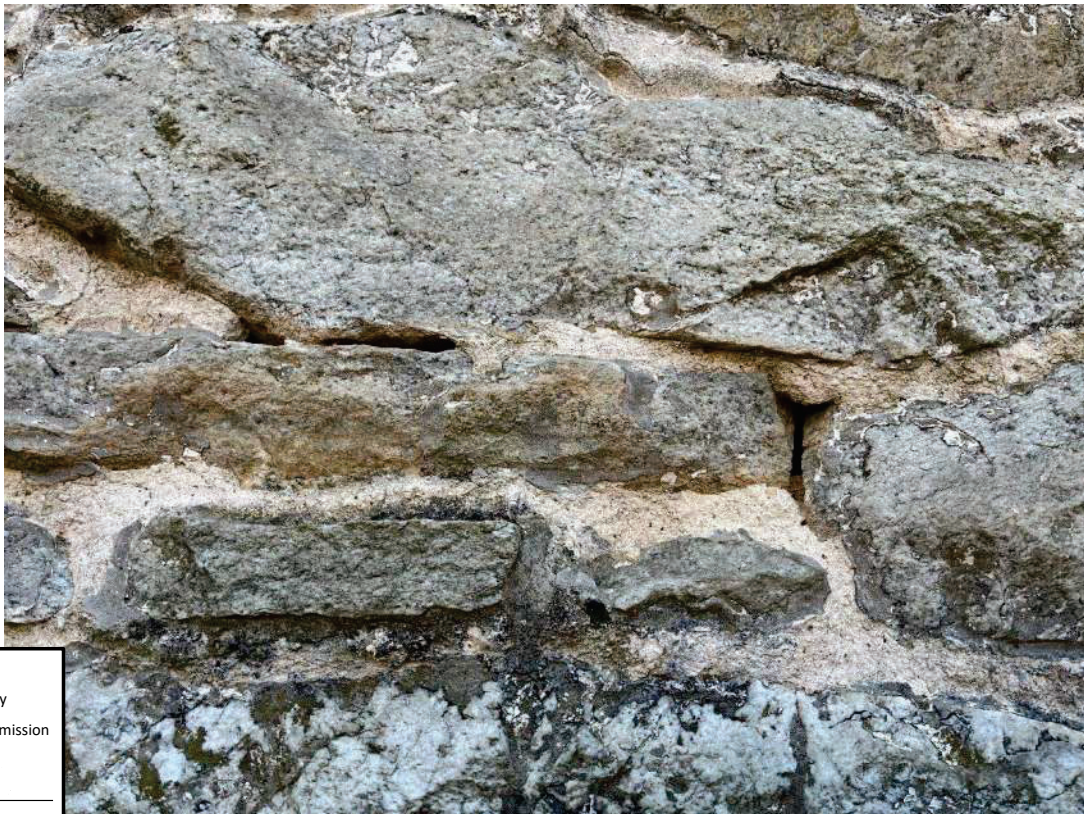
Photo 23 - Masonry Façade Close-Up Showing Missing Mortar

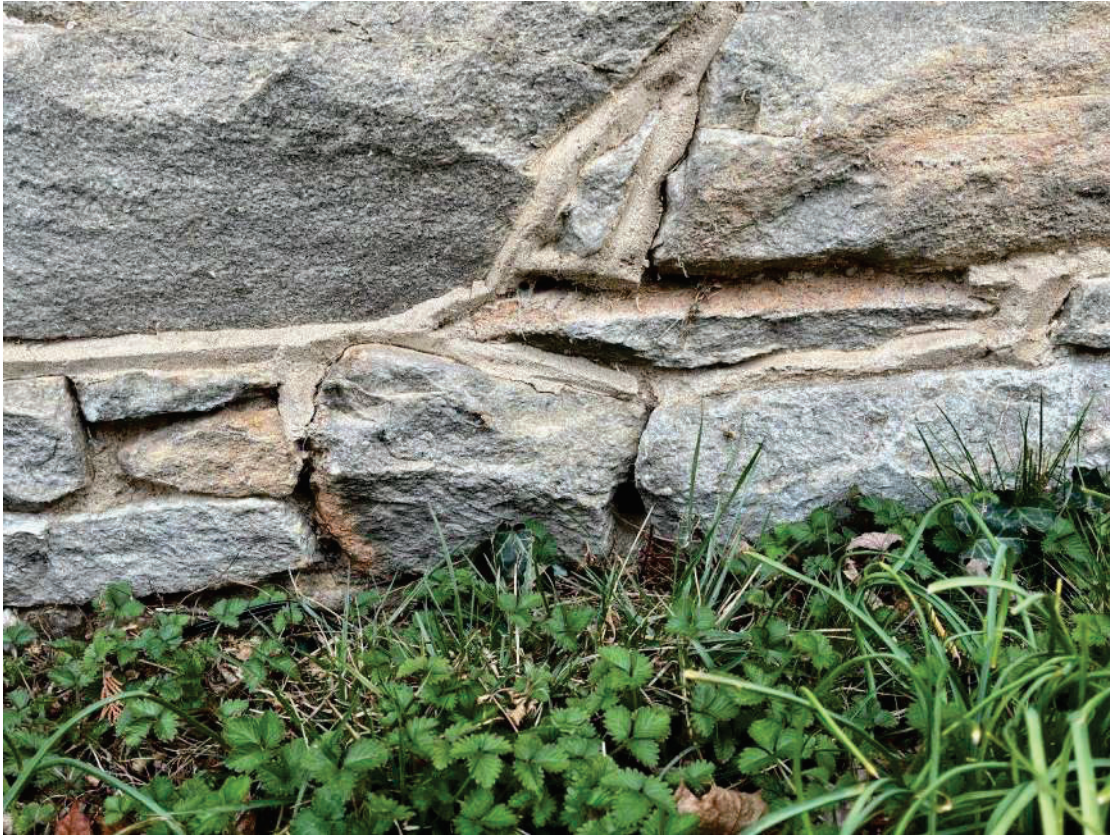
Photo 24 - Masonry Façade Close-Up Showing Missing Mortar

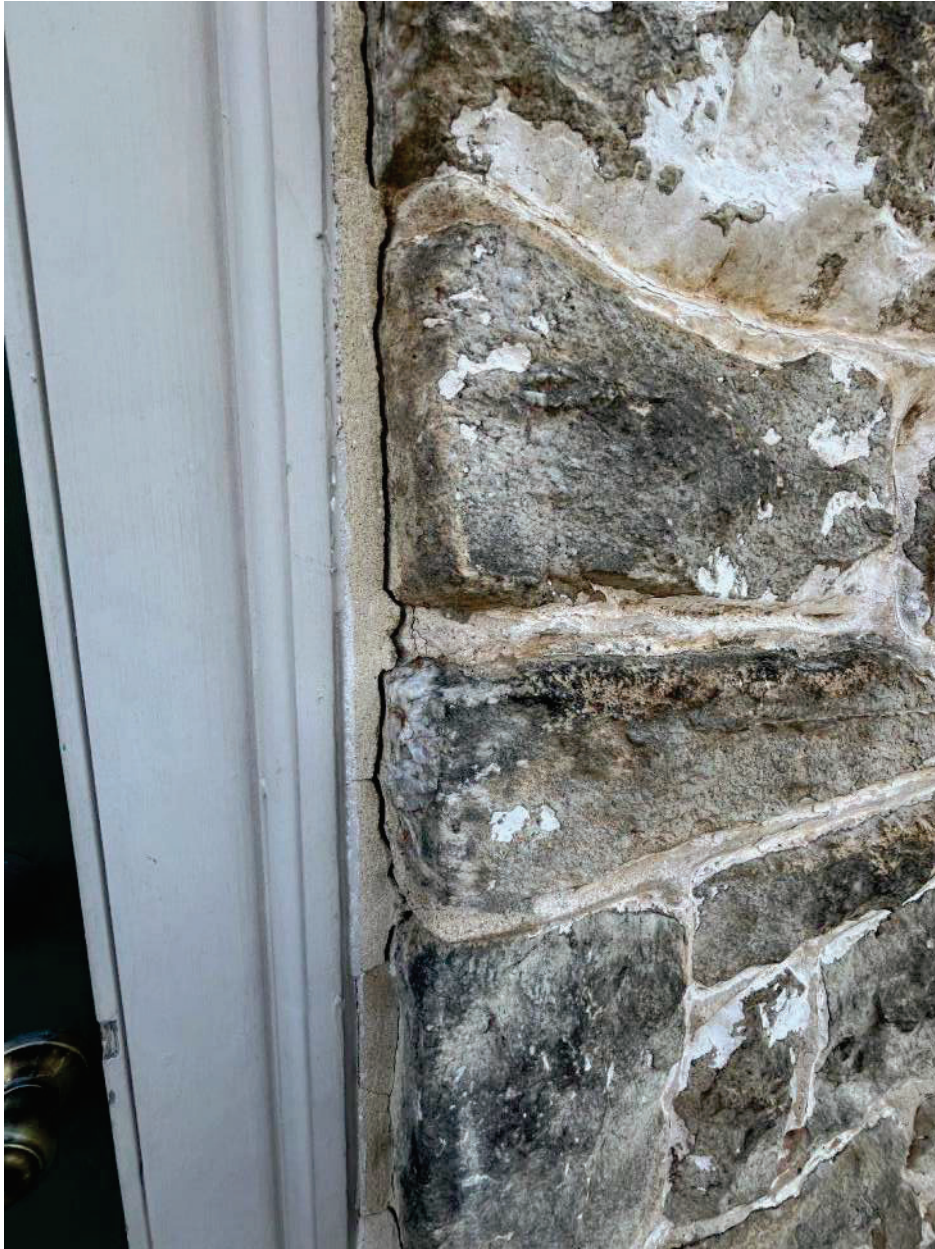
Photo 25 - Masonry Façade Close-Up Showing Mortar Cracks
