## HISTORIC PRESERVATION COMMISSION

SUBJECT: Historic Area Work Permit #1164669– Masonry restoration, window restoration, door replacement, and trim repairs

Applicant: Town of Brookeville; Andrea Scanlon (Agent)  
Address: 5 High Street, Brookeville

Work Item 1A Brookeville Academy - stone facade

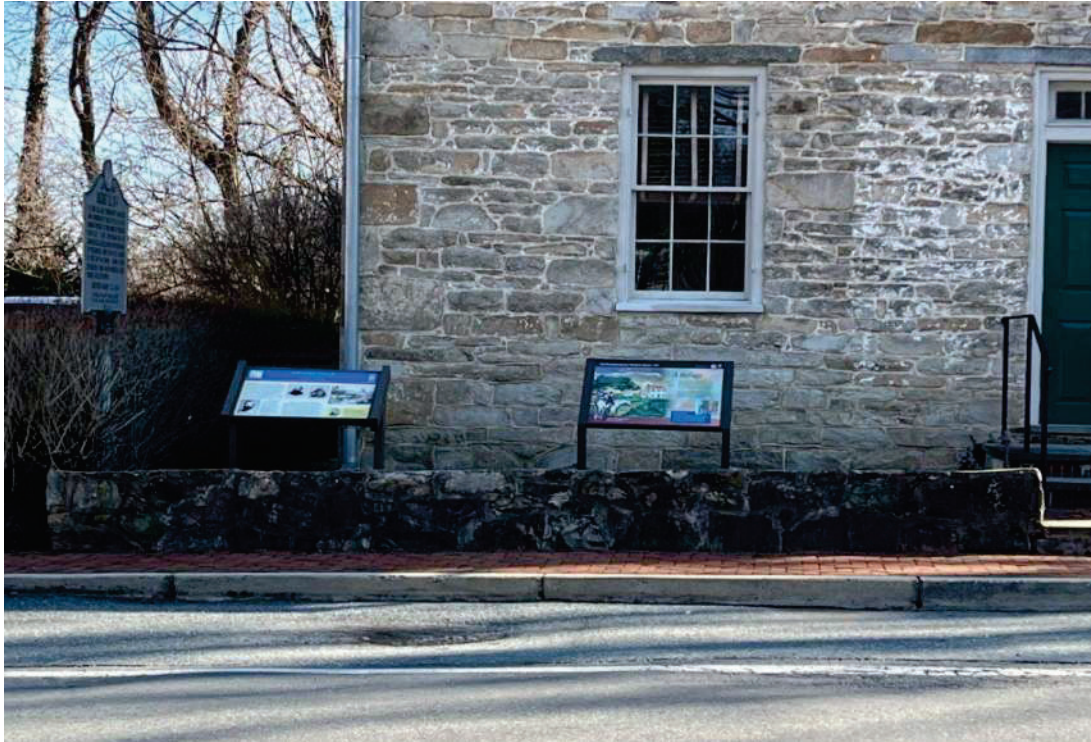
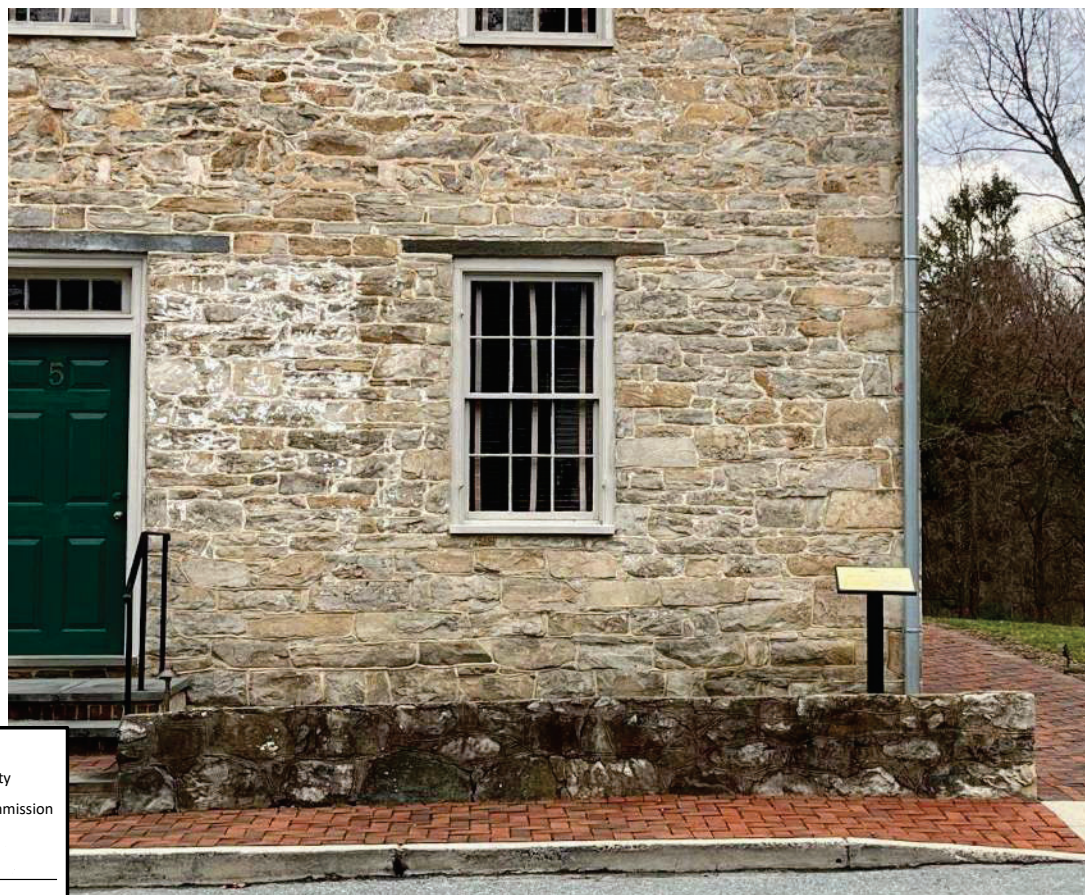
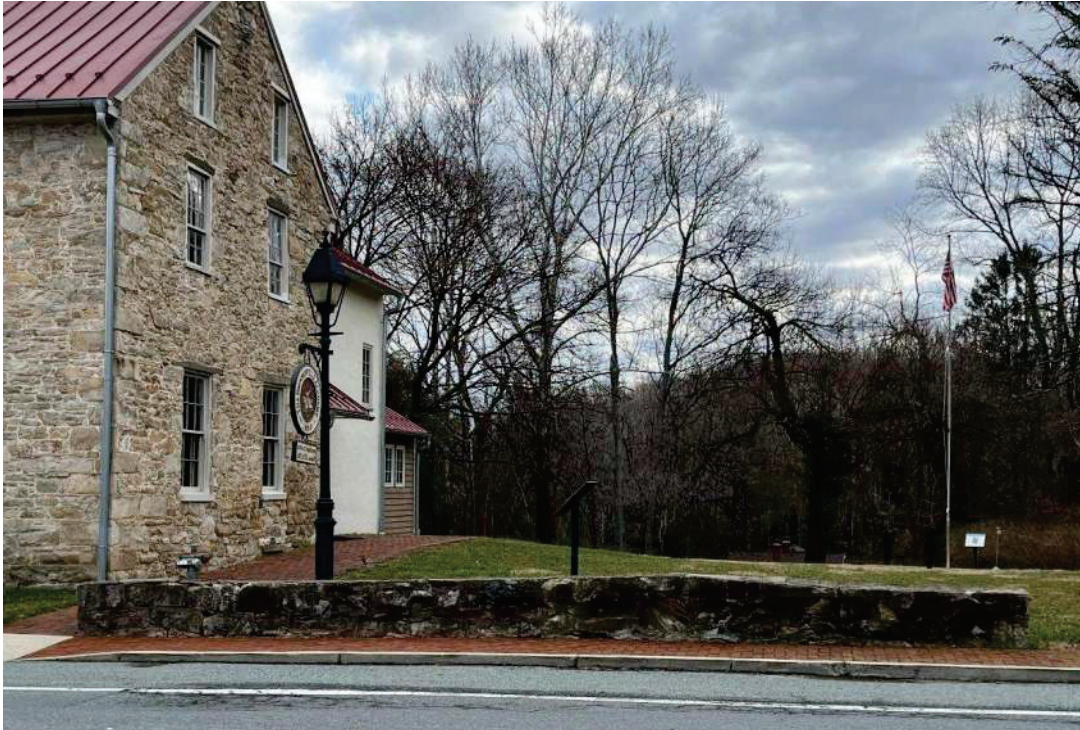
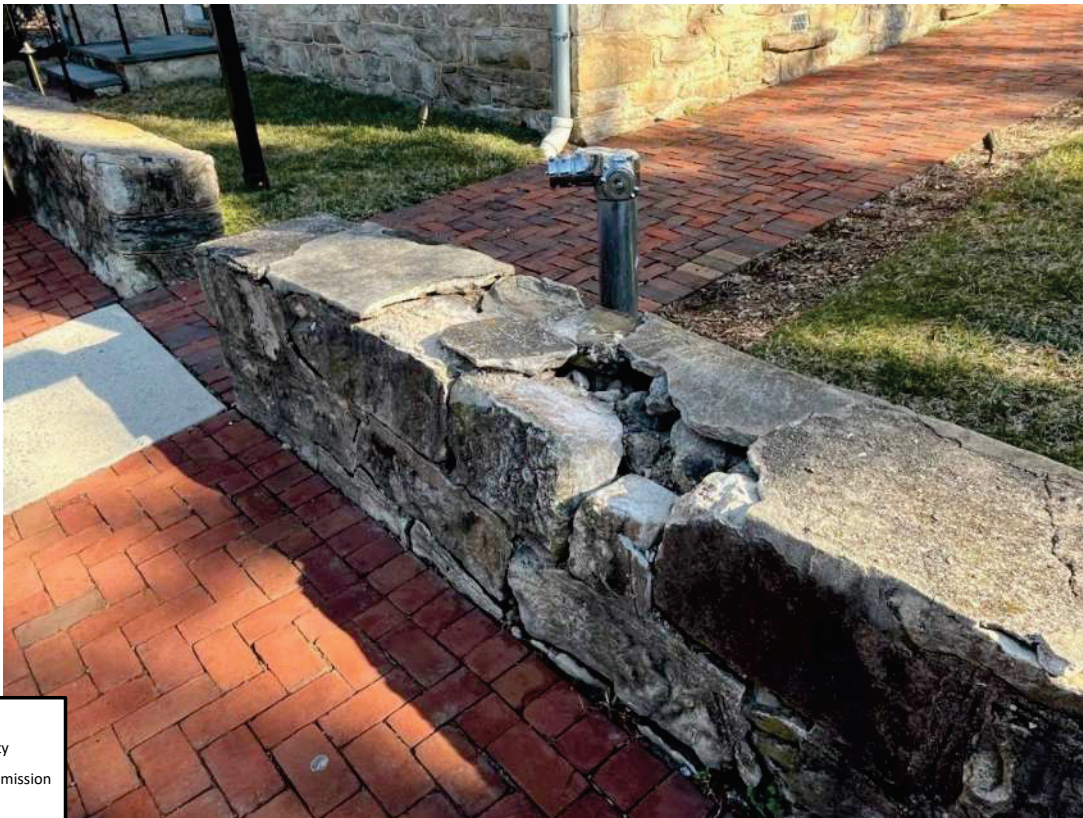
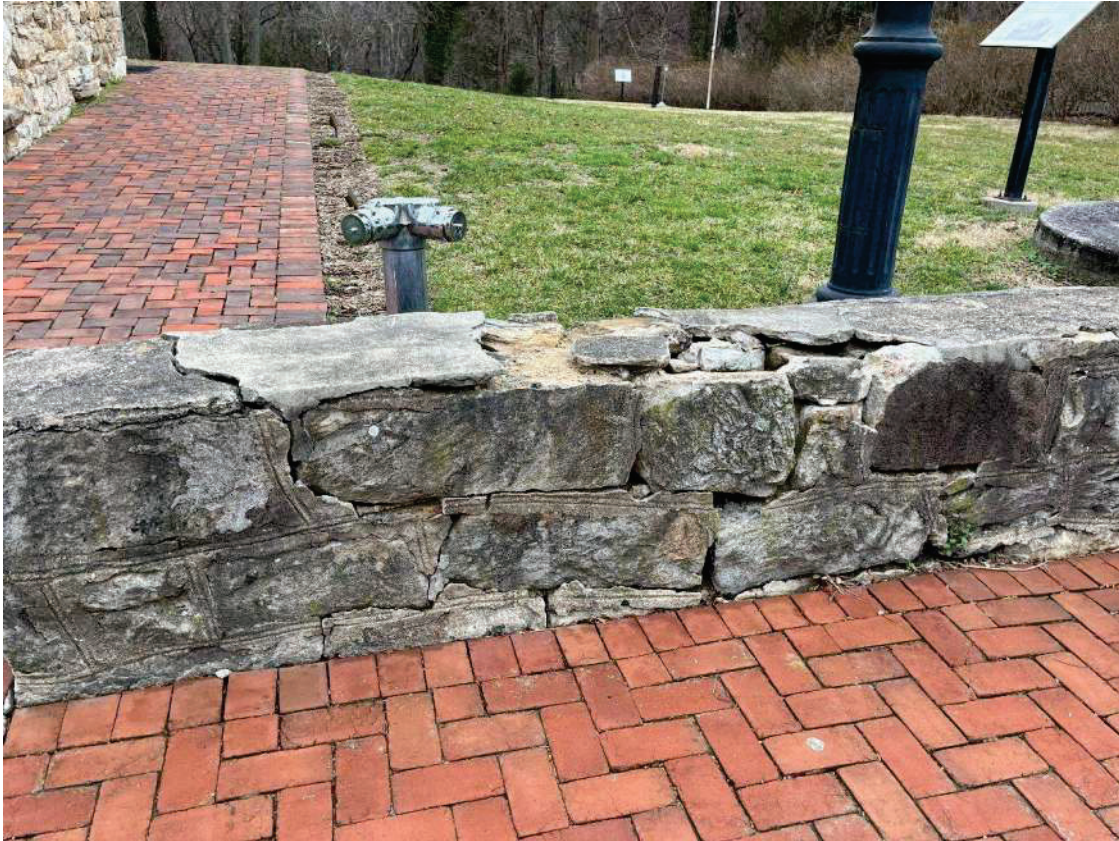
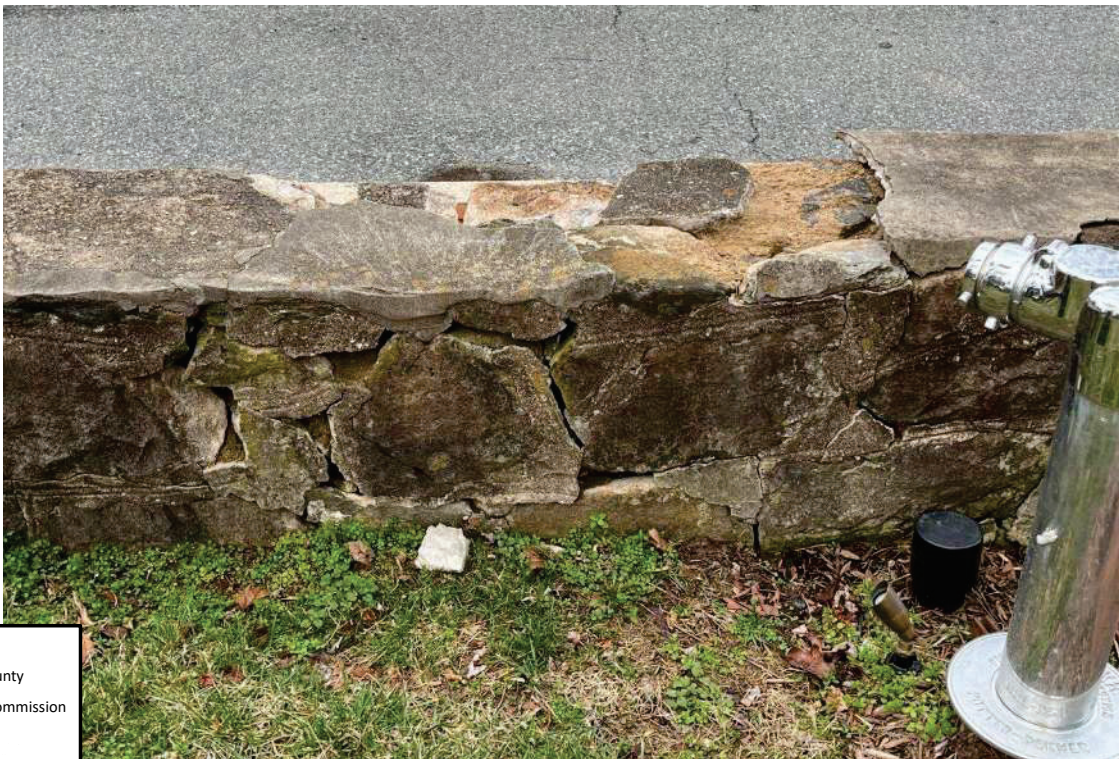
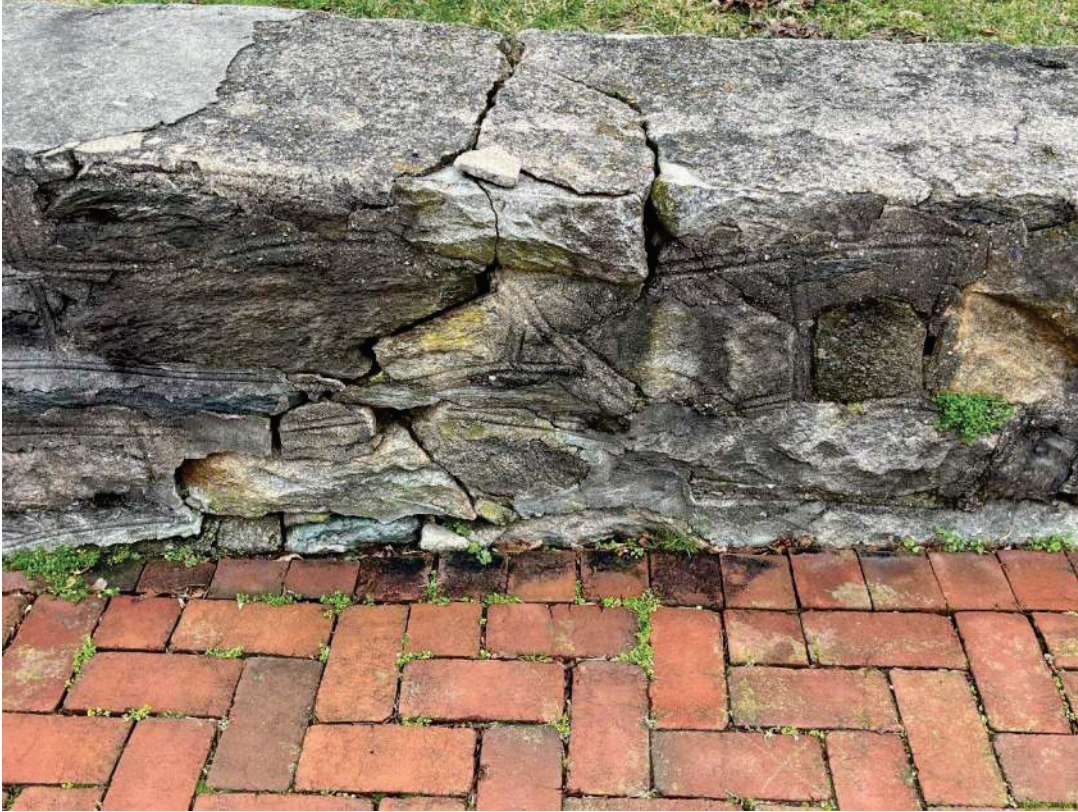
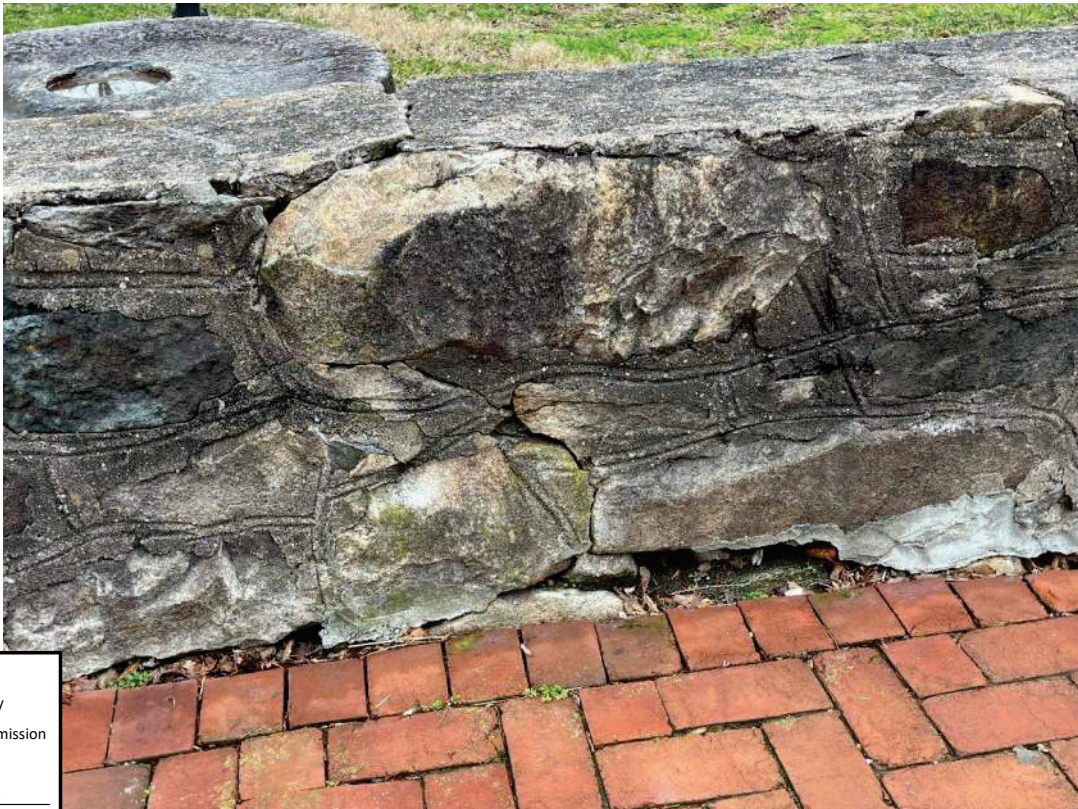
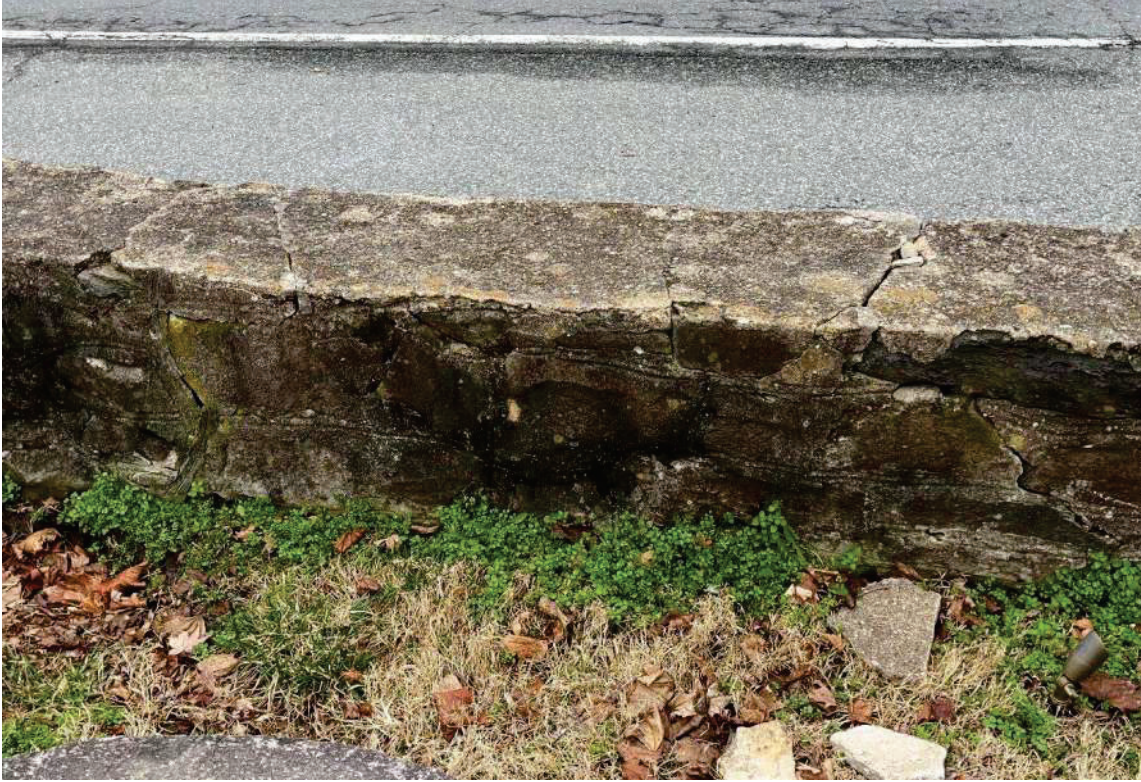
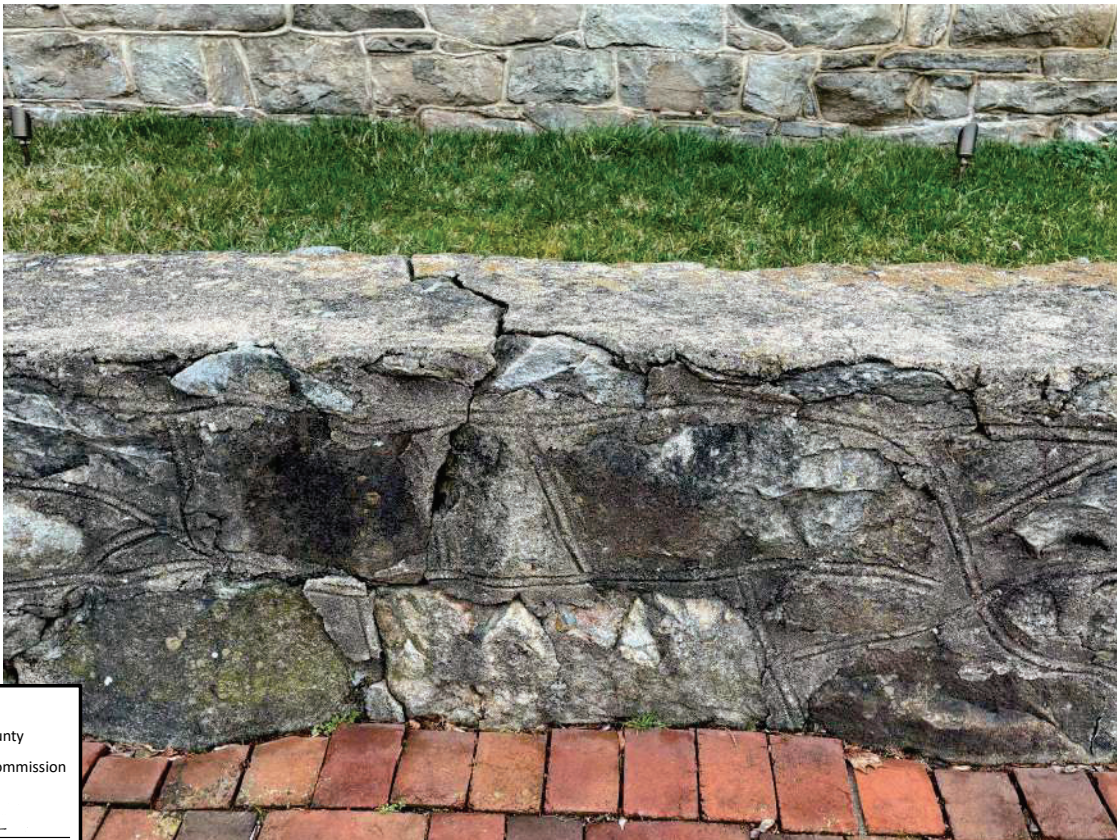
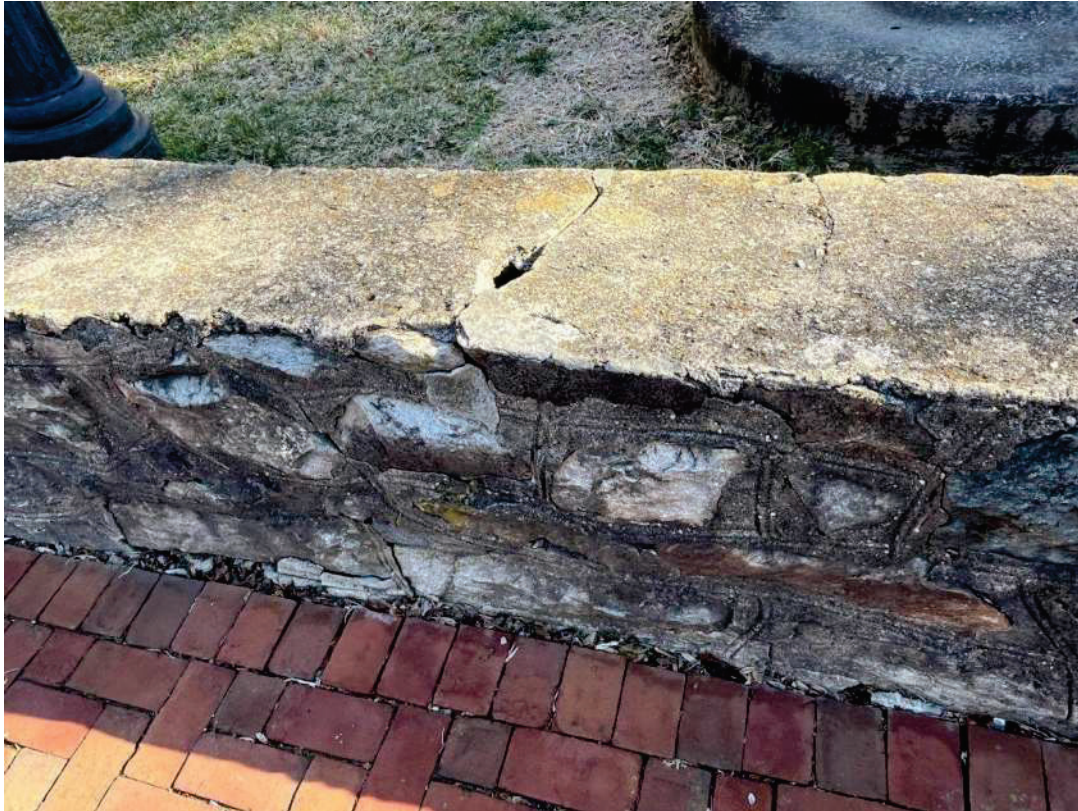
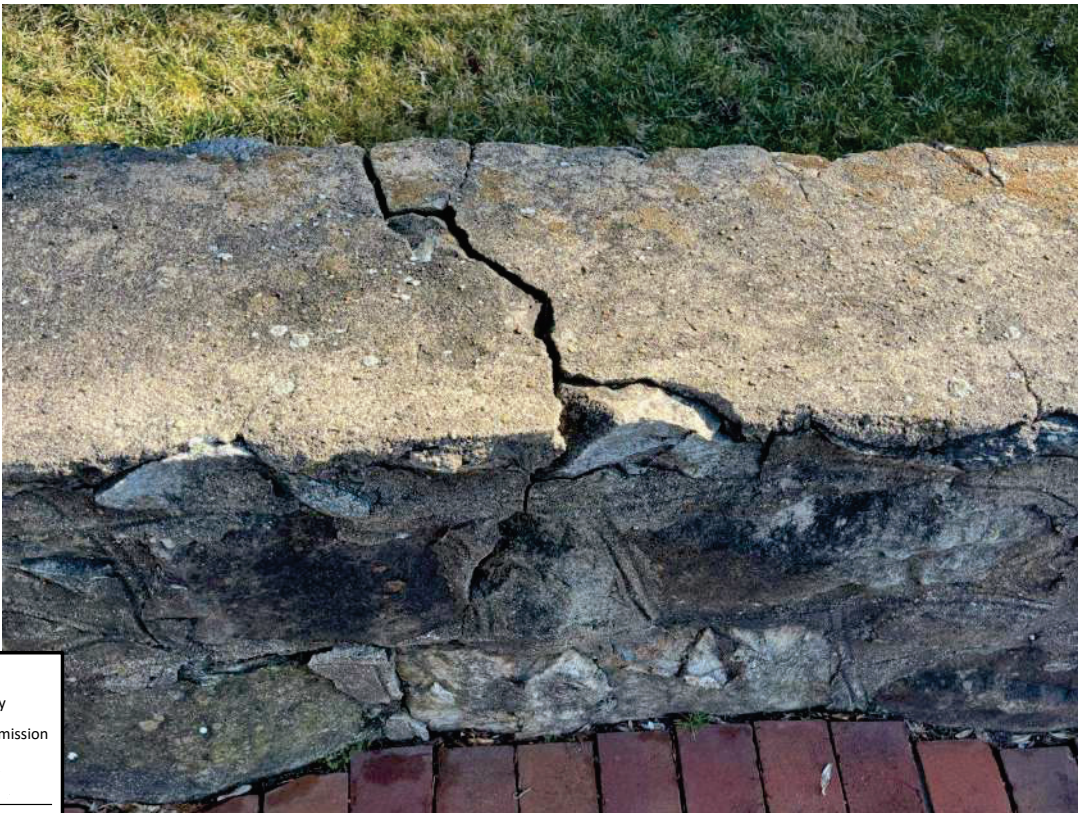
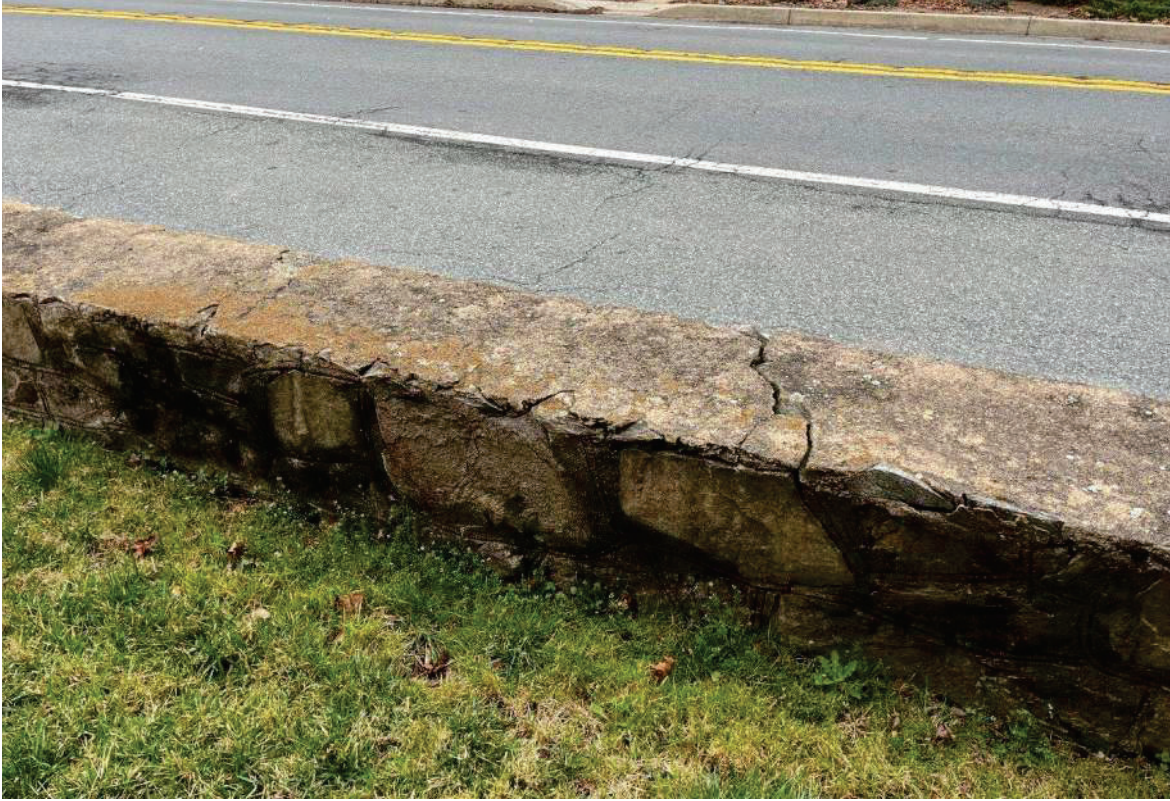
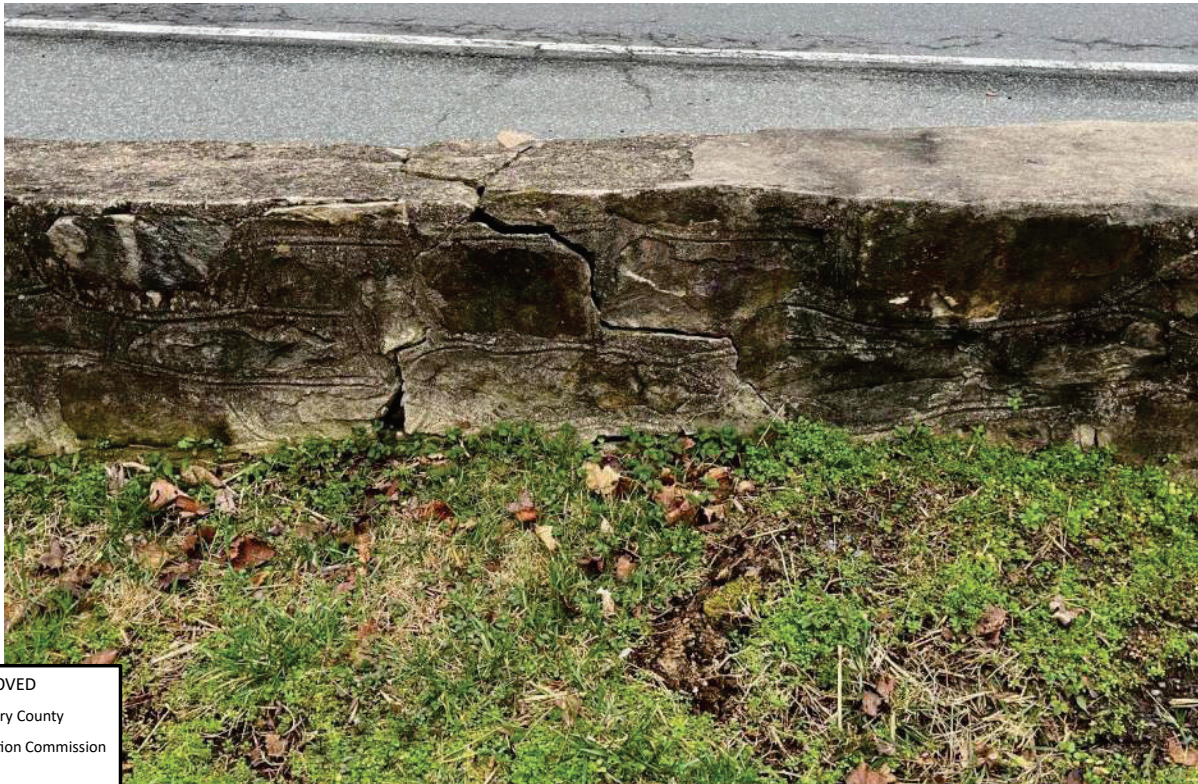
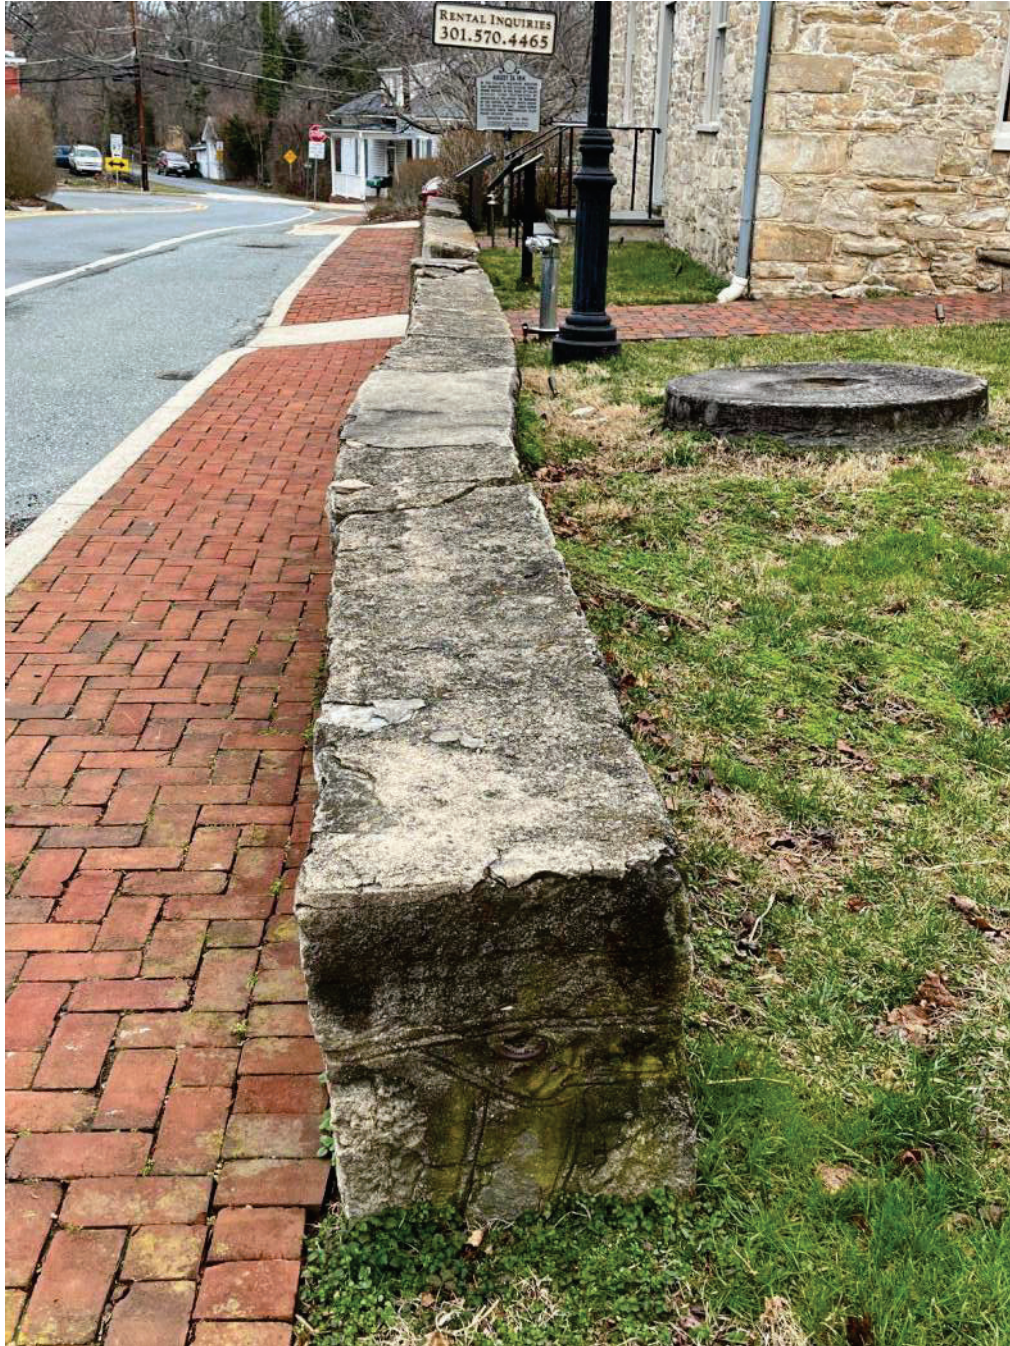
The top layer of parging on the masonry site wall has failed and now portions of the wall are exposed to the elements. This leads to more deterioration of the mortar, forming larger cracks, and undermining the structural integrity of the stone wall.

- Rebuild the sections of the wall that have failed.  
Note: the curved sections of the wall that have bowed over time because of a nearby tree will not be repaired.
- Remove existing mortar and re-point all joints with appropriate lime based mortar.
- Replace top parging across the entire wall.
- Clean all stone
- All work is to be performed per the standards in the US Department of the Interiors Standards for the Treatment of Historic Properties.

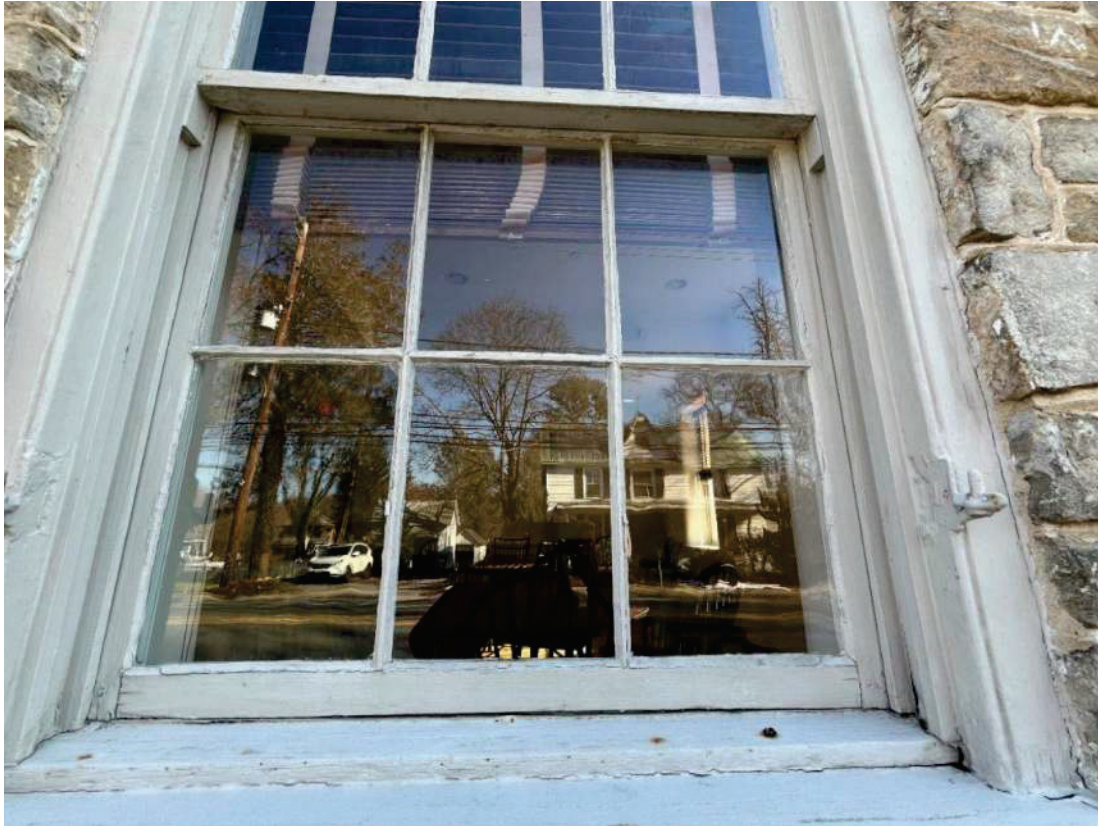
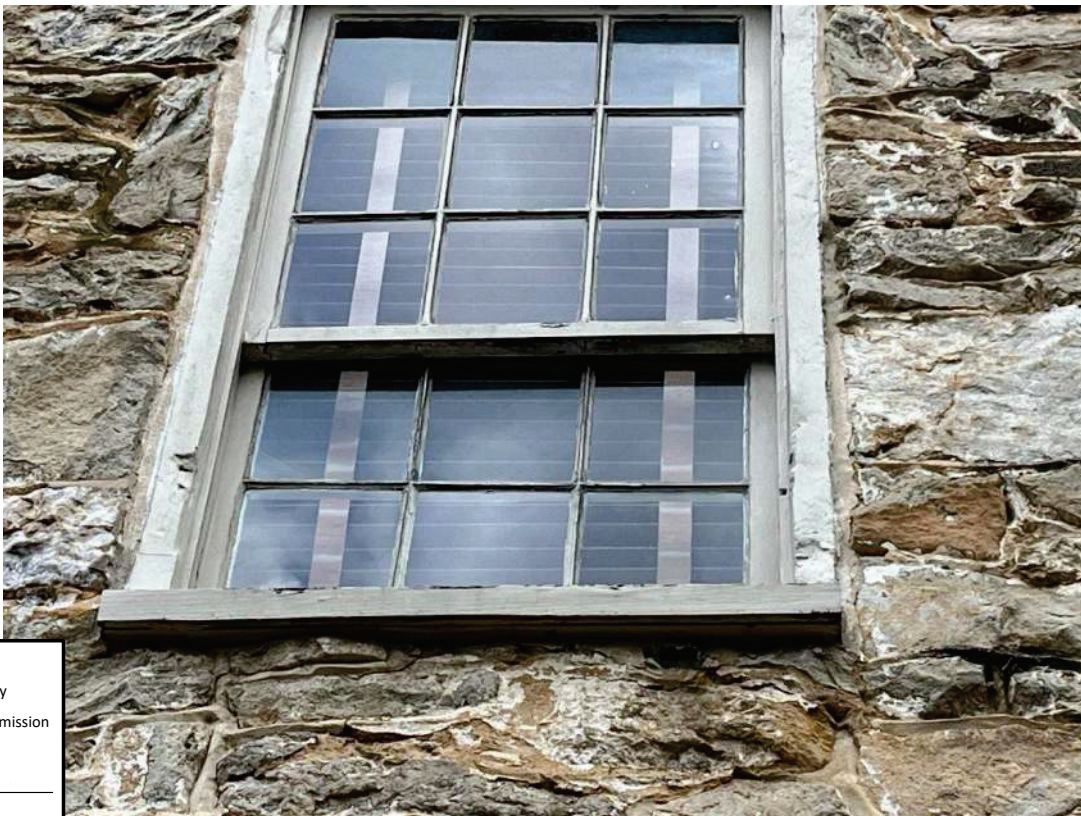
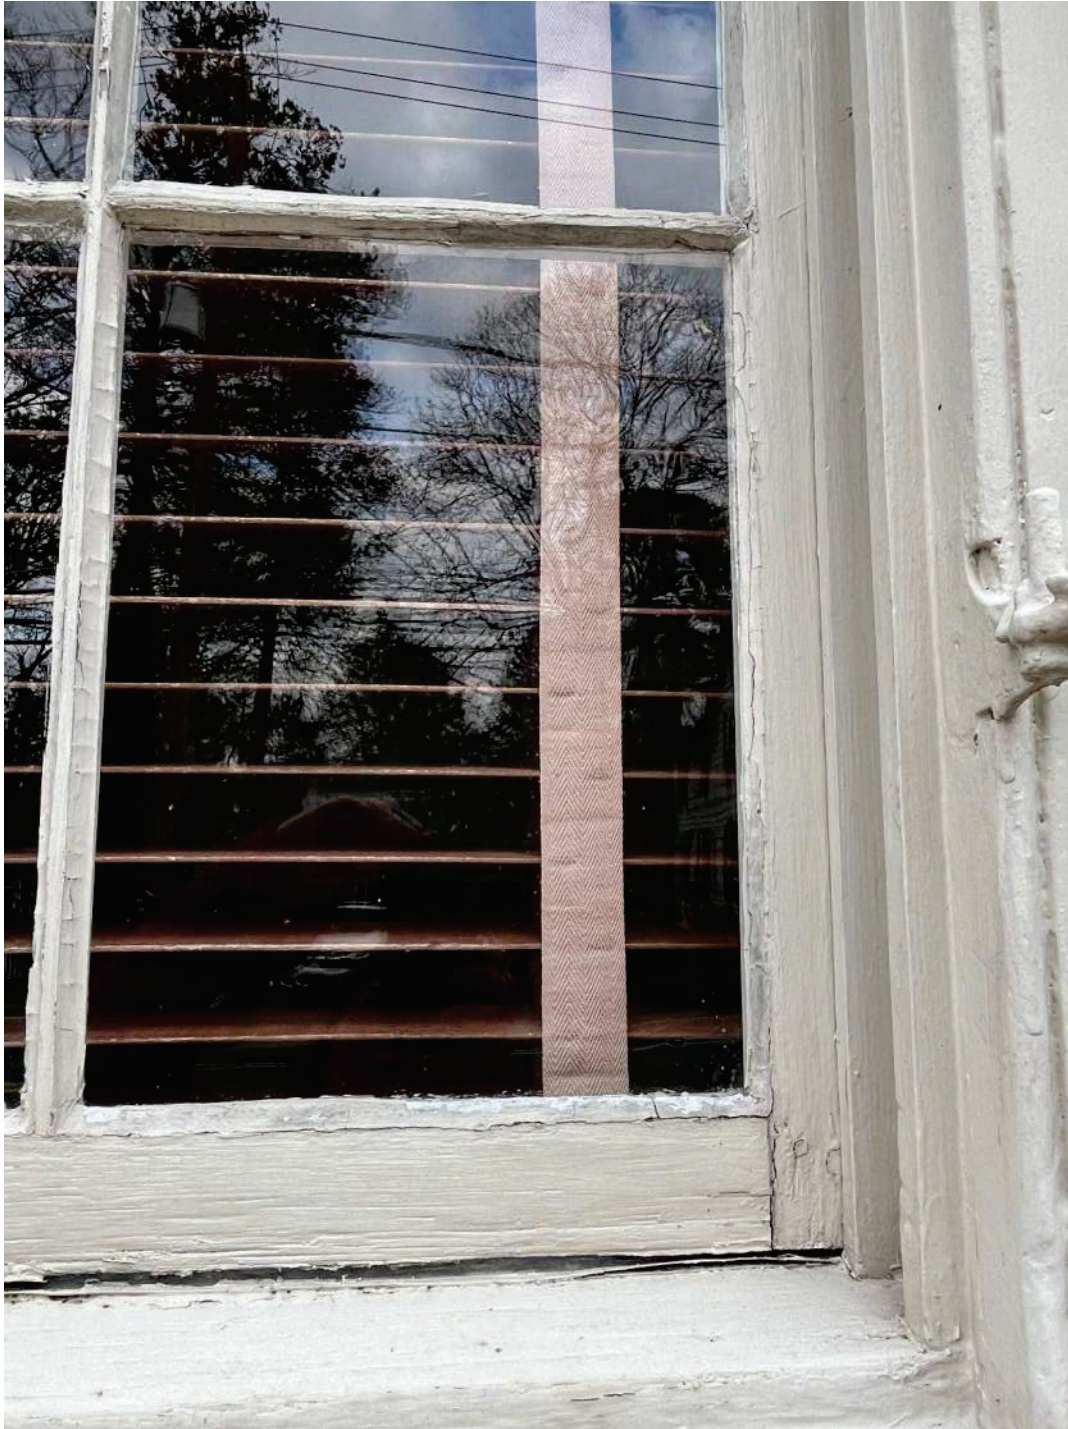
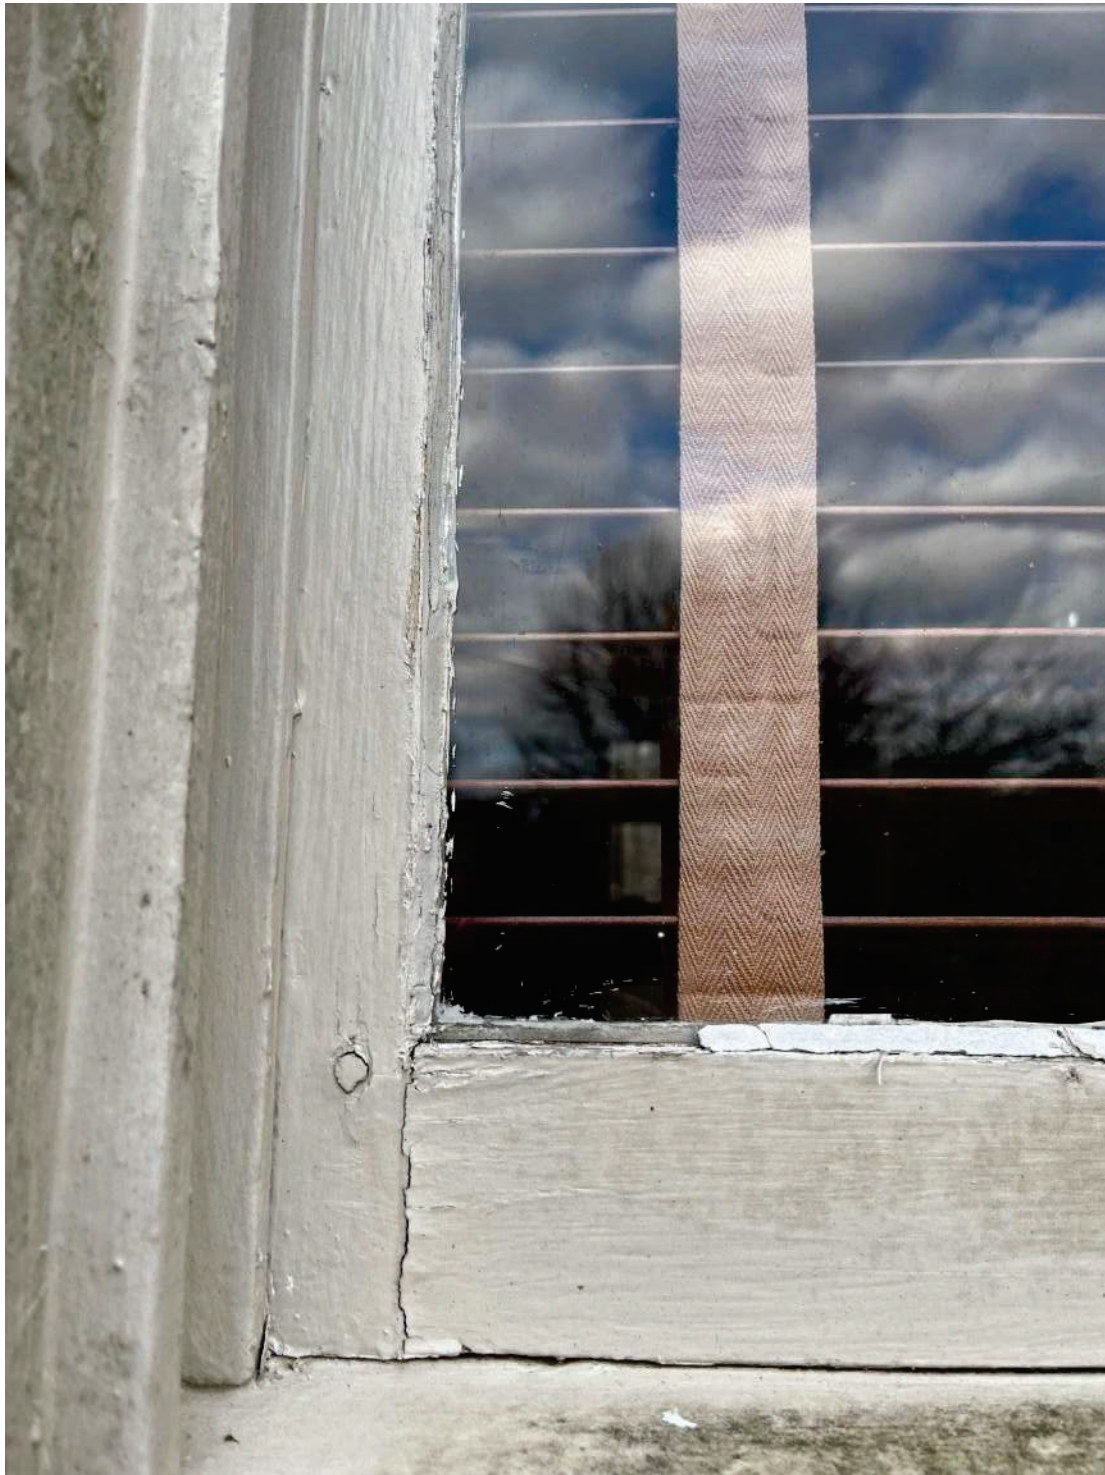
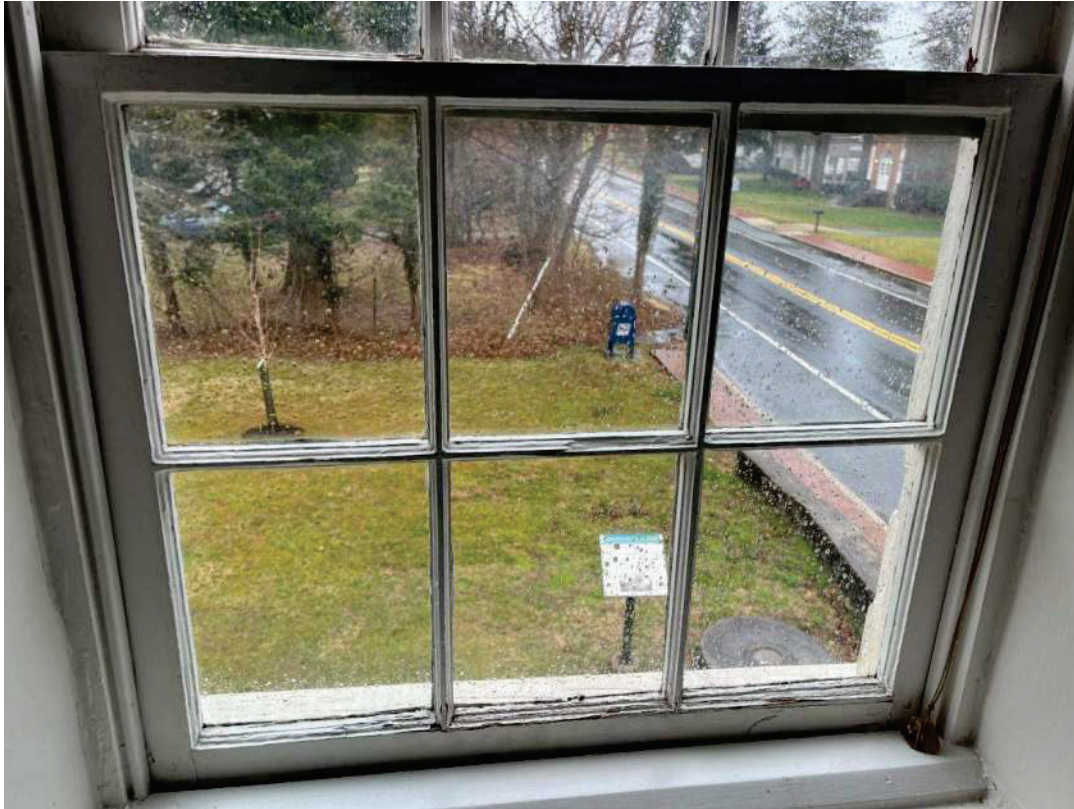
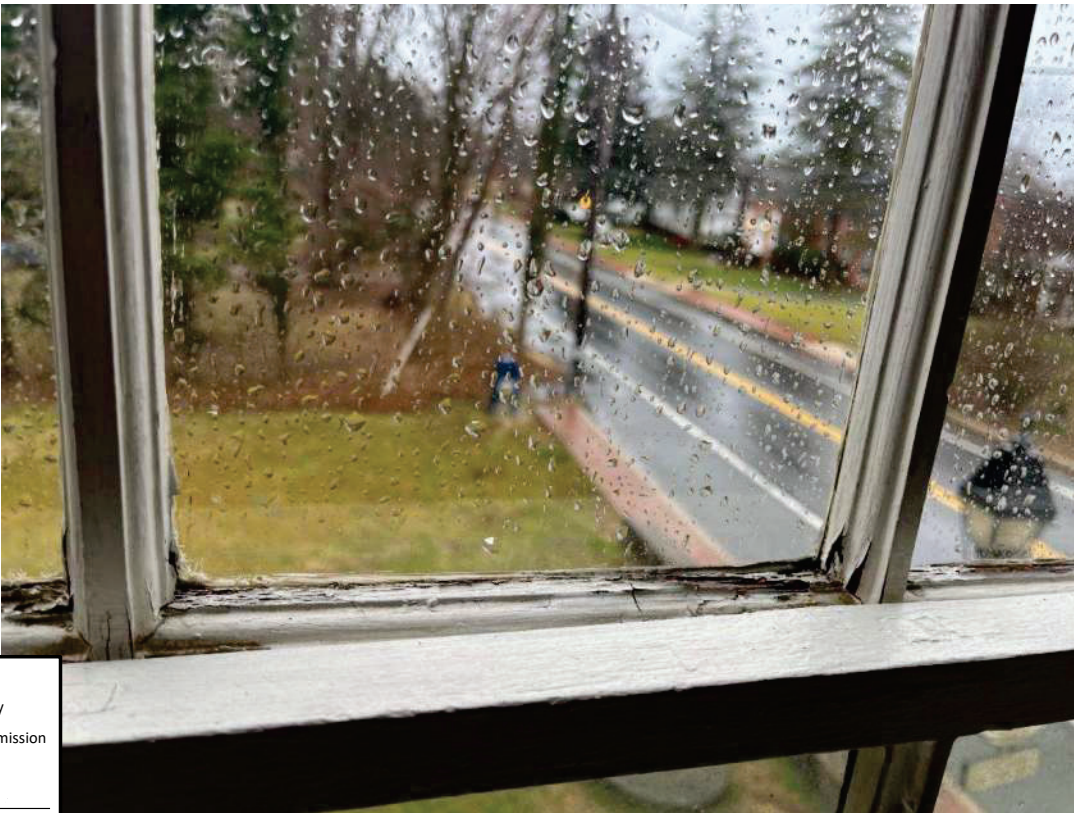
Many of the wood windows are either original or very old. There are broken lites of glass, crumbling glazing putty and wood in need of restoration.

- The existing windows will be repaired, not replaced
- Replace broken lites with single pane glass (vintage glass if possible).
- Refurbish wood as required
- Ensure windows are operating properly
- Replace glazing putty
- Install zinc weatherstripping and kerf applied weather seal, all routed into slots in the windows
- Re-paint windows
- All work is to be performed per the standards in the US Department of the Interiors Standards for the Treatment of Historic Properties.

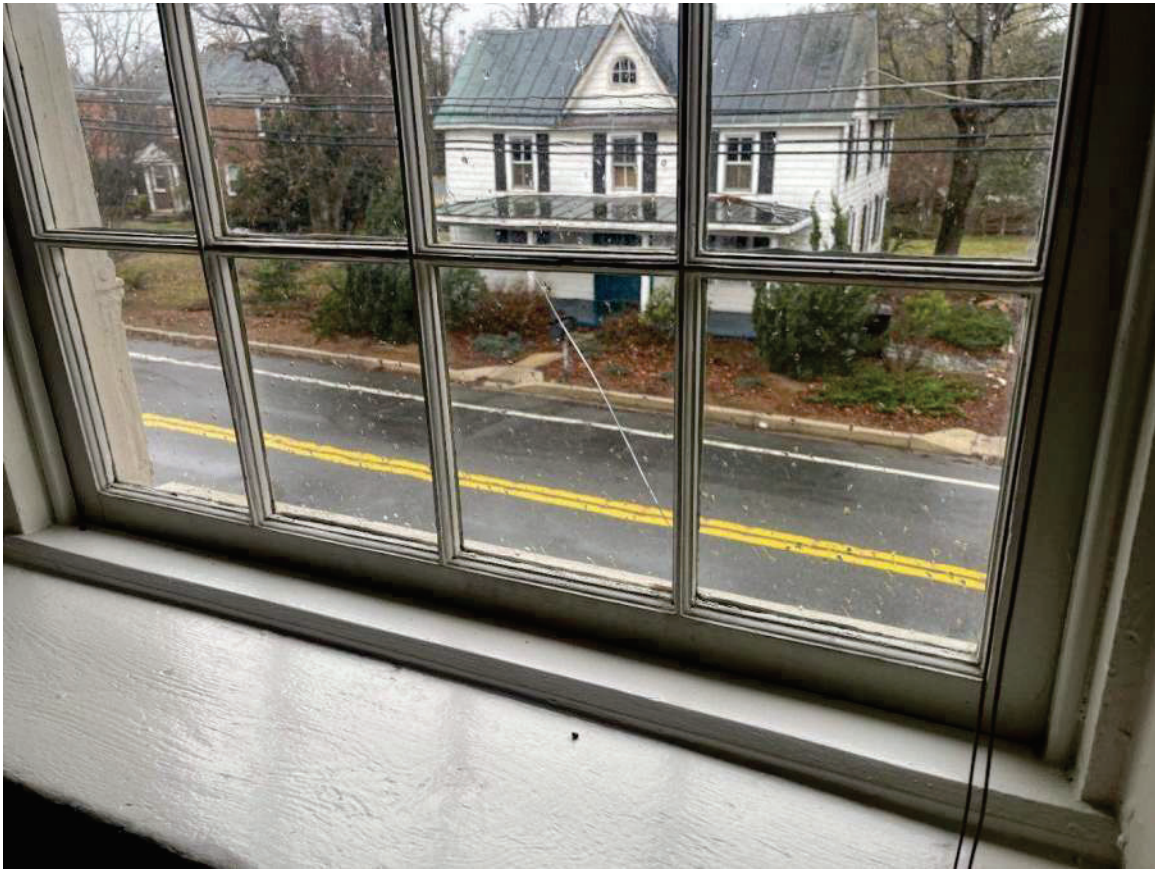
Photo 47 - Window Close-Up Showing Broken Glass
