## HISTORIC PRESERVATION COMMISSION

SUBJECT: Historic Area Work Permit #1164669– Masonry restoration, window restoration, door replacement, and trim repairs

Applicant: Town of Brookeville; Andrea Scanlon (Agent)  
Address: 5 High Street, Brookeville

Work Item 1A Brookeville Academy - stone facade

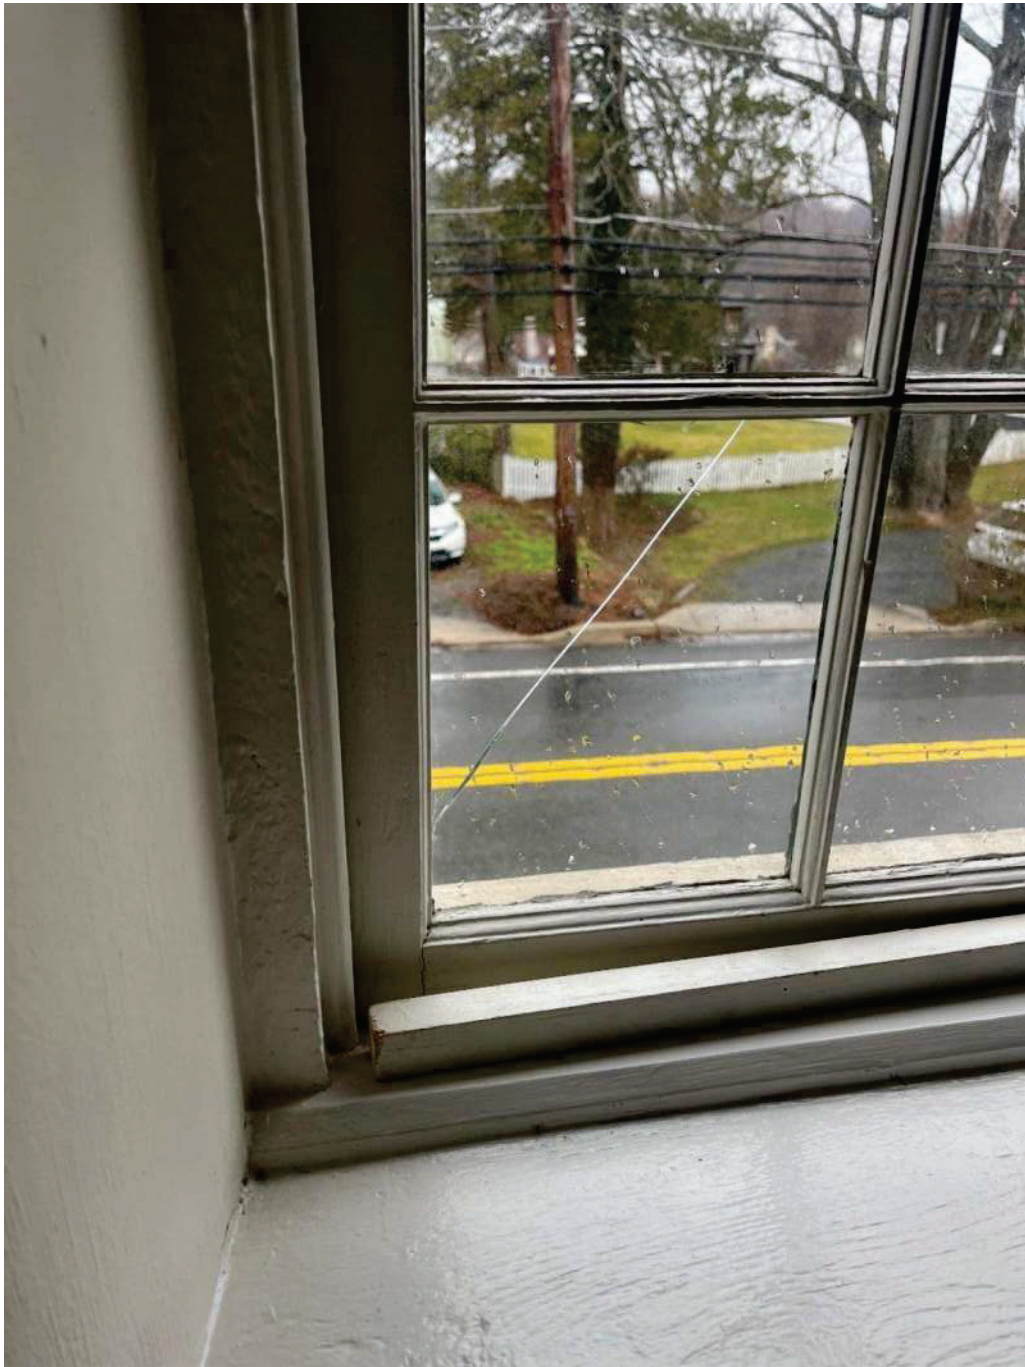
Many of the wood windows are either original or very old. There are broken lites of glass, crumbling glazing putty and wood in need of restoration.

Photo 48 - Window Close-Up Showing Broken Glass

- The existing windows will be repaired, not replaced
- Replace broken lites with single pane glass (vintage glass if possible).
- Refurbish wood as required
- Ensure windows are operating properly
- Replace glazing putty
- Install zinc weatherstripping and kerf applied weather seal, all routed into slots in the windows
- Re-paint windows
- All work is to be performed per the standards in the US Department of the Interiors Standards for the Treatment of Historic Properties.

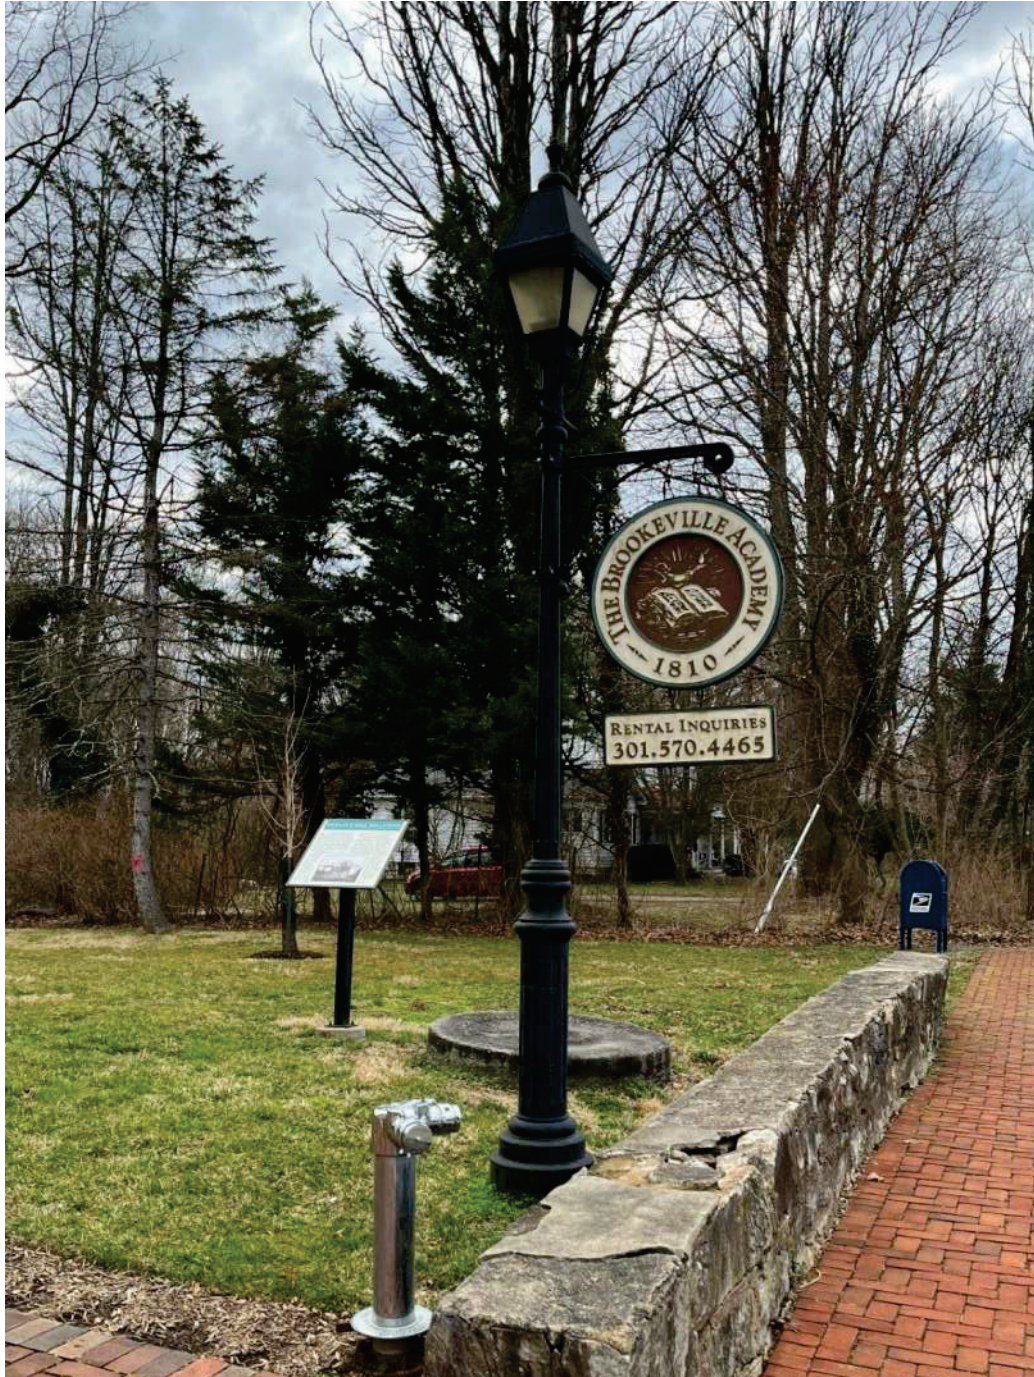
Photo 50 - Exterior Sign and Light Post

The exterior sign and post were installed in 1996. The wooden sign has chips and faded paint.

- Repair and re-paint wooden sign and replace hardware as required
- Re-paint cast iron sign post.
