30/13-5-97A 11018 Kenilworth Ave.  
(Garrett Park Historic District)

# APPLICATION FOR HISTORIC AREA WORK PERMIT

## HISTORIC PRESERVATION COMMISSION STAFF REPORT

**PROPOSAL:** Alteration/Addition/  
Fire Damage Restoration

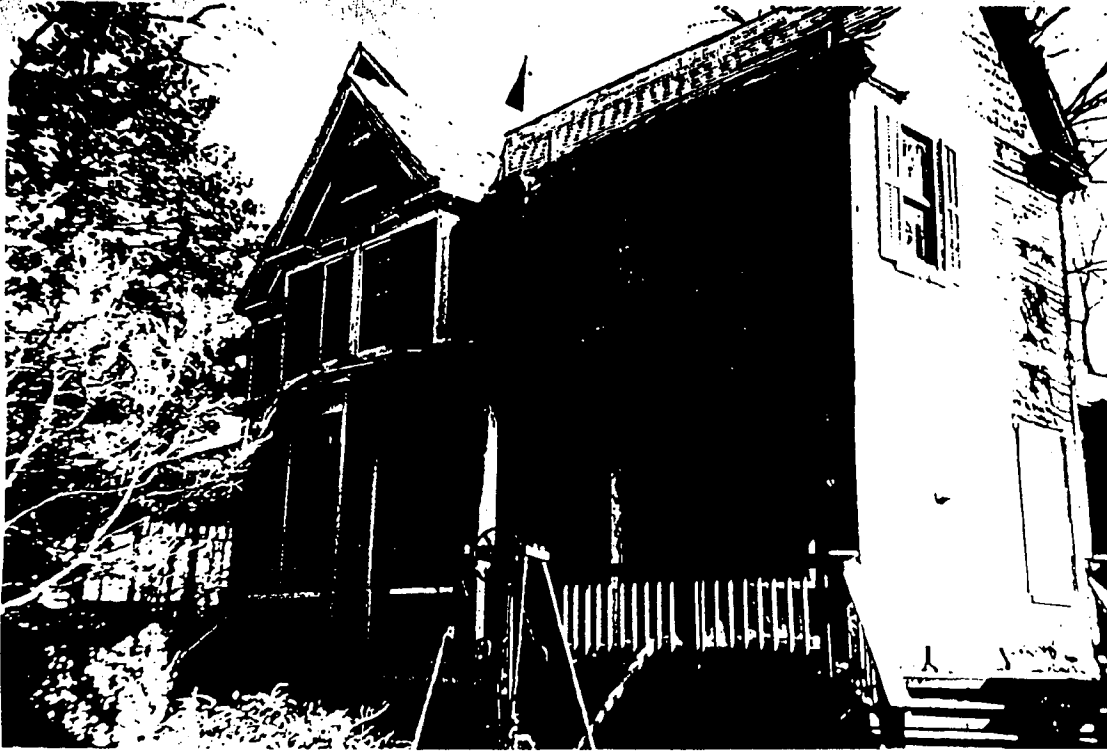
### RIGHT (NORTH) ELEVATION

This is the most significantly damaged area of our home. Damage to the wall framing, second floor joists, bedrooms, and roof framing must involve demolition and rebuilding of these areas due to structural damage. This area was chosen as a starting point for the new addition in order to minimize some of the rebuilding costs.

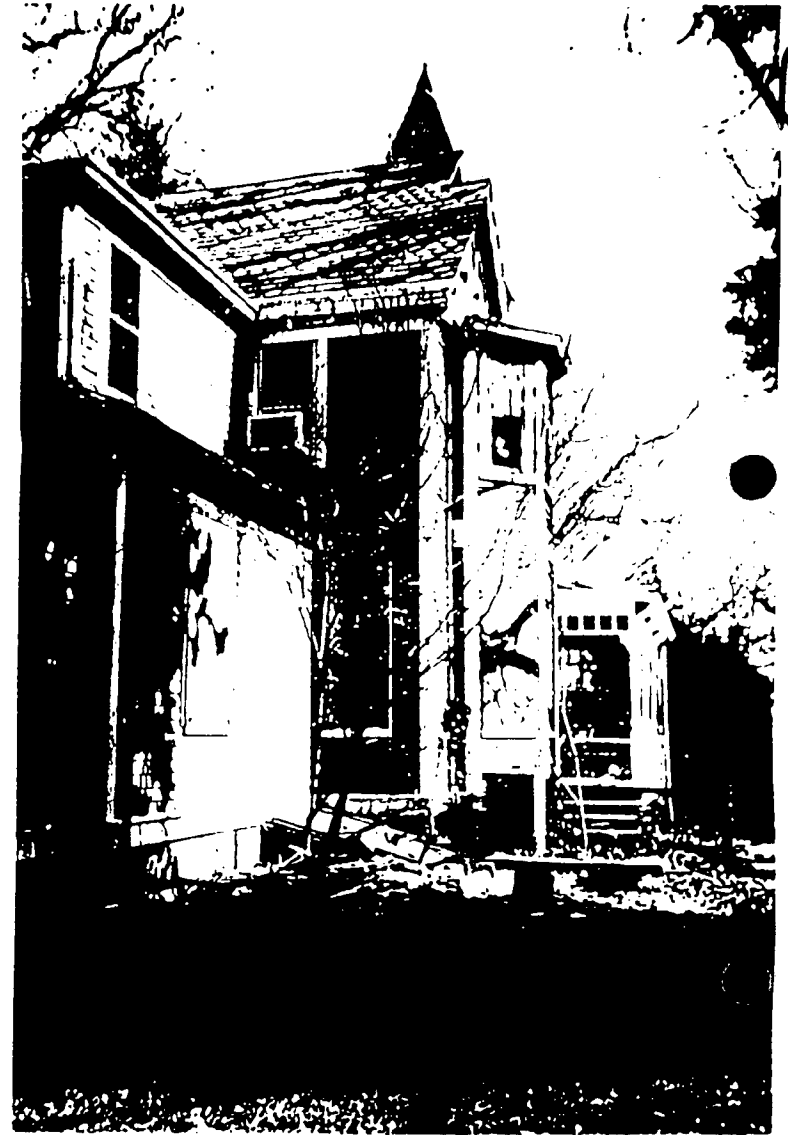
### LEFT (SOUTH) ELEVATION

Damage on this elevation was most severe to the fill-in addition area. Structural damage of the second floor joists requires their removal and installation of new materials. The small second floor bathroom above will need to be rebuilt directly over the foundation walls to meet design load criteria.

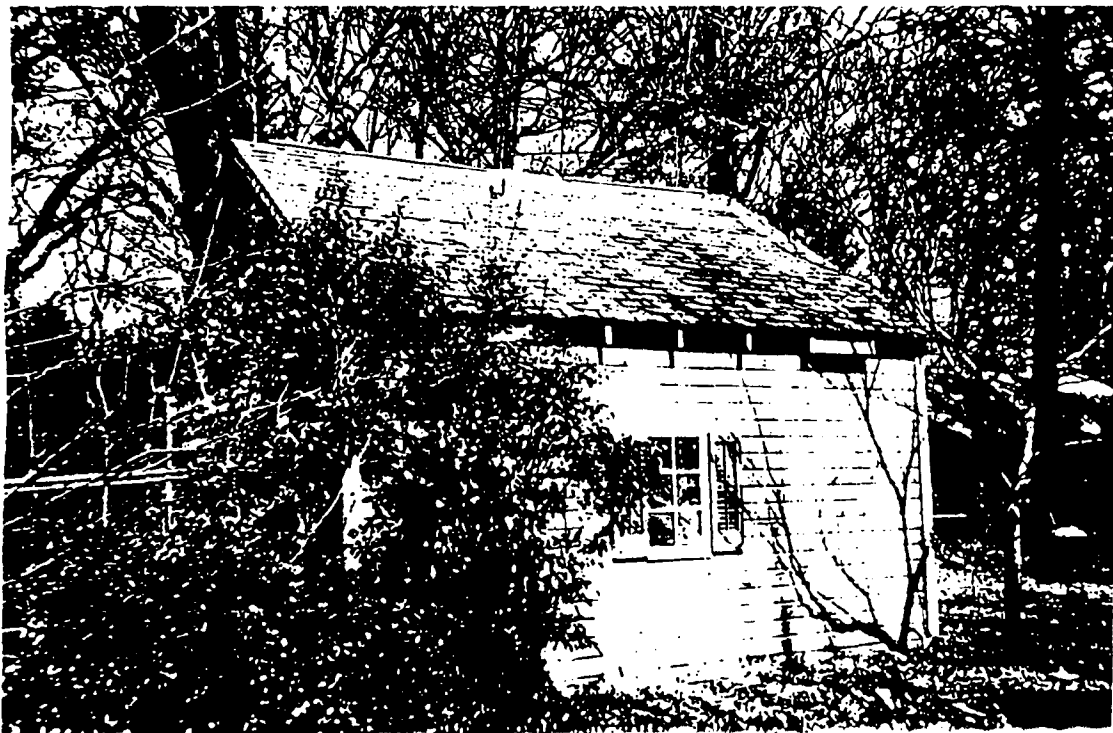
## EXISTING GARAGE

The existing garage details are uncommon to those of the house. Dutch lap siding, exposed rafter tails, casement windows, and asphalt roofing shingles are the most obvious differences. The structural condition of this building finds severe wood rot at the floor plate and lower areas of stud walls. The floor slab sits below the driveway grade immediately to the front (east) side of the garage. This has allowed water to drain into the garage and subsequently cause the structural decay. The age of the garage is unknown but likely built sometime around 1950.

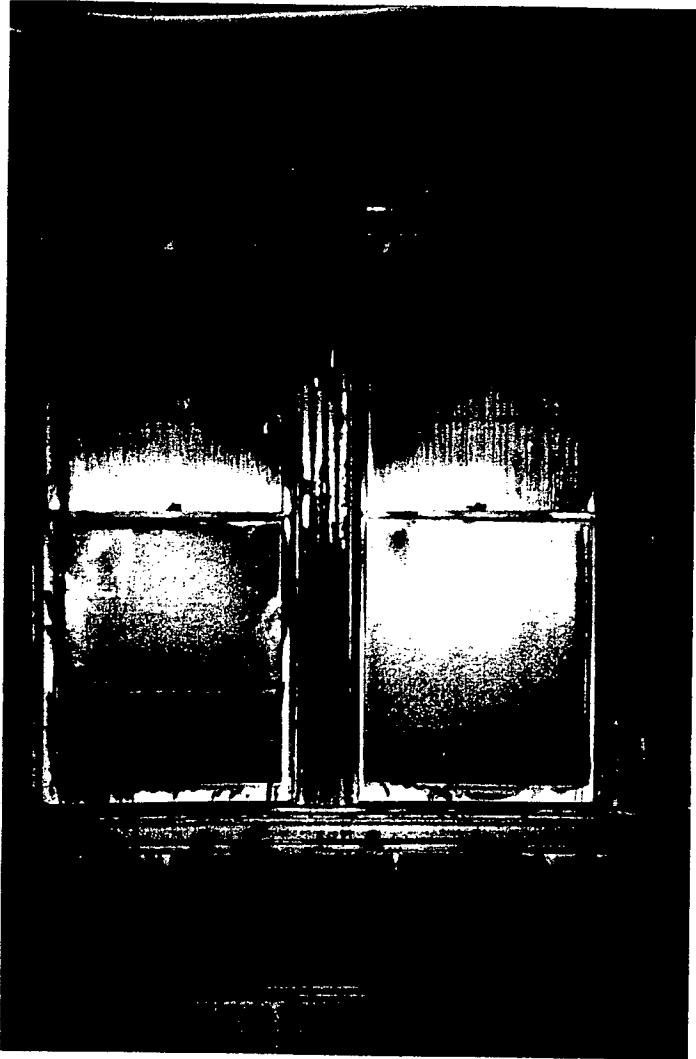
#1: Glass - 3/4 glass broken  
#2 Sash: needs some repair; heat + rot

Note: chain balances -operating

Action: Repair

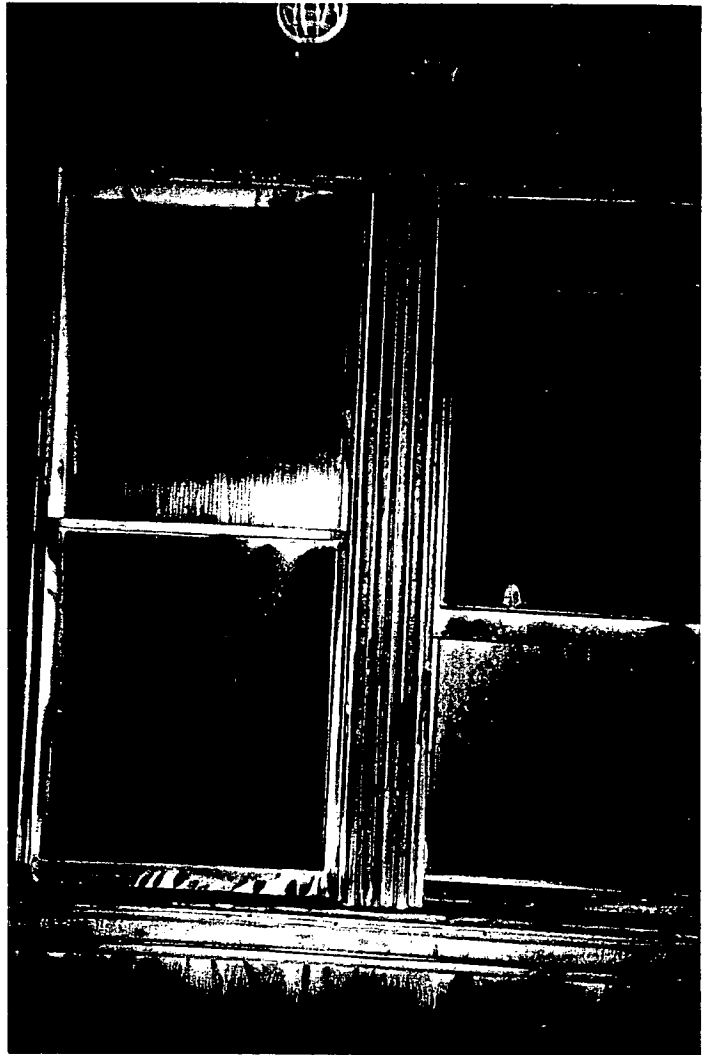
#3 + #4 3/4 Glass broken  
Sash. frame damaged; needs repair

Not Operational, Chains

Action: repair, if possible

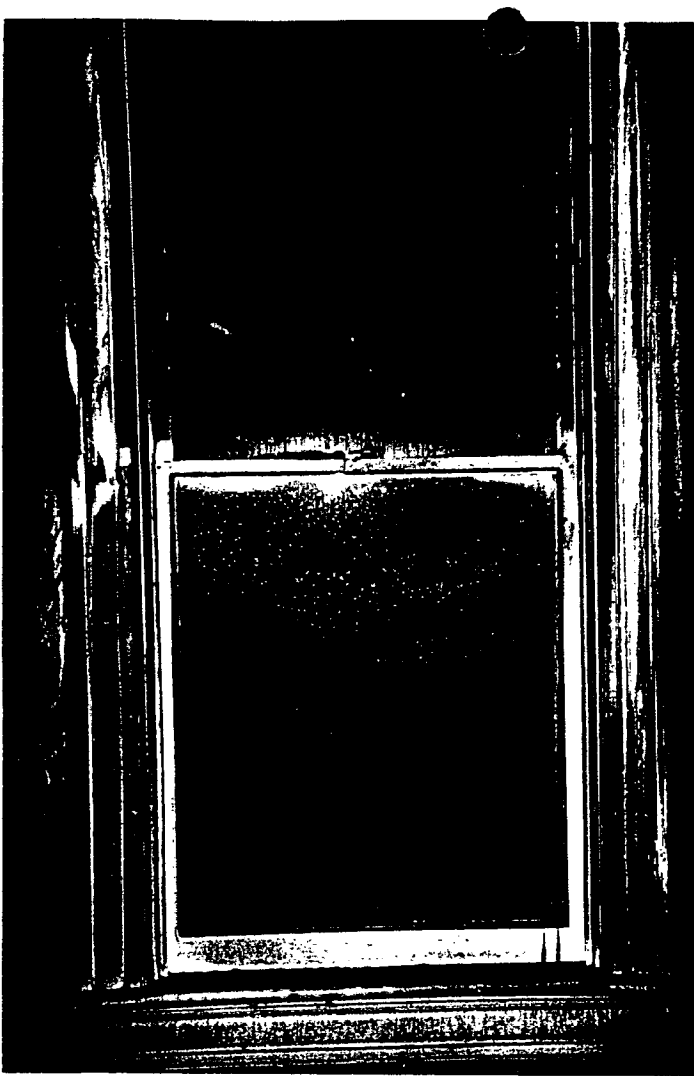
#12 : Glass - 1 broken  
Non-Operational  
Sash - heat damage

Action : Repair

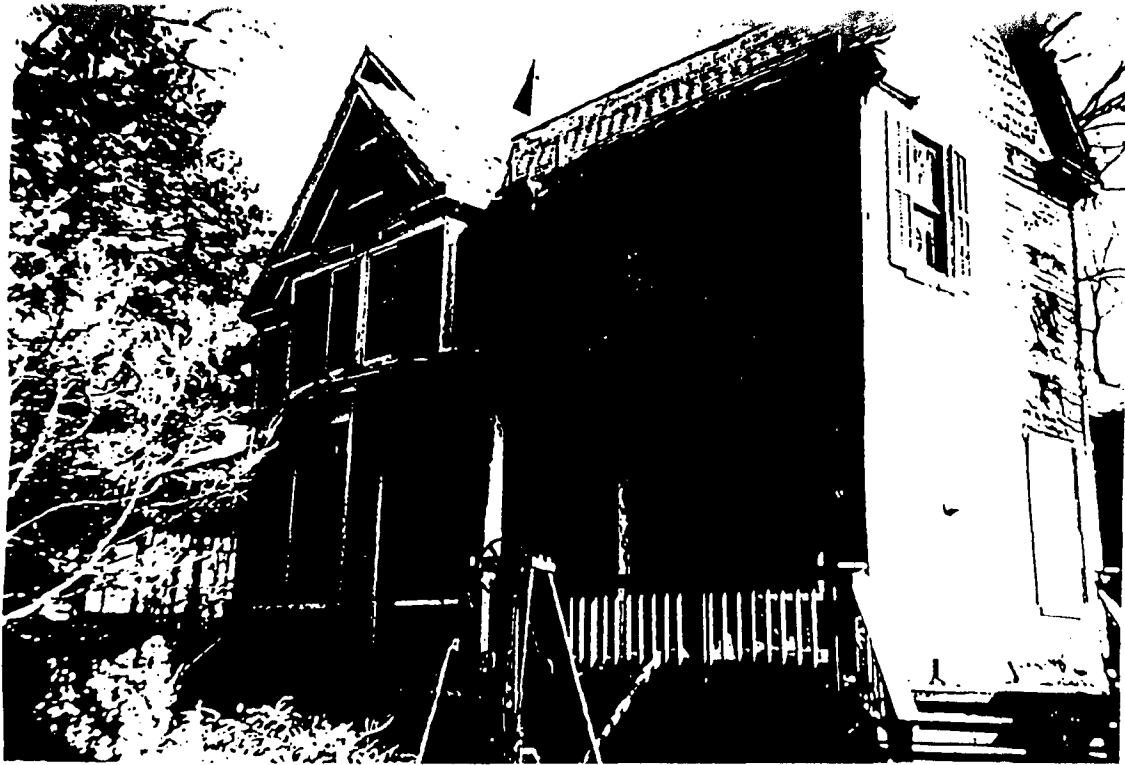
## REAR (WEST) ELEVATION

The rear elevation shows evidence of at least two and possibly three additions to the original main house. The age of the gable wall addition is unknown. The fill-in addition to the right of the gable sits on a brick crawl space and seems to have been added on to the main house sometime around 1950. The small hip roof addition housed a powder room. Its age is undetermined, but no older than the fill-in addition. The pressure treated wood deck built in 1988 will be replaced with a brick patio which will match the existing front walk.

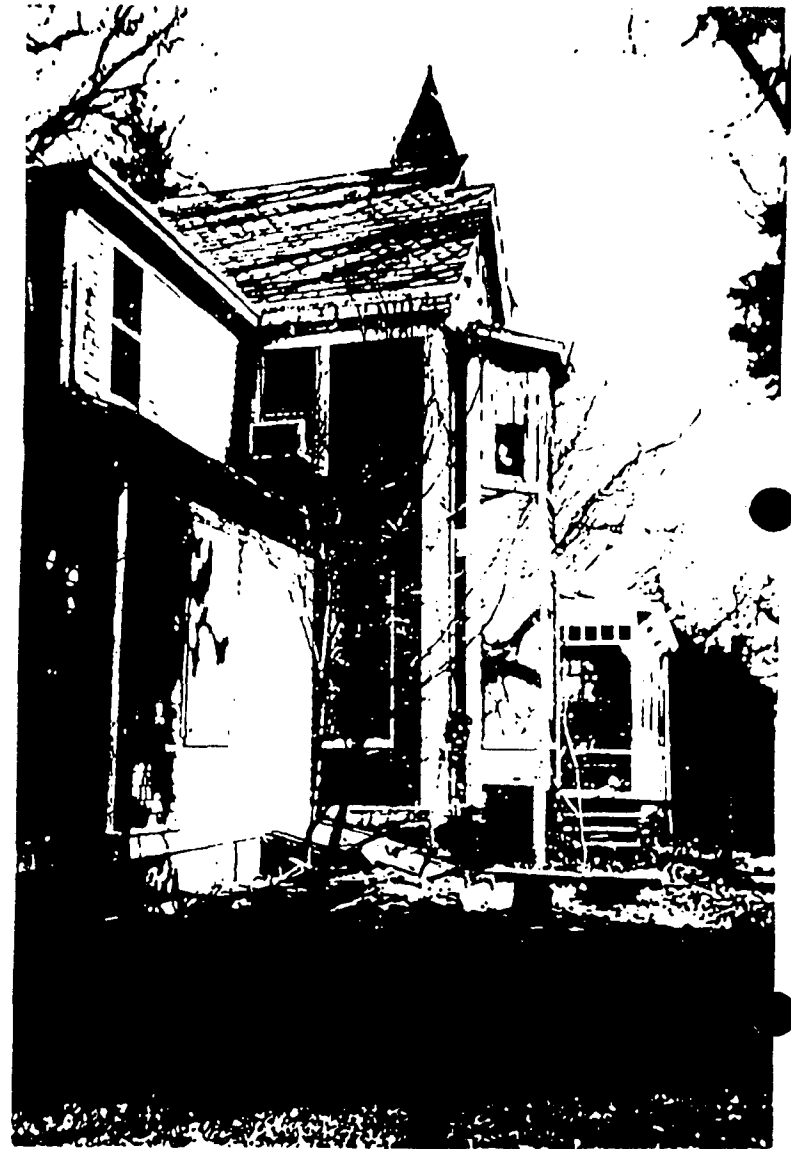
### RIGHT (NORTH) ELEVATION

This is the most significantly damaged area of our home. Damage to the wall framing, second floor joists, bedrooms, and roof framing must involve demolition and rebuilding of these areas due to structural damage. This area was chosen as a starting point for the new addition in order to minimize some of the rebuilding costs.

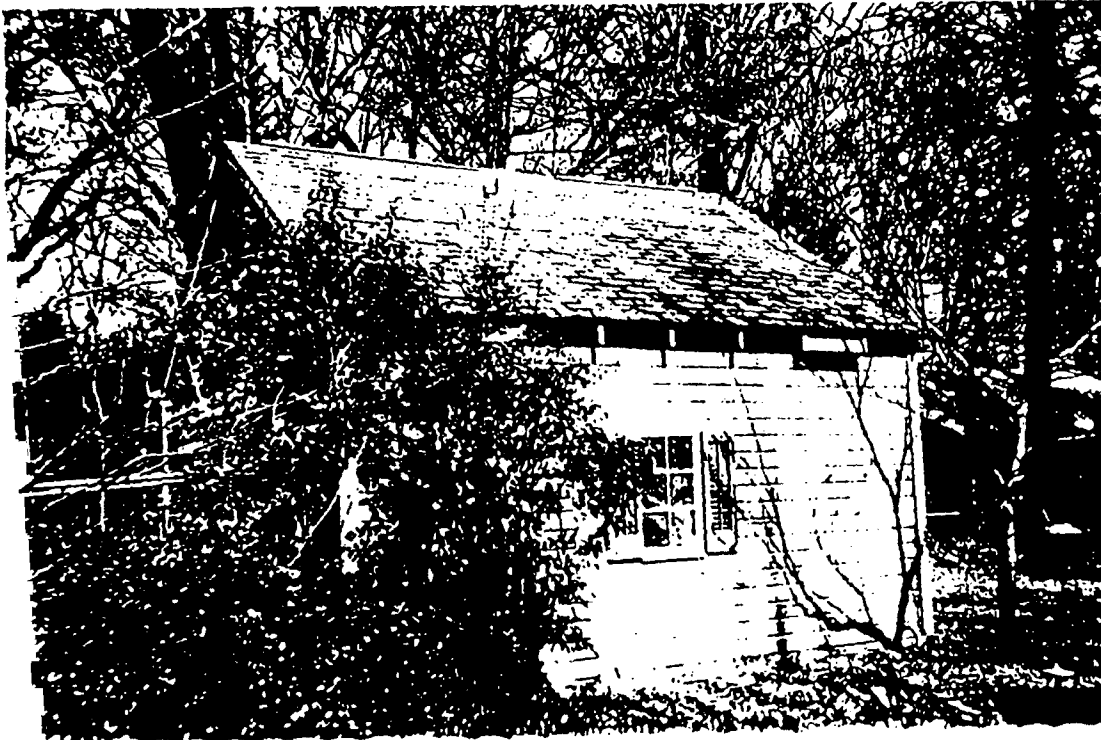
## EXISTING GARAGE

The existing garage details are uncommon to those of the house. Dutch lap siding, exposed rafter tails, casement windows, and asphalt roofing shingles are the most obvious differences. The structural condition of this building finds severe wood rot at the floor plate and lower areas of stud walls. The floor slab sits below the driveway grade immediately to the front (east) side of the garage. This has allowed water to drain into the garage and subsequently cause the structural decay. The age of the garage is unknown but likely built sometime around 1950.

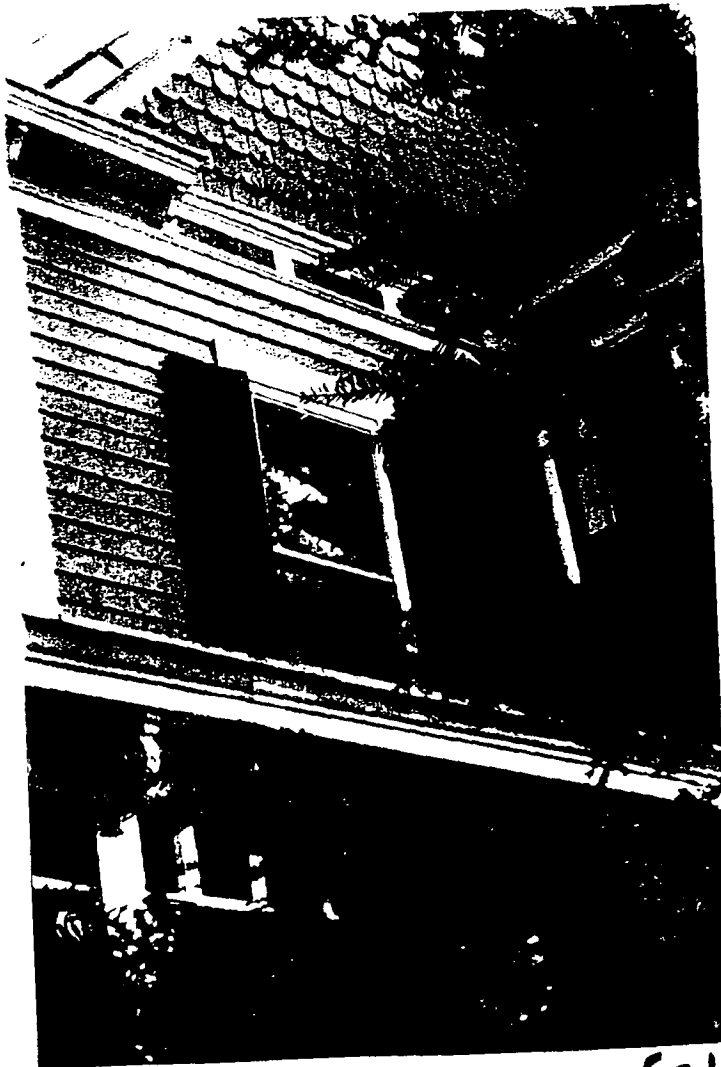
#13  
Glass - All broken  
Non-Operational  
Sash - heat damage  
Action - repair if possible
