30/13-5 11018 Kenilworth Avenue
Garrett Park - Preliminary Consult.

HISTORIC PRESERVATION COMMISSION STAFF REPORT

Address: 11018 Kenilworth Avenue

PROPOSAL: Alteration/Addition/
Fire Damage Restoration

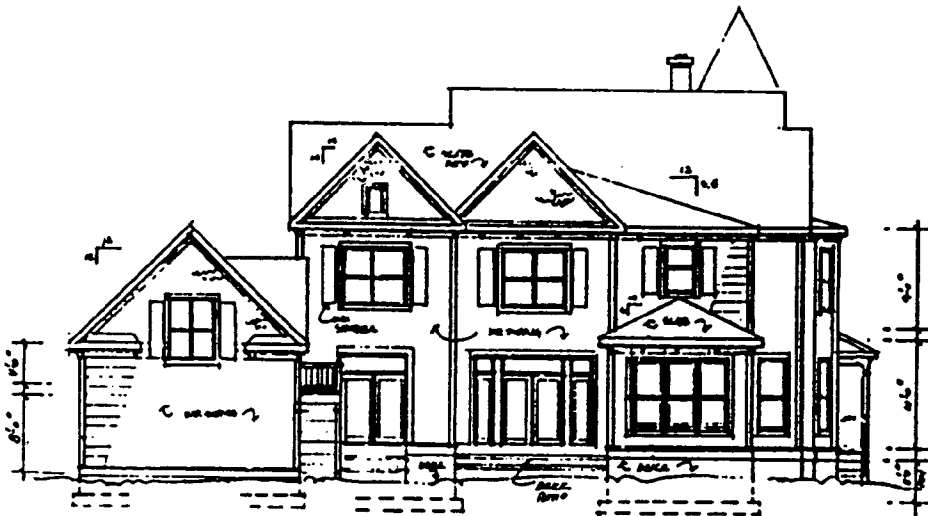
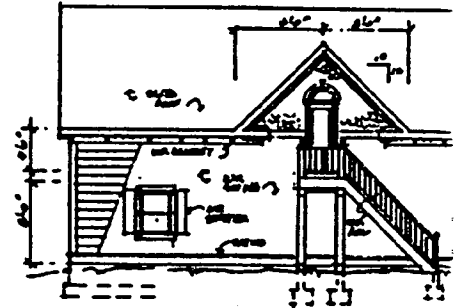
REAR elevation
10'-0"

H6 - concern - not major - massing where garage & side addition come together

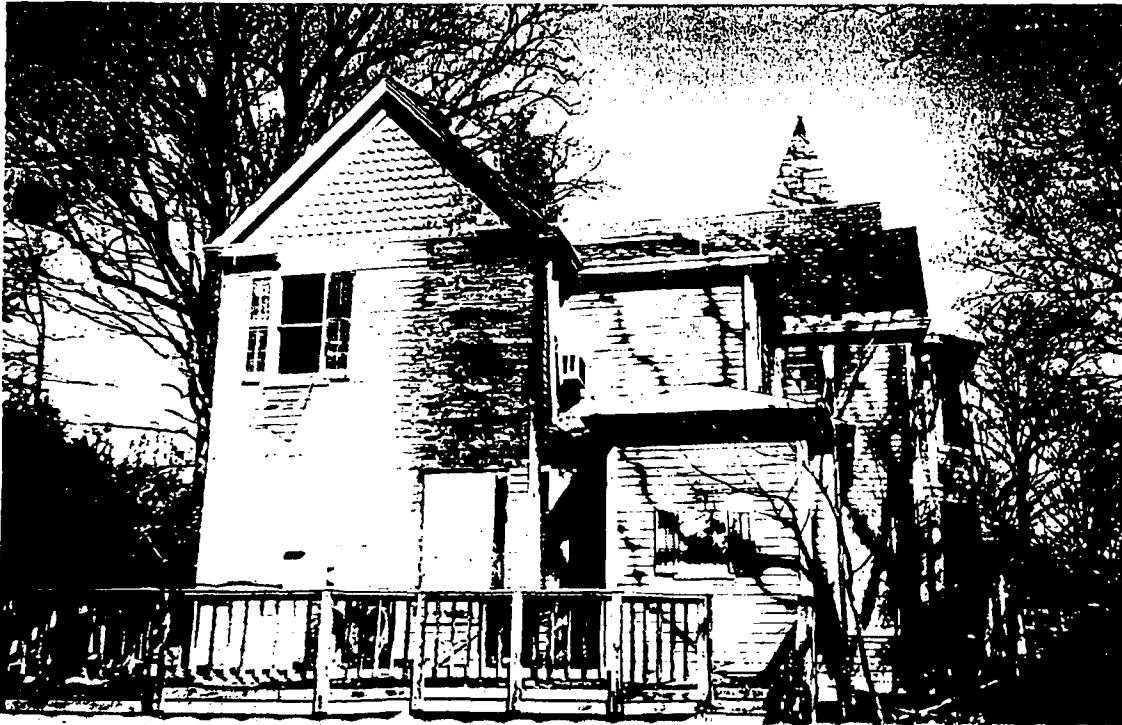
REAR (WEST) ELEVATION

The rear elevation shows evidence of at least two and possibly three additions to the original main house. The age of the gable wall addition is unknown. The fill-in addition to the right of the gable sits on a brick crawl space and seems to have been added on to the main house sometime around 1950. The small hip roof addition housed a powder room. Its age is undetermined, but no older than the fill-in addition. The pressure treated wood deck built in 1988 will be replaced with a brick patio which will match the existing front walk.

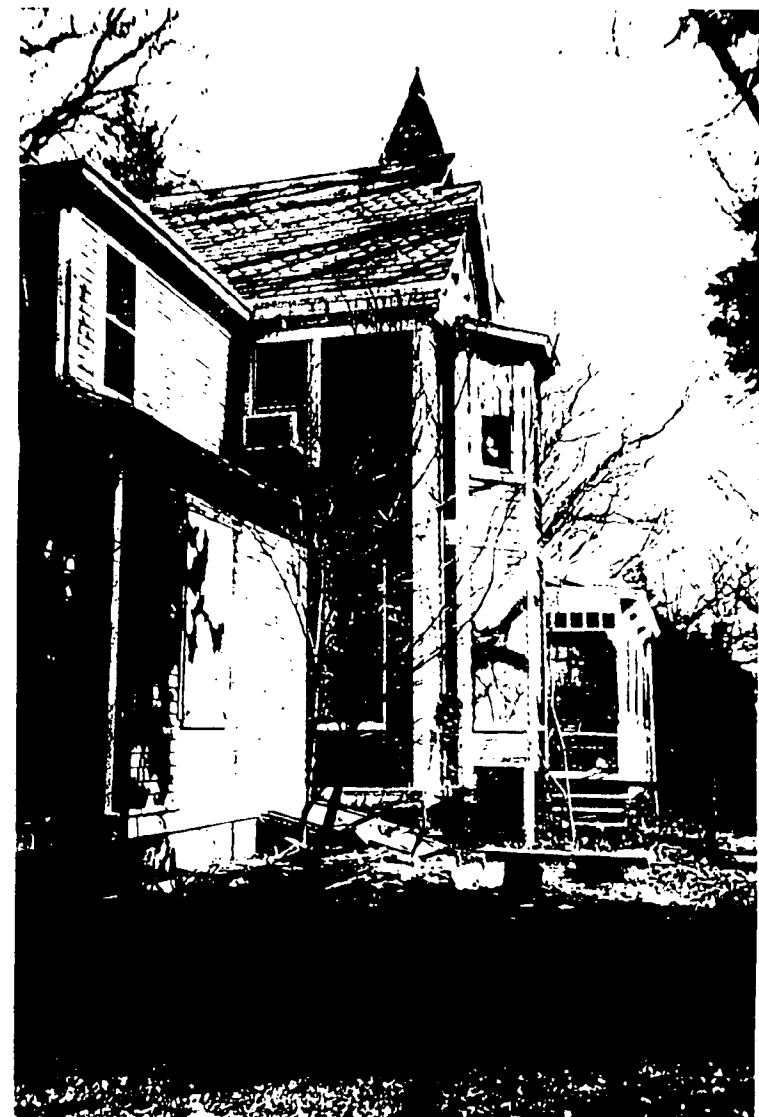
LEFT (SOUTH) ELEVATION

Damage on this elevation was most severe to the fill-in addition area. Structural damage of the second floor joists requires their removal and installation of new materials. The small second floor bathroom above will need to be rebuilt directly over the foundation walls to meet design load criteria.

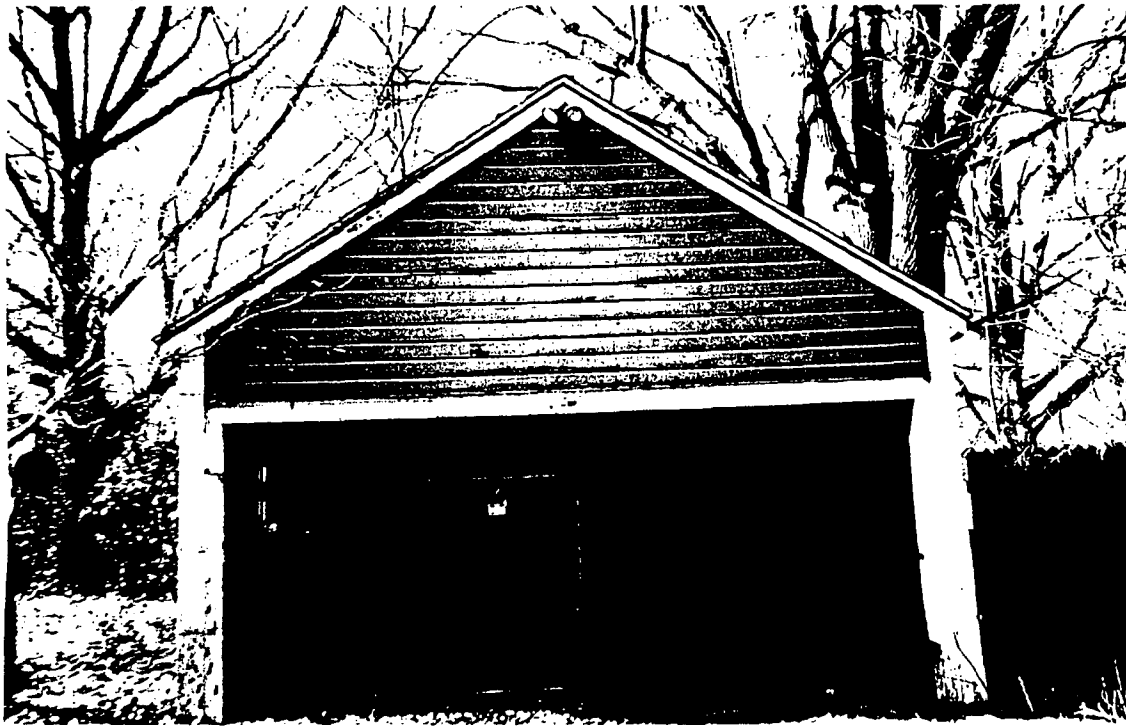
EXISTING GARAGE

The existing garage details are uncommon to those of the house. Dutch lap siding, exposed rafter tails, casement windows, and asphalt roofing shingles are the most obvious differences. The structural condition of this building finds severe wood rot at the floor plate and lower areas of stud walls. The floor slab sits below the driveway grade immediately to the front (east) side of the garage. This has allowed water to drain into the garage and subsequently cause the structural decay. The age of the garage is unknown but likely built sometime around 1950.
