31/6-91B 3934 Baltimore Street,
Kensington

Re: Removal of White Pine
tree

On Friday, October 21, 1994, I conducted a Hazard Tree evaluation on the 32" DBH White Pine (*Pinus strobus*) in the rear of your property. This letter will serve as my report.

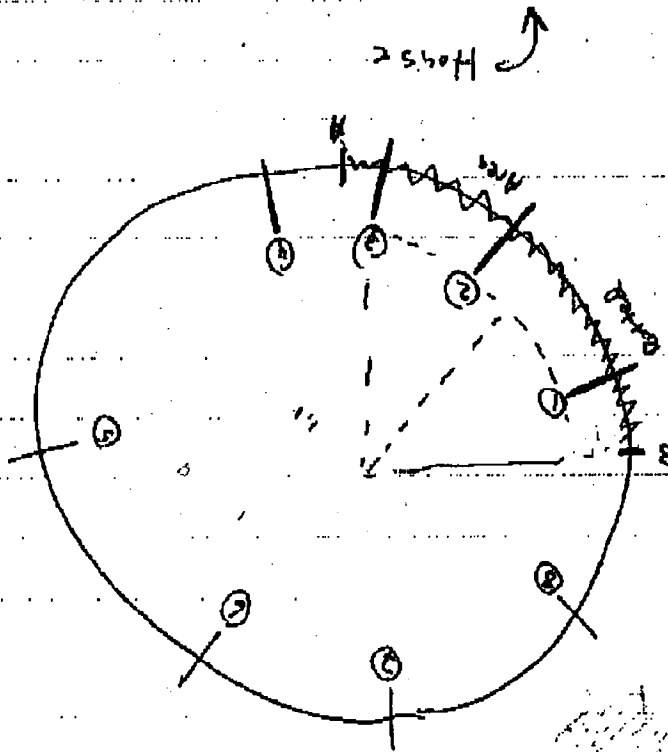
At 4.5' above grade 8 holes were drilled. Those into the face of the rotted area (26 inches wide here) yielded either rotted or semi-rotted wood to a depth of 9 inches. The other sites yielded good wood to a depth of 9 inches. Again, I strongly suspect that the rotted area of the trunk here resembles a pie shaped wedge.

- ⑩ 9" OK
- ⑨ 9" OK
- ⑧ 9" OK
- ⑦ 9" OK
- ⑥ 9" OK
- ⑤ 9" Semi-spr wood
- ④ 9" Punky wood
- ③ 9" Punky wood
- ② 9" Punky wood
- A+B = 26"
- ② 4.5" down ground:

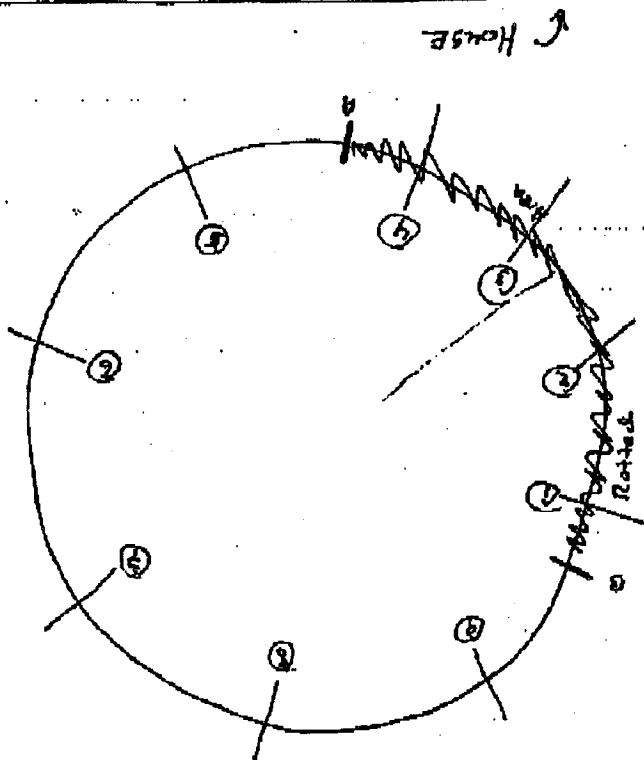
At 6" above grade a total of 9 holes were bored into the trunk. Four of these holes were bored directly into the face of the rotted area (39 inches wide). The rot extends at least 9 inches into the trunk (the length of the bit). The other five sites yielded 9 inches of normal looking wood. I suspect that the rotted area here resembles a wedge shape.

- ⑩ 9" OK
- ⑨ 9" OK
- ⑧ 9" OK
- ⑦ 9" OK
- ⑥ 9" OK
- ⑤ 9" OK
- ④ 9" Rotted wood
- ③ 9" Rotted wood
- ② 9" Rotted wood
- ① 9" Rotted wood
- A+B = 39"
- ② 6" down ground:

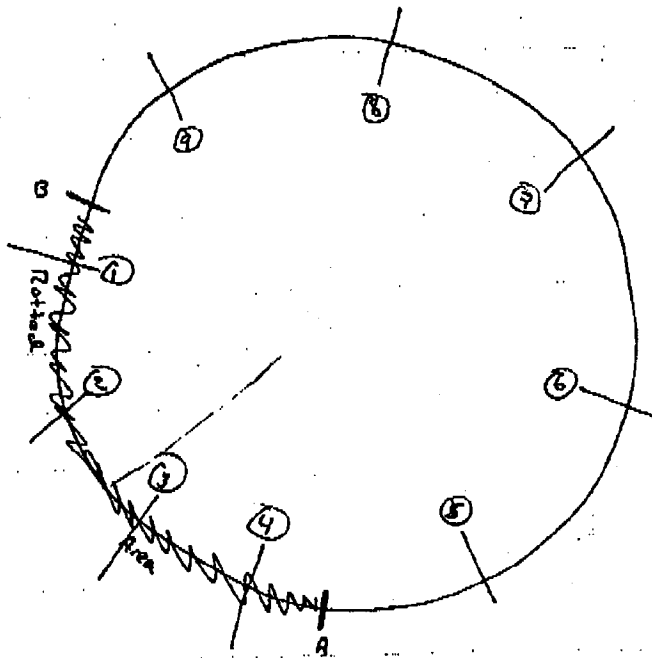
@ 6" above ground:

At 6" above grade a total of 9 holes were bored into the trunk. Four of these holes were bored directly into the face of the rotted area (39 inches wide). The rot extends at least 9 inches into the trunk (the length of the bit). The other five sites yielded 9 inches of normal looking wood. I suspect that the rotted area here resembles a wedge shape.

A to B = 39"

- ① 9" Rotted Wood
- ② 9" Rotted Wood
- ③ 9" Rotted Wood
- ④ 9" Rotted Wood
- ⑤ 9" OK
- ⑥ 9" OK
- ⑦ 9" OK
- ⑧ 9" OK
- ⑨ 9" OK

In light of the above information, I would suggest that the tree either be removed entirely or topped out to lessen the likelihood of wind throw during storms. As with any situation dealing with potentially hazardous trees, TREEMASTERS cannot predict the future with certainty and cannot be held liable for any damage that may occur. This tree may stand for years with no danger to you or the house; on the other hand, it may topple over tomorrow. There is just no way of saying. The safe and conservative approach would be to remove the tree entirely.

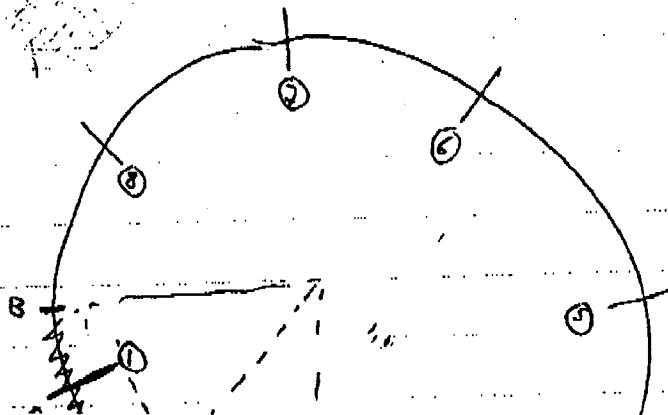
@ 4.5' above ground:

At 4.5' above grade 8 holes were drilled. Those into the face of the rotted area (26 inches wide here) yielded either rotted or semi-rotted wood to a depth of 9 inches. The other sites yielded good wood to a depth of 9 inches. Again, I strongly suspect that the rotted area of the trunk here resembles a pie shaped wedge.

A to B = 26"

- ① 9" Punky Wood
- ② 9" Punky Wood
- ③ 9" Punky Wood
- ④ 9" Semi-lyr Wood
- ⑤ 9" OK
