17/20-93A 18511 Beallsville Road
Wallace Poole House

Address: 18511 Beallsville Road	Meeting Date: 12/15/93
Resource: Wallace Poole House	Review: HAWP/Demolition
Case Number: 17/20-93A	Tax Credit: No
Public Notice: 12/1/93	Report Date: 12/8/93
Applicant: Mary Muldoon	Staff: Nancy Witherell
PROPOSAL: Demolition	RECOMMEND: Approval

HISTORIC PRESERVATION COMMISSION STAFF REPORT

**REPORT ON THE STRUCTURAL CONDITIONS
OF THE ABANDONED TWO-STORY RESIDENTIAL STRUCTURE
THE MULDOON FARM IN POOLSVILLE MARYLAND**

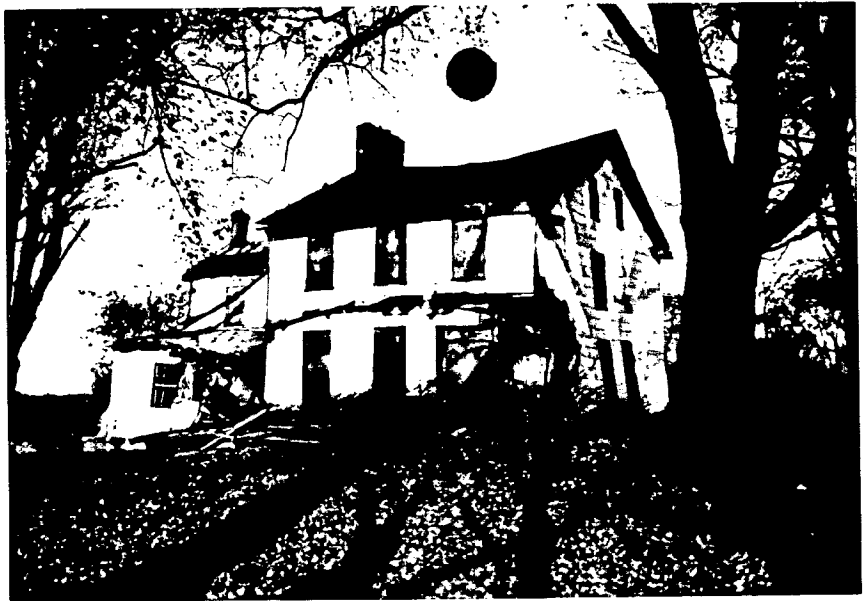
FRONT

1. The front porch is collapsed flat on the ground in front of the house.
2. The southwest corner of the house is open to the elements from the first floor to the roof. An advanced state of vegetal growth is occurring. Deterioration of wood structural elements is severe at this point. The house has been pulled off its foundation at this corner. A view of the south elevation shows the settling of the house on the ground along this side.

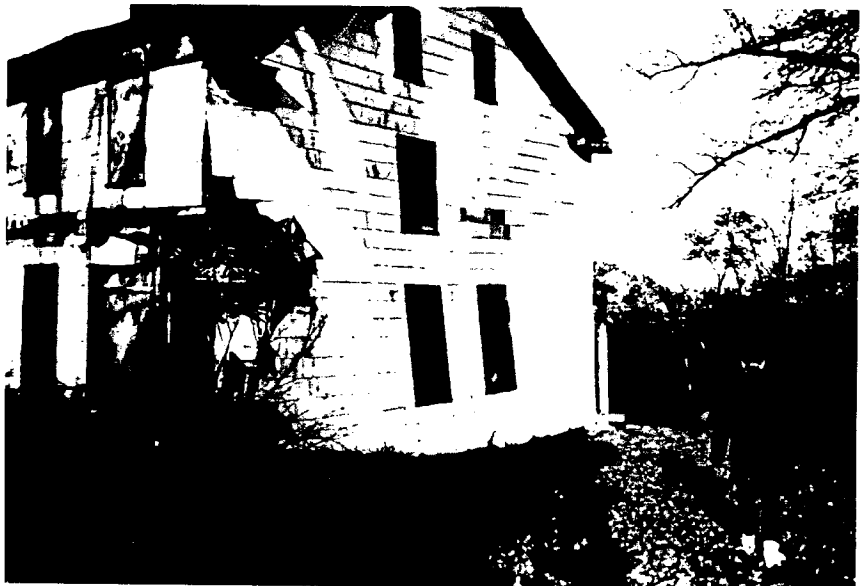
FRONT
RIGHT
CORNER
(STAIR-
HALL)

3. On the interior at this corner, the staircase is virtually completely detached from the interior walls. The steps have collapsed due to long exposure to the elements and to the stress of the dislocation of the house from its foundation. Only portions of 4 balusters remain of the entire staircase. The front door and original sidelight glass are gone.

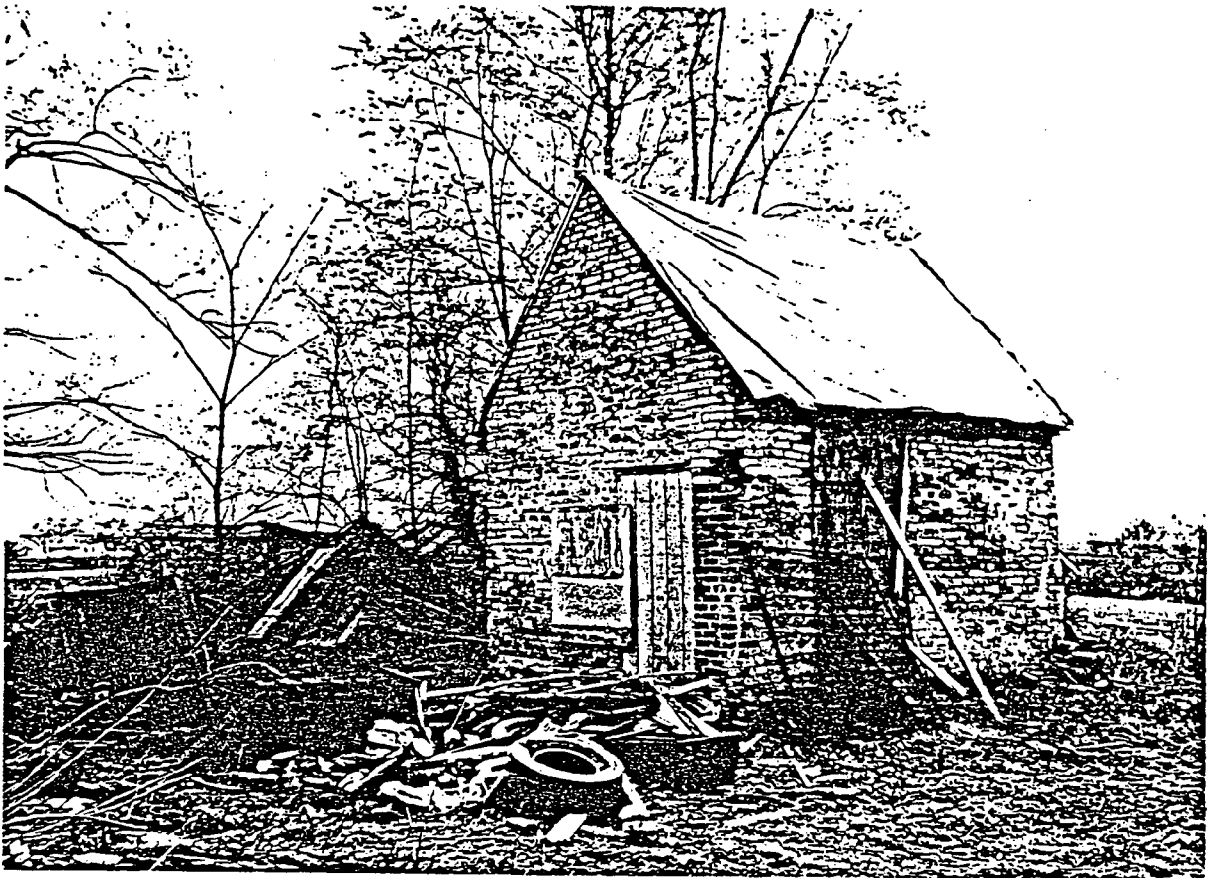
The brick smokehouse contains one room, has a door on the South side, facing the main dwelling, a window in the East wall and one in the West wall. The masonry is damaged in several places but can be restored. The wood shingle roof is covered in plastic to stabilize it. The gables, front and back, have a pierced brick design. Openings are boarded up.

Smokehouse of
pierced
brick con-
struction.
South & East
facades.
