Corby Estate / Strathmore Hall

30/012-96A

Window Rehab. HPC 7/10/96

Re: Easement Committee Review
Strathmore Hall
Montgomery County

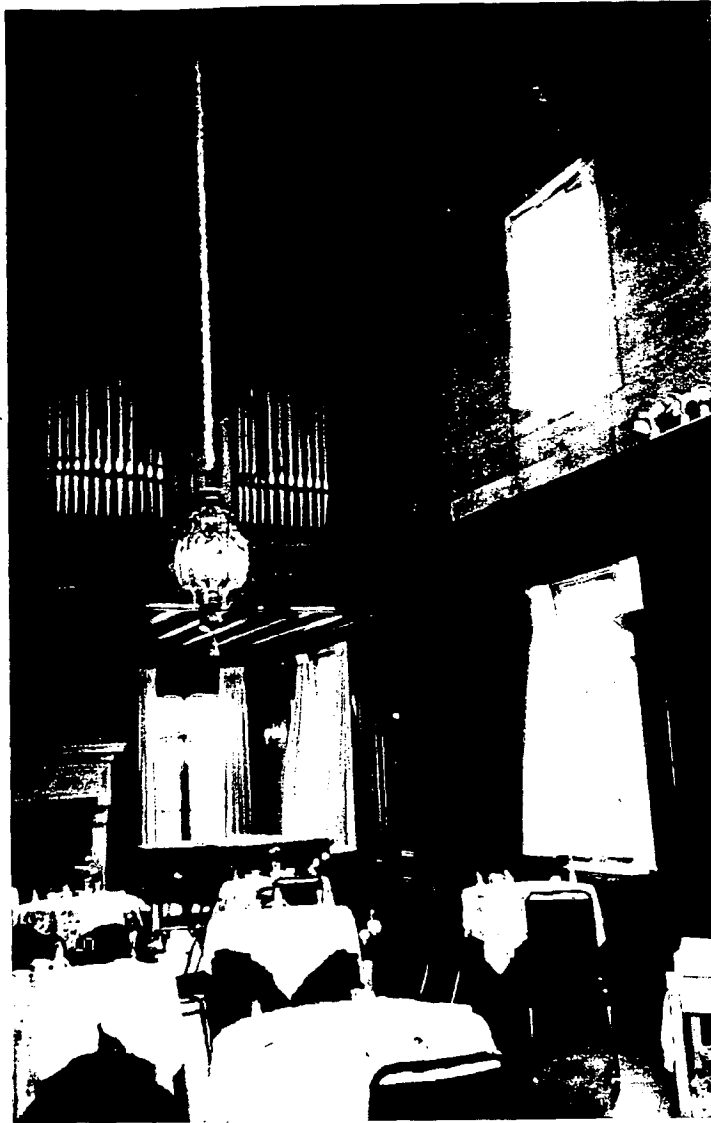
Photo #1: Interior view of music room. 8/12 Faux-finish double-hung sash are at lower level. 8x8 casement sash are at upper level.

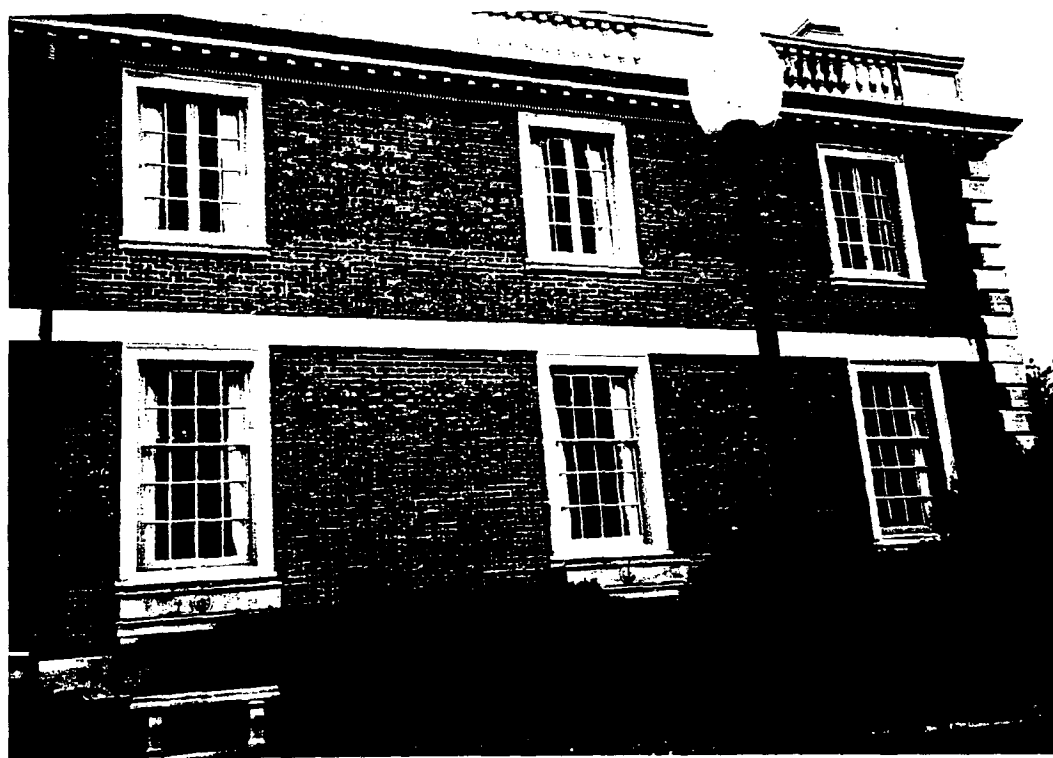
Photo #2: Exterior view of sash at Music Room.

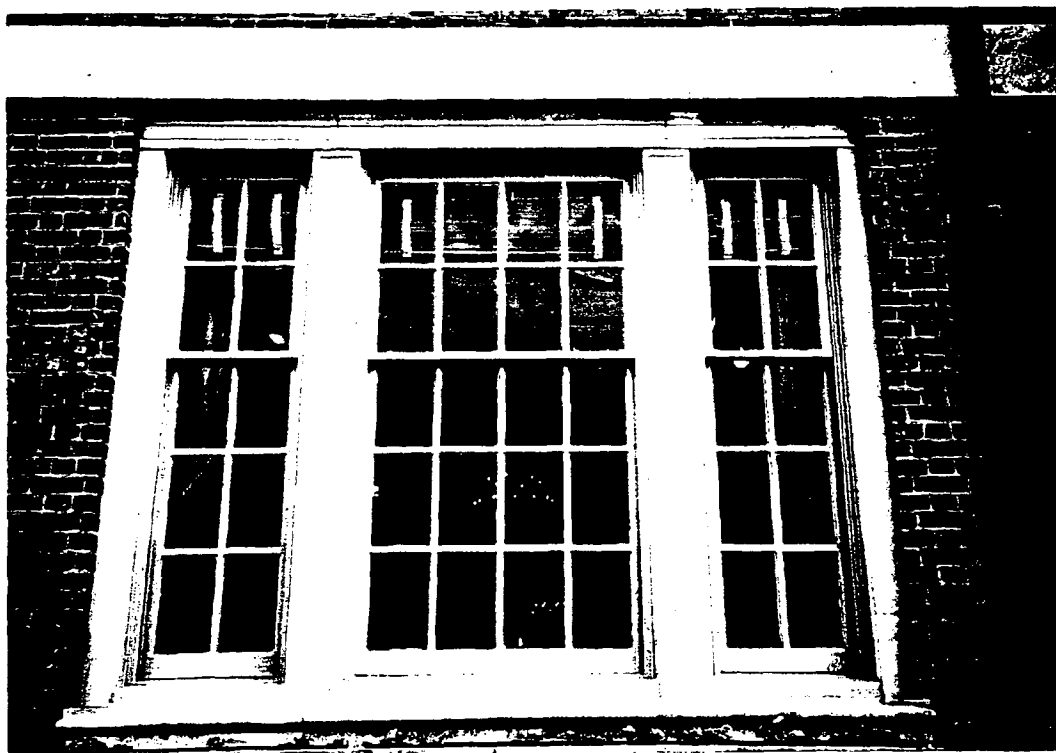
Photo #5: Exterior view of sash at Gallery (Rm. 110).

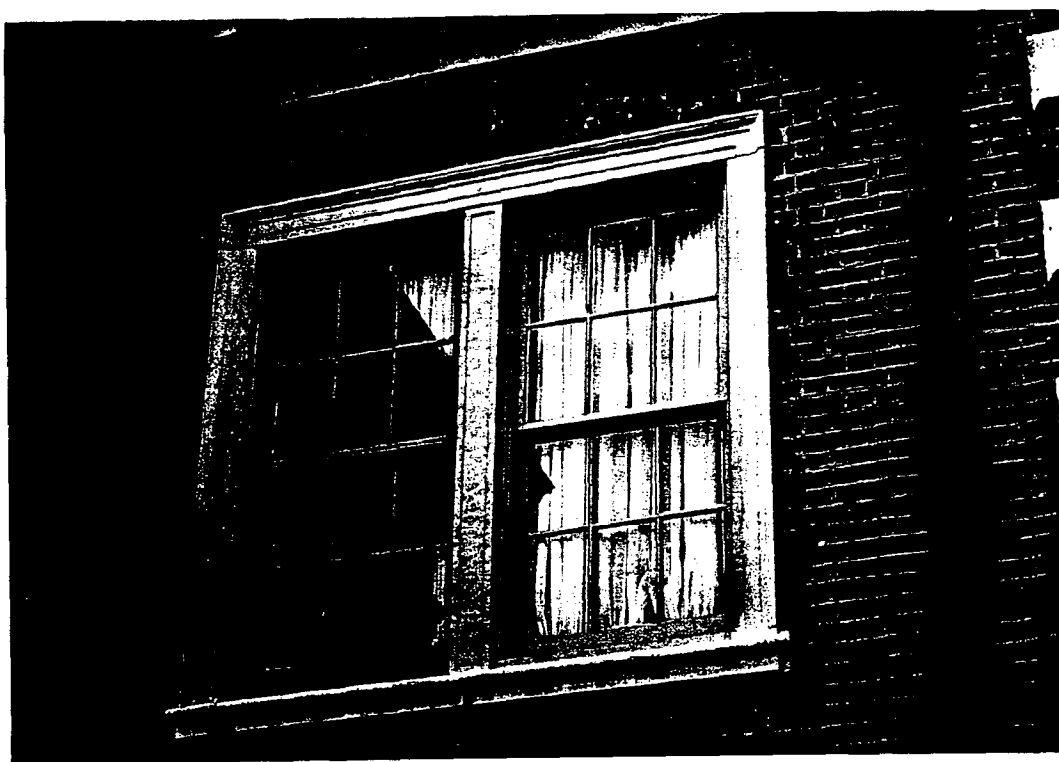
Condition: Lower rails of sash exhibit open joints and water staining. Interior faux-finish is flaking, exposing a white undercoating. Sash are loose in their frames.

Comment: Thermal performance of these sash is poor due to the lack of storm sash or insulated glass. Air infiltration rates are high due to the lack of complete perimeter weather-stripping.

Photo #7: Exterior view of sash at second floor Gallery (Sash No.s 212, 213).
Note narrow muntins (Type 3) at this sash.

1. Only windows within openings 208, 209, 210, 211, 212, 213 and 214 should be replaced. Replacement sash shall match existing lite configuration, operation, muntin and head profiles. Glazing may be double pane.

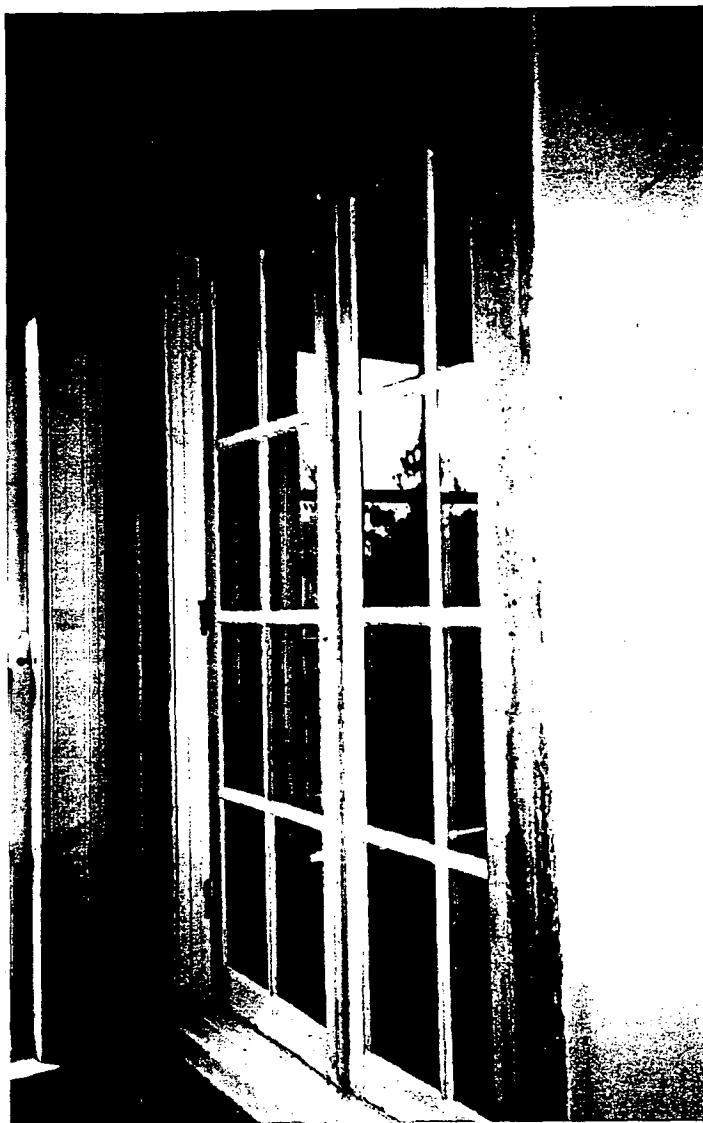
Photo #9: Detail view of exterior casement sash at Music Room.
This sash opens onto the second floor hallway.
This historic sash will be restored (archived) in place.

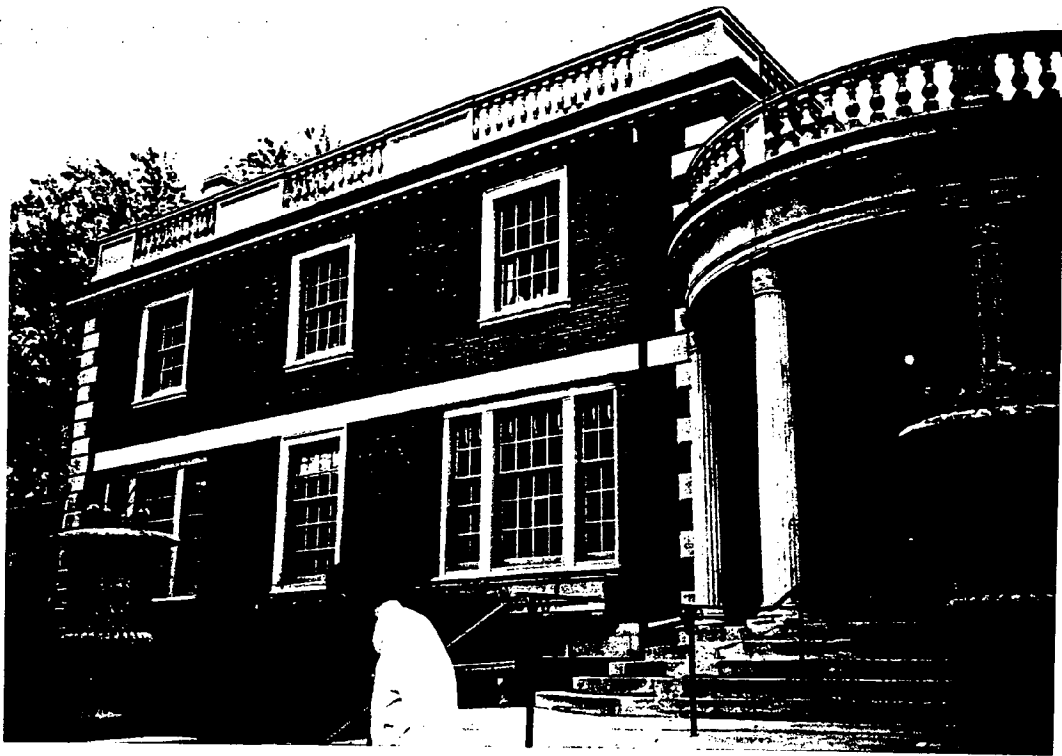
Photo #10: Exterior view of sash at first floor Gallery and kitchen, and second floor offices.
The sash at the kitchen and offices must remain operable.

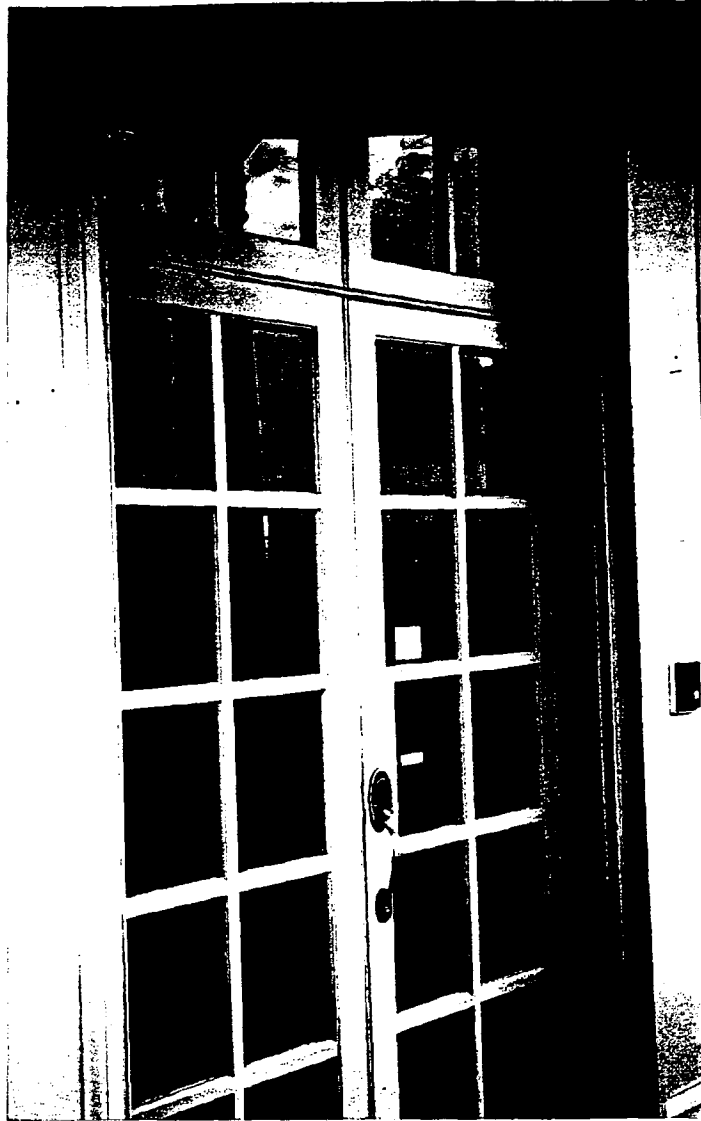
Photo #14: Exterior view of south entrance door No.s 109B. These doors will be replaced with new, double insulated French doors with egress hardware.

- 3) Replace the central, north and south entrance doors with new wood double glazed true divided light doors. These doors must be re-swung in order to comply with life safety codes. Profiles of the new doors will replicate existing door profiles. The new doors are to be set within the existing frames, and doors at the first floor level will incorporate new panic (egress) hardware.

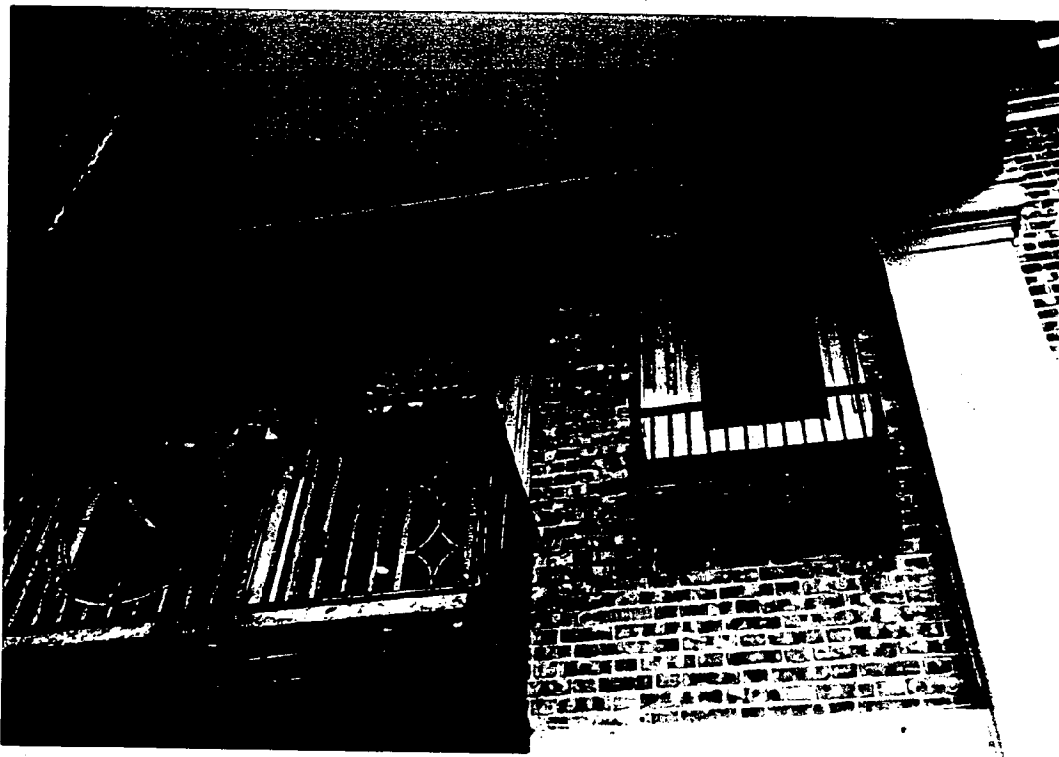
Photo #15: Exterior view of second floor French door No.s 259A. These doors will be replaced with true divided lite French doors.

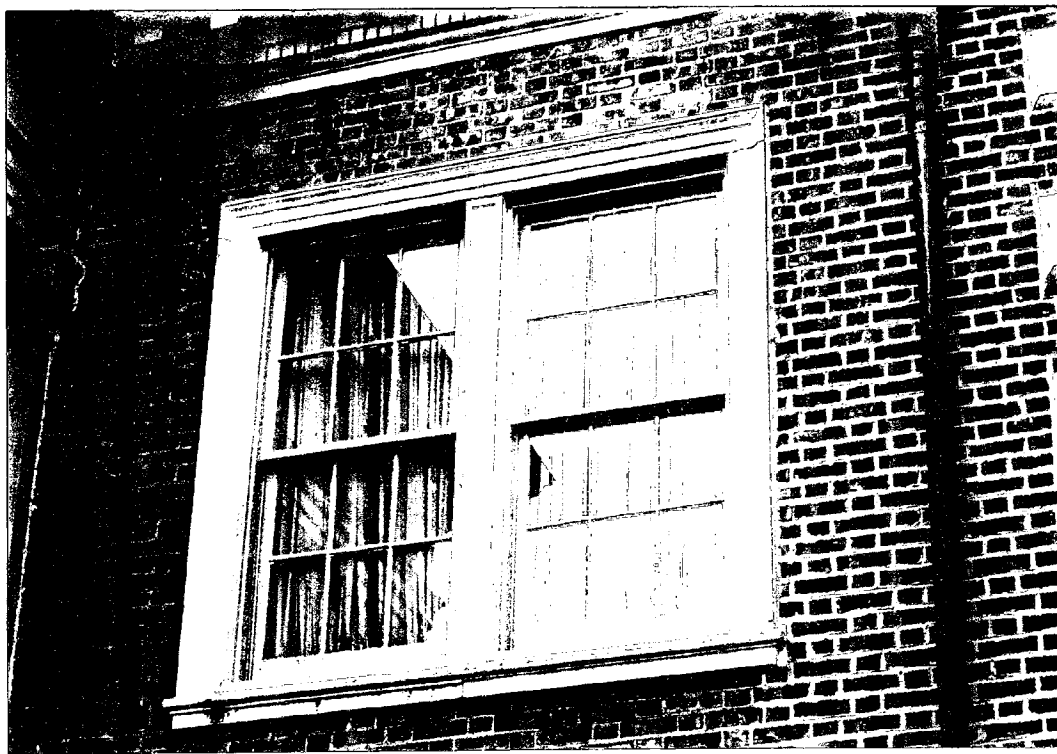
Photo #7: Exterior view of sash at second floor Gallery (Sash No.s 212, 213).
Note narrow muntins (Type 3) at this sash.

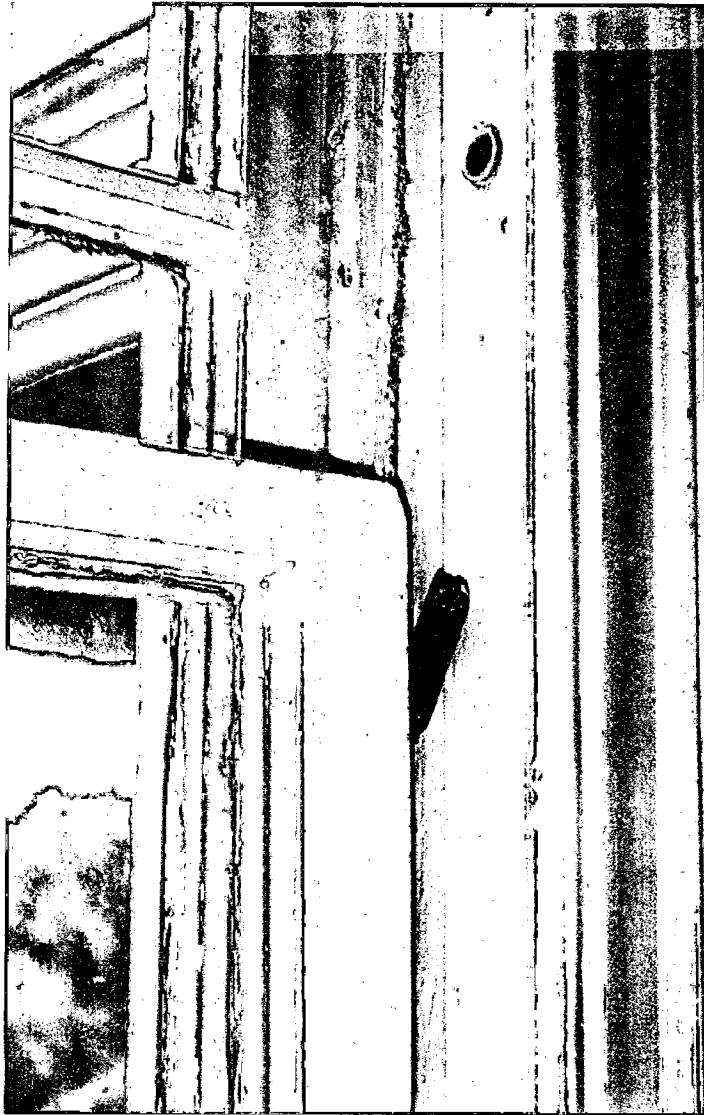
Photo #8: Detail view of loose sash at jamb (object easily fits in gap).
This is a typical condition for all narrow-muntin sash at Strathmore Hall.
See Photo #7 for exterior view of sash.

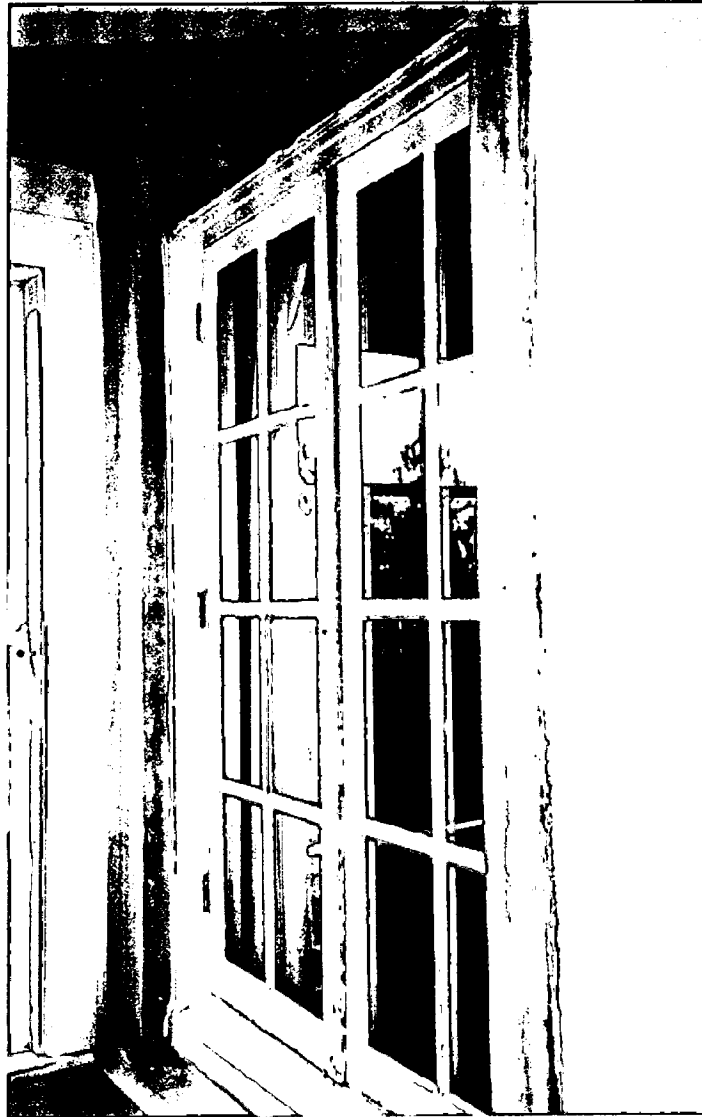
Photo #9: Detail view of exterior casement sash at Music Room.
This sash opens onto the second floor hallway.
This historic sash will be restored (archived) in place.

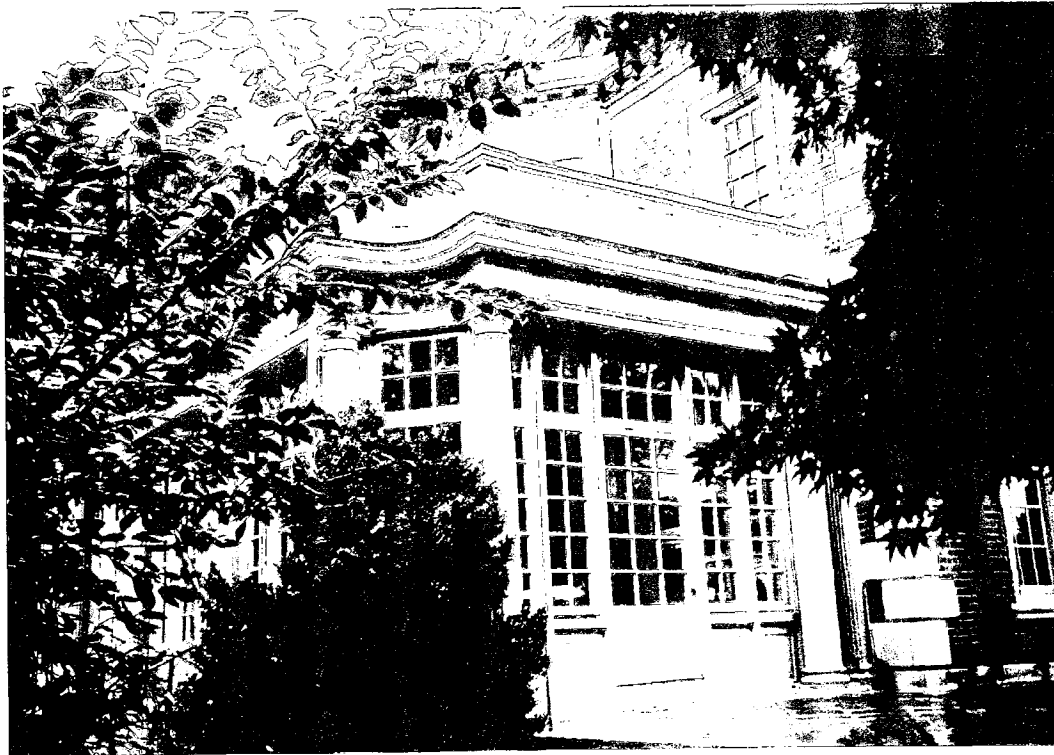
Photo #12: Exterior view of sun room window No.s 121 and 122. These sash will be restored and will receive exterior wood-framed storm glazing.

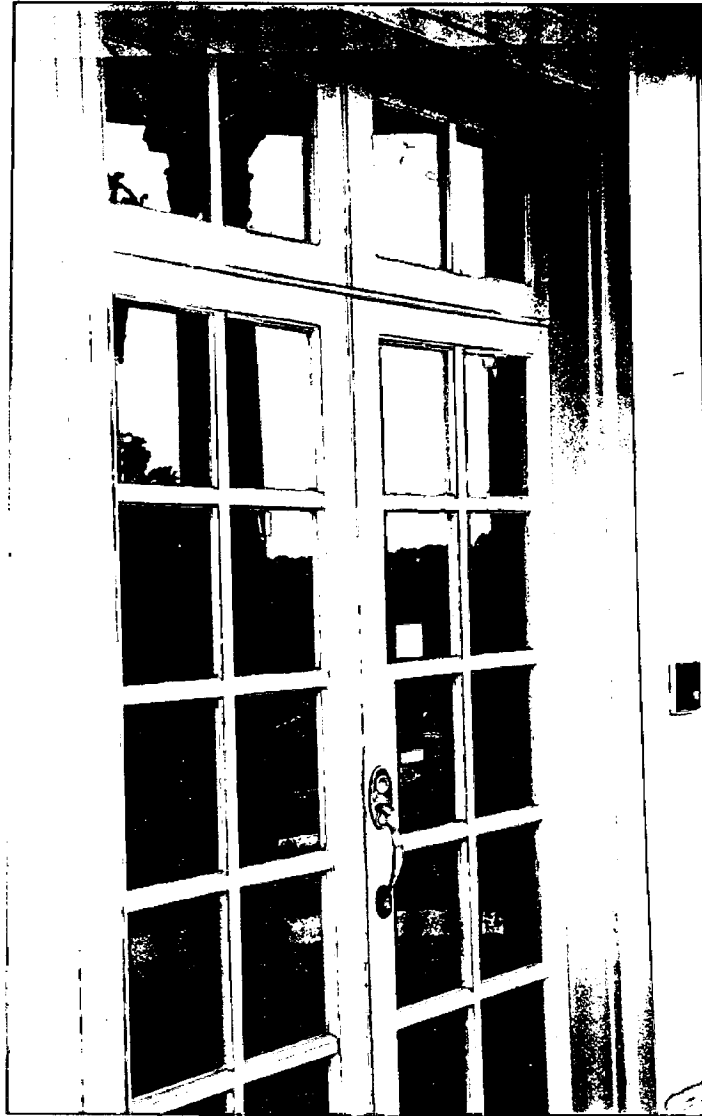
Photo #14: Exterior view of south entrance door No.s 109B. These doors will be replaced with new, double insulated French doors with egress hardware.

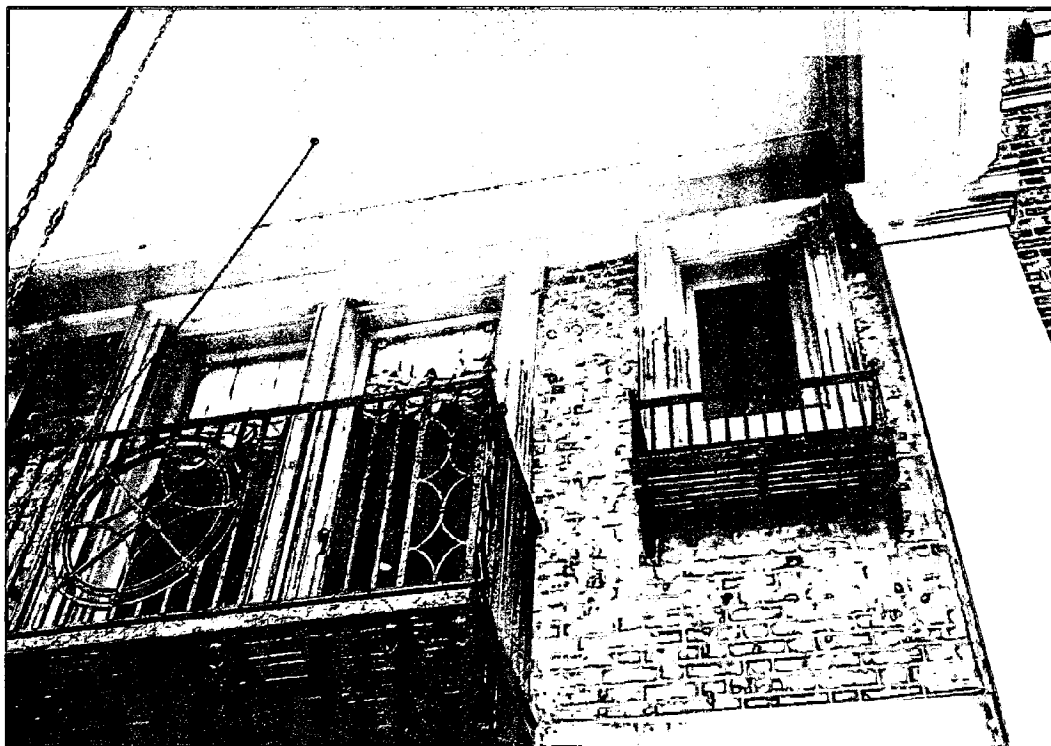
Photo #15: Exterior view of second floor French door No.s 259A. These doors will be replaced with true divided lite French doors.

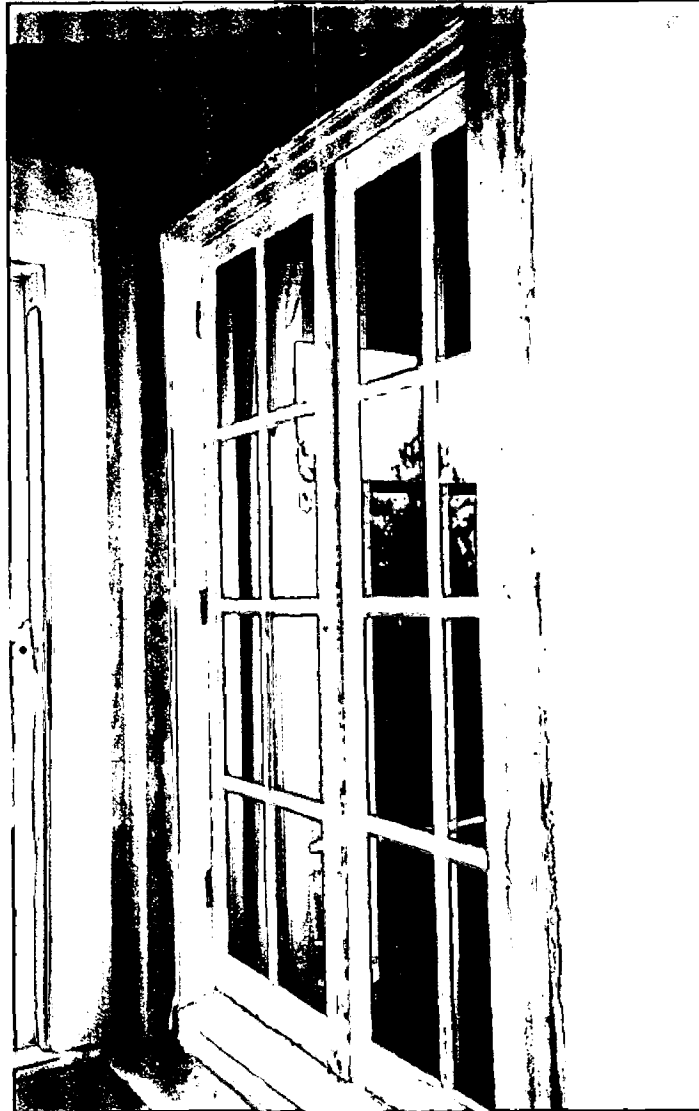
Photo #9: Detail view of exterior casement sash at Music Room.
This sash opens onto the second floor hallway.
This historic sash will be restored (archived) in place.

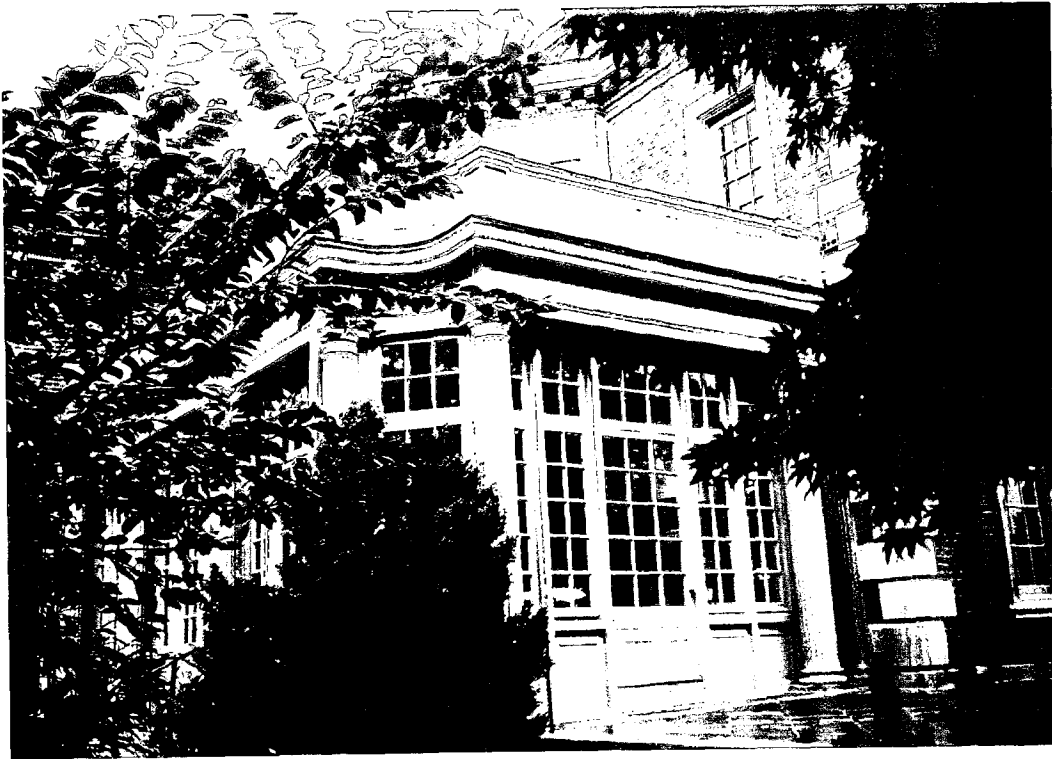
Photo #12: Exterior view of sun room window No.s 121 and 122. These sash will be restored and will receive exterior wood-framed storm glazing.

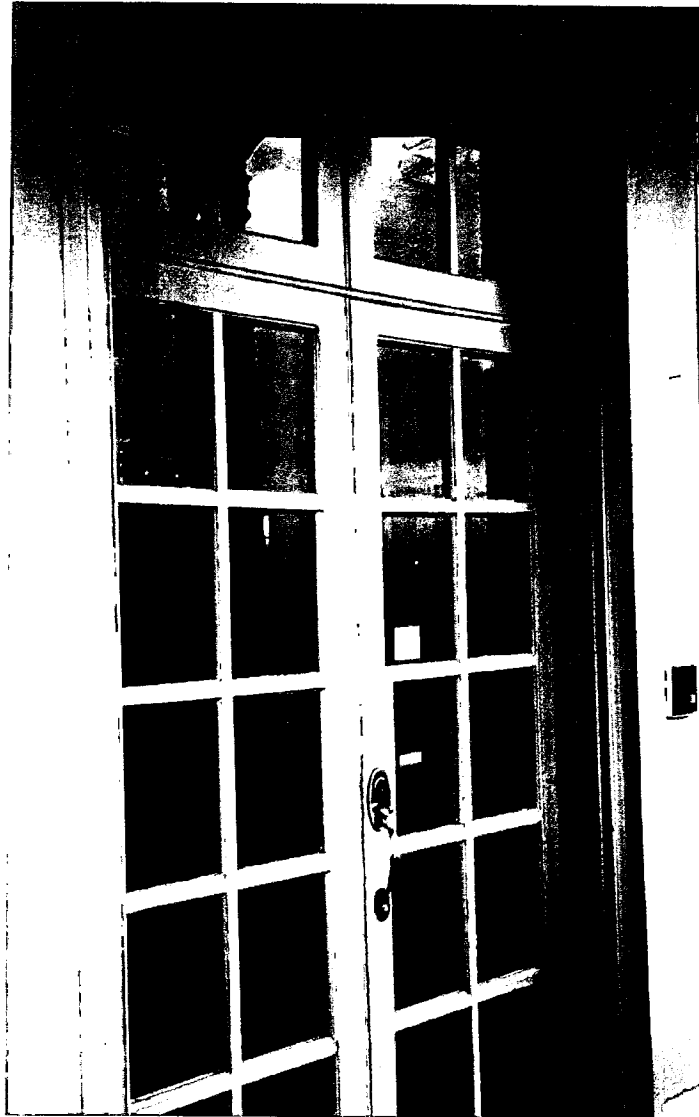
Photo #14: Exterior view of south entrance door No.s 109B. These doors will be replaced with new, double insulated French doors with egress hardware.

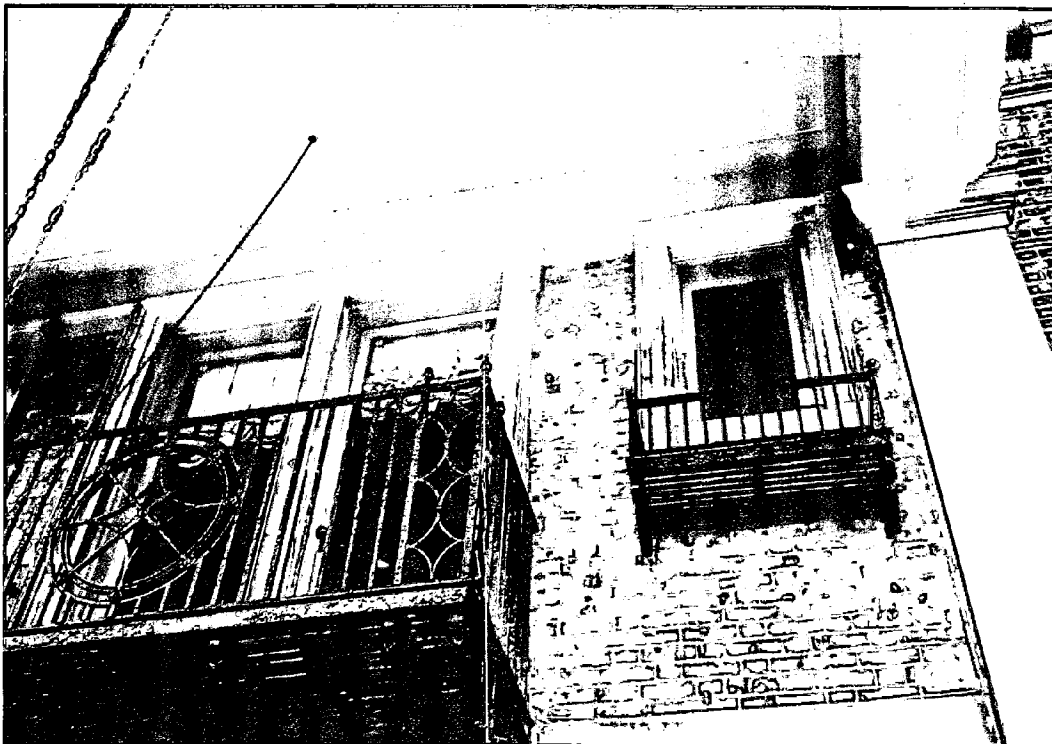
Photo #15: Exterior view of second floor French door No.s 259A. These doors will be replaced with true divided lite French doors.

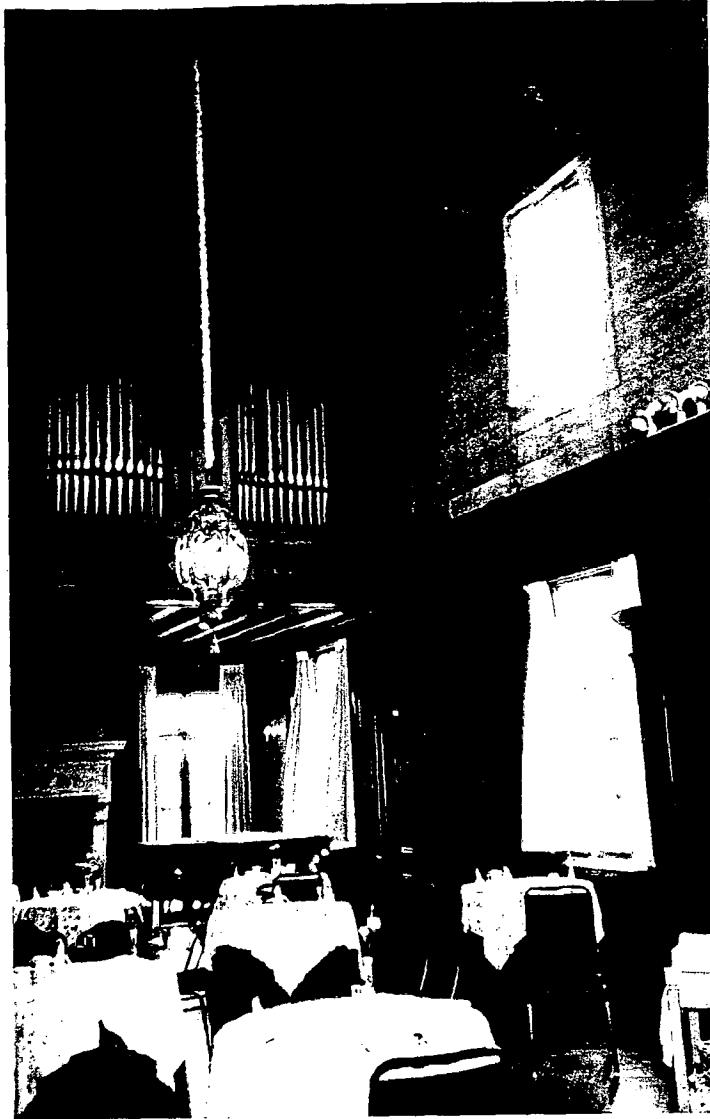
Photo #1: Interior view of music room. 8/12 Faux-finish double-hung sash are at lower level. 8x8 casement sash are at upper level.

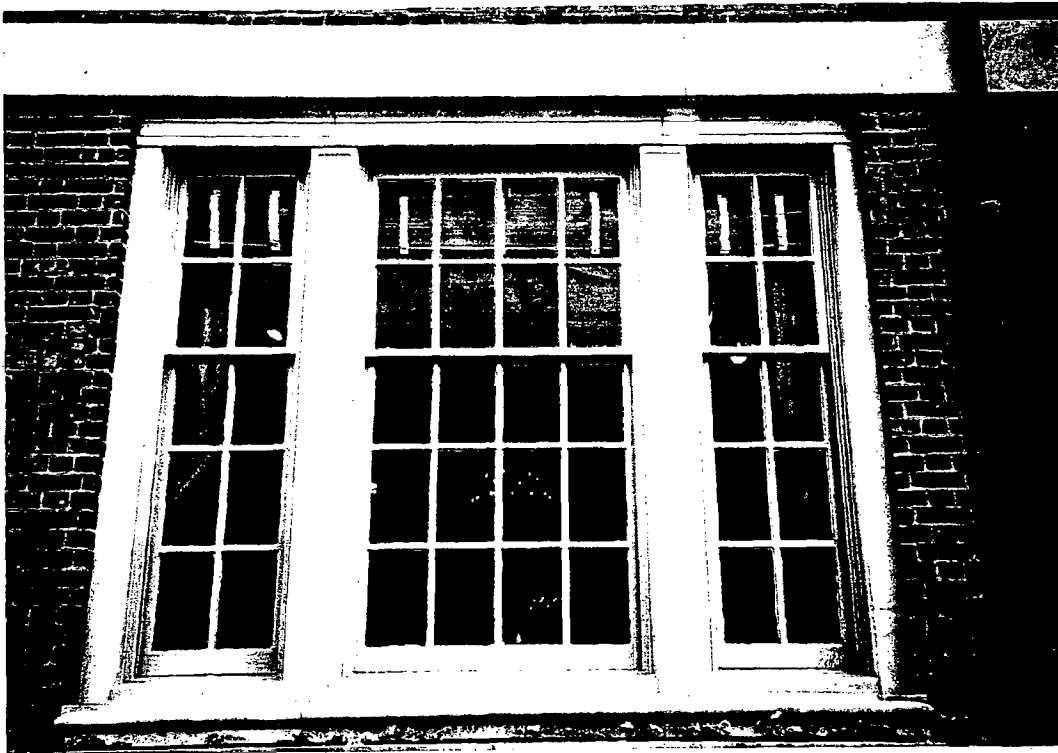
Photo #5: Exterior view of sash at Gallery (Rm. 110).

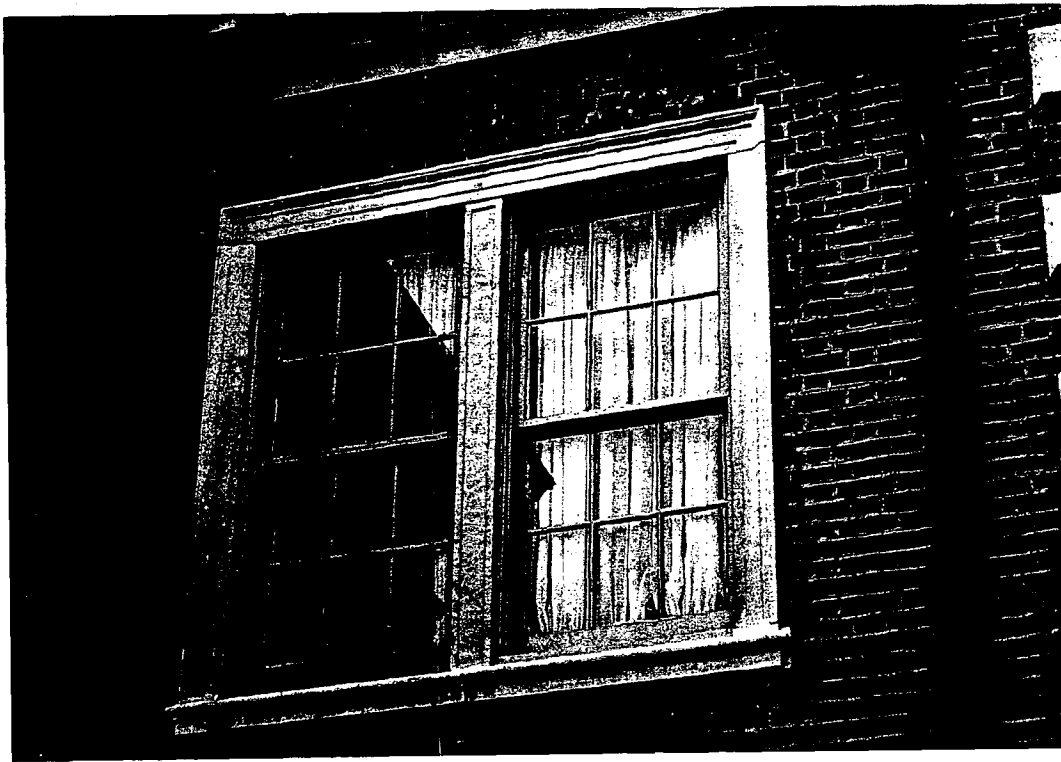
Photo #7: Exterior view of sash at second floor Gallery (Sash No.s 212, 213).
Note narrow muntins (Type 3) at this sash.

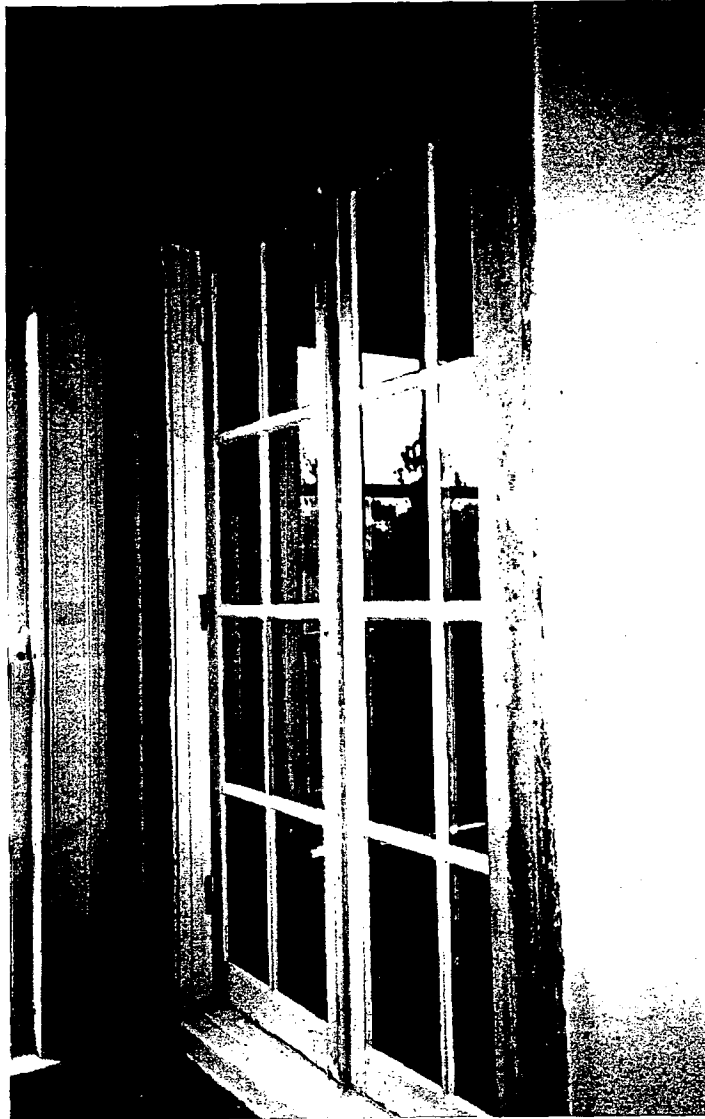
Photo #9: Detail view of exterior casement sash at Music Room.
This sash opens onto the second floor hallway.
This historic sash will be restored (archived) in place.

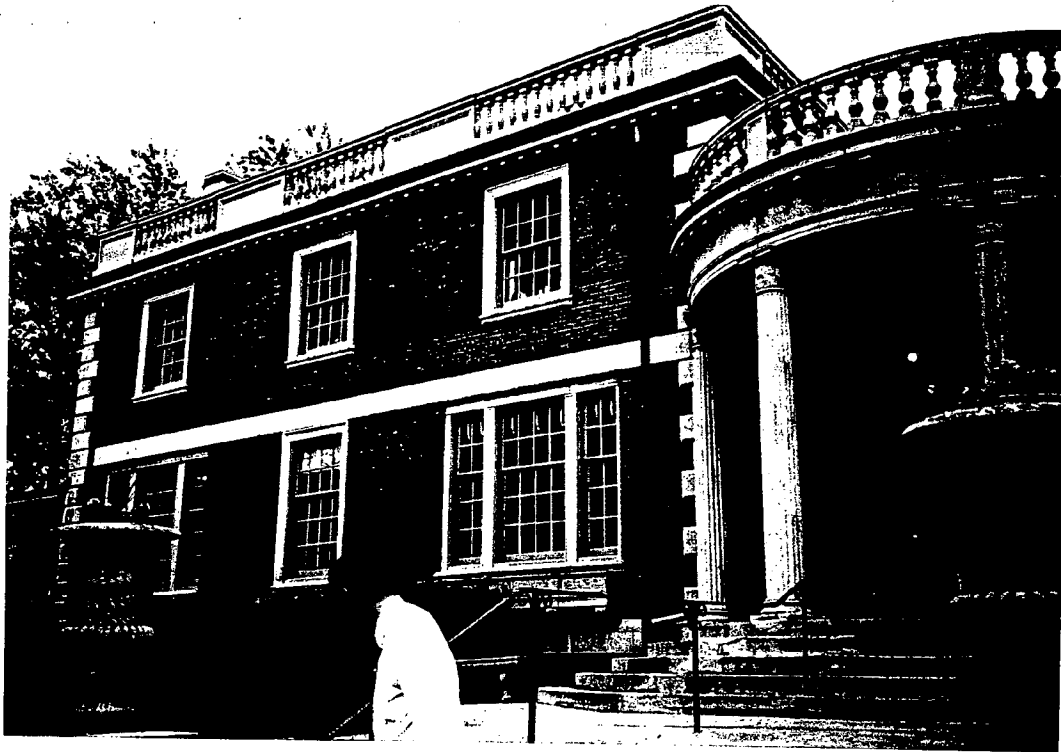
Photo #10: Exterior view of sash at first floor Gallery and kitchen, and second floor offices.
The sash at the kitchen and offices must remain operable.

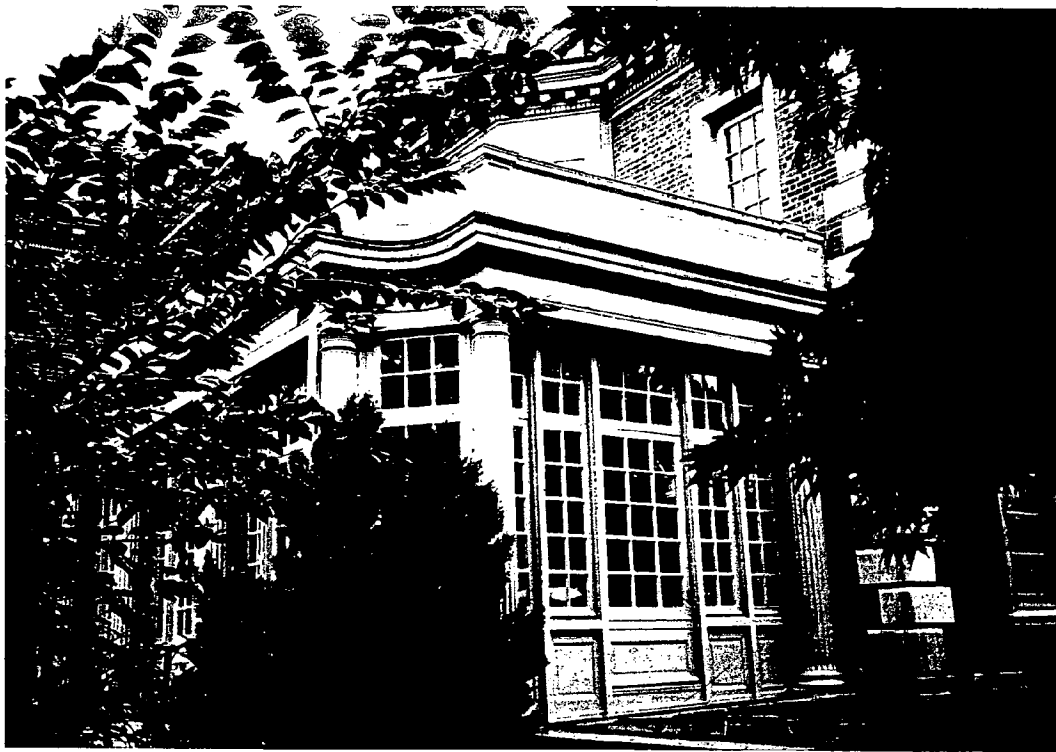
Photo #12: Exterior view of sun room window No.s 121 and 122. These sash will be restored and will receive exterior wood-framed storm glazing.

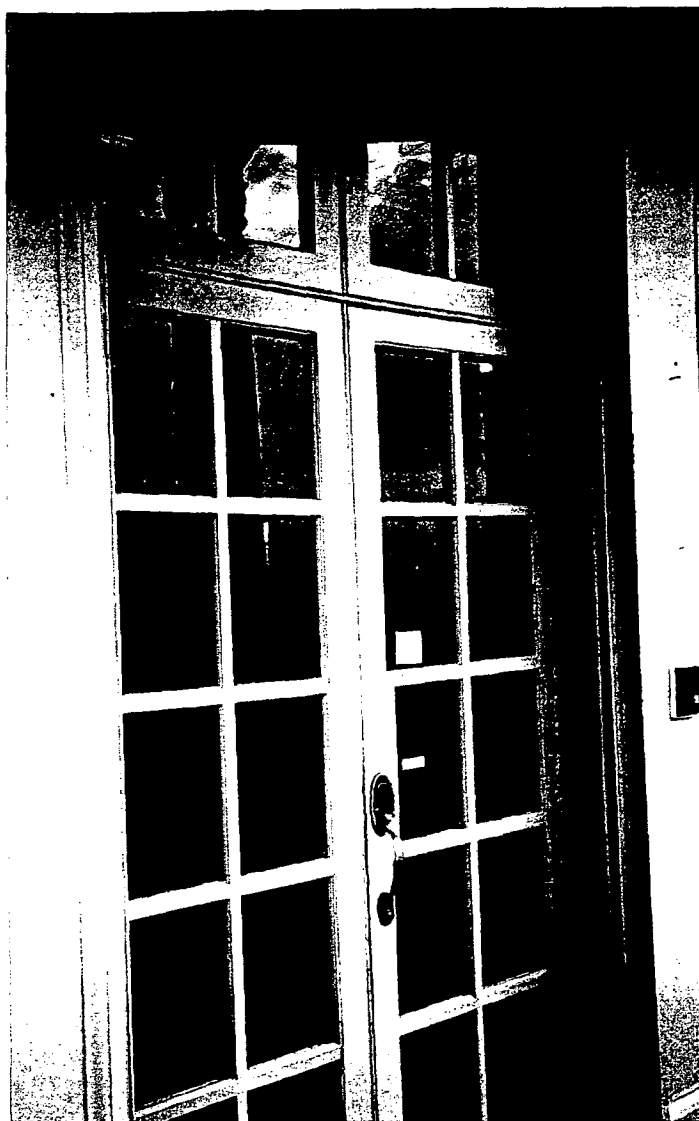
Photo #14: Exterior view of south entrance door No.s 109B. These doors will be replaced with new, double insulated French doors with egress hardware.
