36/7-3-98A 8619 Colesville Rd. S. Sp.  
(MP #36/7-7 Silver Theatre Shopping  
Center)

**ROOF REPLACEMENT  
 MASONRY RESTORATION  
 SILVER THEATRE  
 SILVER SPRING, MARYLAND**

**REPORT OF EXISTING CONDITIONS  
AND FINDINGS  
REGARDING THE RESTORATION OF  
THE ROOF OF THE SILVER THEATER**

**SILVER SPRING  
MONTGOMERY COUNTY  
MARYLAND**

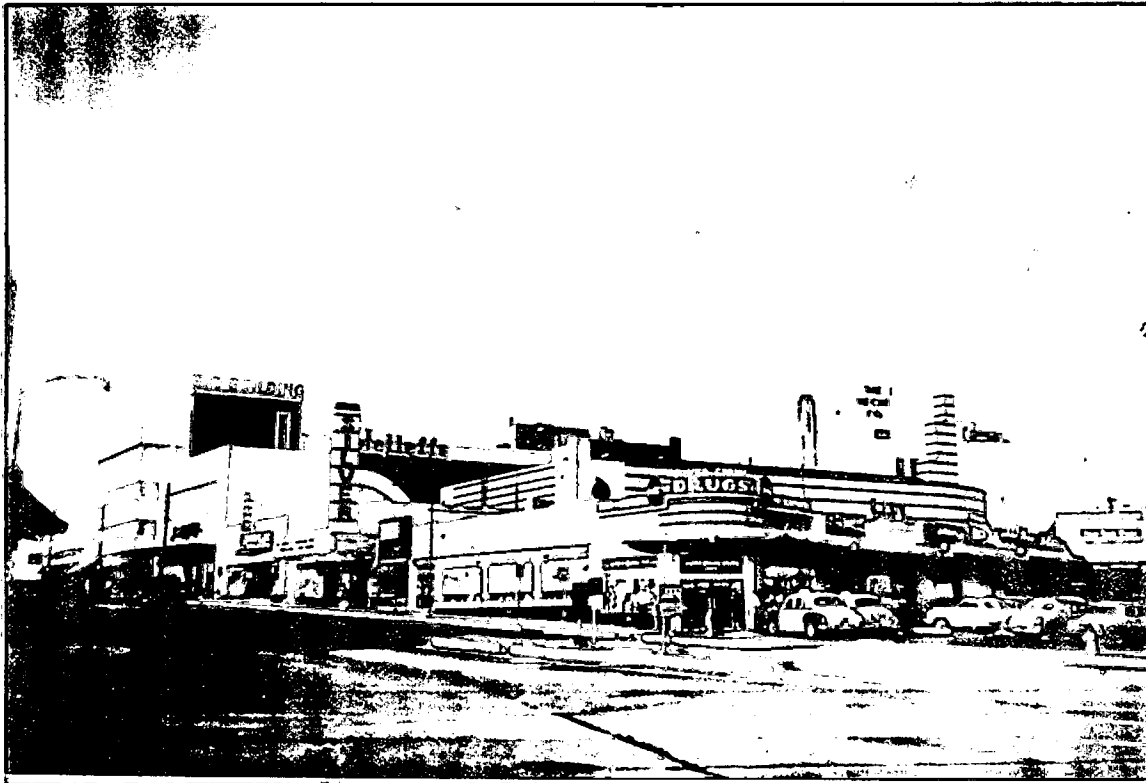
003 Mid-twentieth-century photo showing the mansard roof and original chimney.

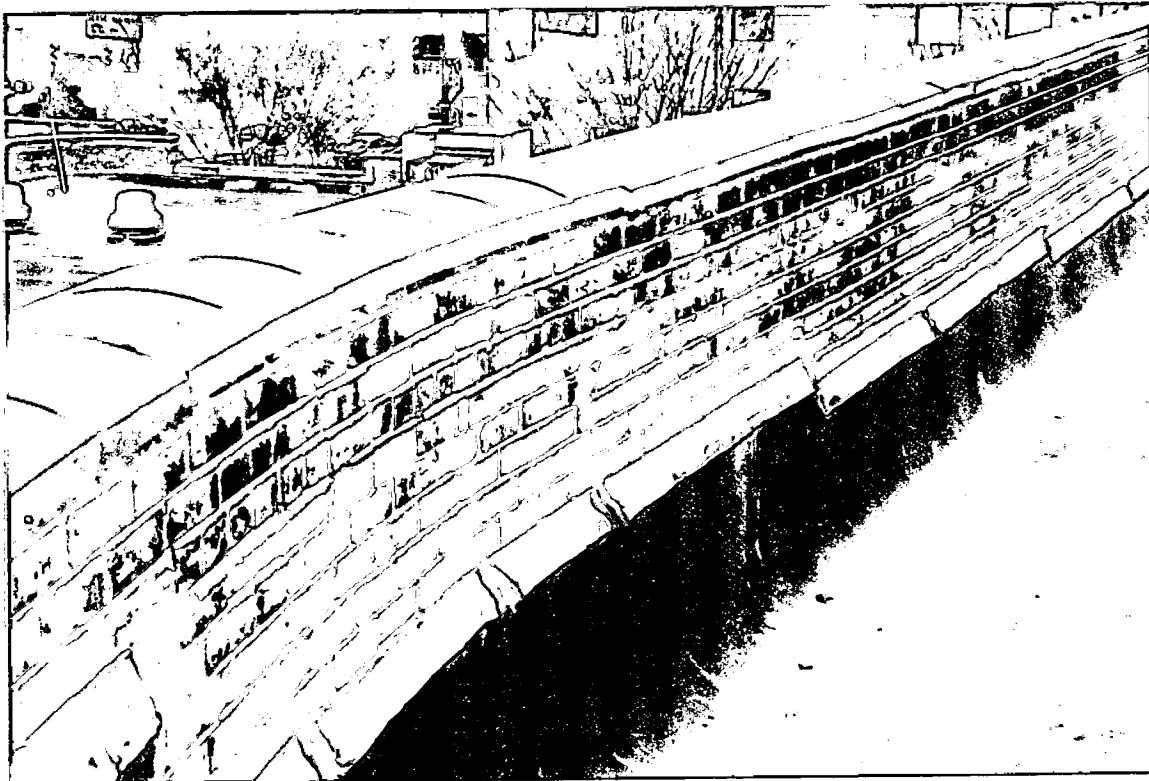
004 East face of the west parapet wall of the auditorium roof showing separated joint, metal counter-flashing and terra-cotta parapet cap (1998 photograph).

The results of the mortar sample testing reflected in the laboratory report indicate that the original mortars are appropriate for the types of masonry found on the parapet wall and that the colors are appropriate to their substrata masonry depending on base colors and locations. This is common for the type of construction during the period. The mortar, in general, is in good condition, with only about 30% patch pointing replacement required. The original joints, however, are reverse struck and it is recommended that replaced joints should be correctly struck when installed.

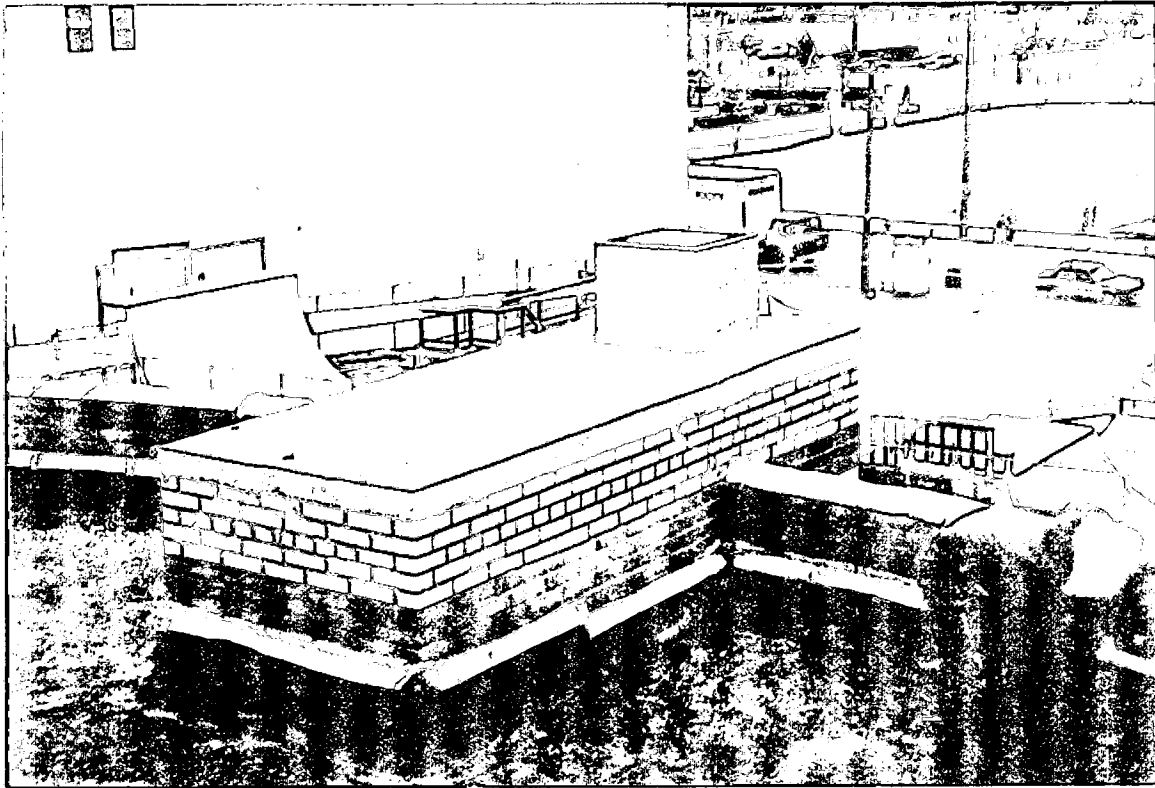
005 Base of the demolished chimney intersecting the south (apse) end of the auditorium (note chimney flue at right of photo, 1998 photograph)

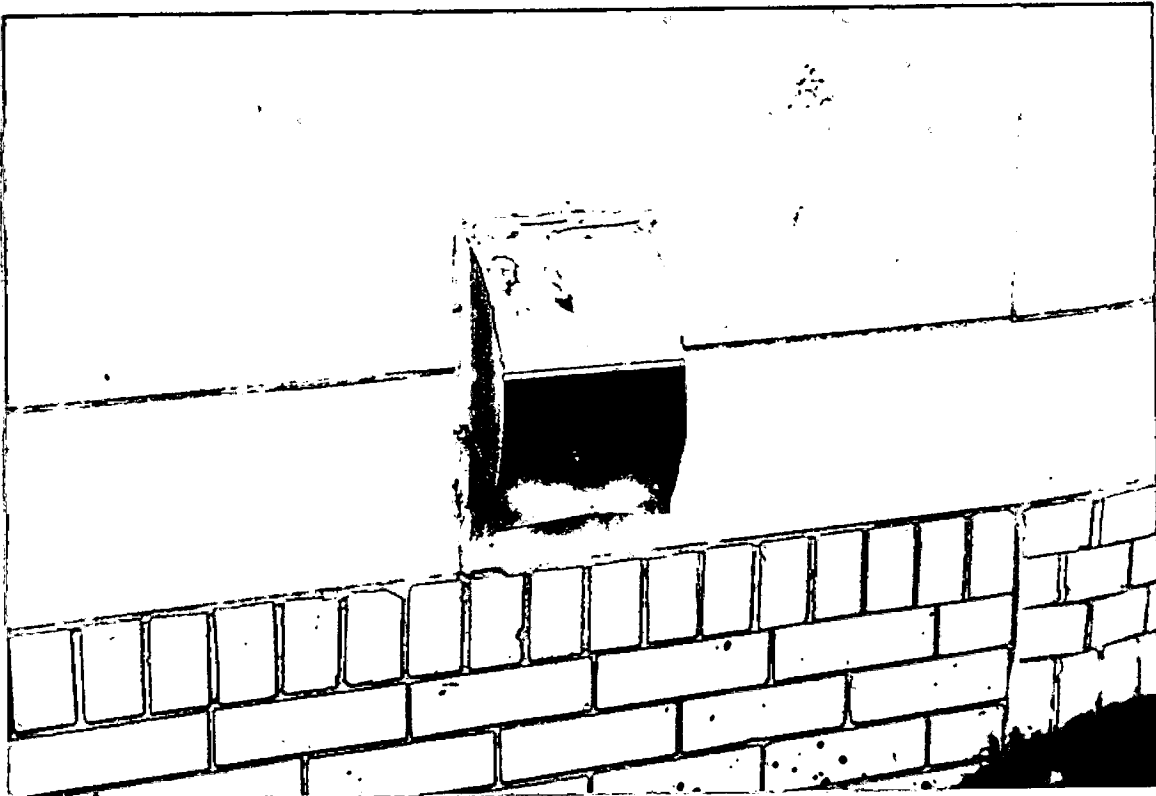
007 Existing original sheet metal scupper and caststone parapet wall cladding with buff brick parapet wall below (1998 photograph).

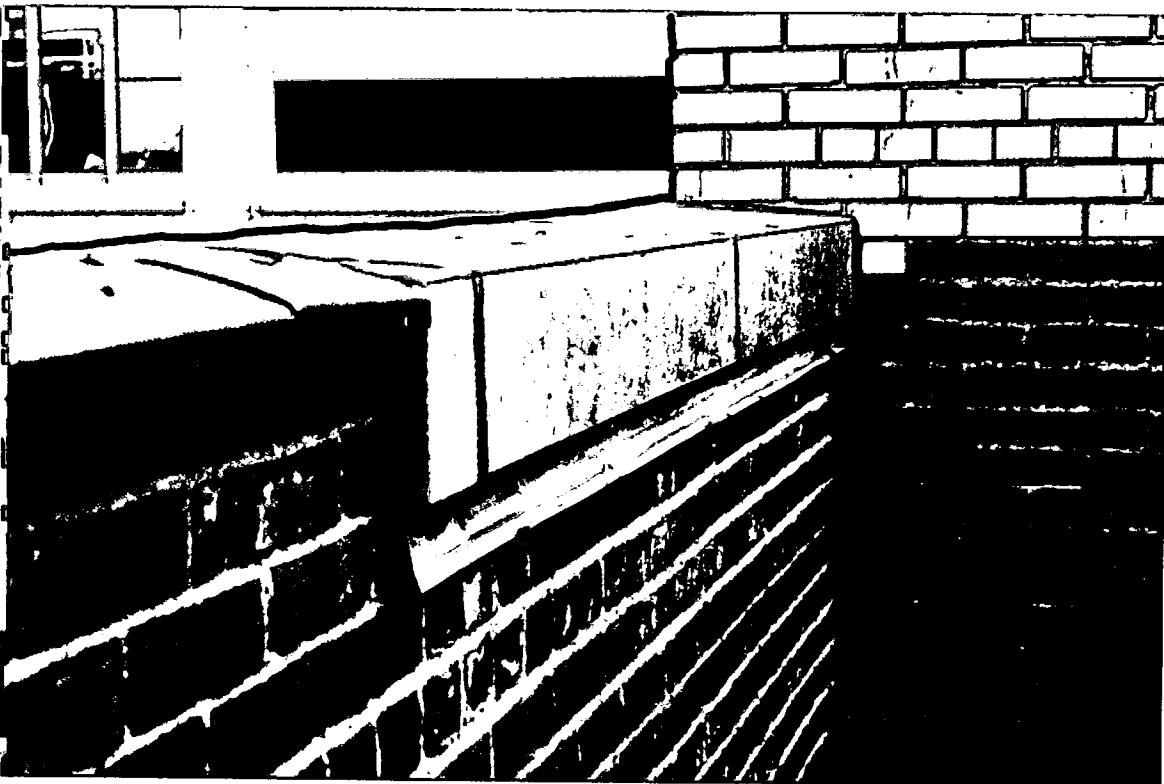
008 Juncture of caststone and terra-cotta parapet caps at the northwest corner of auditorium roof (1998 photograph).

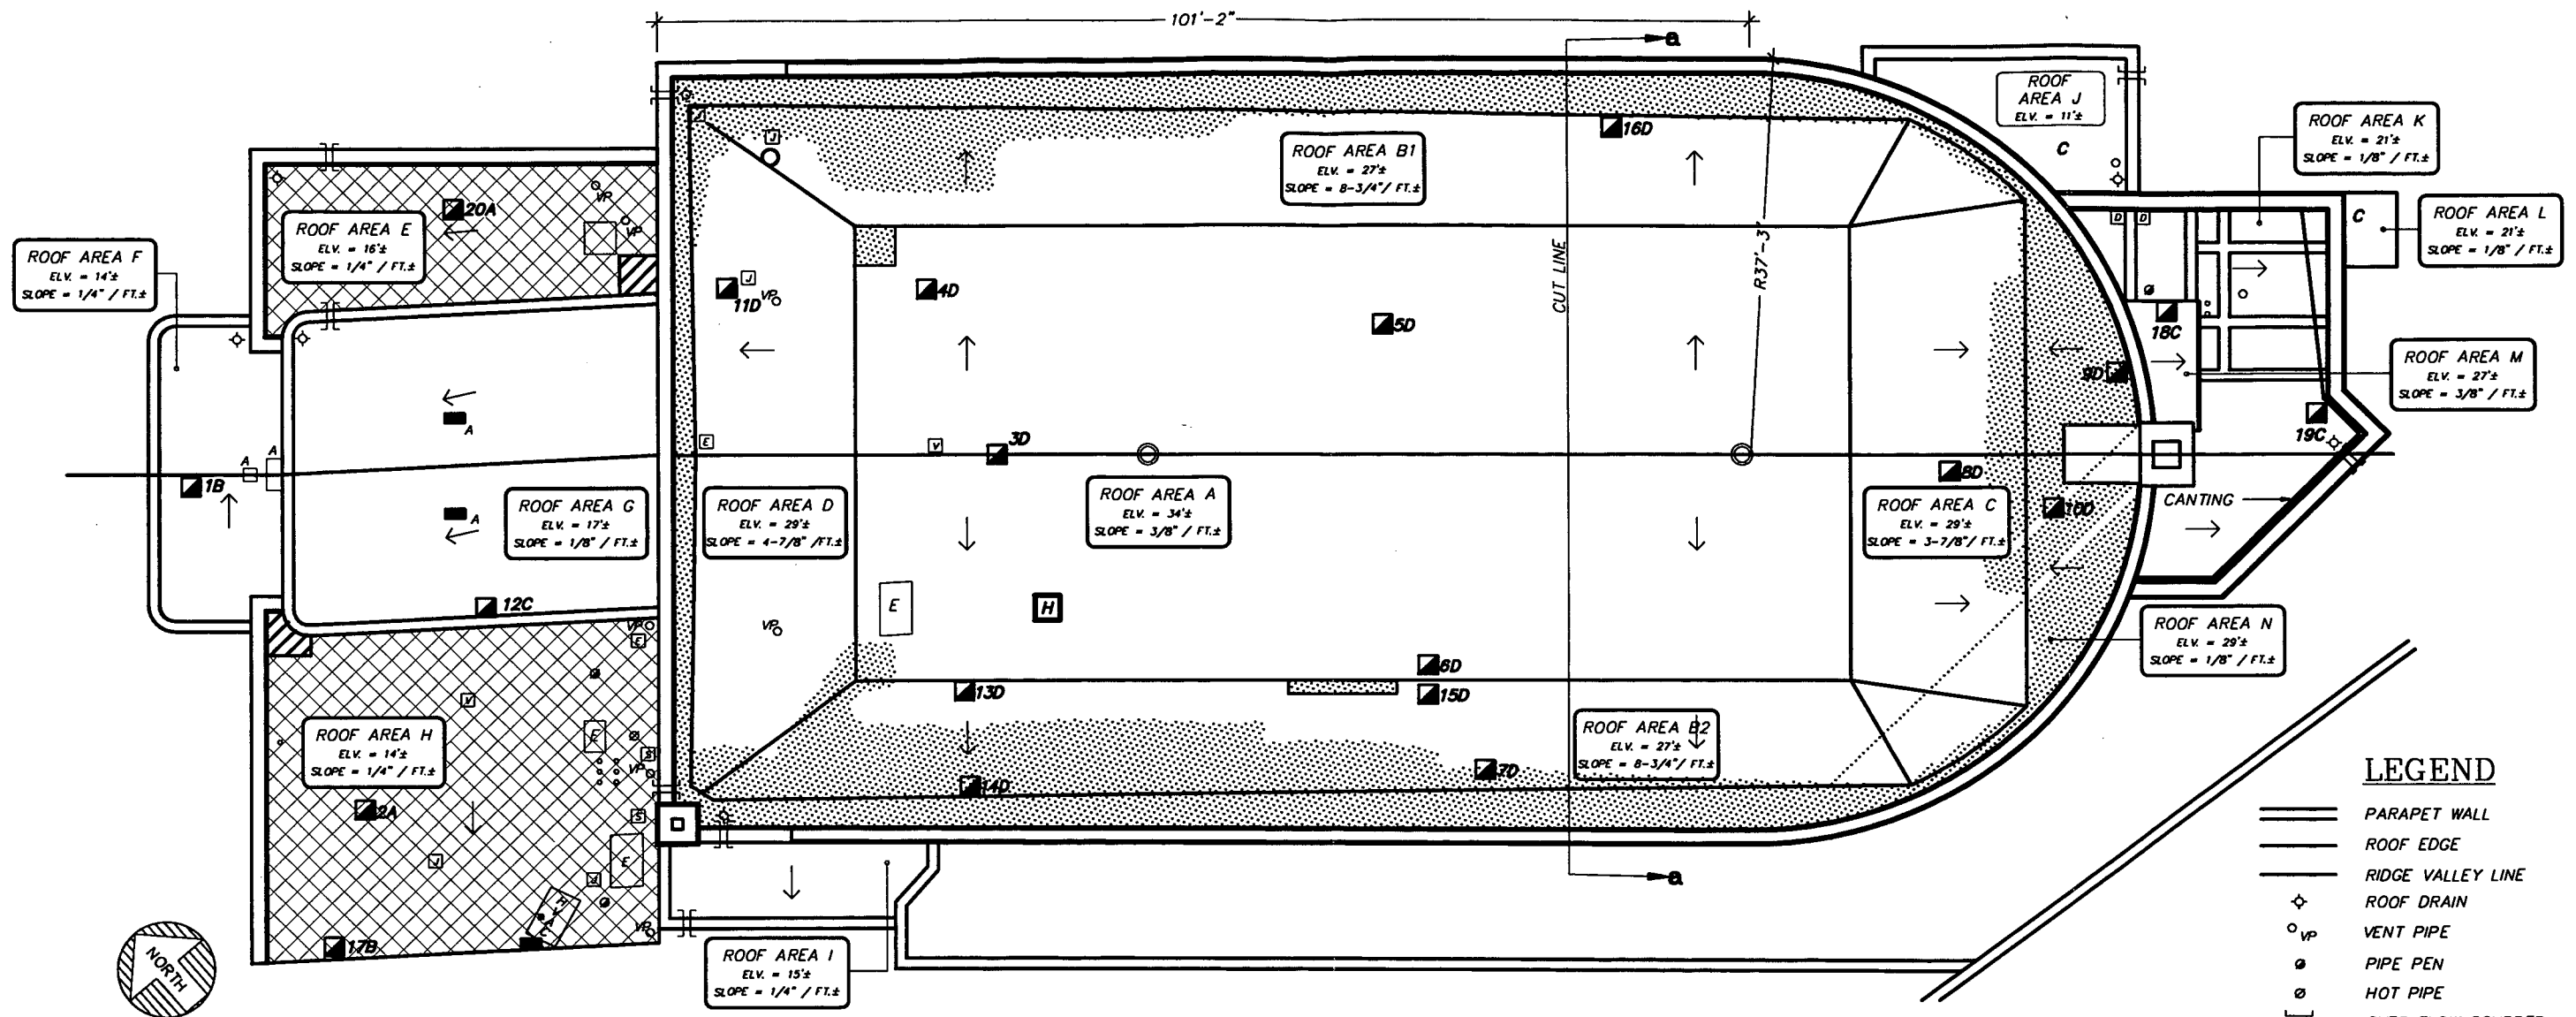
ROOF SK-1

Roof areas A, B, C, D and N above the theater auditorium, are composed of gypsum deck. Existing gypsum deck that is found to be deteriorated should be removed and replaced in kind. It is estimated that approximately 20% (approximately 2000 square feet) of the existing gypsum deck above the auditorium must be replaced due to past or current water intrusion below failed roof membrane.

PLAN OF ROOF SHOWING EXTENT OF DECK REPLACEMENT

The minimum extent of roof deck replacement that will be required is shown on the attached drawing Roof / SK-1.

For the Auditorium roof, Vitetta Group recommends the use of new nailable gypsum deck, 2 1/2" to 3" in depth, poured over 5/8" thick gypsum form board to match the original roof deck assembly as observed during the field investigations and corroborated by the information found on the original construction documents. The system can be obtained from United States Gypsum Company through their representative for cementitious deck gypsum roof systems, the Proteet Group of Charlotte, NC. Literature describing this system is attached to this report (attachment A).

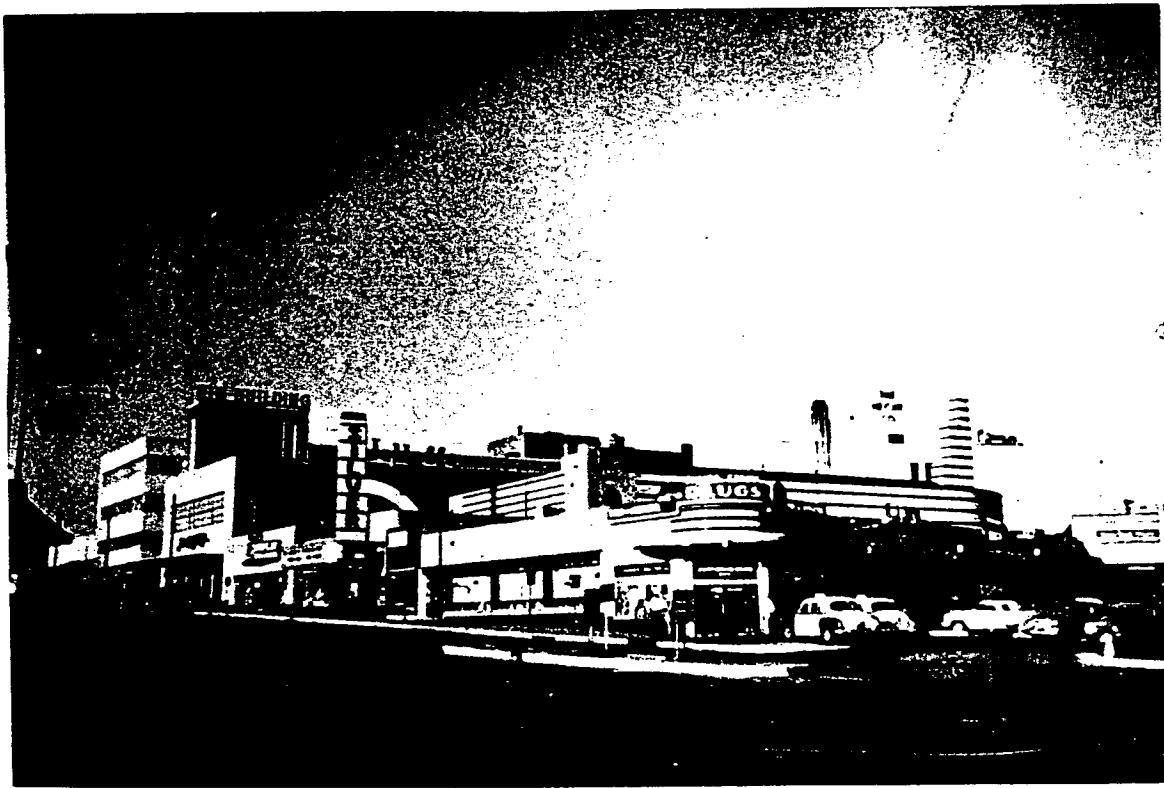
003 Mid-twentieth-century photo showing the mansard roof and original chimney.

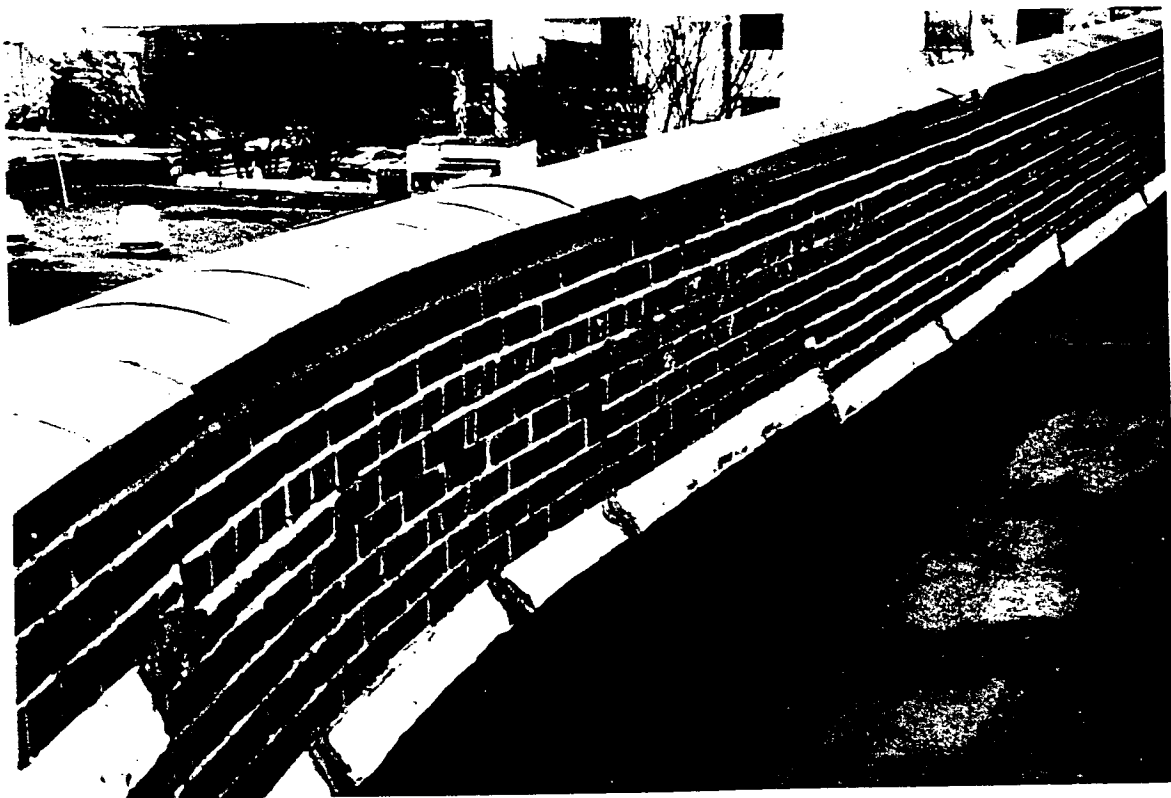
004 East face of the west parapet wall of the auditorium roof showing separated joint, metal counter-flashing and terra-cotta parapet cap (1998 photograph).

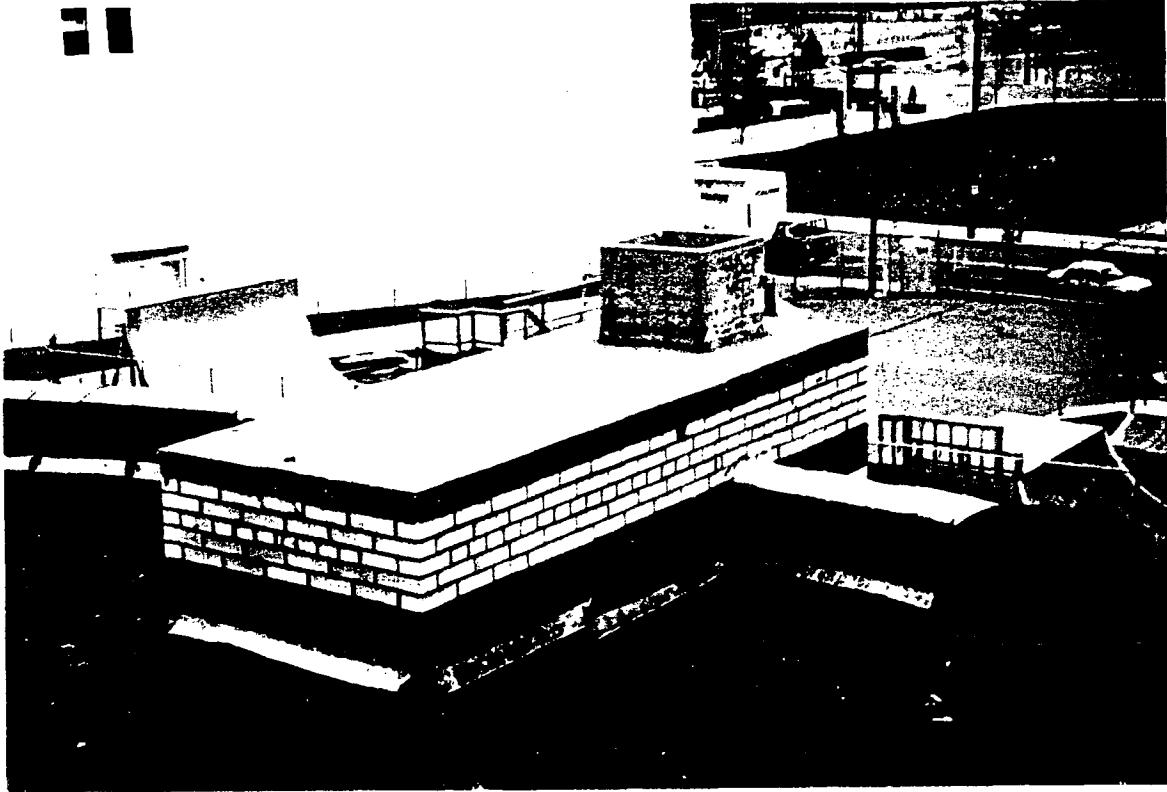
005 Base of the demolished chimney intersecting the south (apse) end of the auditorium (note chimney flue at right of photo, 1998 photograph)

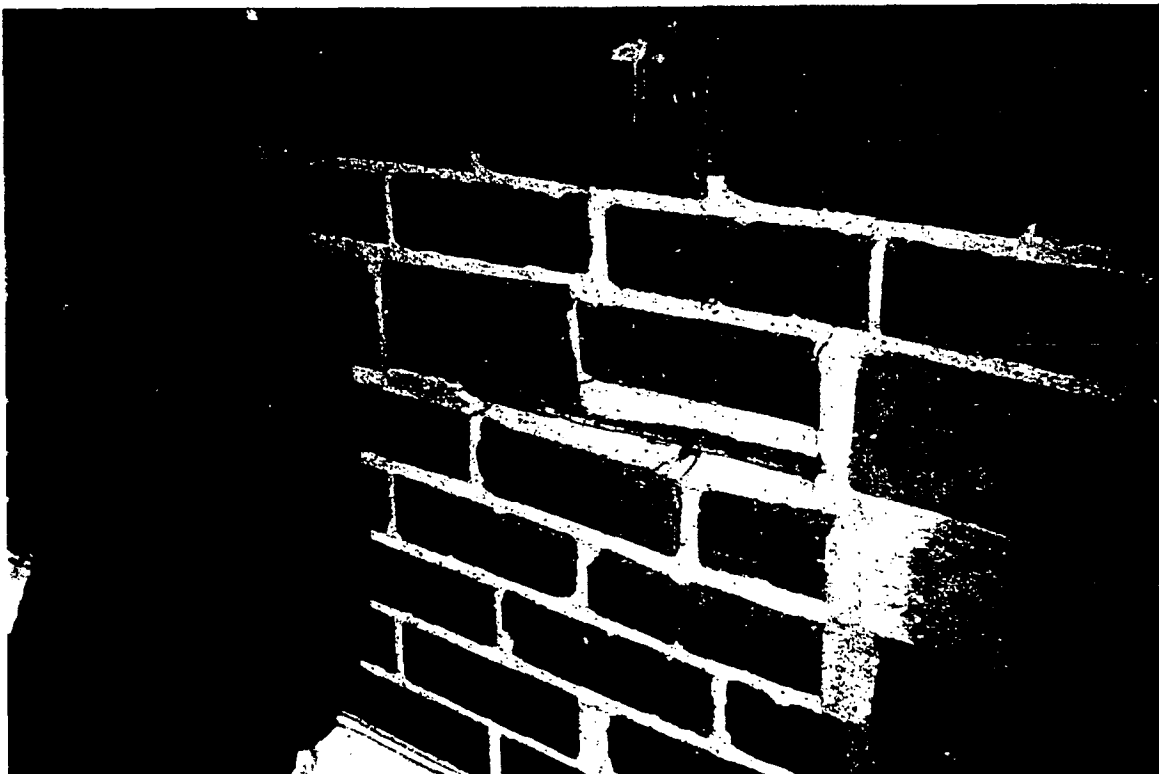
006 Detail of west face of the east parapet wall showing mortar joints and the steel plate exposed (1998 photograph).

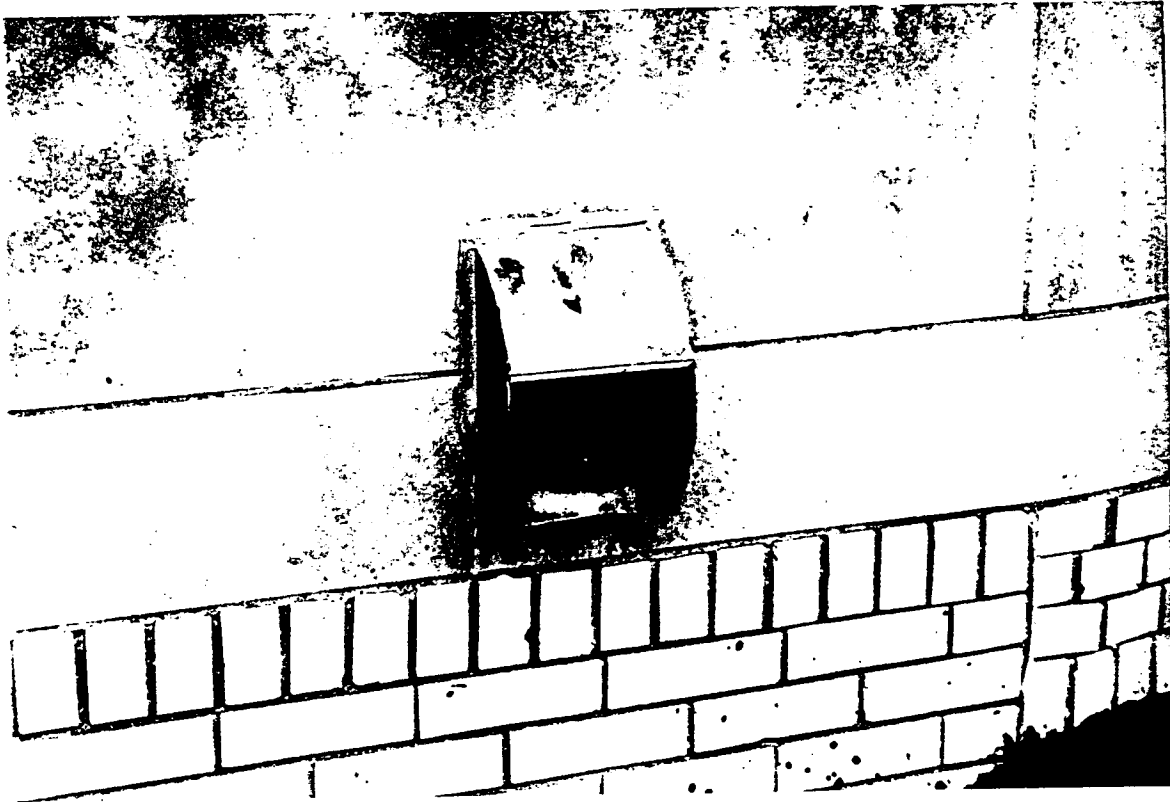
007 Existing original sheet metal scupper and caststone parapet wall cladding with buff brick parapet wall below (1998 photograph).

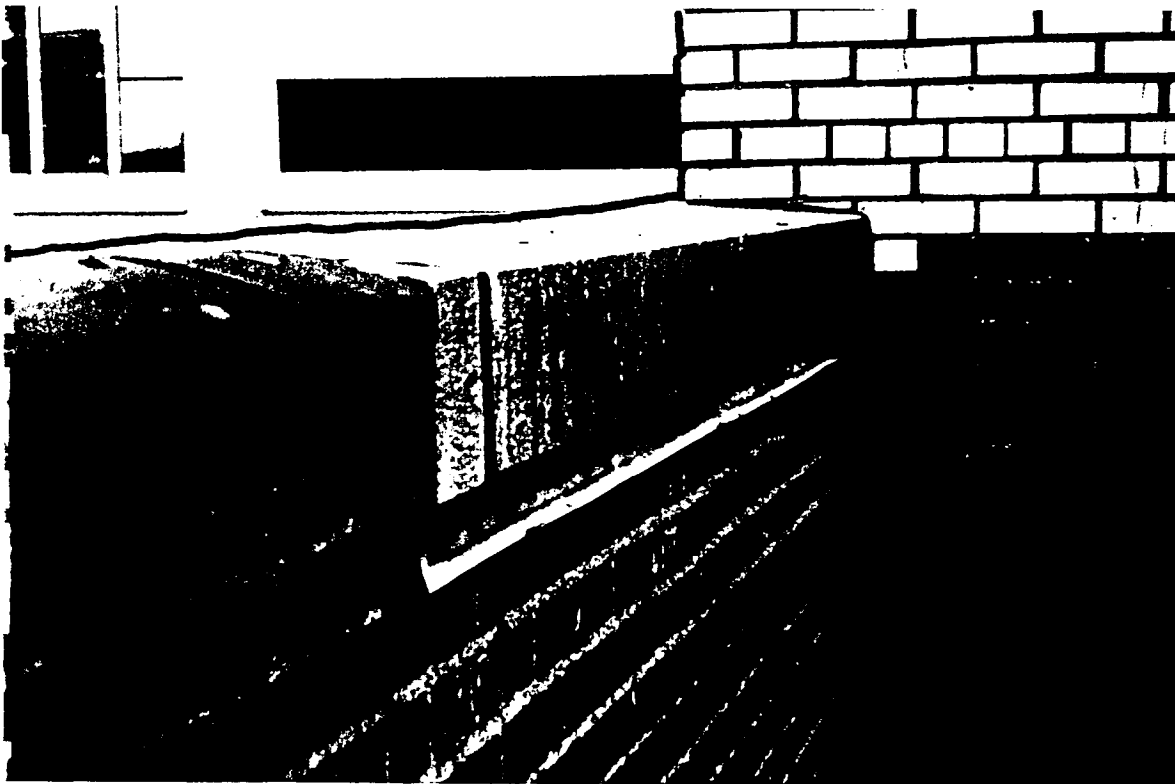
008 Juncture of caststone and terra-cotta parapet caps at the northwest corner of auditorium roof (1998 photograph).

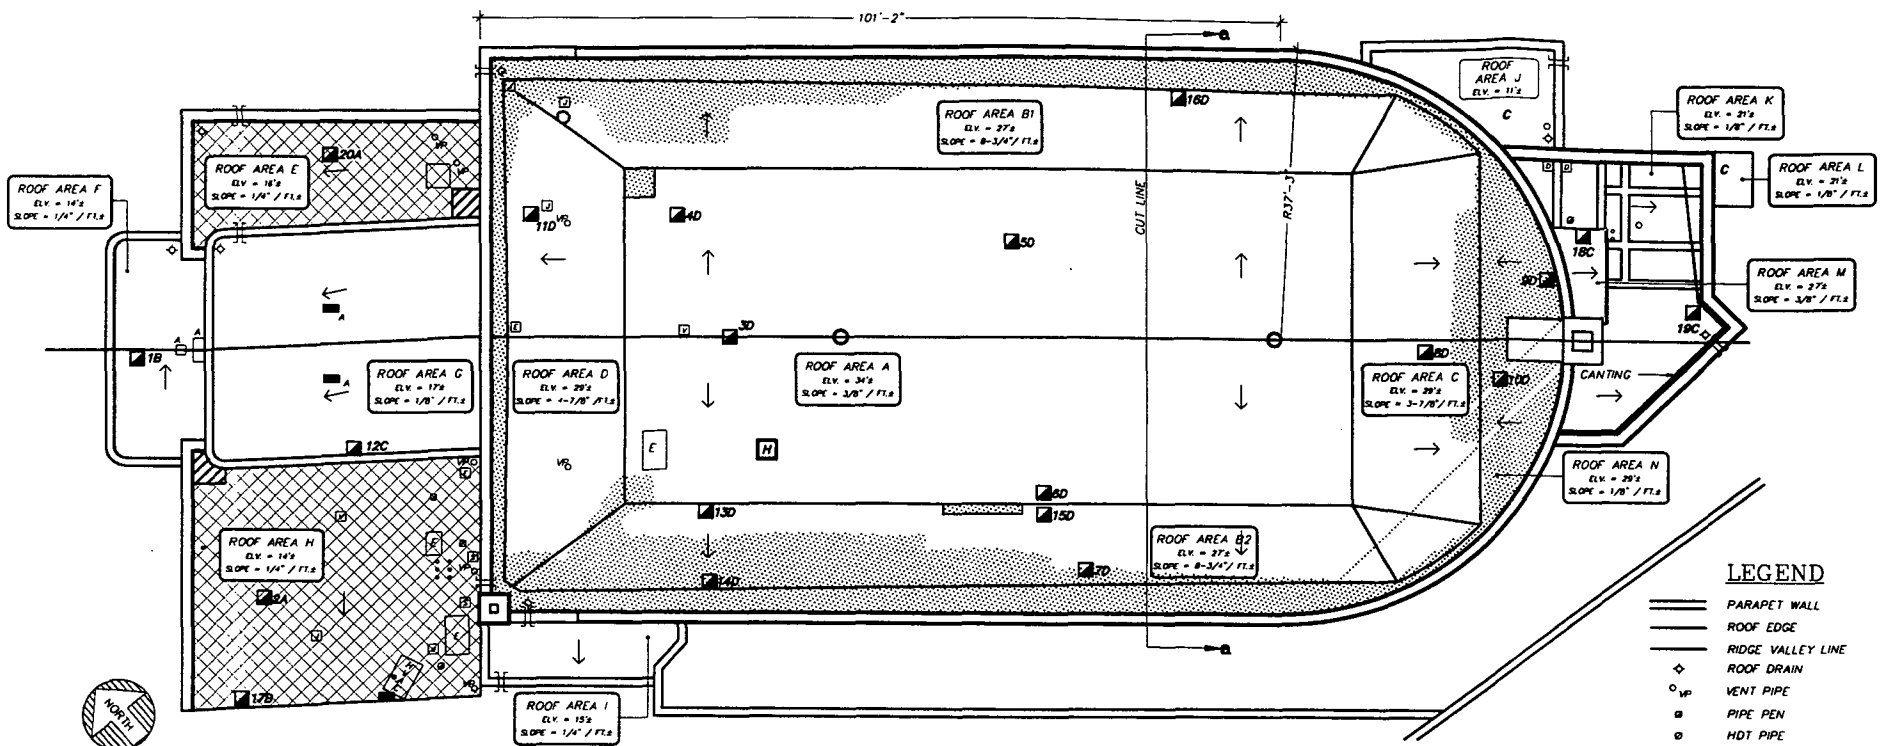
SK-1

PLAN OF ROOF SHOWING EXTENT OF DECK REPLACEMENT
