Grand Re-Opening Historic Clarksburg Store

Willson's Store, Clarksburg Photos taken April 17, 2007

The Wilson Store, Oct. 2005 Front of store, picture taken from across 355. (West Side)

HISTORIC PRESERVATION COMMISSION STAFF REPORT

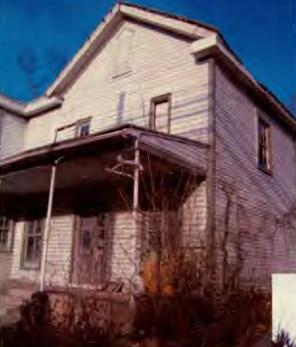
South West Corner of front of store #002

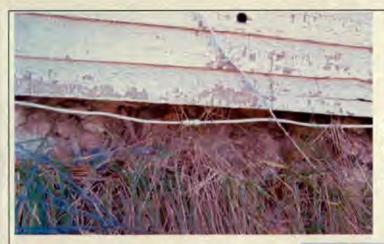
008

Foundation detail, shows typical repair done previously.

To begin this process, the building will be lifted with shoring from the inside. The entire old foundation will be removed, and rebuilt to modern code. The structure will then be reset on the new foundation. The stones from the original foundation will be used to "dress" the new foundation on the exterior. Plans for this portion of the work have been drawn up by a structural engineer, and approved by the Montgomery County HPC and Department of Permitting Services. The major impact on the structure will be to assure that it will be sound for another hundred years, and making it once again a commercially viable general store.

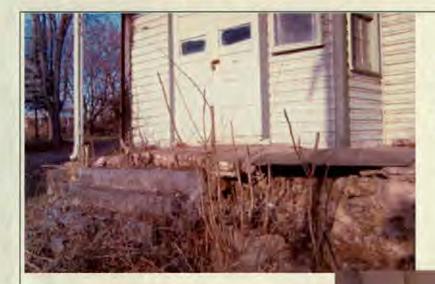
010

Front Porch North West Side, shows large part missing, and block steps leading to Post Office double doors.

The entire concrete porch will be removed, in part to allow for the replacement of the building foundation. The porch will be rebuilt in a style typical of an 1840's frontier building, with wood planking and simple wood posts. The HPC has agreed that this would be the most appropriate restoration. While no photos of the store exist that show the original porch, a photo of the Levi Price store, which he owned prior to purchasing the Wilson Store in 1914, shows a similar front porch. We plan to have the planks, posts, and wood beams for under the porch milled at a local saw mill, in a "rough hewn" style, appropriate for the frontier period. The original shed roof of the porch will be repaired. The steps on the north side of the porch, made from concrete block, most likely added in the late 1960's, will be removed. The poured concrete steps leading to the front door will be replaced with wooden steps. The impact of this work will be significant. By restoring the front porch to a period style, the whole building will visually become a real trading post and 1800's general store once again.

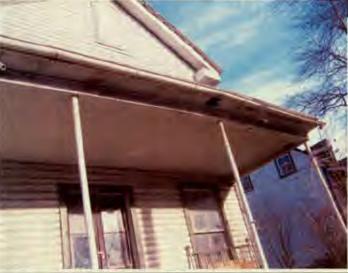
011

Front Porch, looking north, shows missing steel column

Front Porch, shows decay under gutter, steel posts.

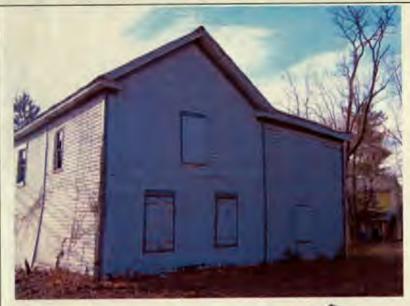
#004

Back of store, east side.

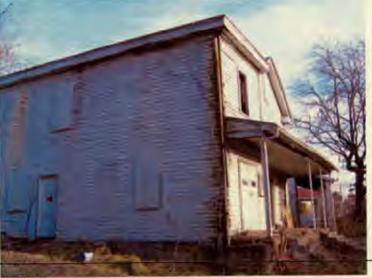
North West corner of store
