29/38-05A 8311 Comanche Court  
MP Site #29/38 **Glenmore**

SUBJECT: Historic Area Work Permit #378988

Address: 8311 Comanche Court, Bethesda; *Master Plan* Site # 29/38, **Glenmore**

<b>Address:</b>	8311 Comanche Court, Bethesda	<b>Meeting Date:</b>	05/11/05
<b>Applicant:</b>	Nancy Everett and Mike Nannes	<b>Report Date:</b>	05/04/05
<b>Resource:</b>	<i>Master Plan</i> Site #29/38 <b>Glenmore</b>	<b>Public Notice:</b>	04/27/05
<b>Review:</b>	HAWP	<b>Tax Credit:</b>	Partial
<b>Case Number:</b>	29/38-05A	<b>Staff:</b>	Michele Oaks
<b>PROPOSAL:</b>	Rehabilitate and Replace Windows

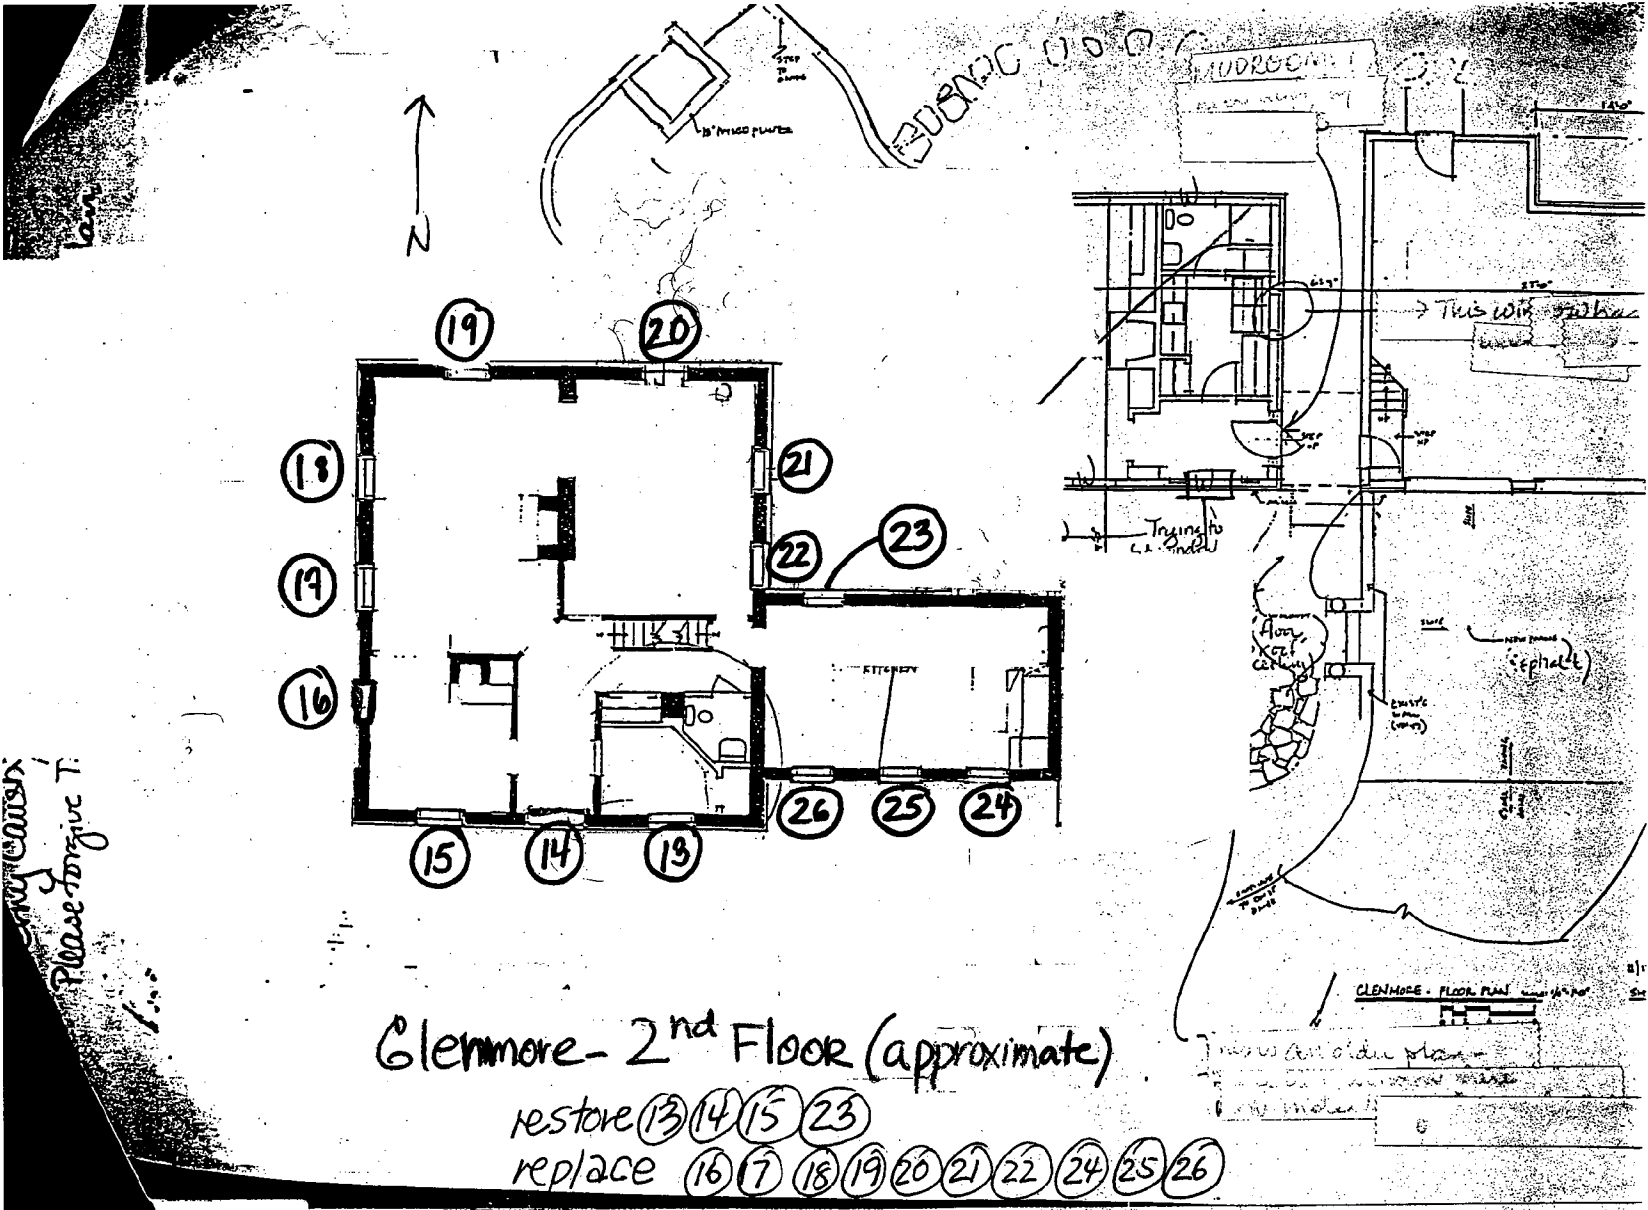
Glenmore - 2nd Floor (approximate)

- restore (13) (14) (15) (23)
- replace (16) (17) (18) (19) (20) (21) (22) (24) (25) (26)

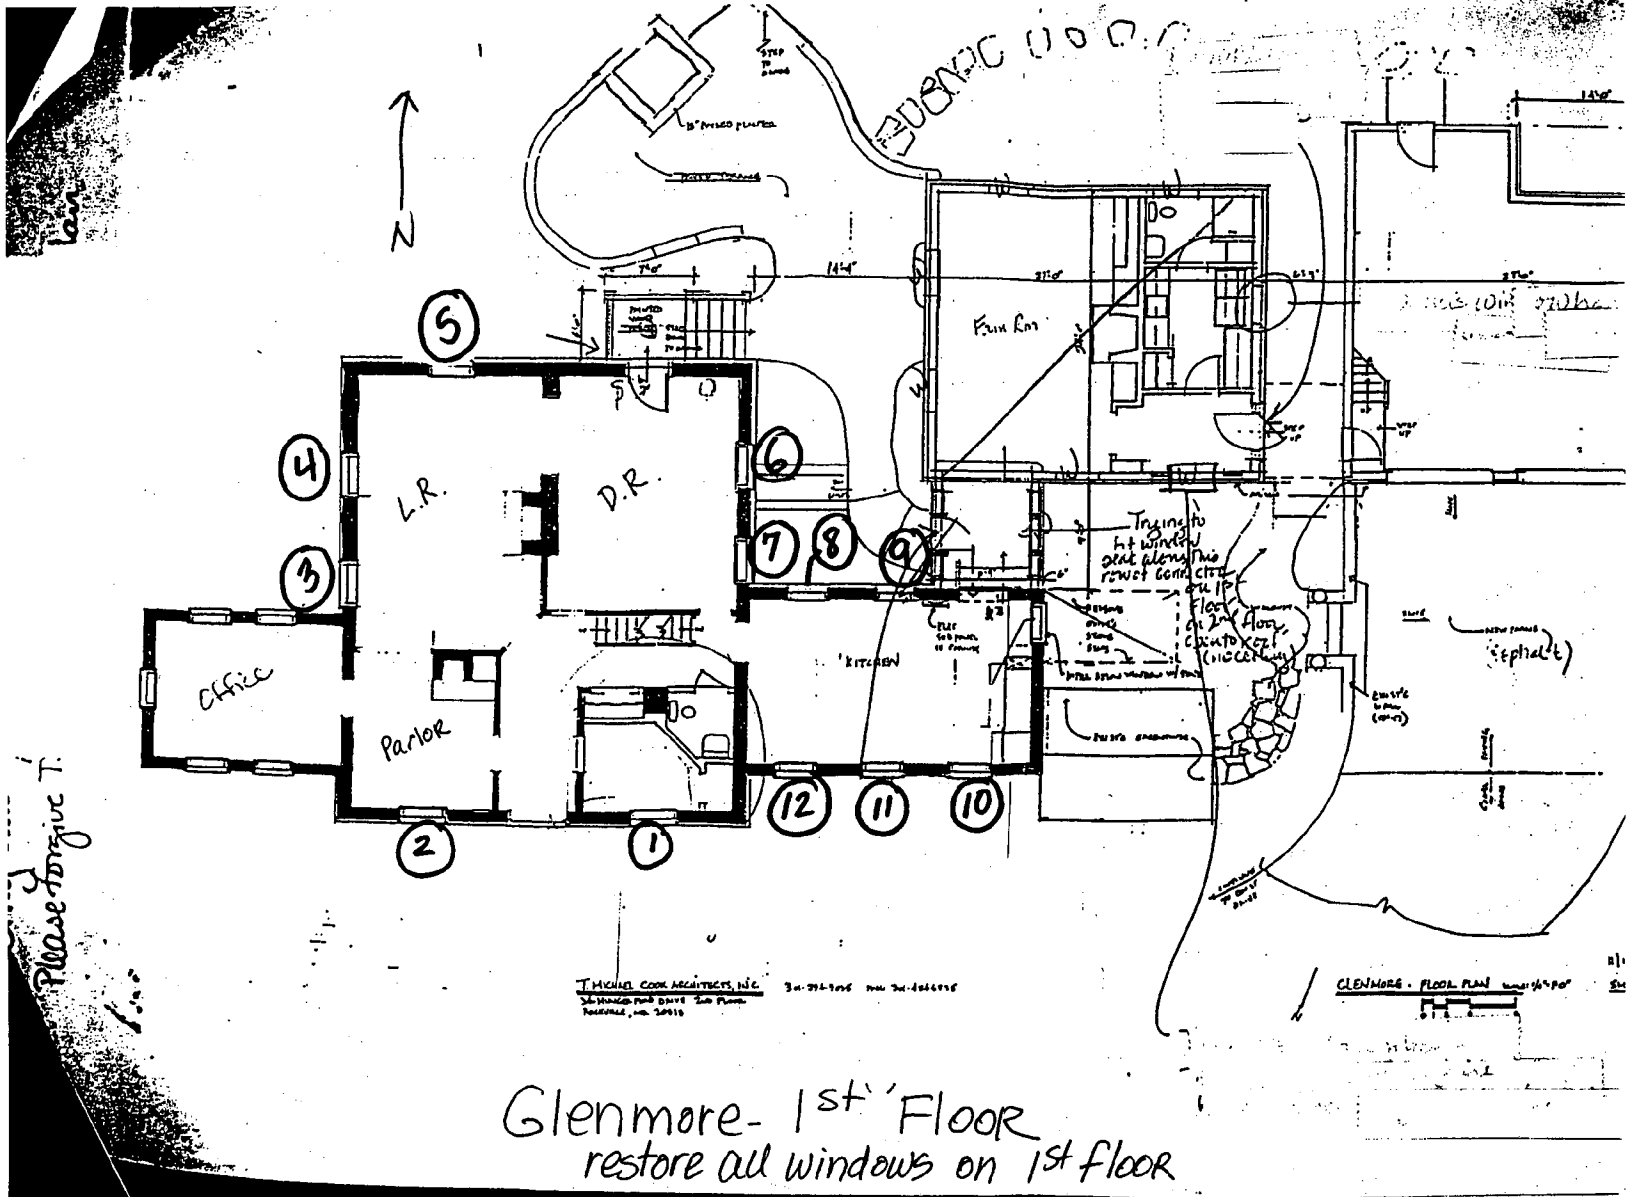
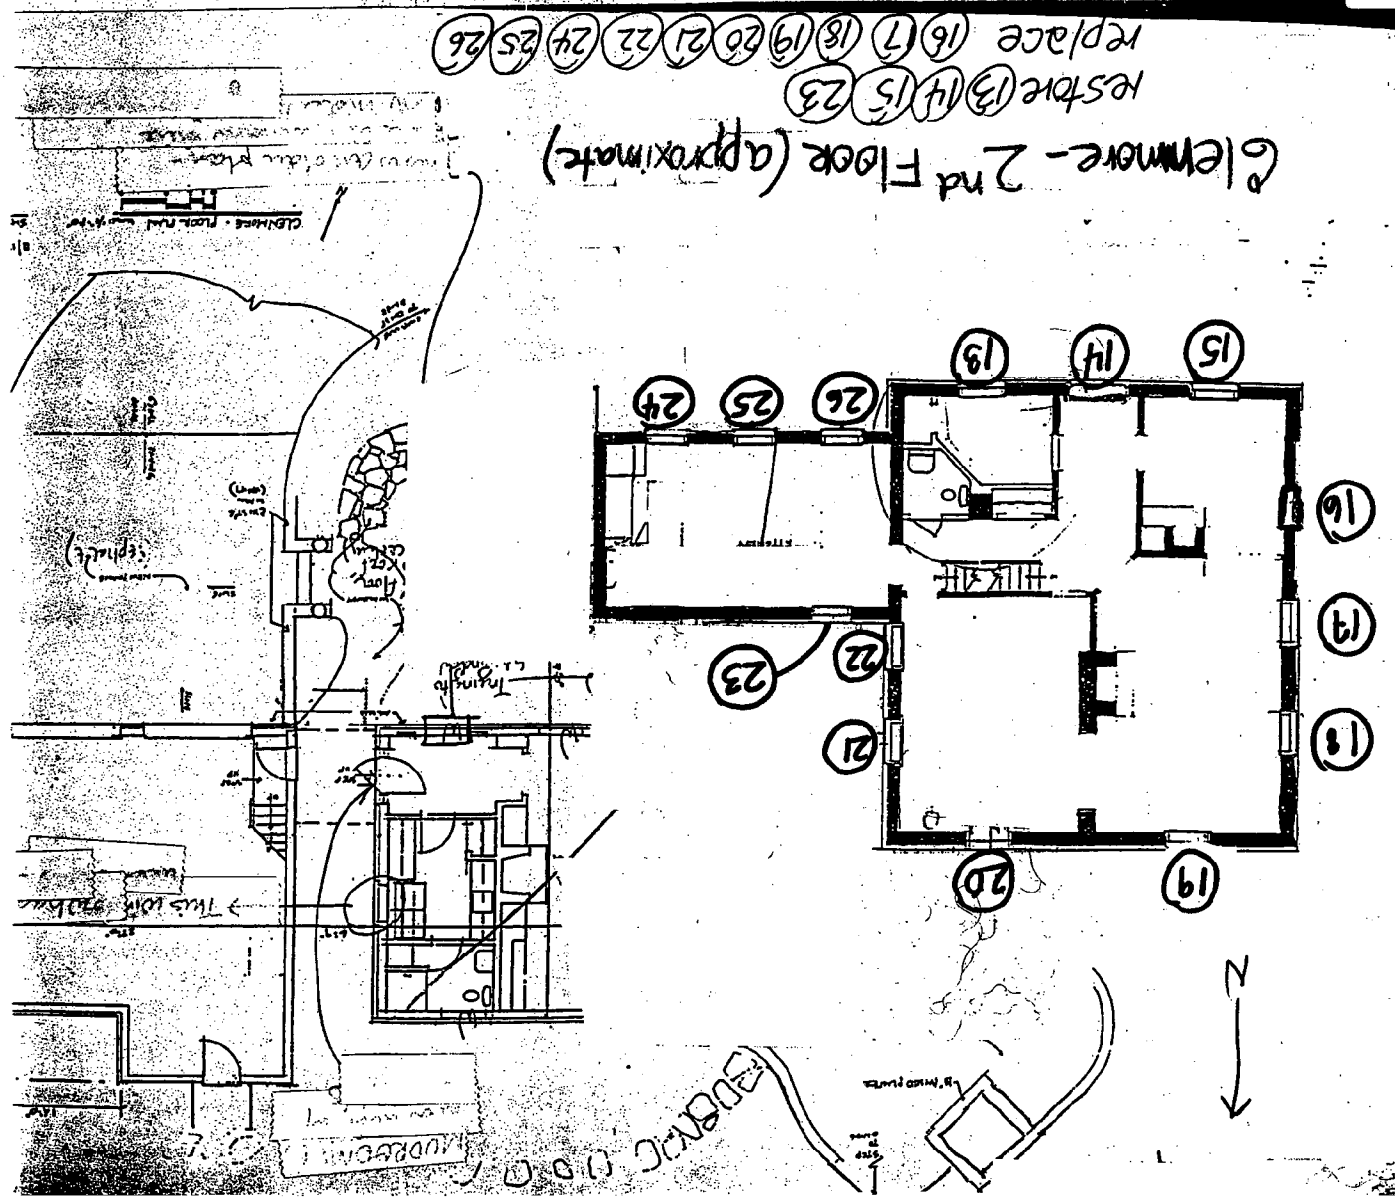
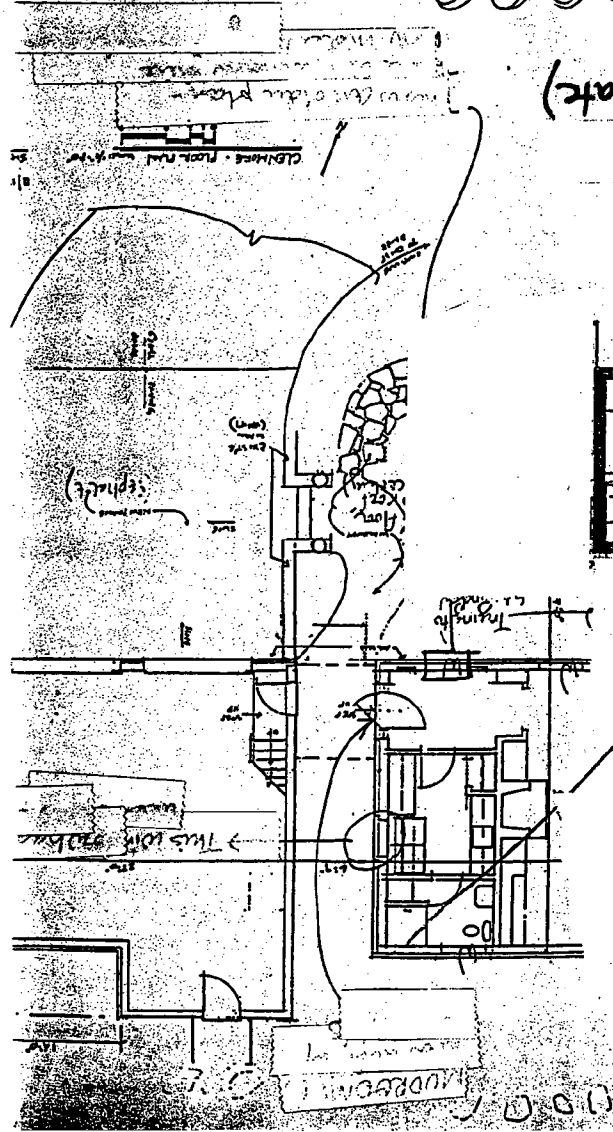
GLENMORE - FLOOR PLAN  
 SCALE: 1/4" = 1'-0"

Restore 13, 14, 15, 23

replace 16, 17, 18, 19, 20, 21, 22, 24, 25, 26

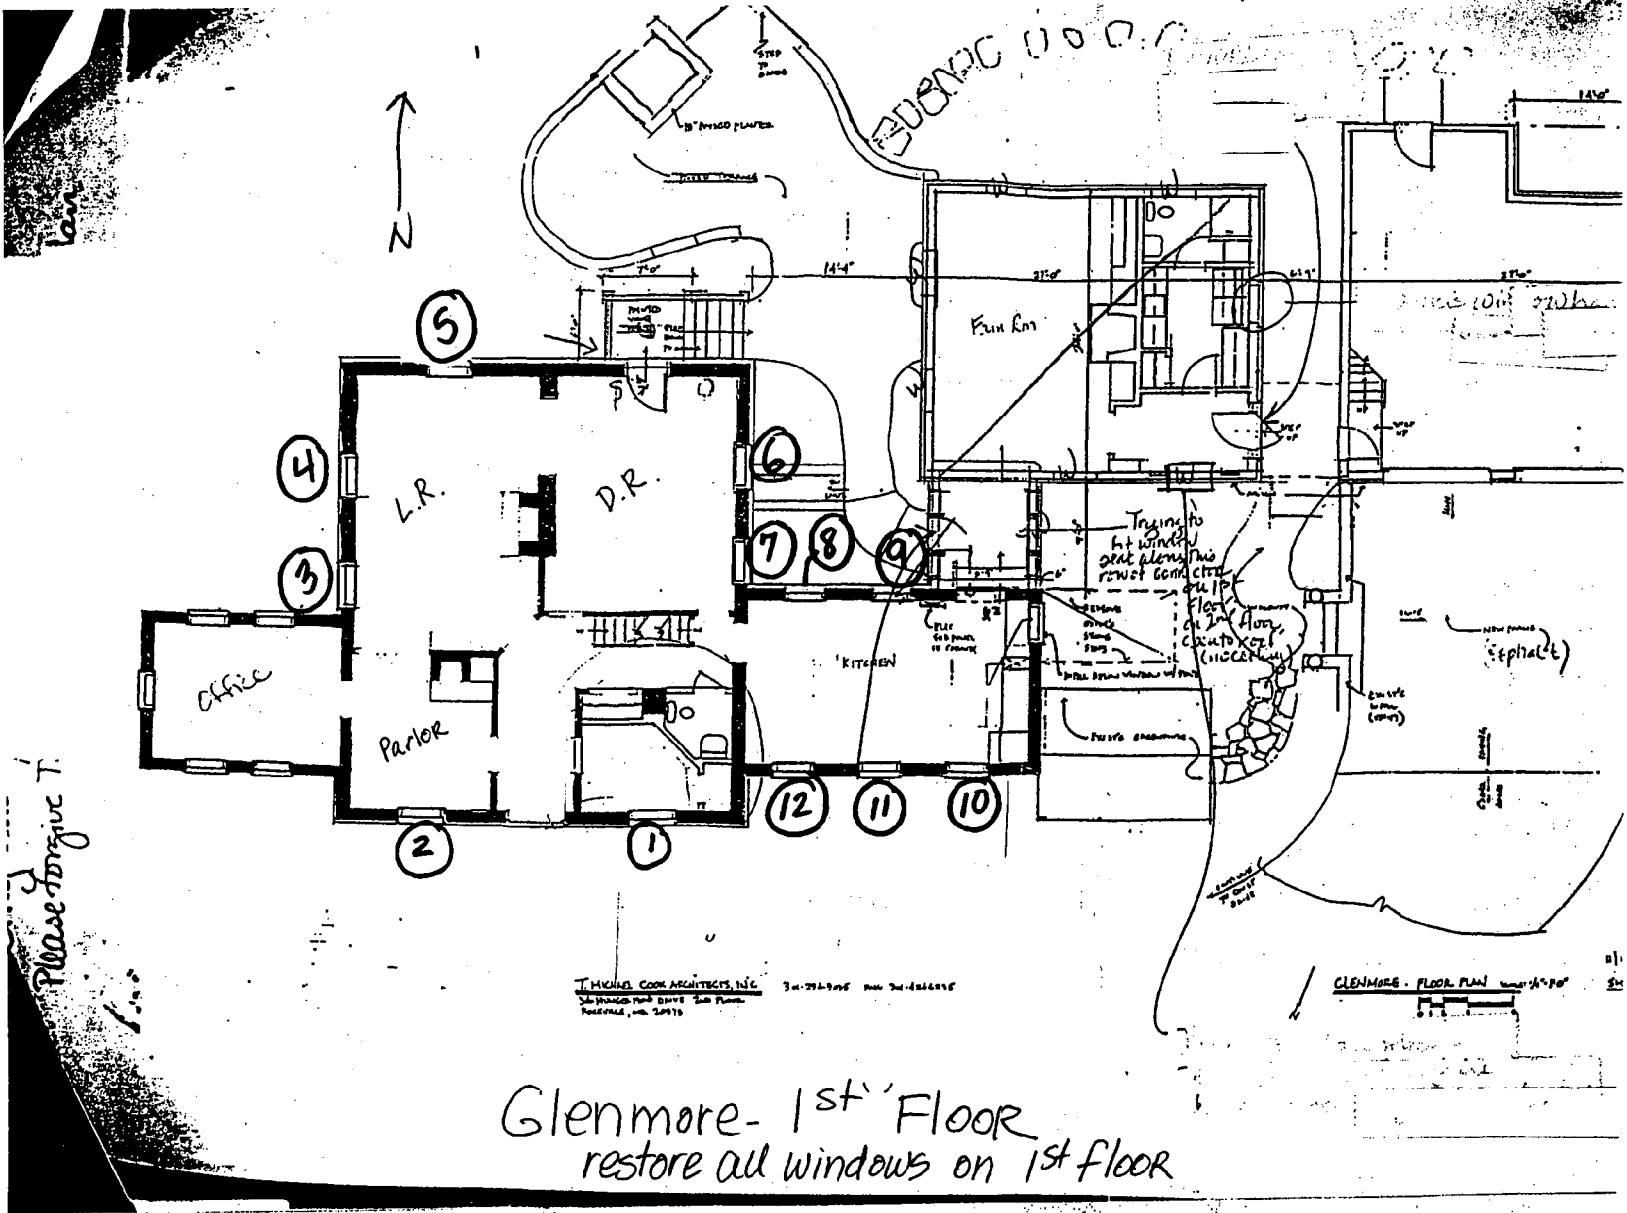
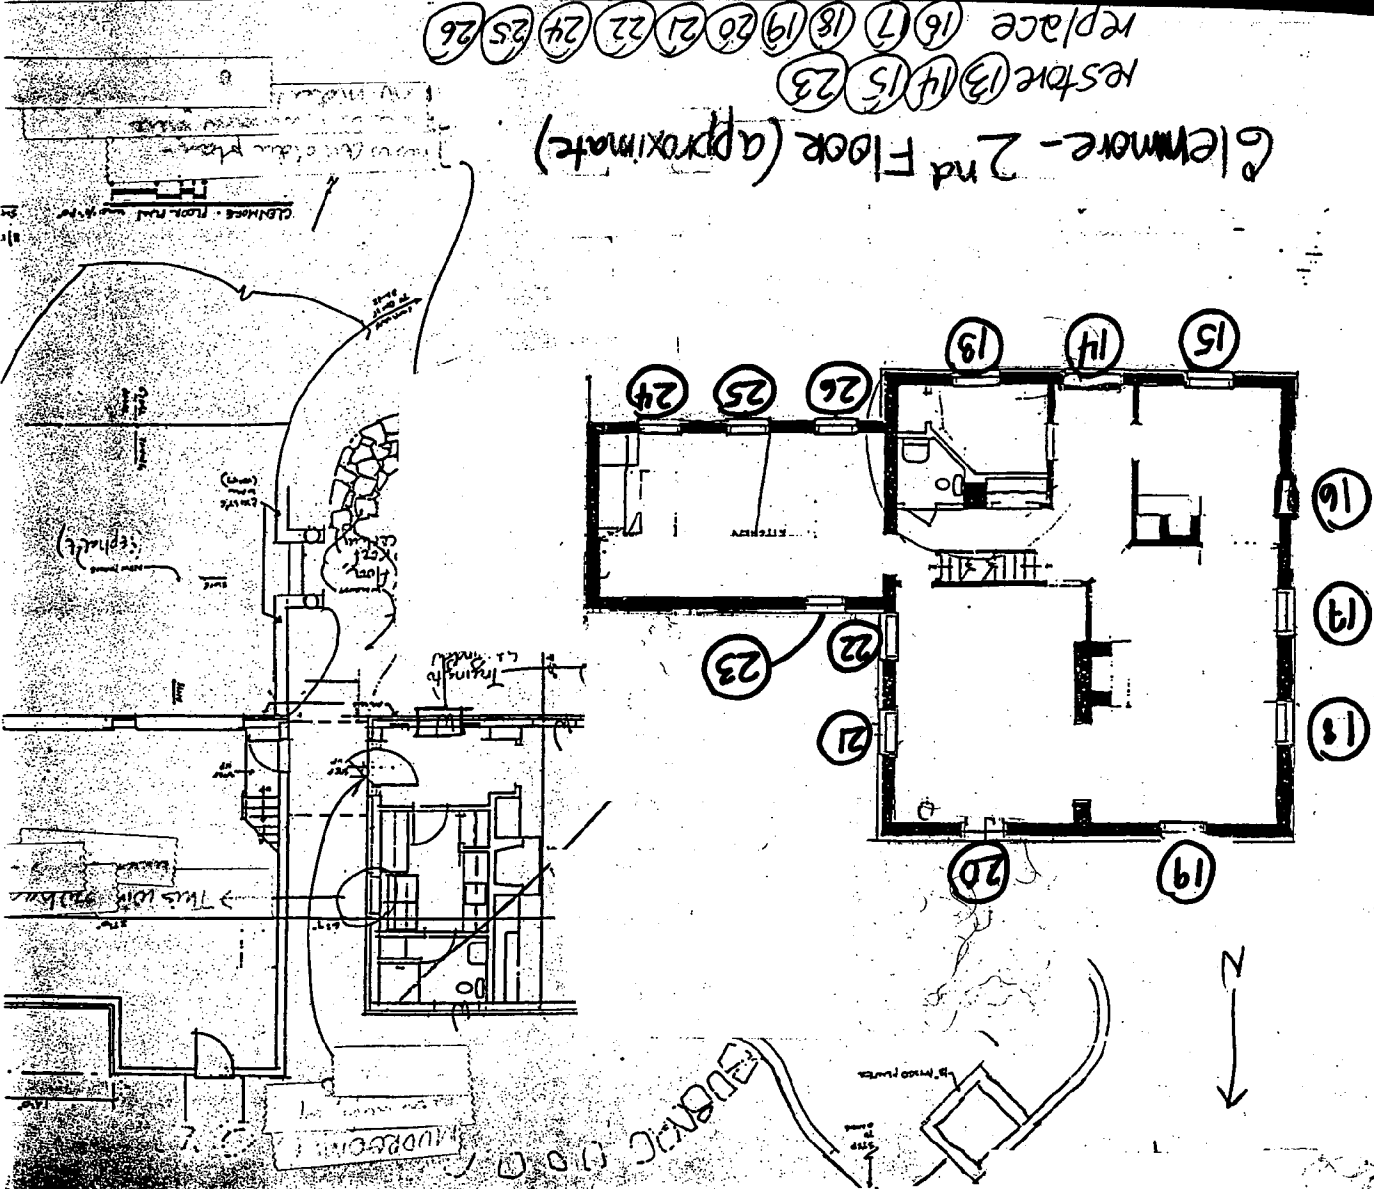
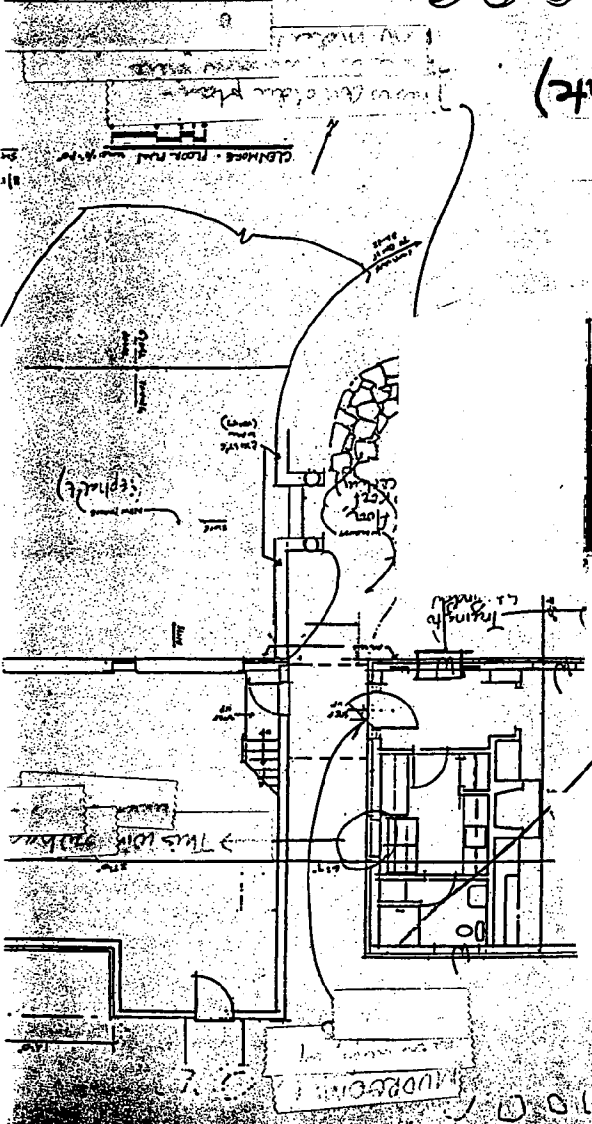
GLENMORE - FLOOR PLAN  
 1/16" = 1'-0"  
 01/11/00

restore (13, 14, 15, 23)

replace (16, 17, 18, 19, 20, 21, 22, 24, 25, 26)

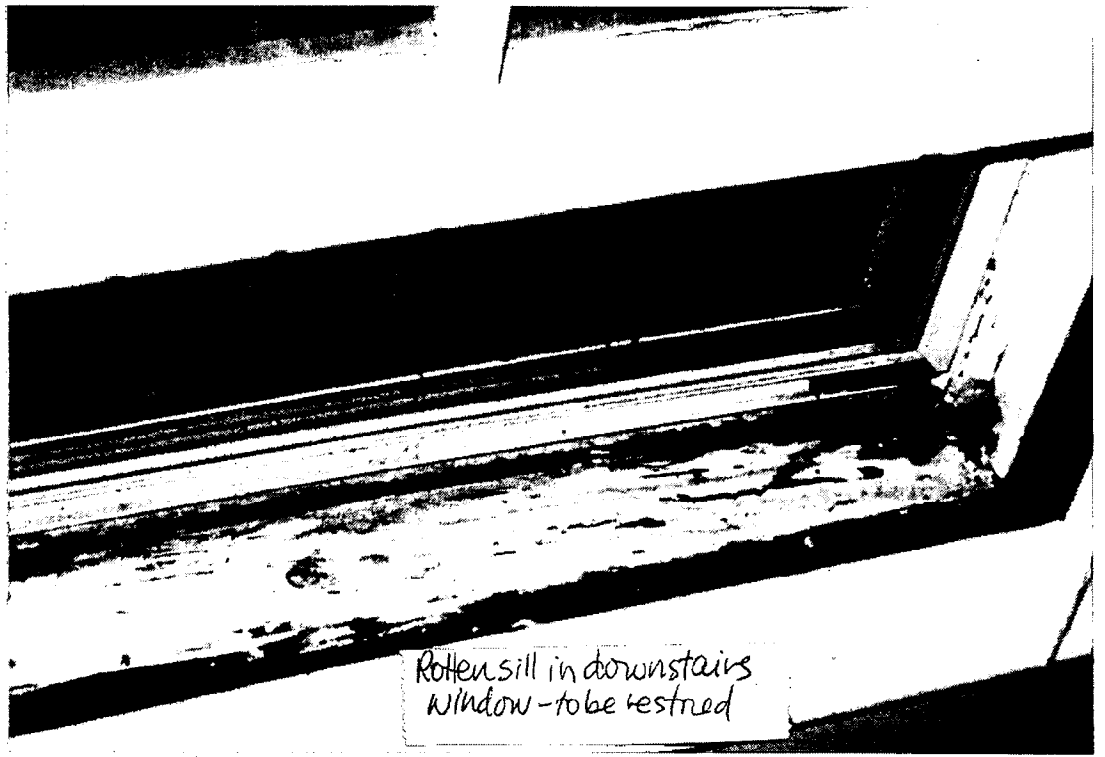
Rotten sill in downstairs window - to be restred

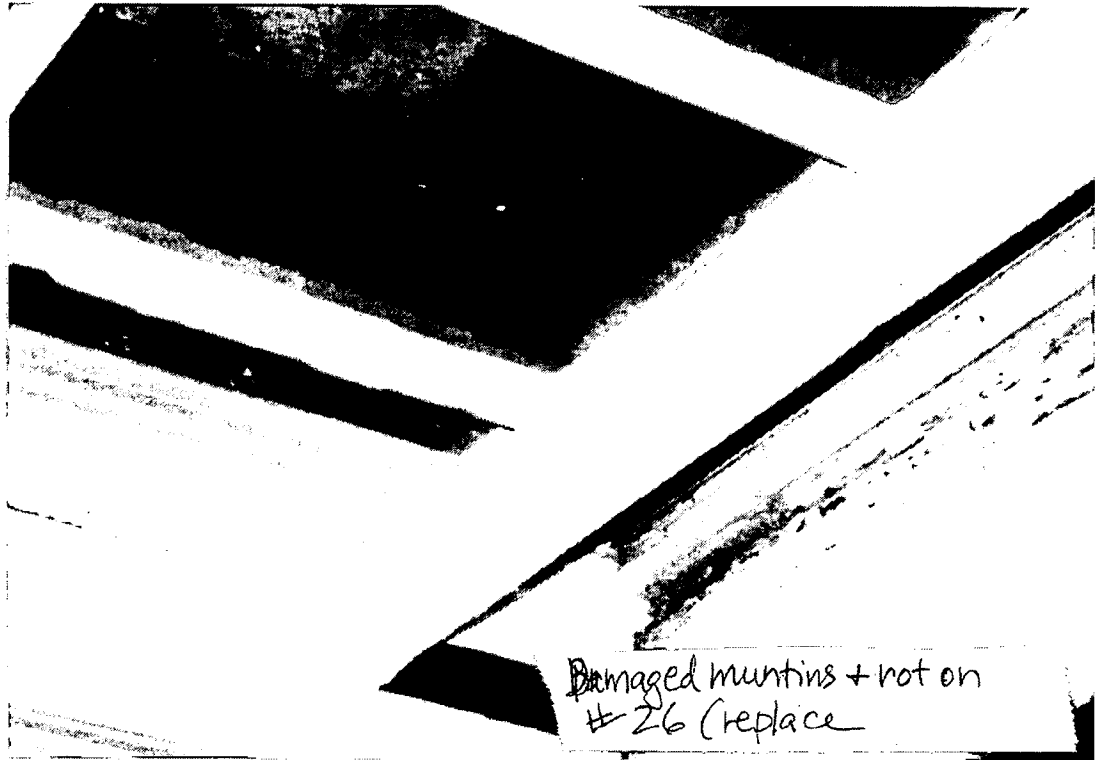
Damaged muntins + not on # 26 (replace

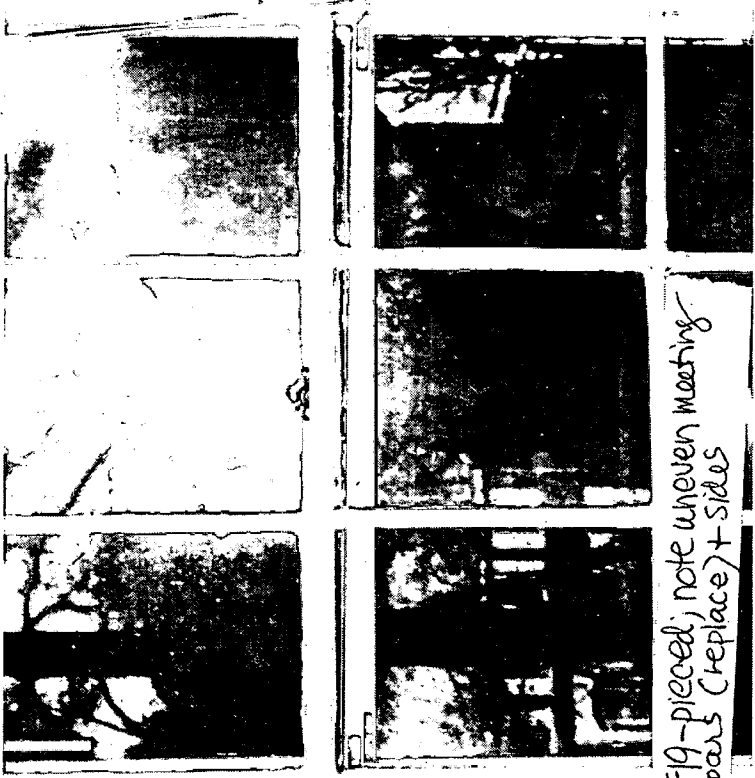
#19 - pieced; note uneven meeting  
boards (replace) + sides

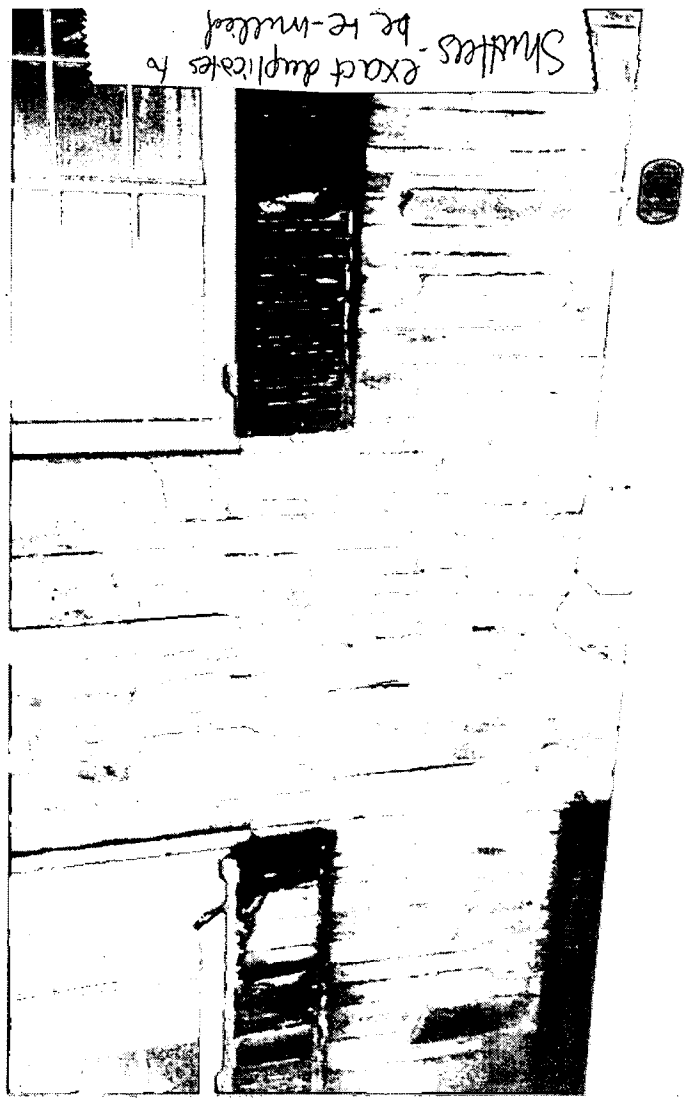
Shutters - exact duplicates to  
be re-installed

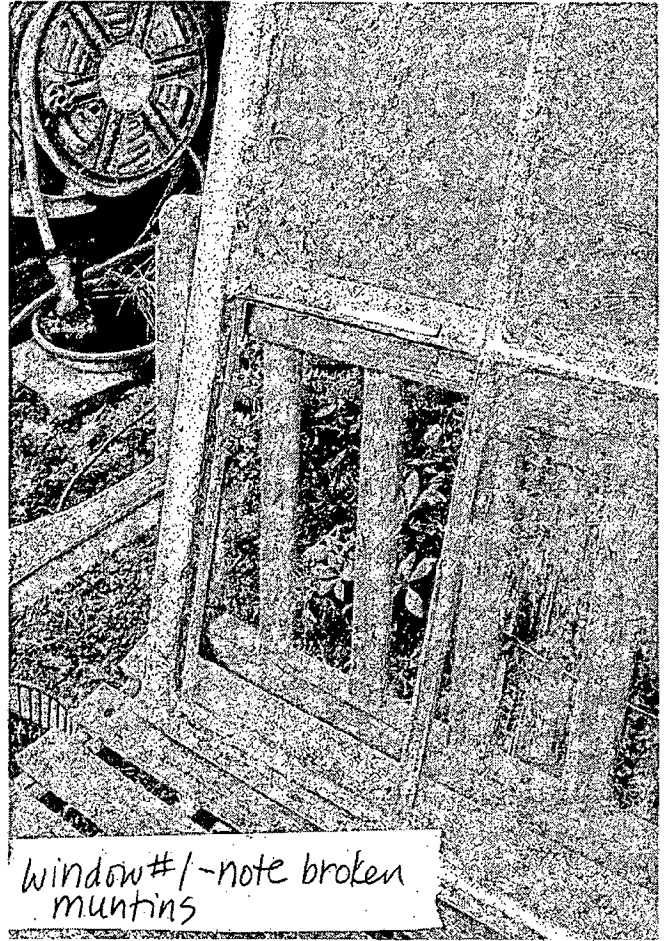
Window #1 - note broken muntins

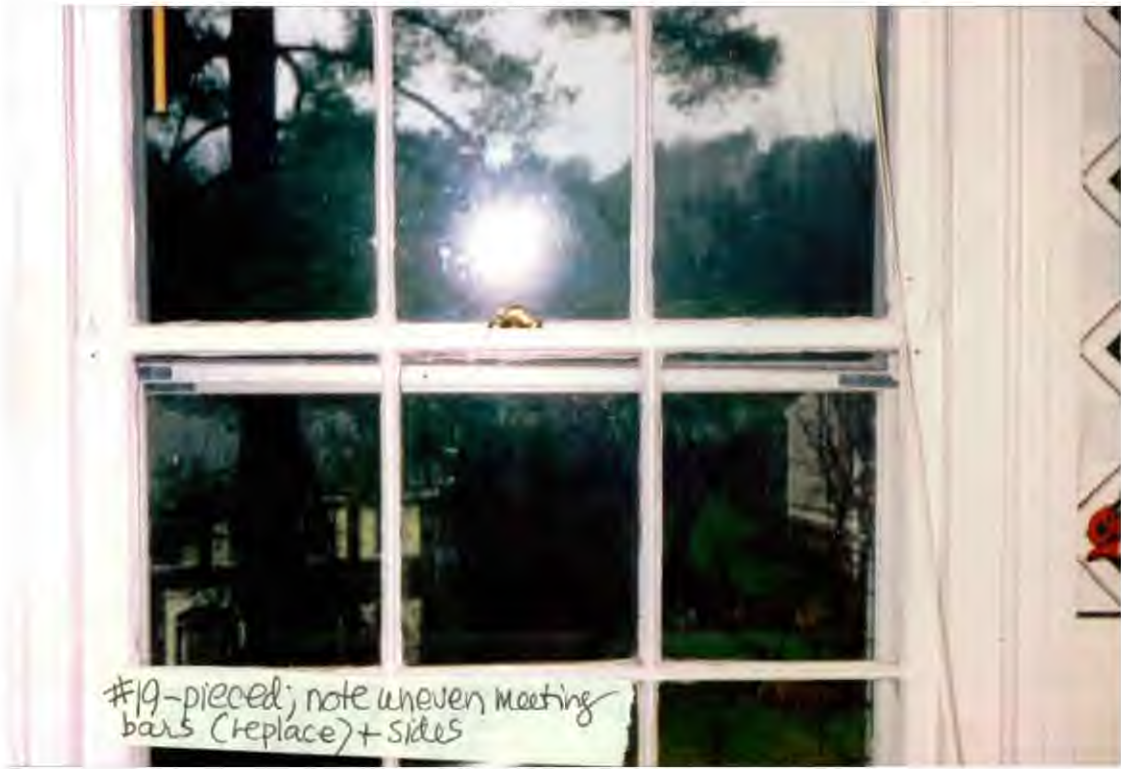
#19-pieced; note uneven meeting  
bars (replace) + sides
