37/03-06F 511 Philadelphia Ave

Takoma Park Historic District, 37/03

**Subject:** 511 Philadelphia Avenue - window survey  
**Location:** Takoma Park  
**Start:** Tue 3/14/2006 9:30 AM  
**End:** Tue 3/14/2006 10:00 AM  
**Recurrence:** (none)  
**Categories:** Site Visit

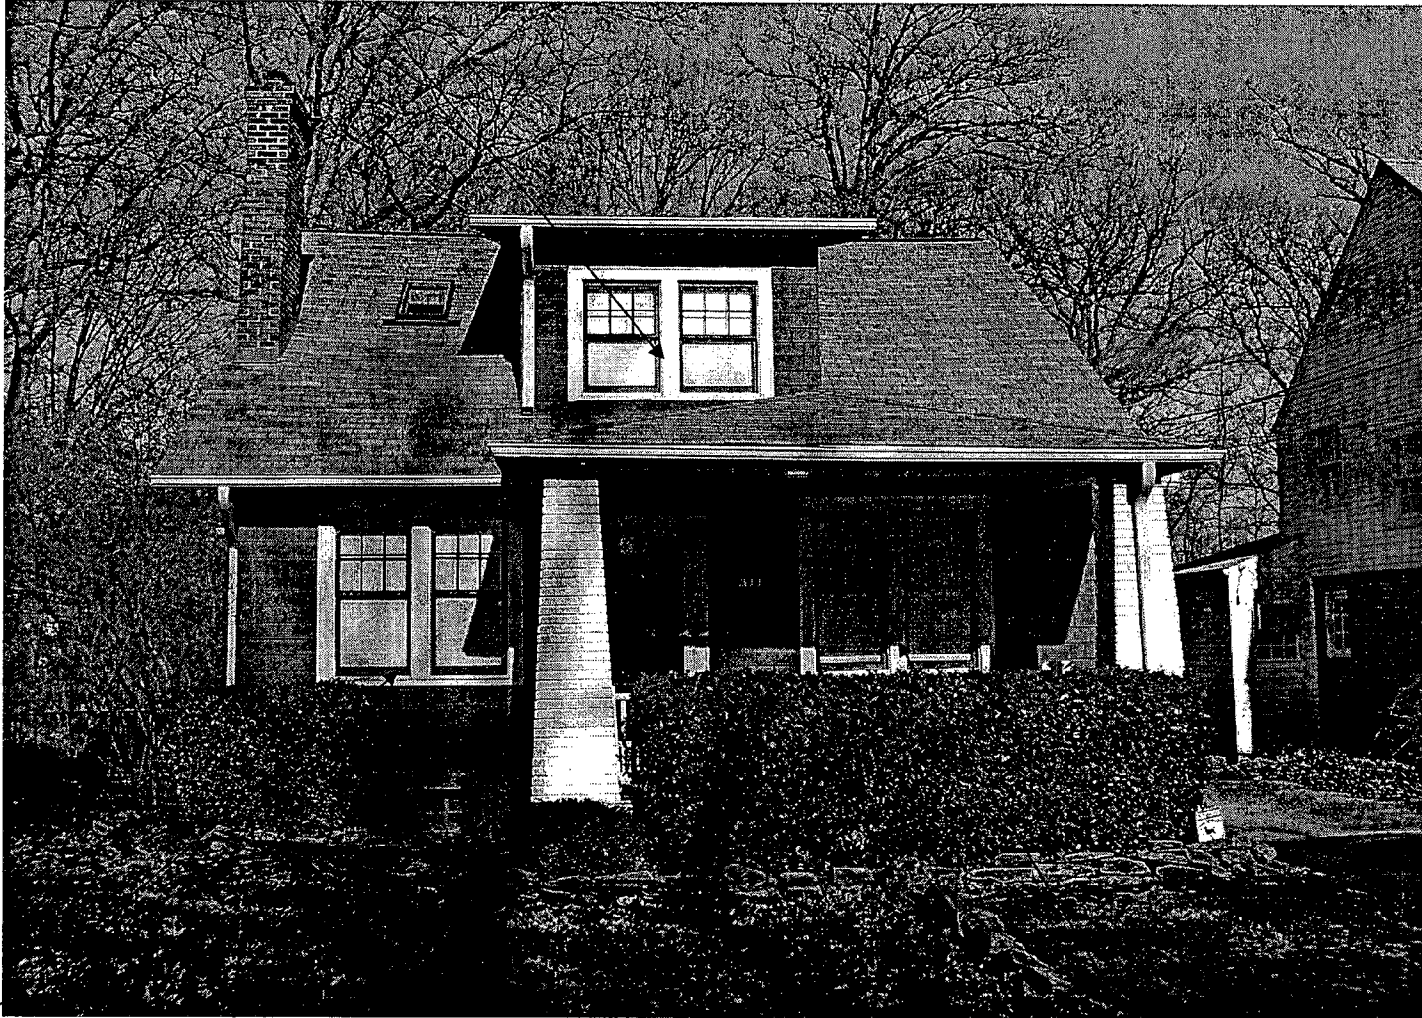
Replace these two windows

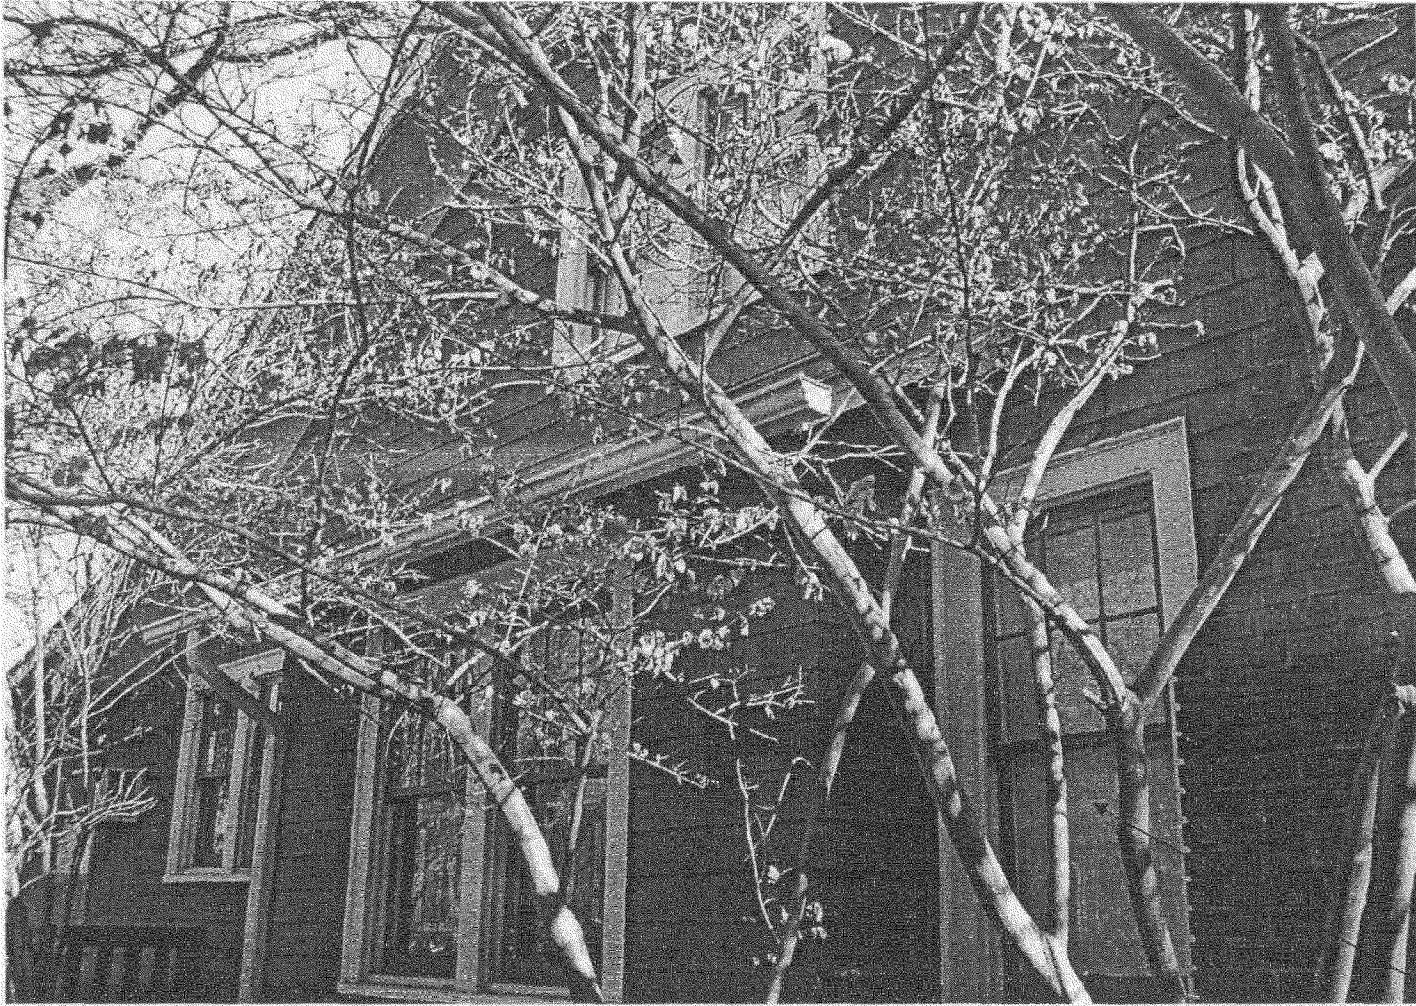
Replace these two windows

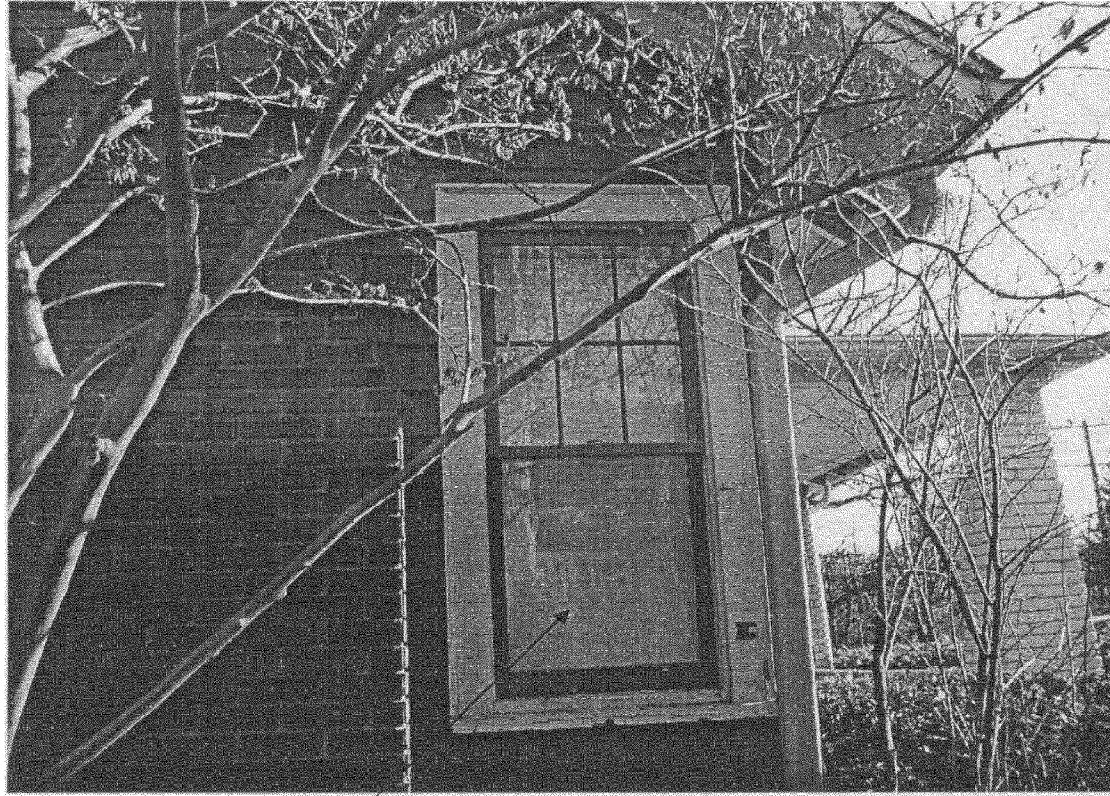
511 PHILADELPHIA AVENUE

Replace this window

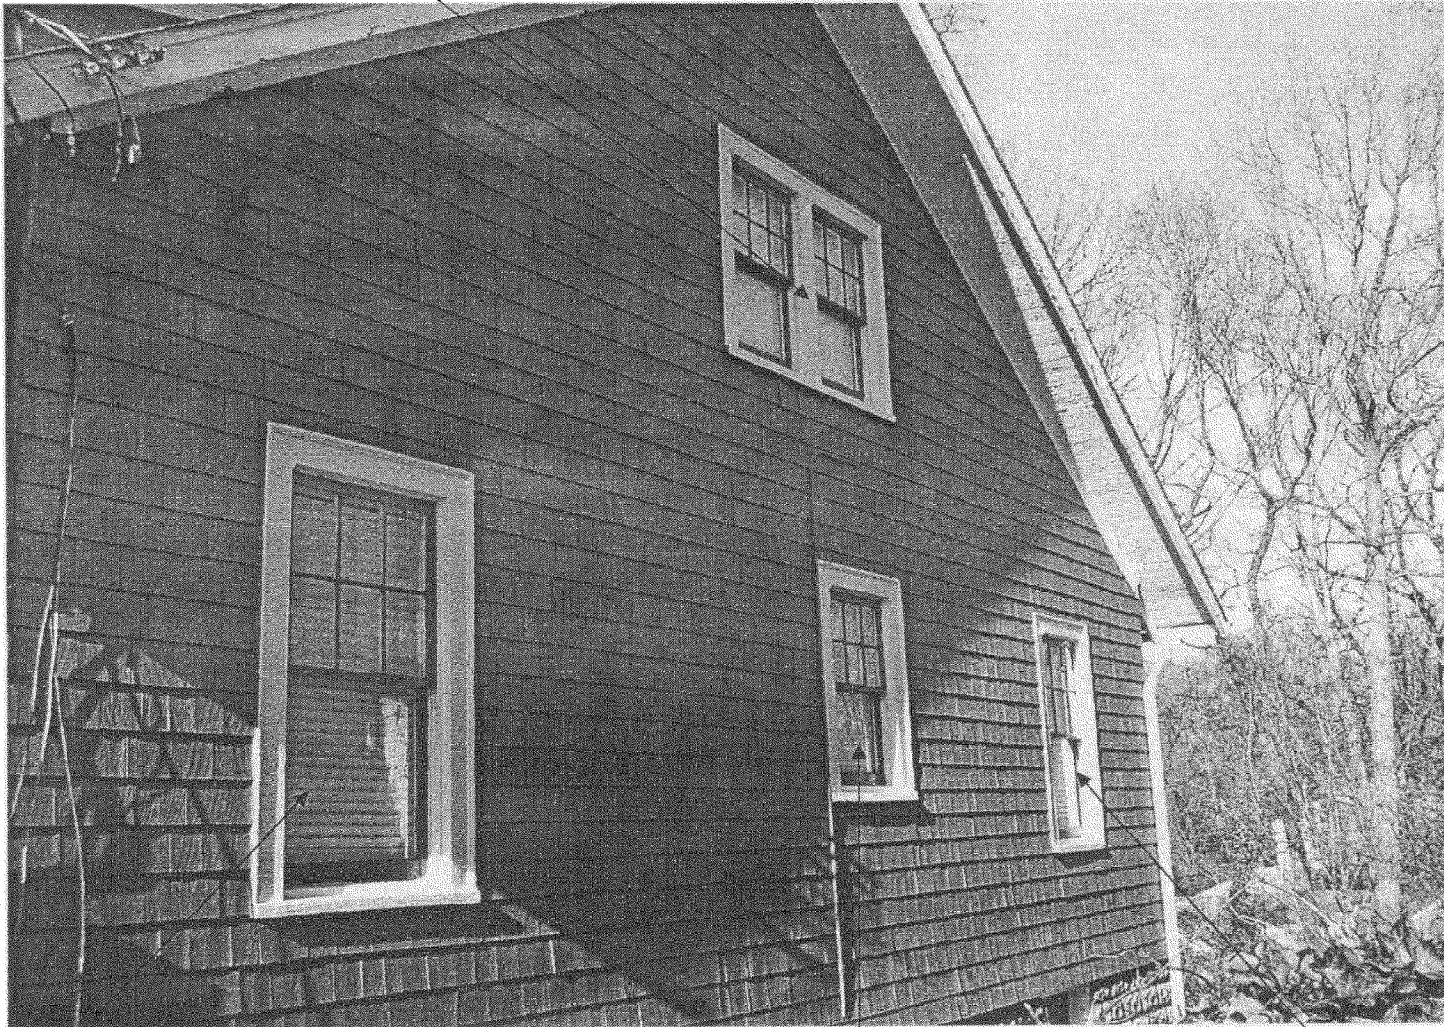
Replace these two windows

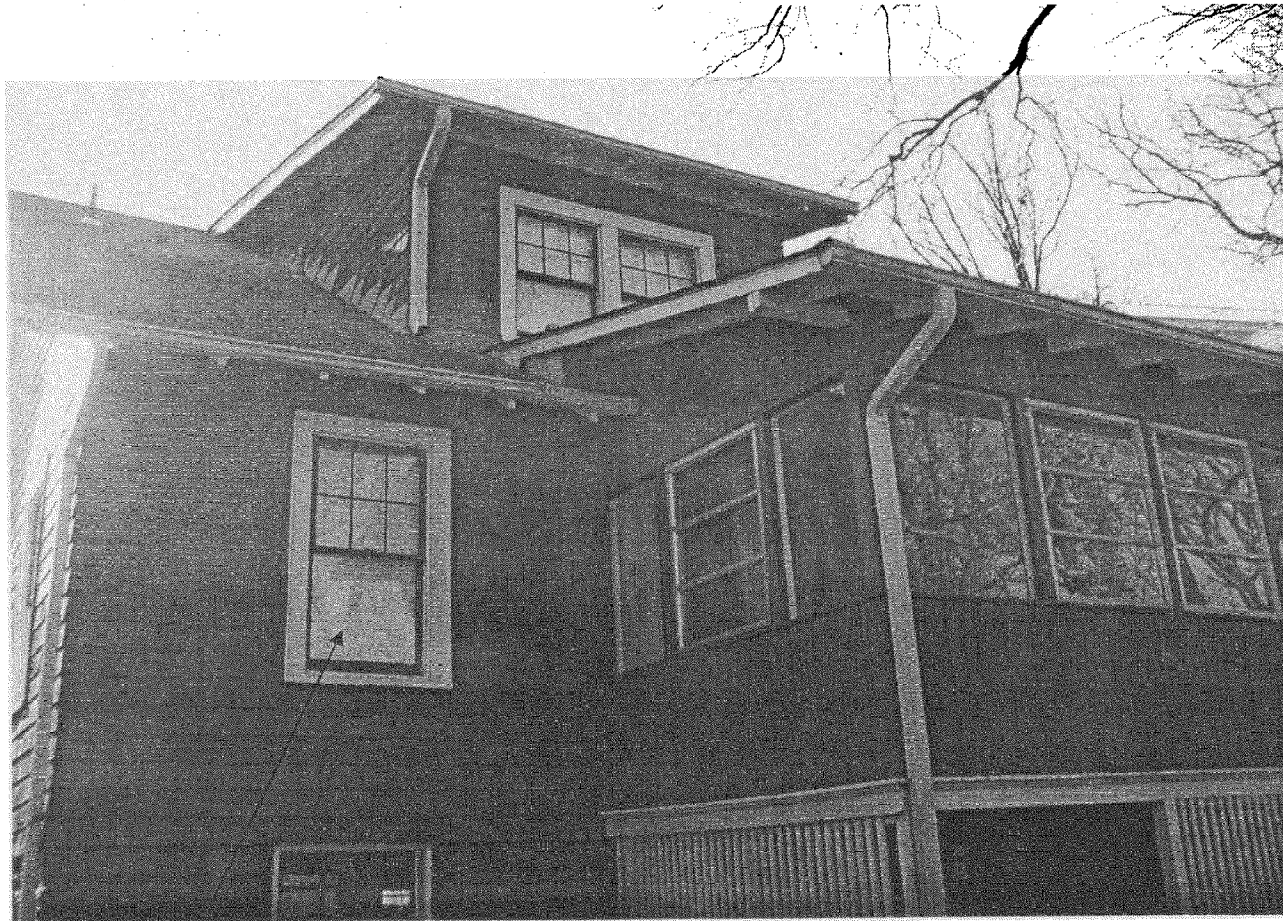
13

Replace this window

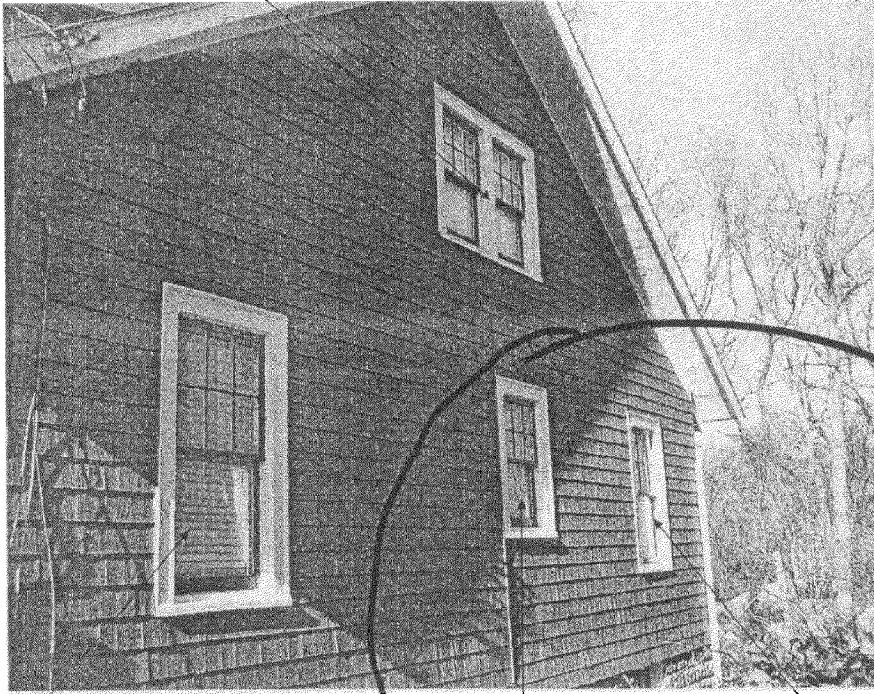
511 PHILADELPHIA AVENUE

~~Replace the two windows~~

Replace this window

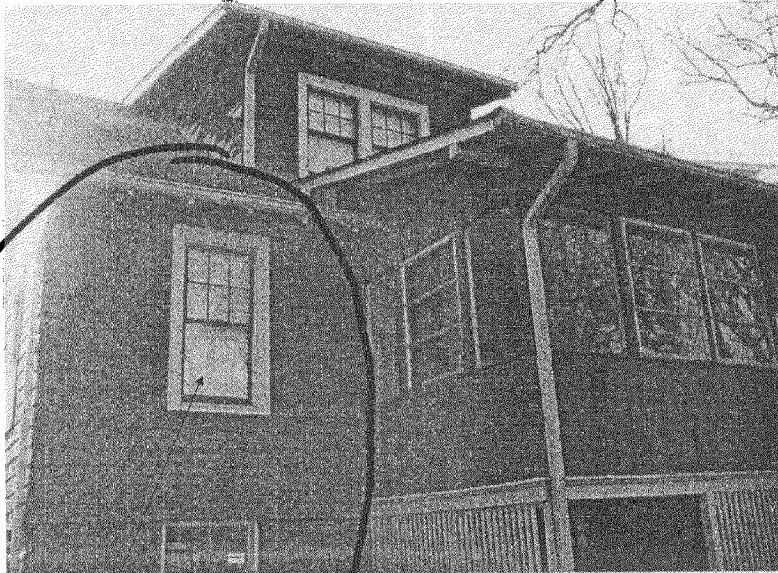
511 PHILADELPHIA AVENUE

Replace this window

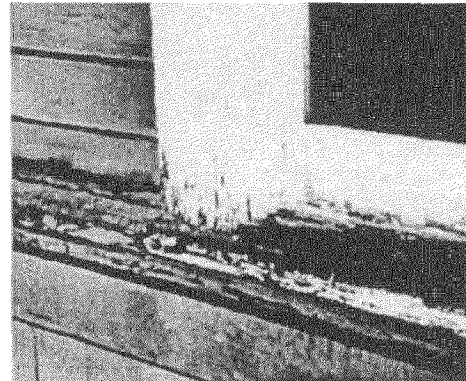
**Deterioration of poorly maintained windows usually begins on horizontal surfaces and at joints, where water can collect and saturate the wood. Photo: NPS files.**

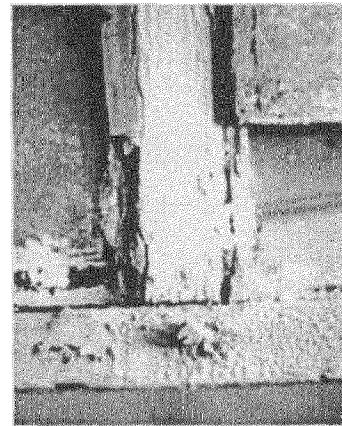
**This historic double-hung window has many layers of paint, some cracked and missing putty, slight separation at the joints, broken sash cords, and one cracked pane. Photo: NPS files.**

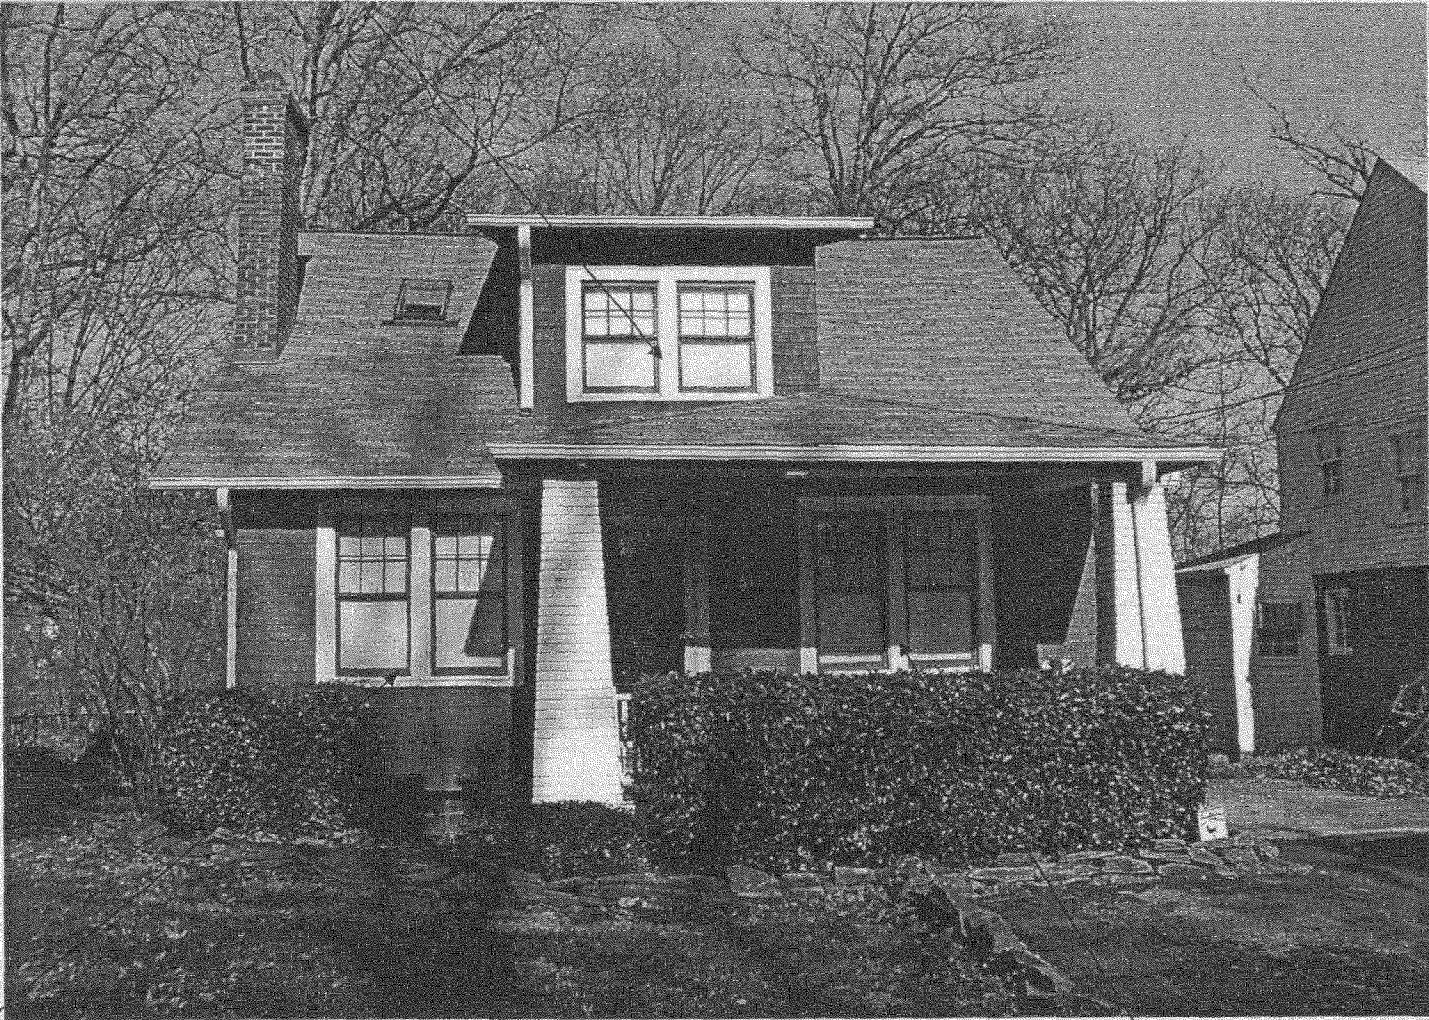
Replace these two windows

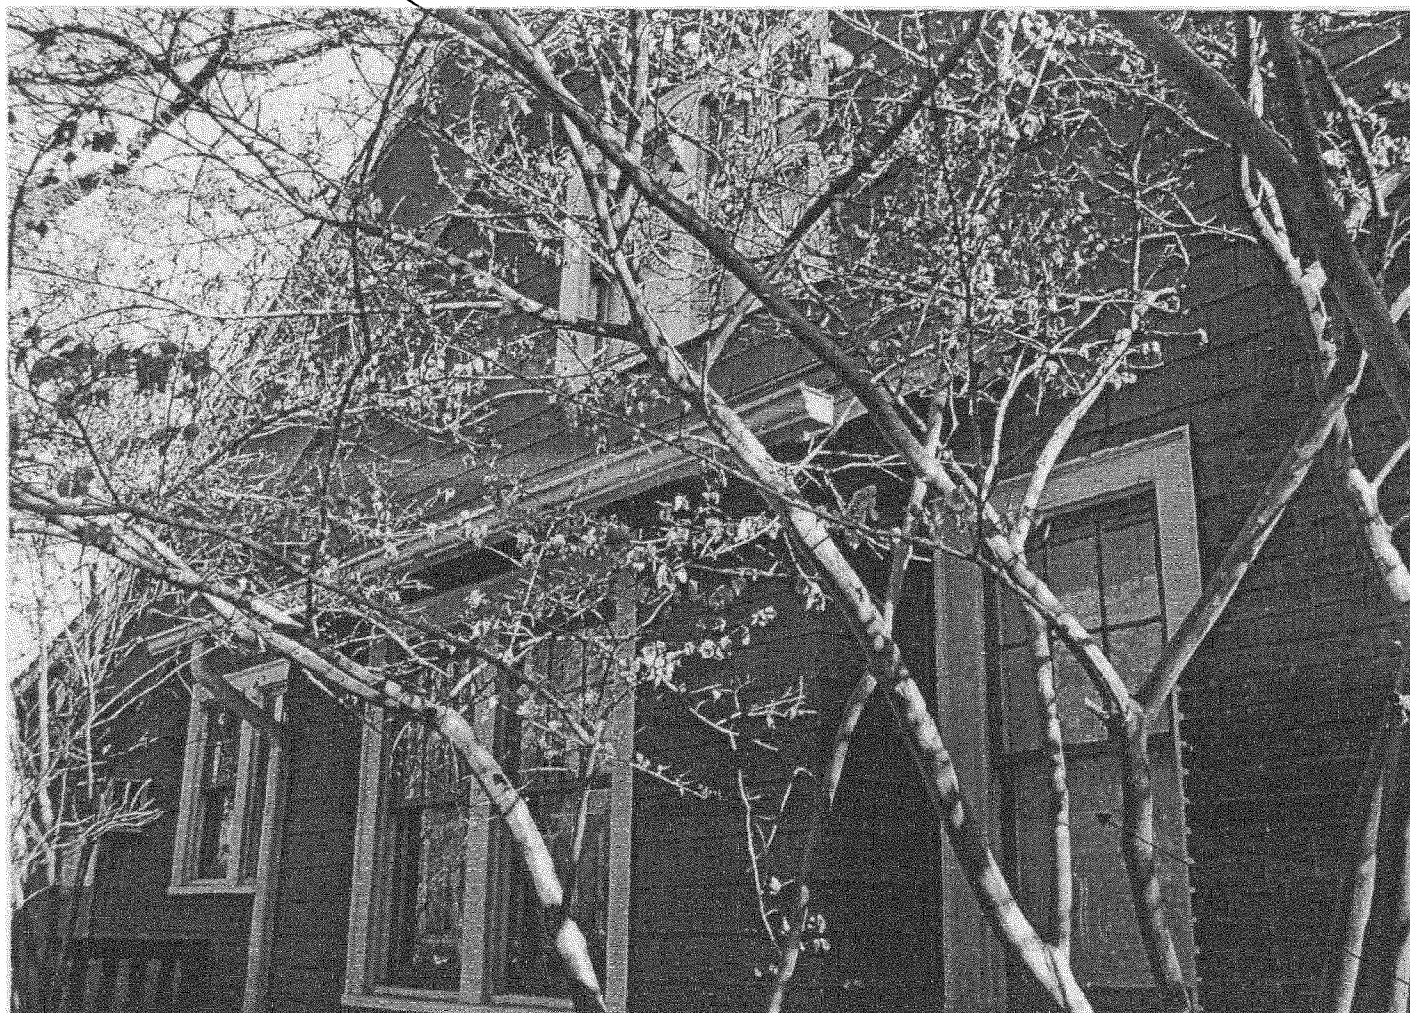
Replace these two windows

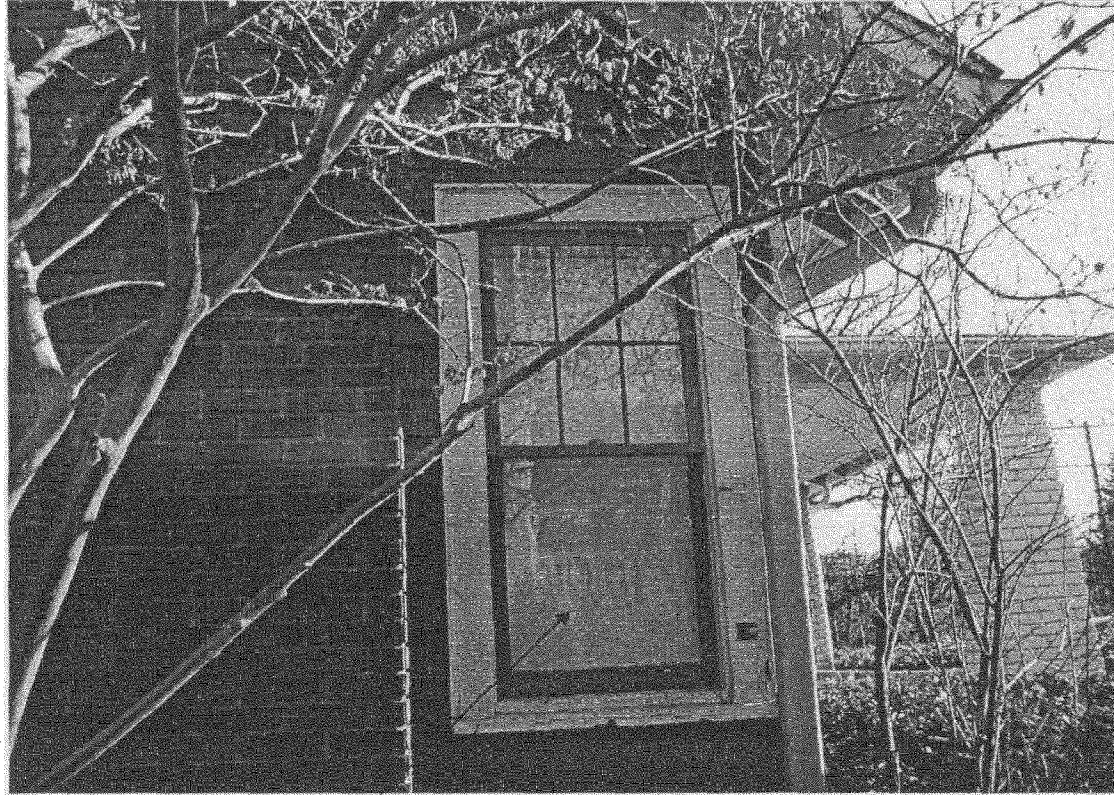
511 PHILADELPHIA AVENUE

Replace this window

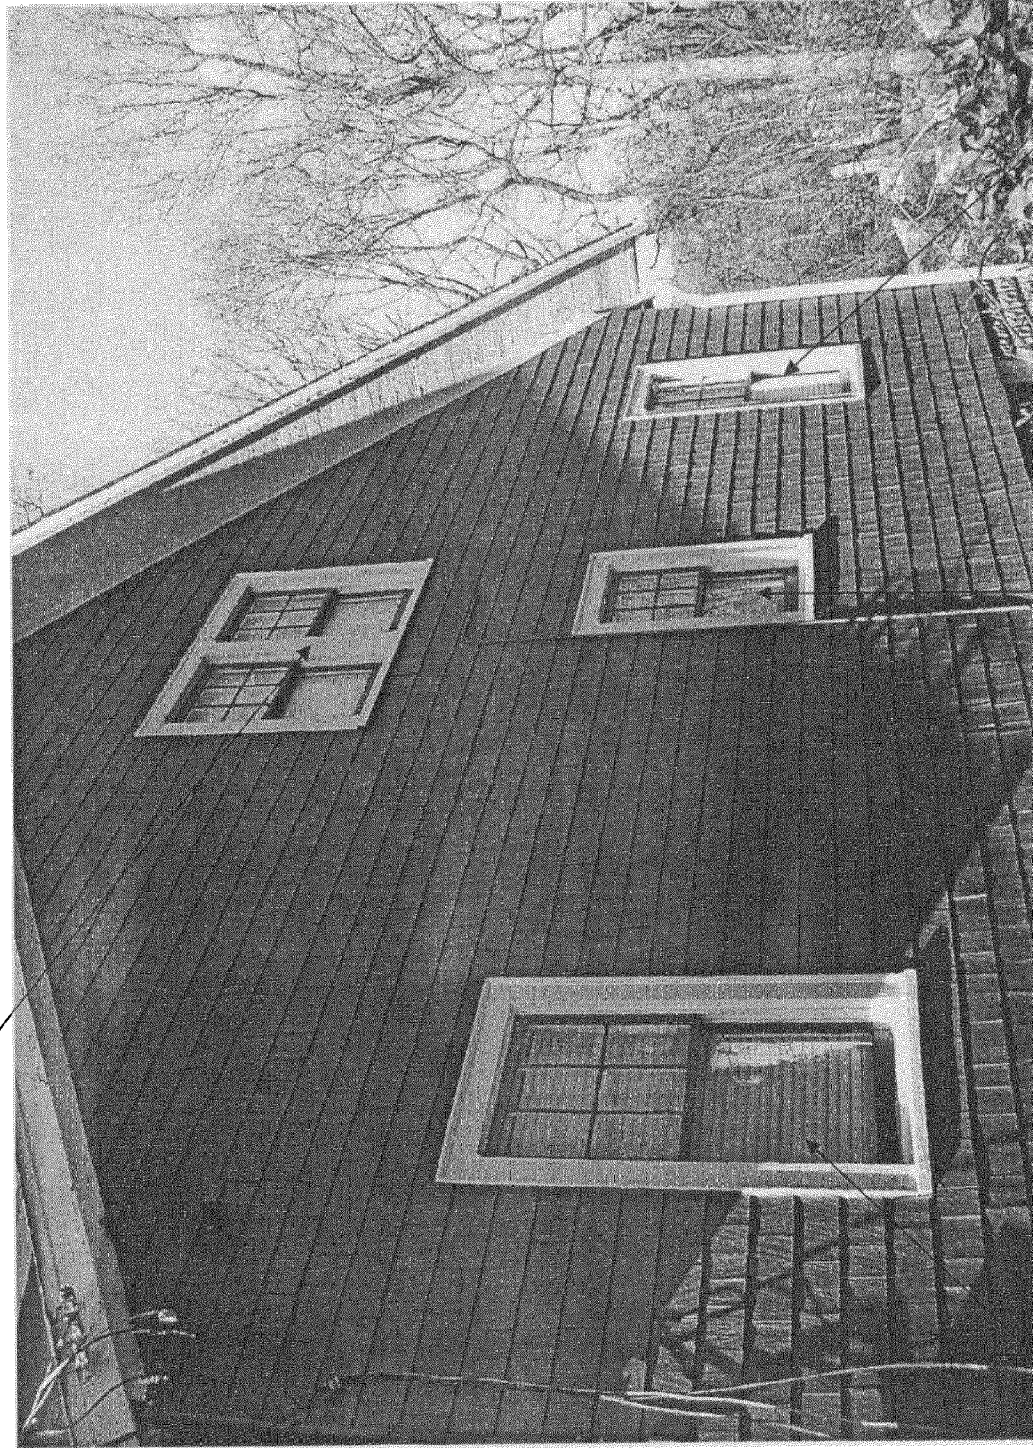
Replace these two windows

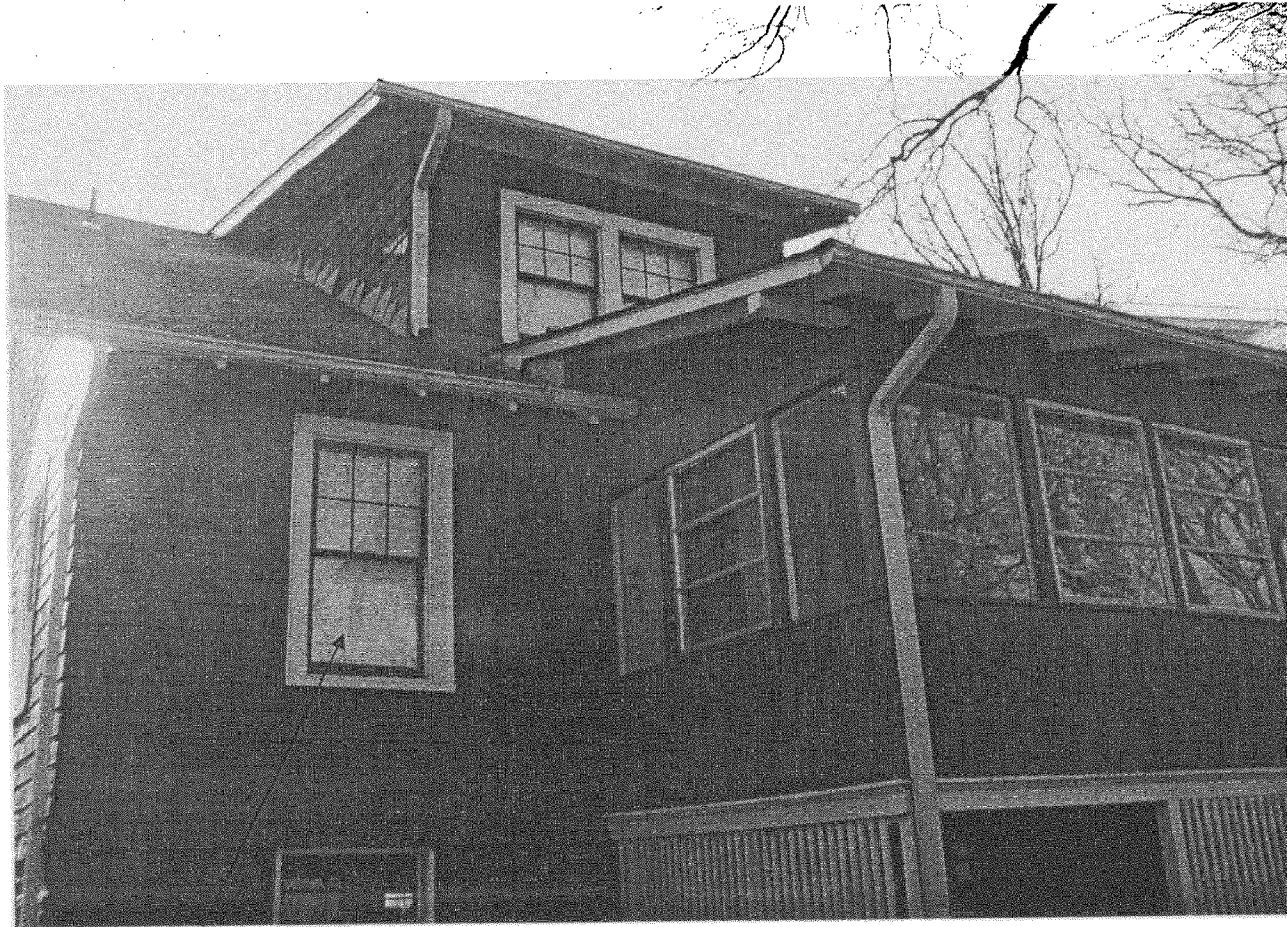
511 PHILADELPHIA AVENUE

Replace this window

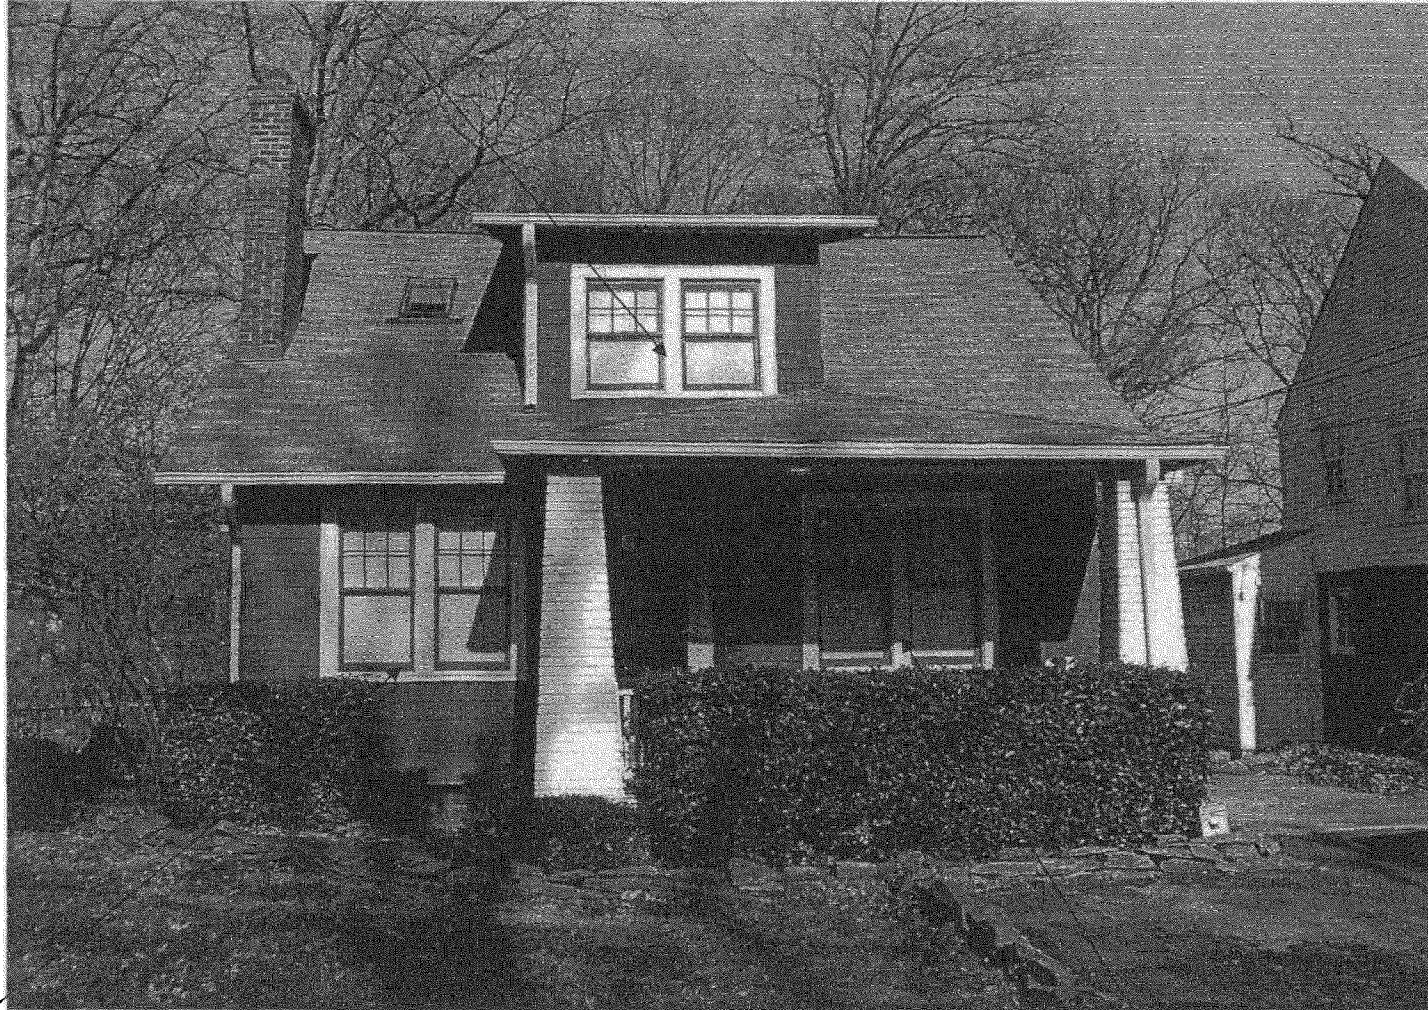
Replace these two windows

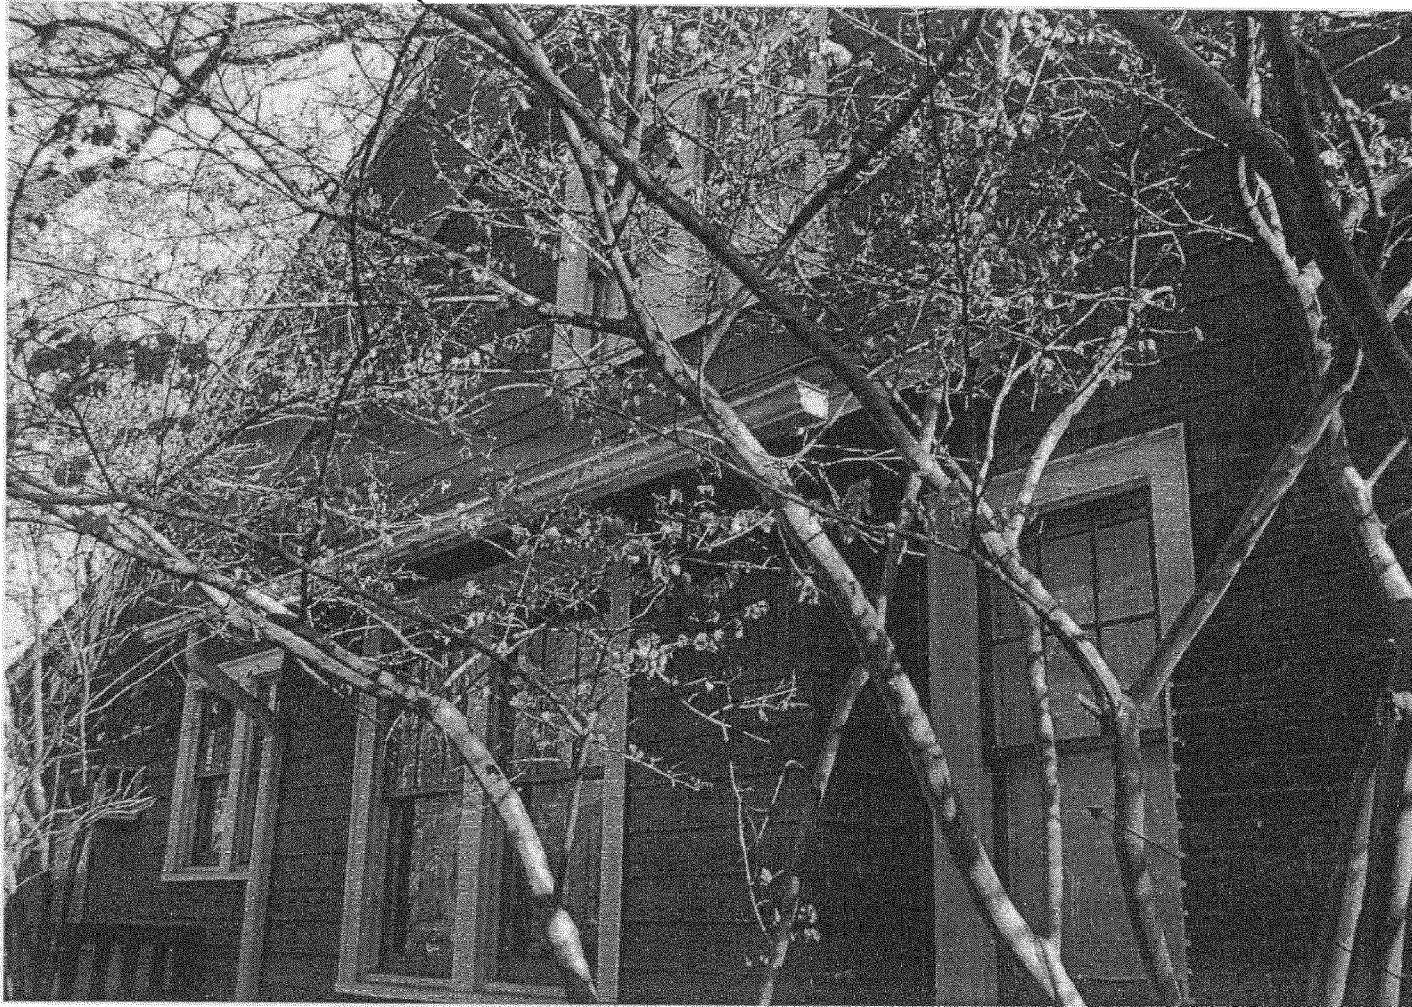
Replace these two windows

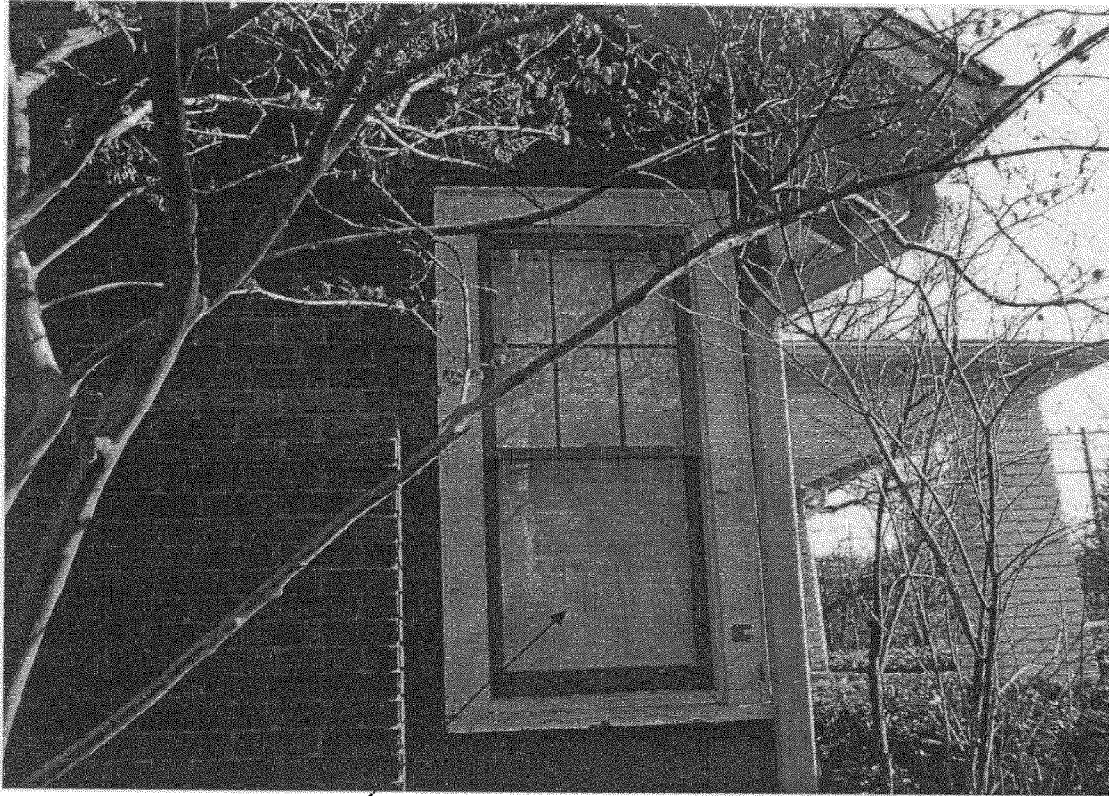
511 PHILADELPHIA AVENUE

Replace this window

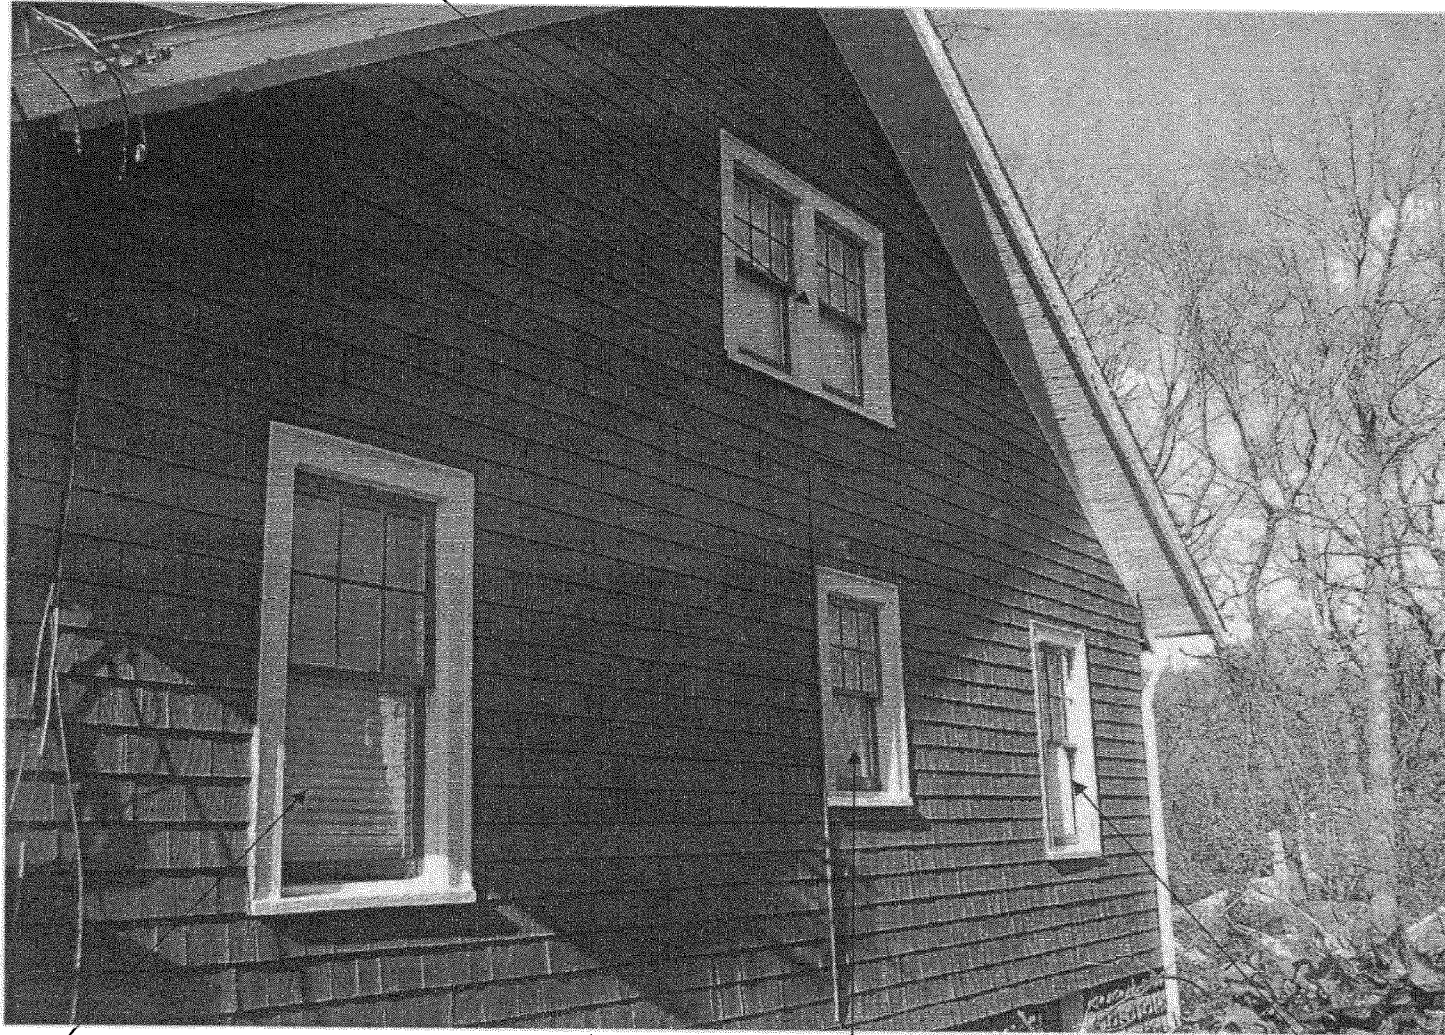
Replace these two windows

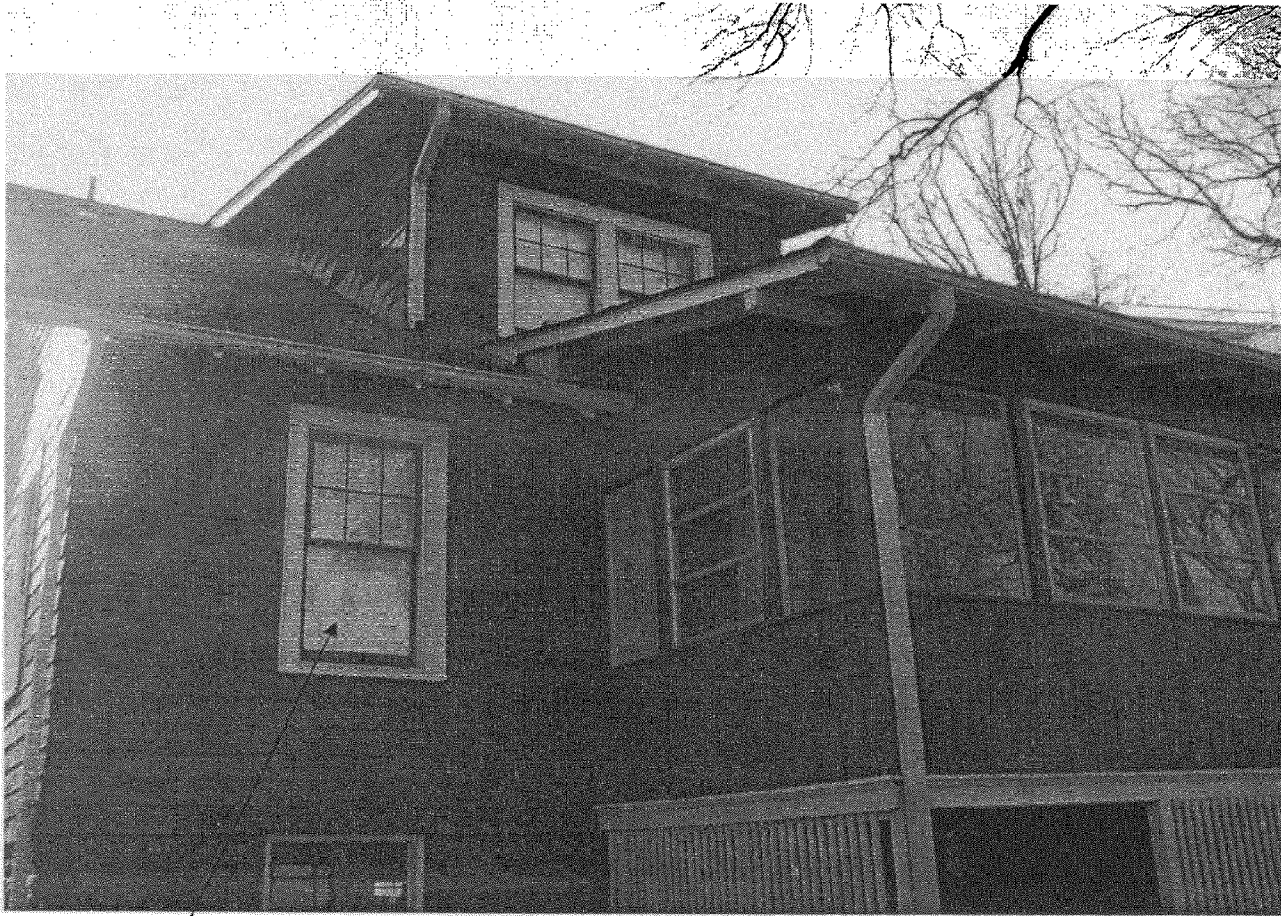
511 PHILADELPHIA AVENUE

Replace this window

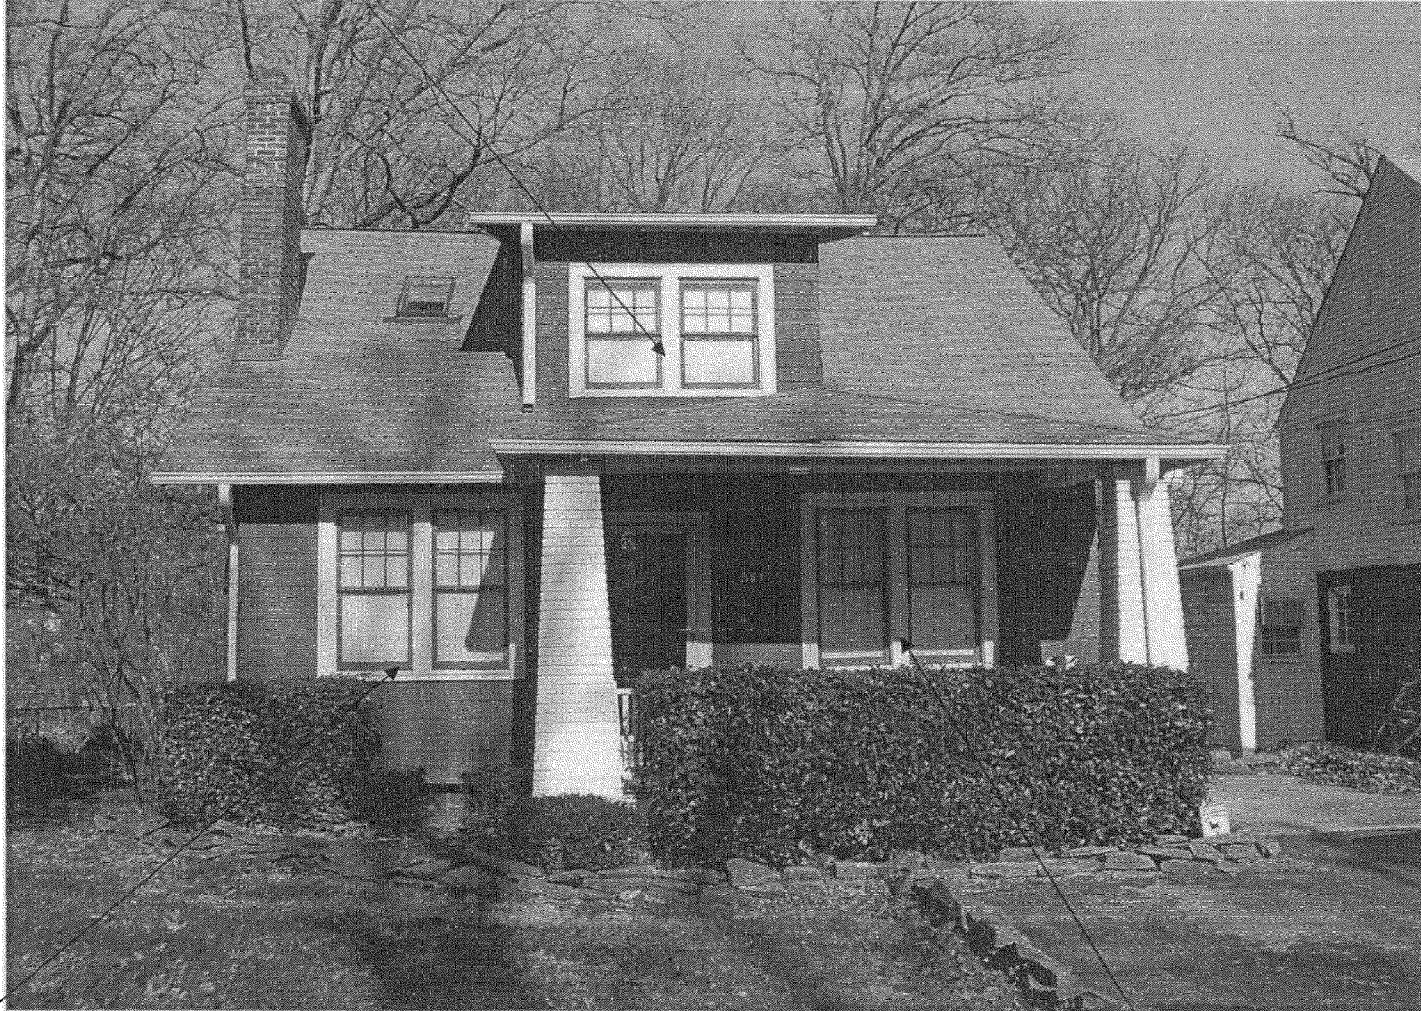
Replace these two windows
