37/03-06F 511 Philadelphia Ave

Takoma Park Historic District, 37/03

**Subject:** 511 Philadelphia Avenue - window survey  
**Location:** Takoma Park  
**Start:** Tue 3/14/2006 9:30 AM  
**End:** Tue 3/14/2006 10:00 AM  
**Recurrence:** (none)  
**Categories:** Site Visit

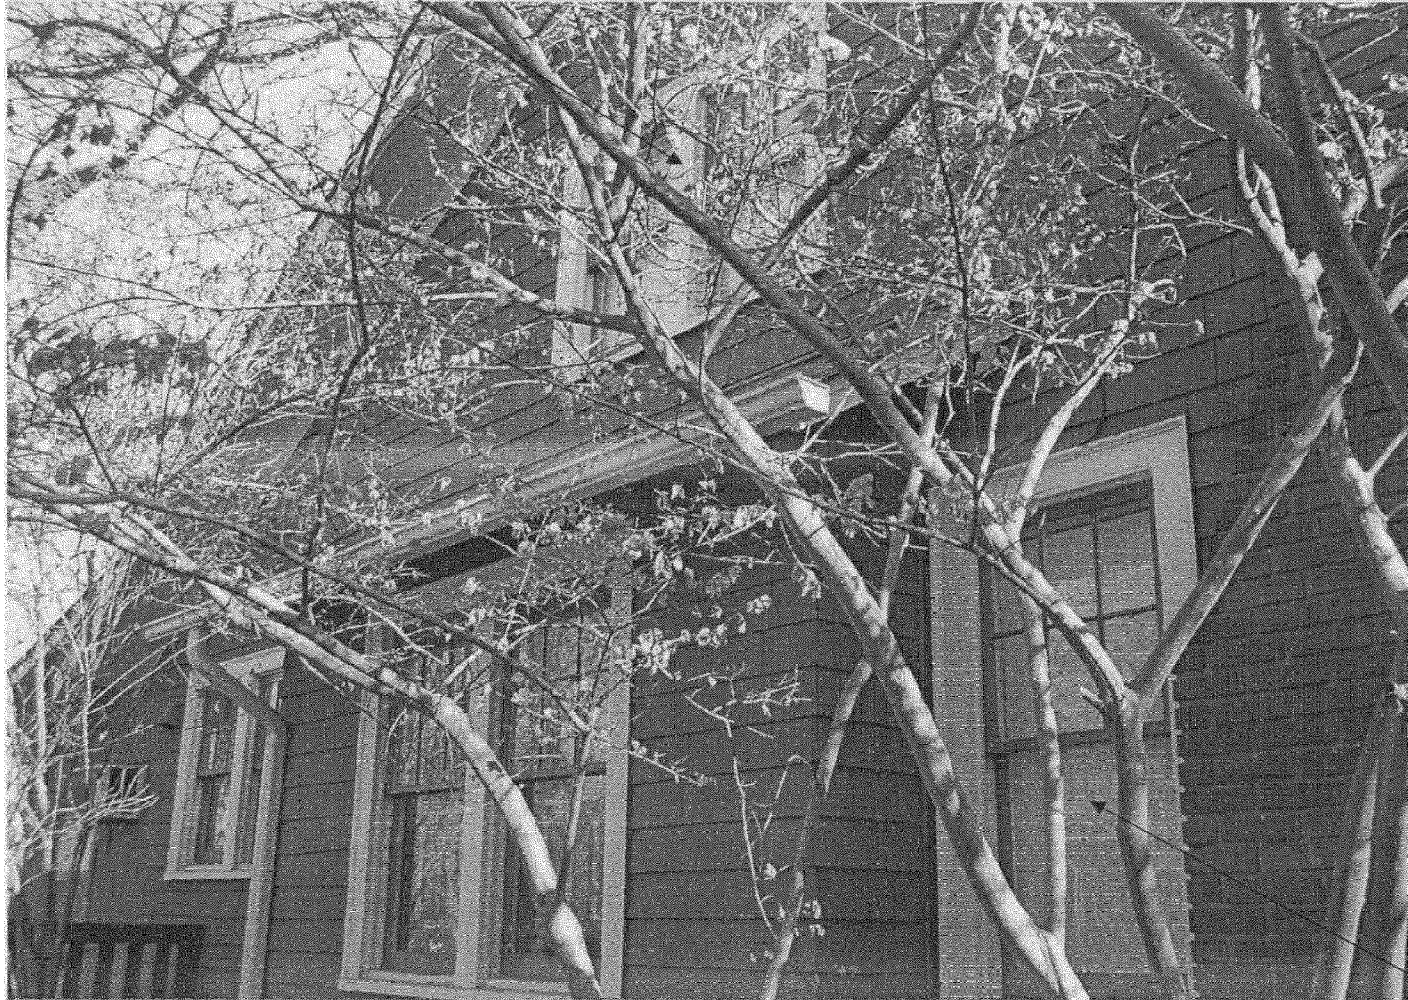
Replace these two windows

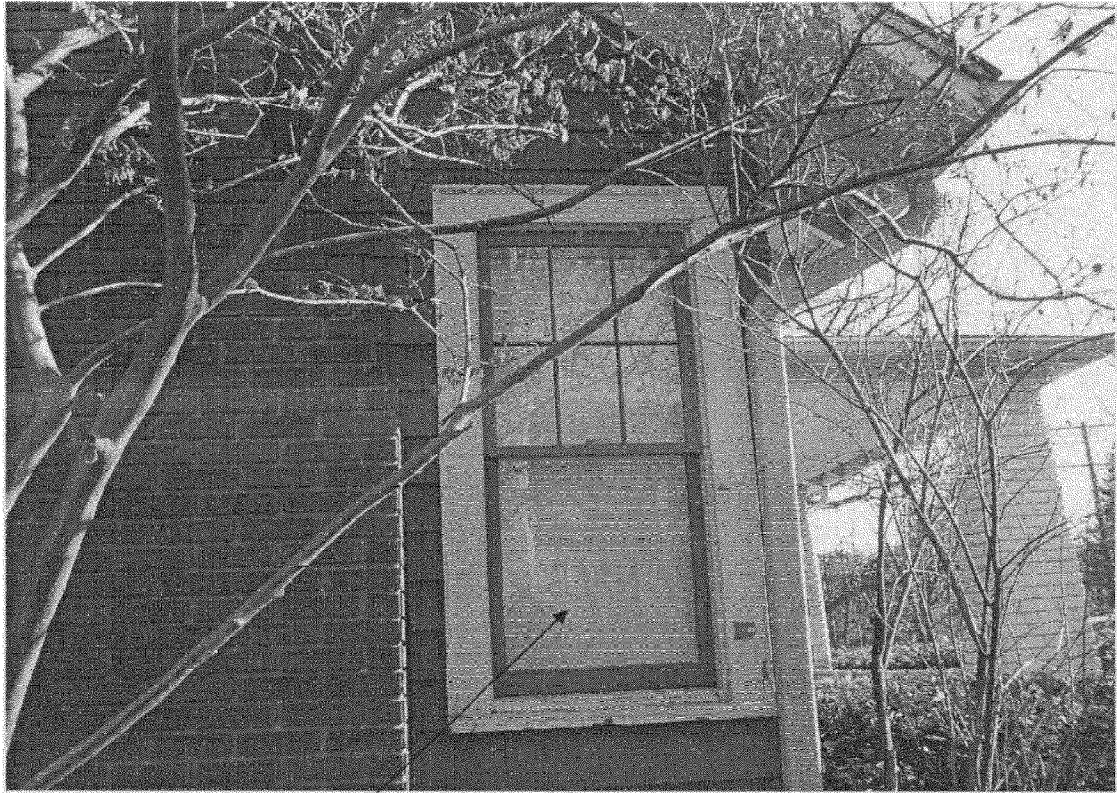
511 PHILADELPHIA AVENUE

Replace this window

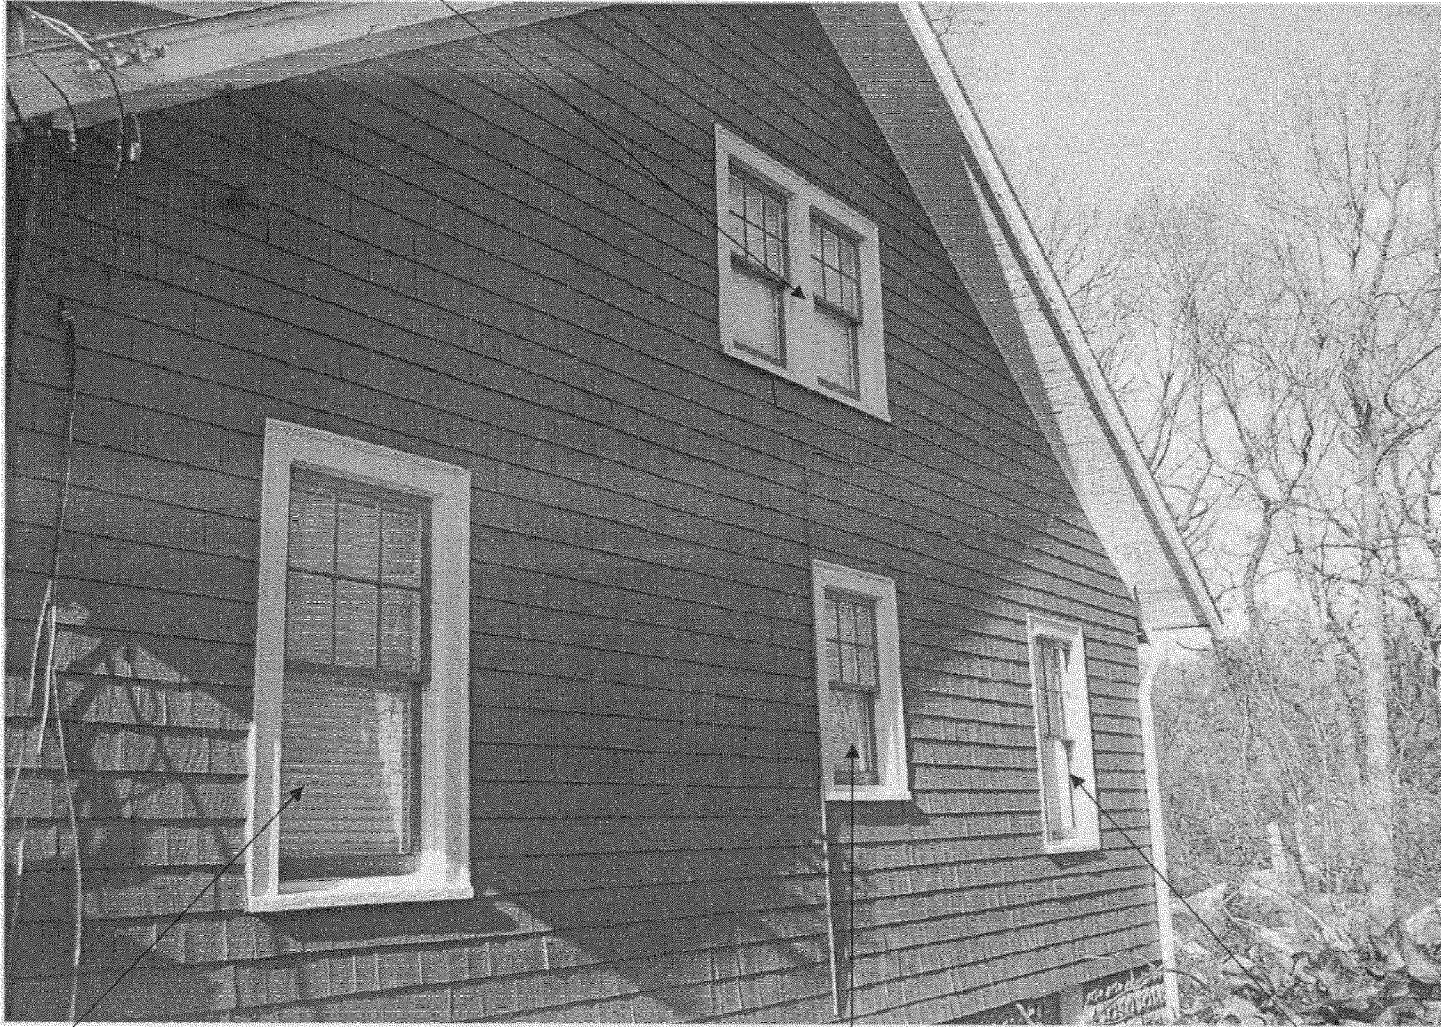
Replace these two windows

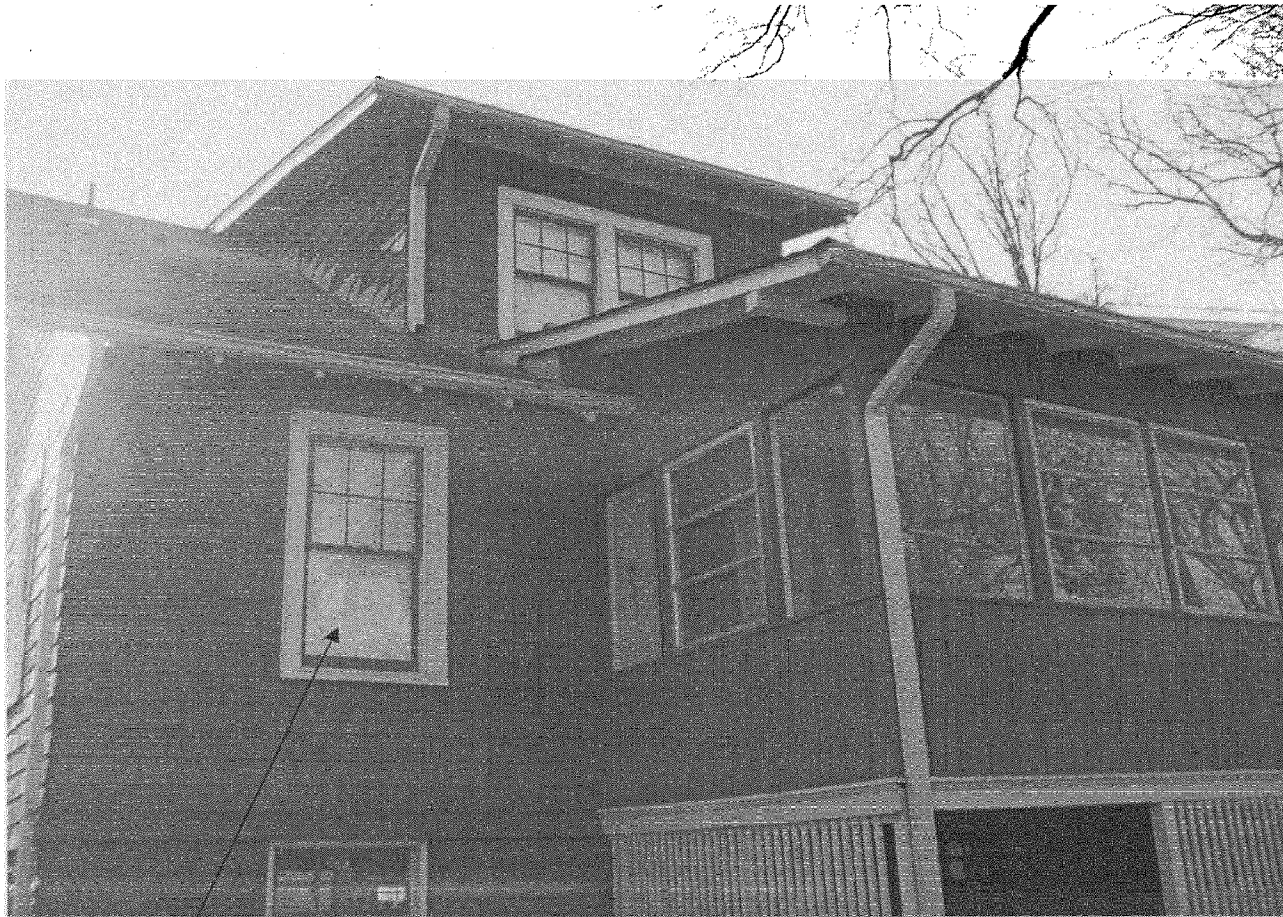
13

Replace this window

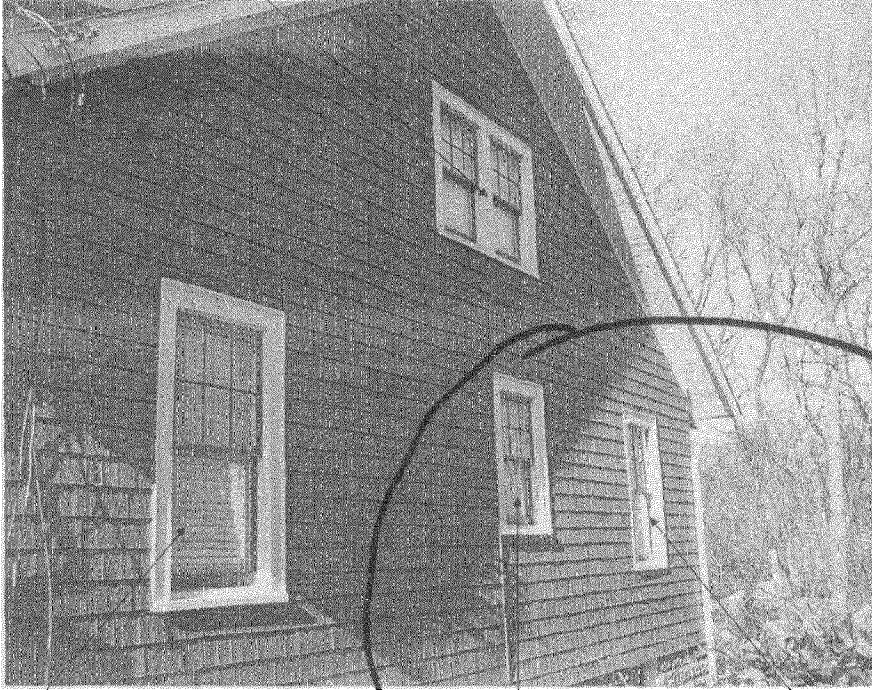
511 PHILADELPHIA AVENUE

~~Replace this window~~

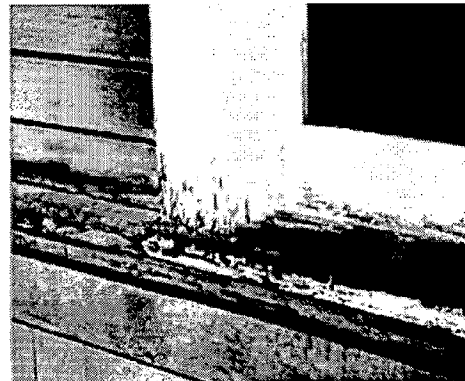
**Deterioration of poorly maintained windows usually begins on horizontal surfaces and at joints, where water can collect and saturate the wood. Photo: NPS files.**

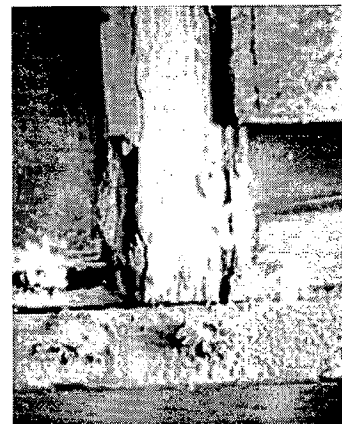
**This historic double-hung window has many layers of paint, some cracked and missing putty, slight separation at the joints, broken sash cords, and one cracked pane. Photo: NPS files.**
