SUBJECT: Historic Area Work Permit: 846182: Building Additions

Applicant: David O'Neil and Laura Billings Address: 5904 Cedar Parkway, Chevy Chase

### **Billings O'Neil Residence HAWP Revision 2**

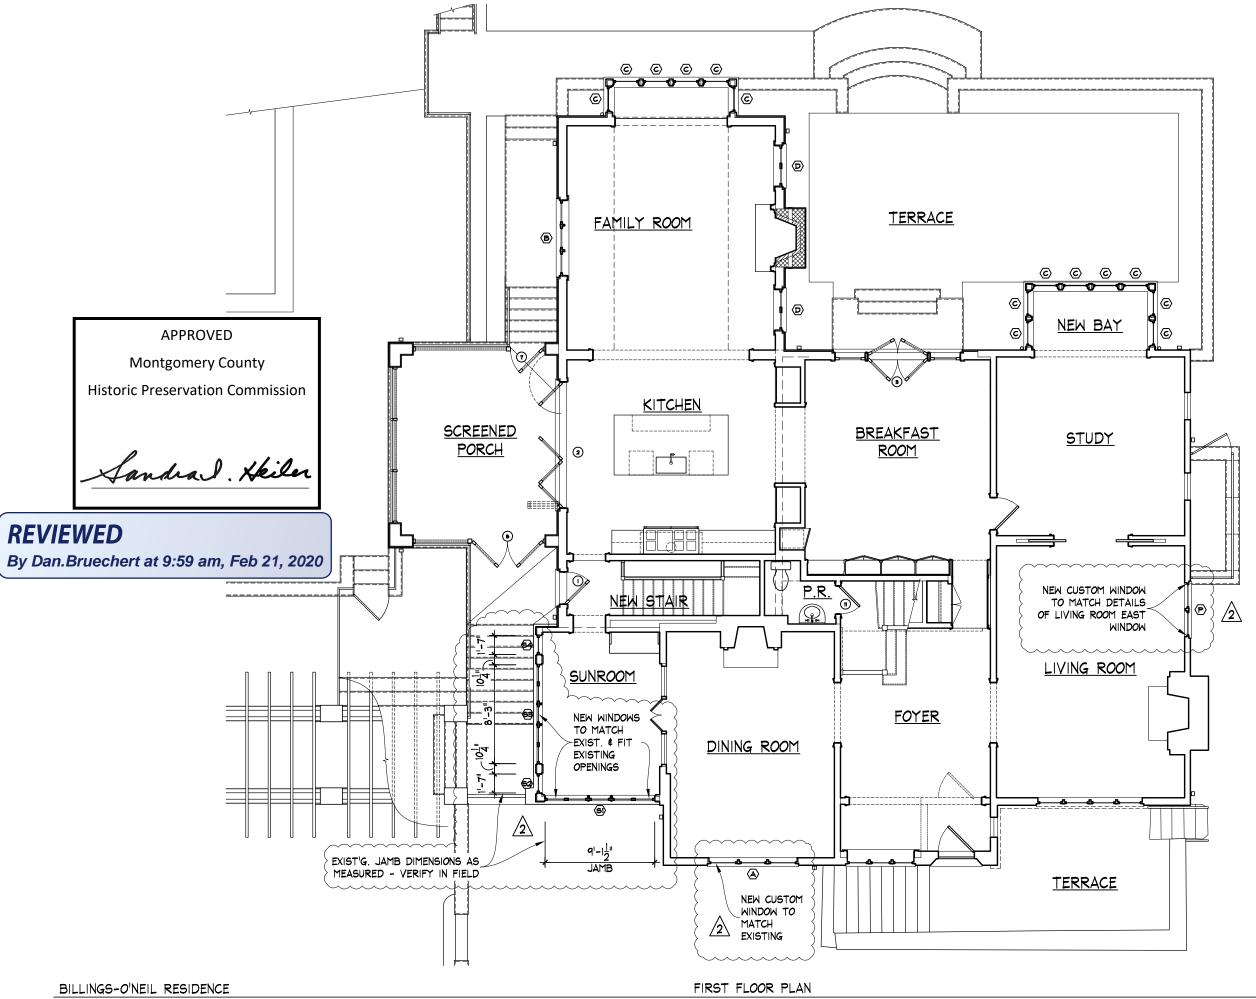
We have evidence that this room was originally a porch. The wood floor has been removed and there is clay tile on concrete with a step-down from the dining room (photo 4). This clay tile matches the tile on the front terrace. The walls beneath the windows are stone, matching the stone on the exterior of the house (photo 3, 4, 5). There are windows and French doors between this room and the dining room indicating it was originally a porch. Therefore, we do not believe these windows are original.

The existing windows in this room have deteriorated to the point that they do not operate. They cannot be repaired. We propose to replace these windows with custom units sized to fit the existing jamb openings.

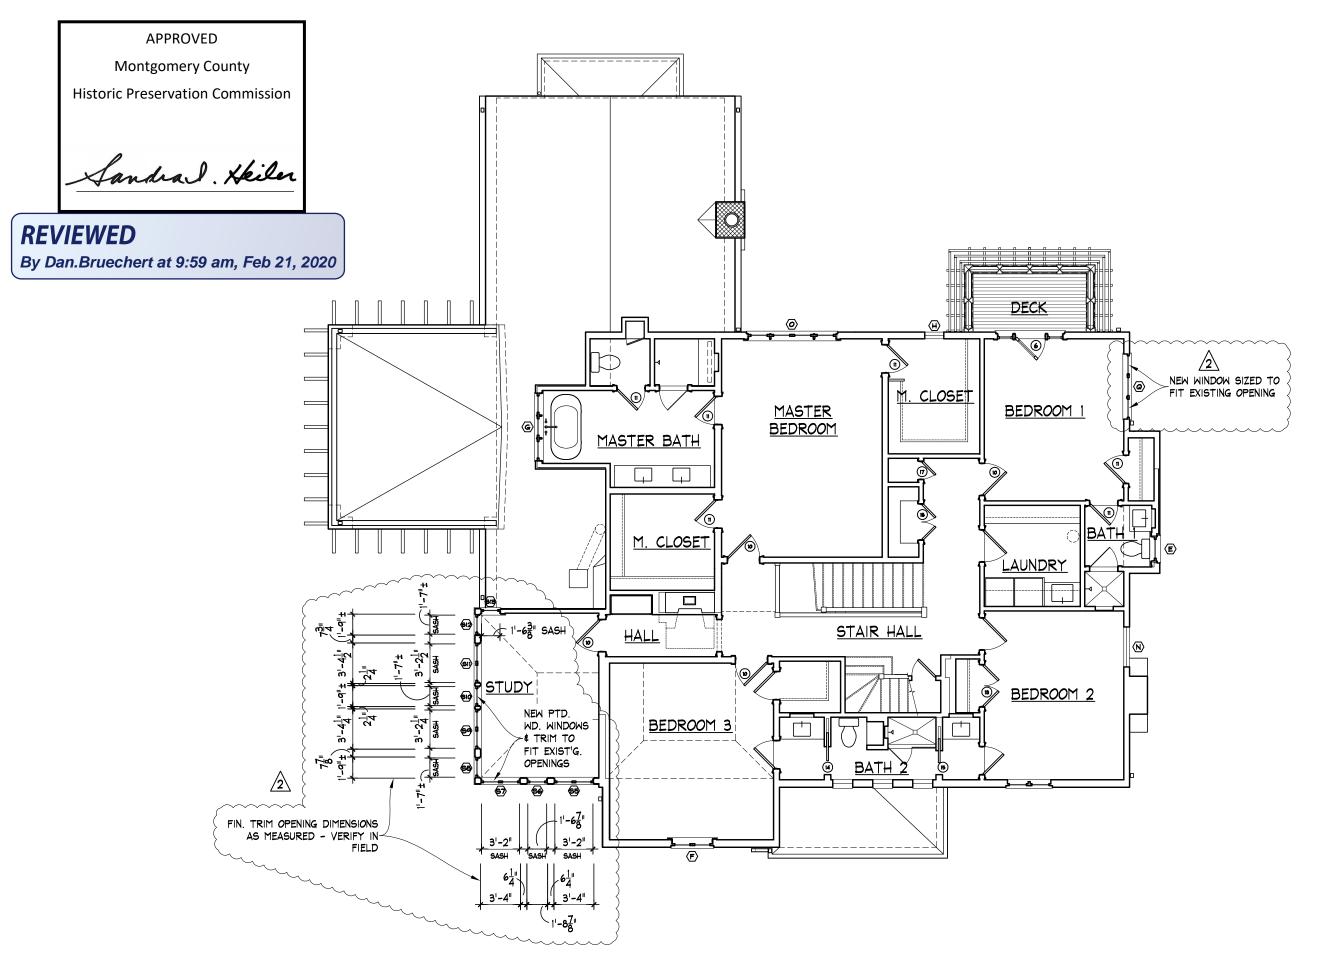
We have evidence that this room was added at a later date. All of the framing in this room is newer than that in the rest of the house, evidenced by a clear difference in color (photo 6, 7). The steel windows do not match the other windows in the house (photo 8, 9).

The existing steel windows are in disrepair, have been modified in places and do not operate. We propose to replace these with wood framed windows with similar pattern.

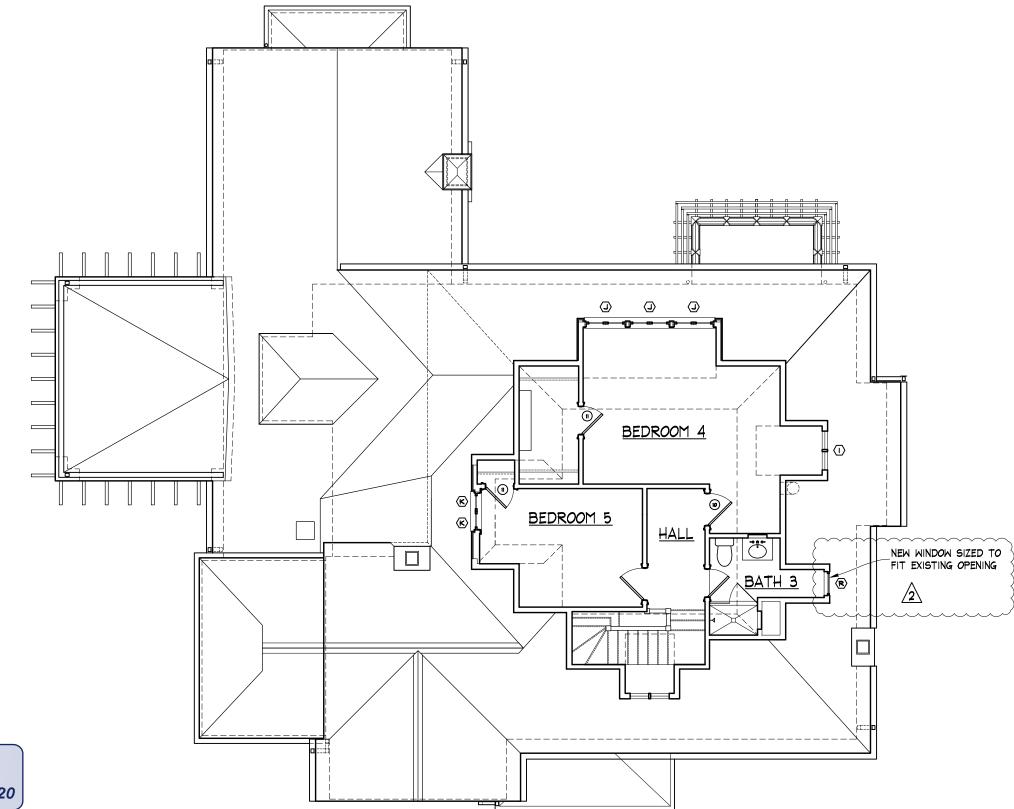
The original approved plans call for replacing the center sash. However, after further inspection, the two flanking sashes are rotted and will not close fully (photo 10). We propose to replace this window with a custom unit to match the existing details and frame dimensions.
