## HISTORIC PRESERVATION COMMISSION

Marc Elrich  
County Executive

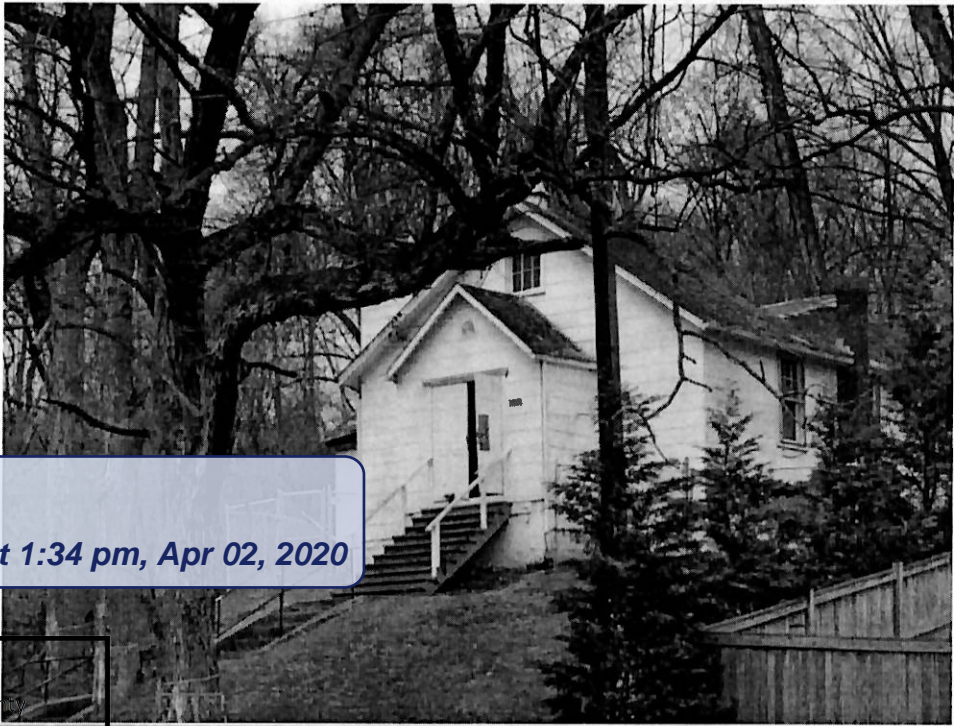
**REVIEWED**  
By Michael Kyne at 1:34 pm, Apr 02, 2020

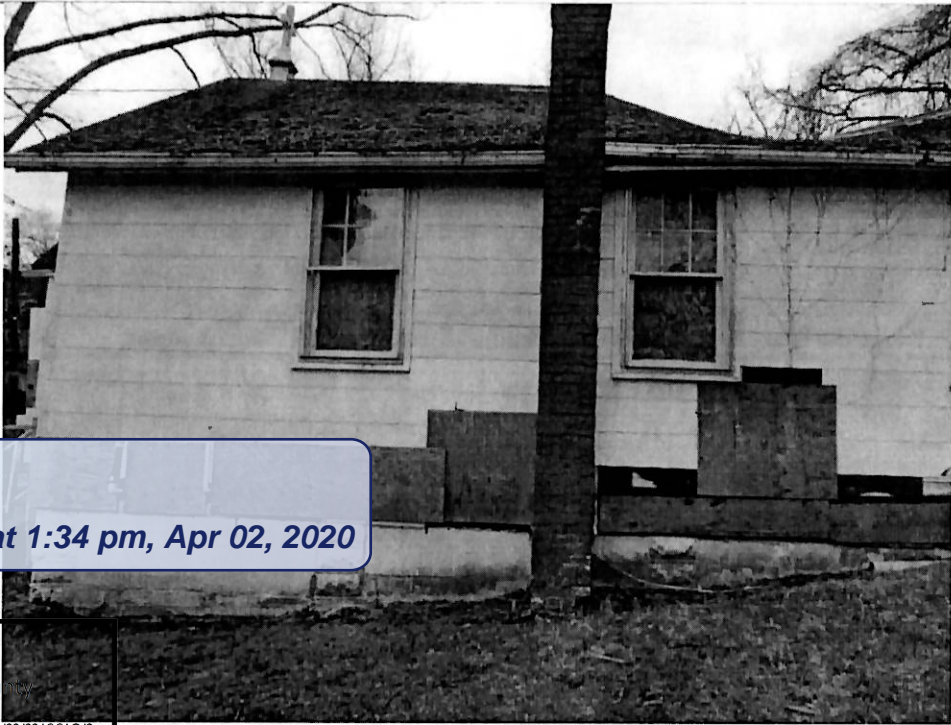
**REVIEWED**  
By Michael Kyne at 1:34 pm, Apr 02, 2020

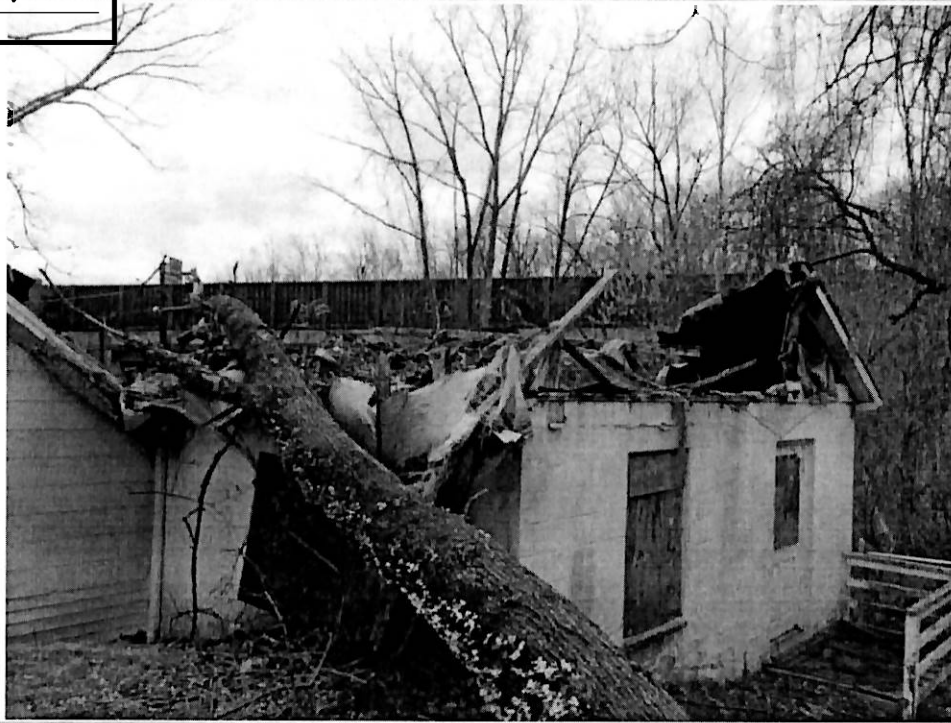
Photo No. 4: Rear (West) elevation view of damaged structure

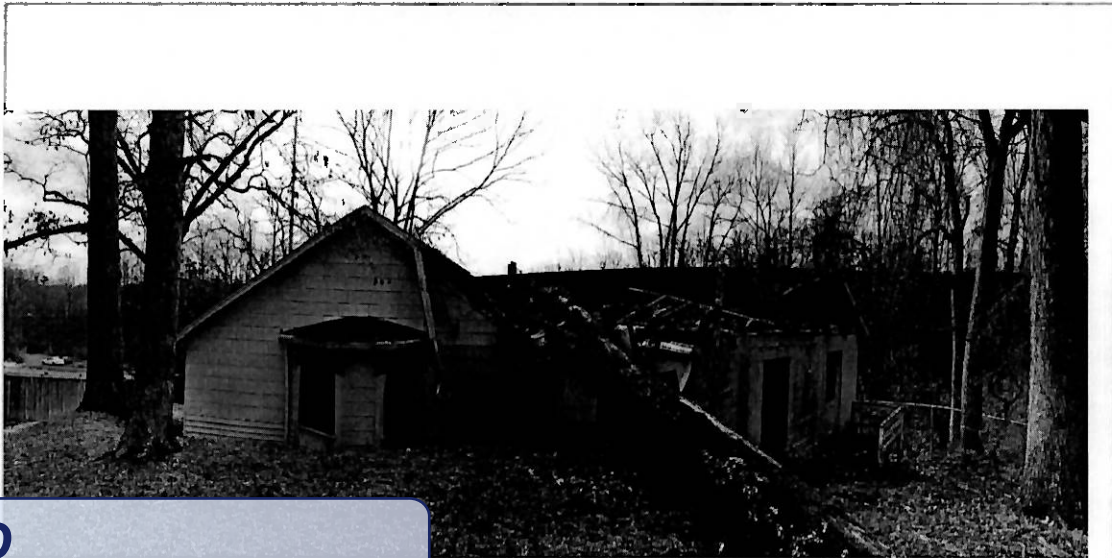
Existing Property Condition Photographs (duplicate as needed)

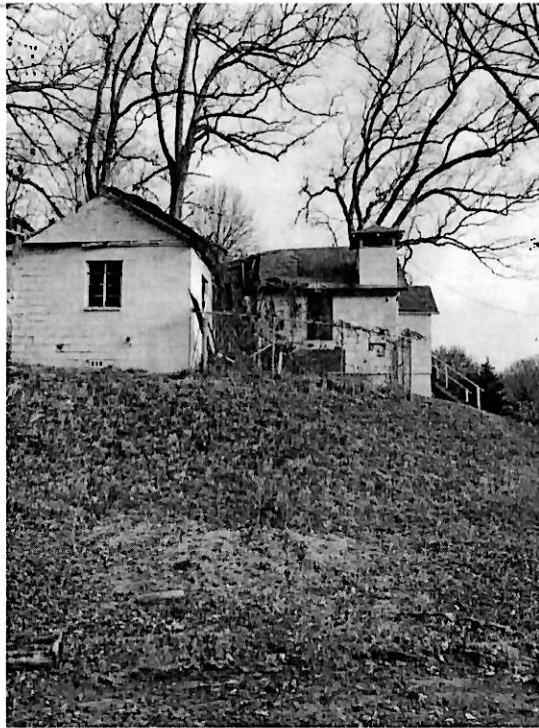
Photo No. 6: Left Side (South) elevation view of damaged structure  
Detail: \_\_\_\_\_

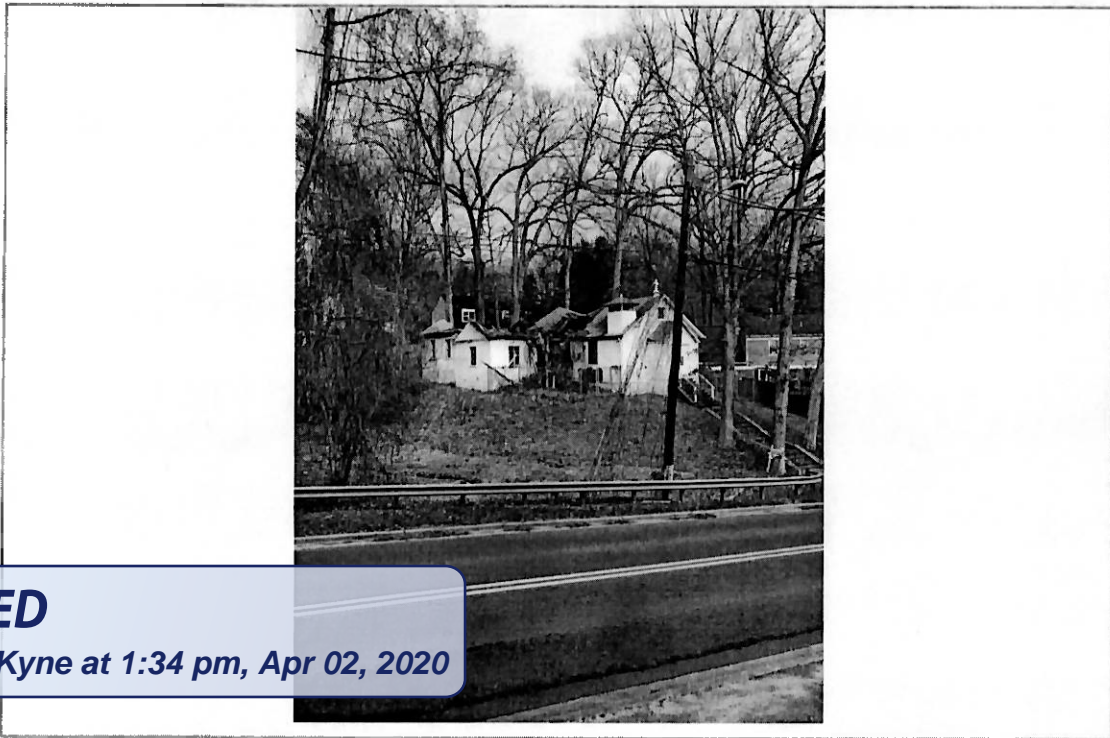
Existing Property Condition Photographs (duplicate as needed)

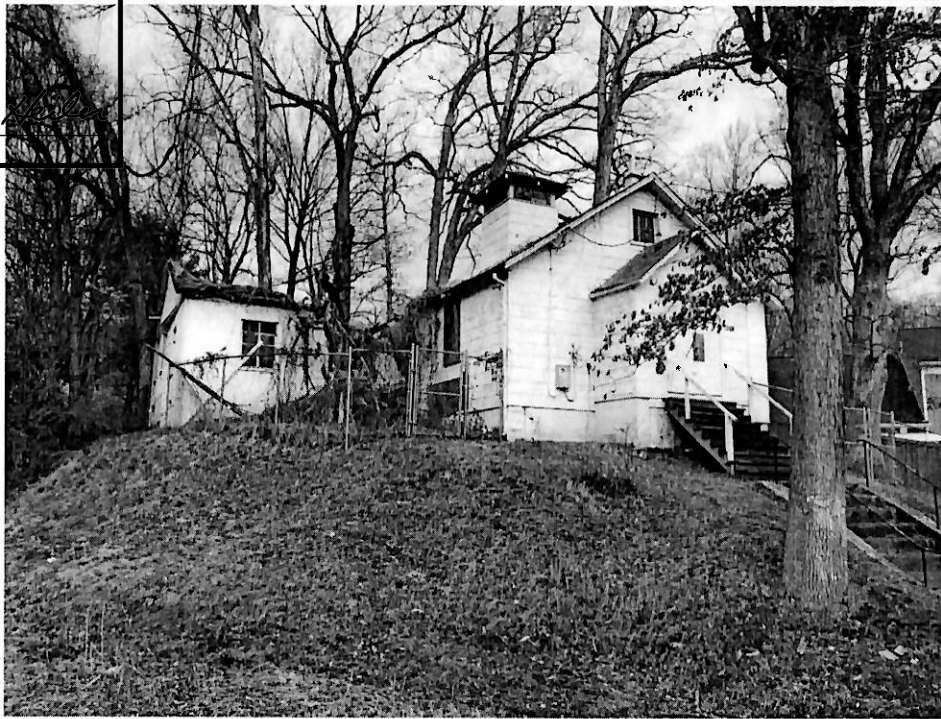
Photo No. 8: View of damaged structure looking Northwest

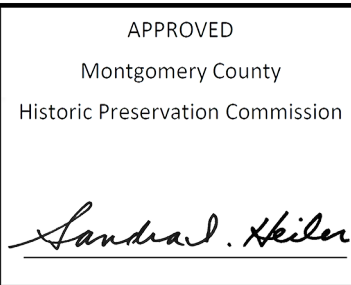
Re: Structural Assessment Letter Report  
First Agape AME Zion Church  
7700 Seven Locks Road, Bethesda, MD 20817  
DTSE Project No. 0054-003-01

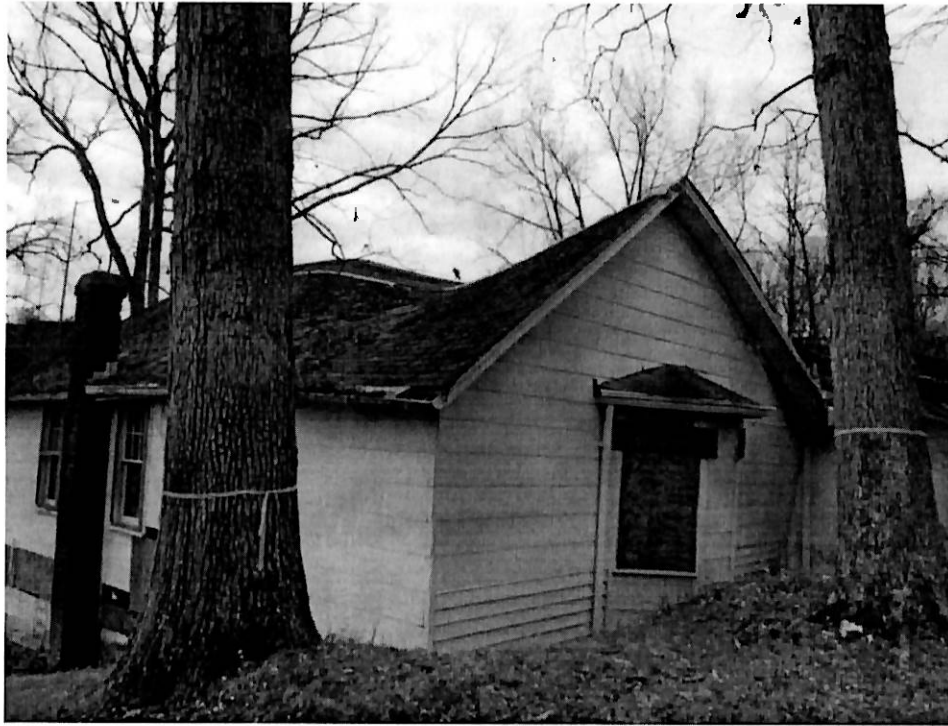
Photo No. 7: View of the northwest corner of the structure, showing similar issues noted in the previous photo.

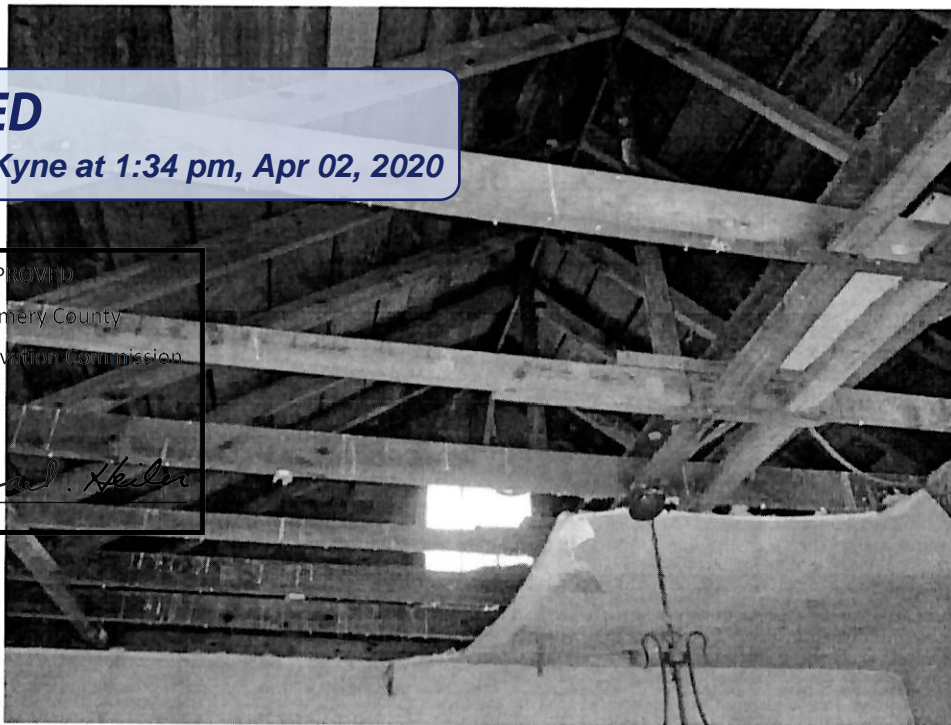
Photo No. 16: View of structure's intact roof framing above the front entrance area.
