### HISTORIC PRESERVATION COMMISSION

SUBJECT: Historic Area Work Permit #907465: Roof replacement

Address: 5 High Street, Brookeville

## 1. WRITTEN DESCRIPTION OF PROJECT

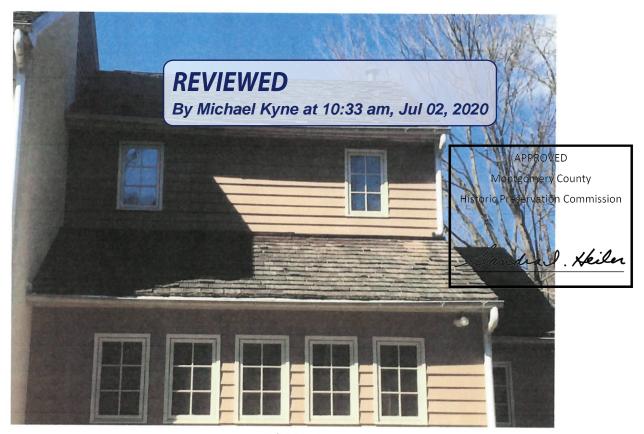
The existing cedar roof, which was installed in 1996, is failing and needs to be replaced to protect the building. The existing gutters are sagging and no longer shedding water from the building appropriately.

Damaged Shingles 1

b) This project includes removal of the existing cedar roof, gutters and downspouts from both the historic structure and recent addition. The cedar roof will be replaced with a standing seam metal roof. Snow guards will be installed across the West Elevation (front). The gutters and downspouts will be replaced inkind.

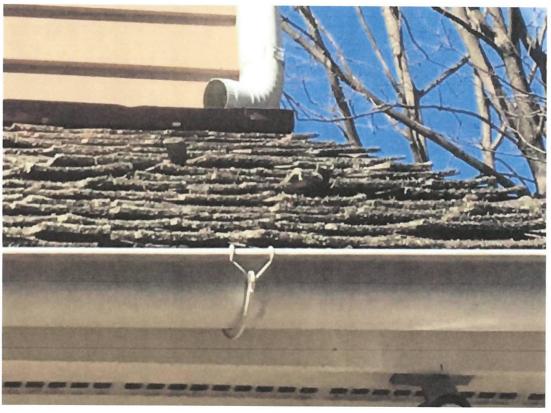
Damaged Shingles 2

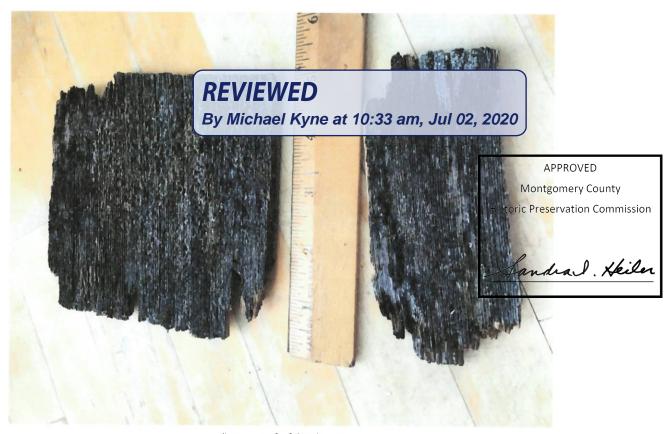
**Damaged Shingles 3**

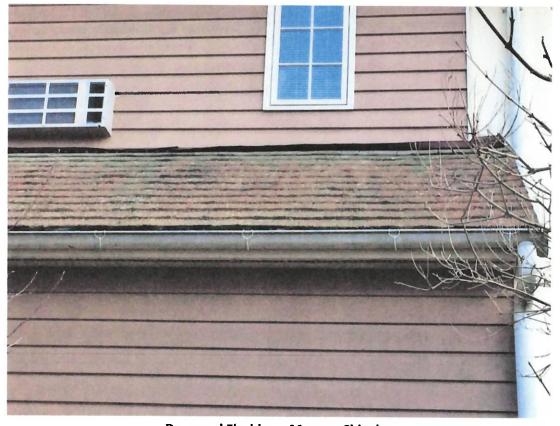
Damaged Flashing - Moss on Shingles

The existing plywood substrate, will remain. Synthetic underlayment will be installed over plywood. Selfadhered membrane flashing will be applied at valleys, eaves, ridges, etc.

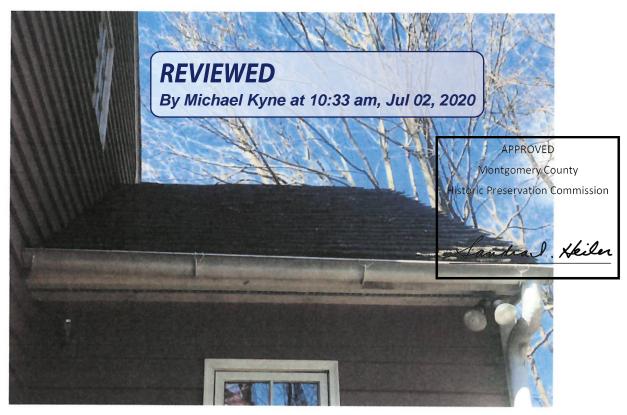
Damaged Shingles - Damaged Gutter 1

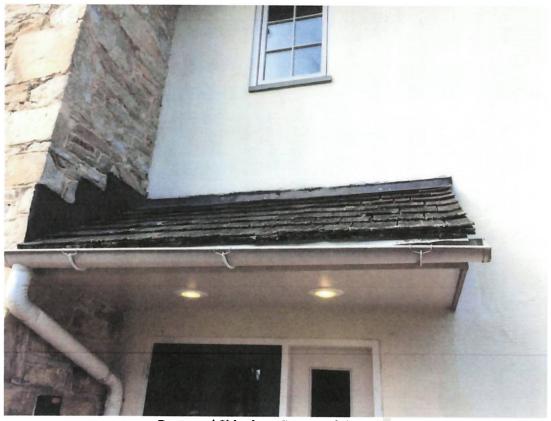
Damaged Shingles - Damaged Gutter 2
