SUBJECT: Historic Area Work Permit #920991: Demolition of accessory buildings

Scope of Work Application to demolish two non-contributing accessory structures.

ASBESTOS, LEAD PAINT AND RADON REPORT

FOR
21414 GEORGIA AVENUE
Brooksville, MD 20833

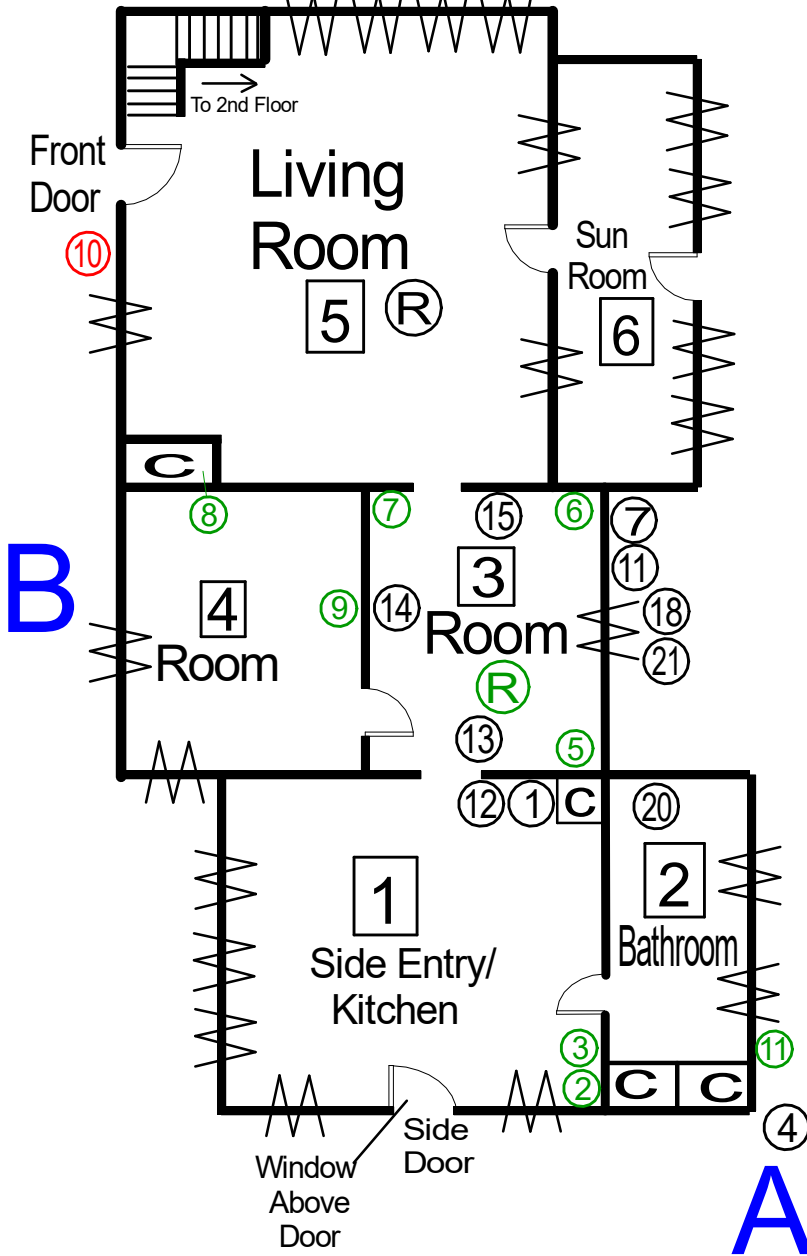
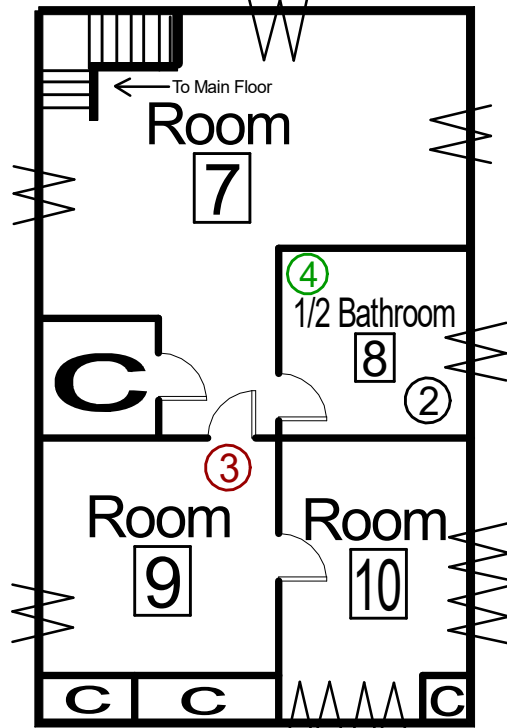
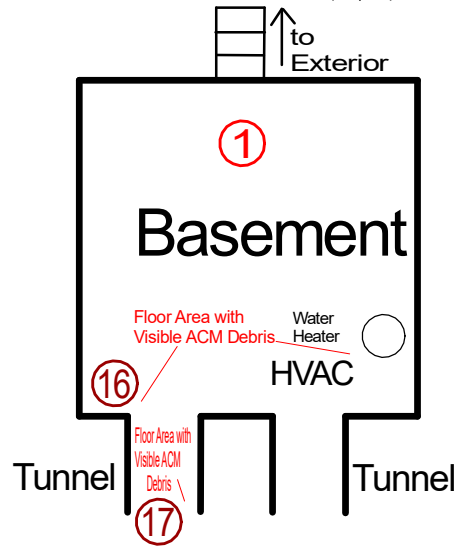
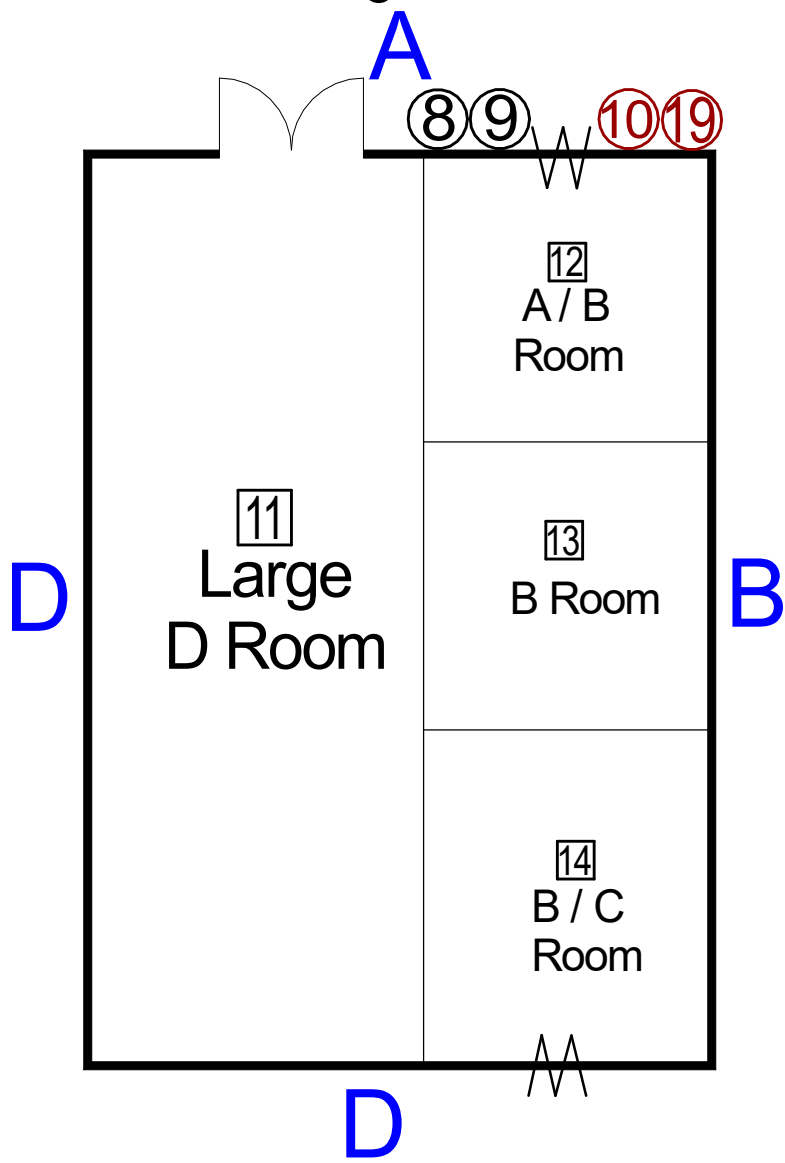
Both sets of laboratory data are included in Appendix A. A Figure with the House and 3 Sheds is included in Appendix B with the asbestos sample locations is provided in Appendix B.

The Ceramic Tile Mastic was found to contain 15% Chrysotile Asbestos. This material was found to be present in the ½ Bathroom (ALWE Room 8) throughout each of the lower walls (75 square feet), and at Walls C and D of ALWE Room 9 (25 square feet) for a total of 100 square feet present. This material was described by the laboratory as having a tan/cream/olive appearance. This material was not sampled in the original survey because the condition of this material had deteriorated, allowing the mastic to be visible. Please note that a similar material located at the Bathroom (ALWE 2) of Yellow Mastic Dots, located behind ceramic-designed metal outer walls had tested negative by laboratory analysis.

The **Gray Wall Vapor Barrier (2nd Layer)** was found to contain **30-50% Chrysotile Asbestos**. This material is only **present along each wall of the Large Shed**. The outer (1st layer) material is described as exterior brick pattern siding shingle, and tested negative by laboratory analysis. ALWE initially sampled this material on May 12, 2014, and also took a confirmatory sample of this material on June 18, 2014, and both samples tested positive by laboratory analysis. Also on June 18, 2014, ALWE quantified this material and found that approximately **1,700 square feet was present**. Please note that the samples were taken from exposed areas along Wall A of the Large Shed, and the material was observed to be in poor condition.

The **Loose Pipe Insulation** was found to contain **40-50% Chrysotile Asbestos**. This material was observed present in the Basement of the House unattached to the piping and in poor condition in 2009. In 2014, ALWE collected two more samples. Each of the three samples collected tested positive by laboratory analysis. This material was observed present exposed beneath soil at the A/B tunnel, A/B corner of the room, and D/A corner of the room. There was approximately 20 square feet of this material observed on this date. Due to poor condition of the Basement and soil being present, more of this asbestos-containing material might be present. Additionally, this asbestos-containing pipe insulation may be hidden within the walls. ALWE advises not entering this Basement without proper protective equipment including full body disposable suits and appropriate respirators.

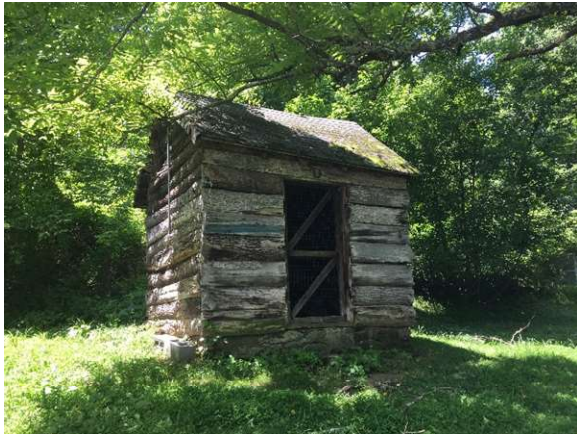
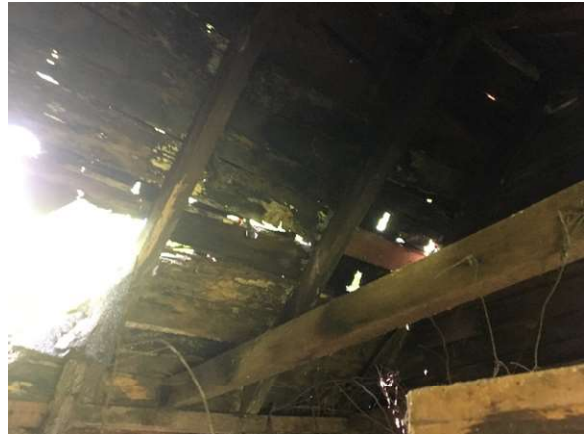
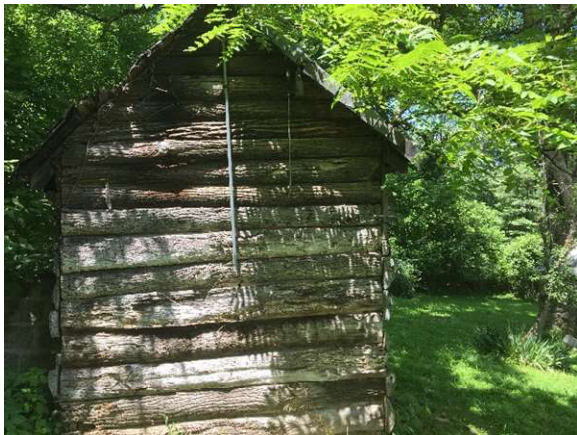
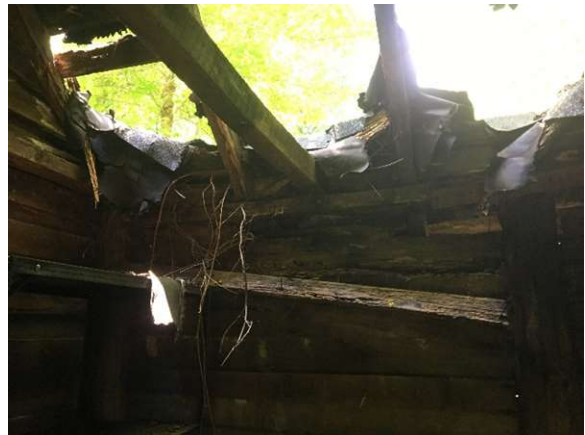
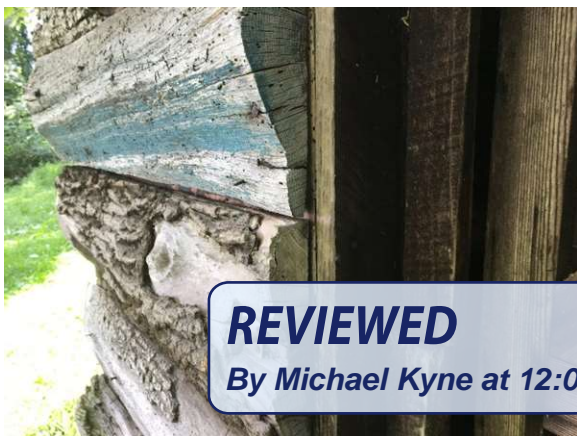
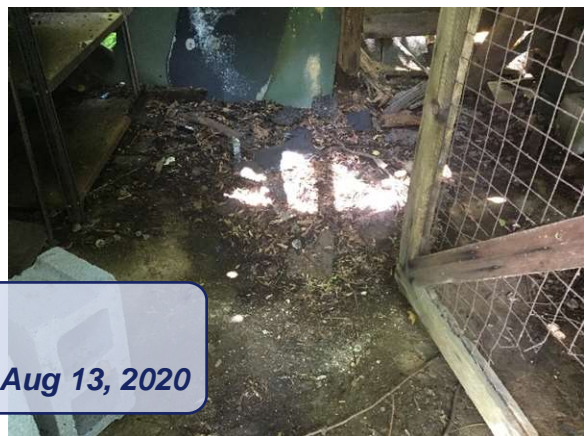
Photos: Shed

Non-contributing shed sits southwest of the dwelling; barn sits to the west, well-removed and buffered from the main dwelling
