7213 Cedar Avenus, Takoma Park THPC Case # 37/03-11 R] Takoma Park Histori Sistrict

Historic Area Work Permit #565295 & 581291, garage demolition and new garage construction

MONTGOMERY COUNTY HISTORIC PRESERVATION COMMISSION STAFF REPORT

Garage demolition and new garage construction

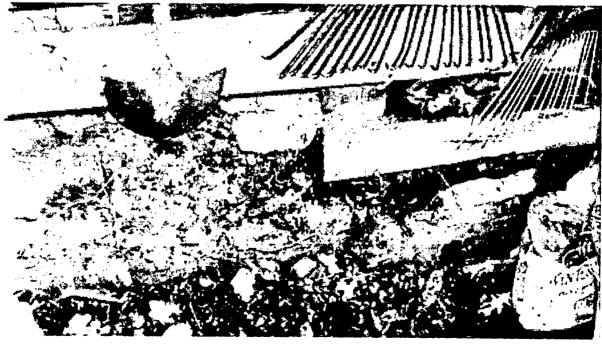
- 1. The cement foundation on the right side is crumbling and fractured (photos-3, bottom).
- 2. Original framing is water and termite damaged, particularly on the right side (left side is in better condition). Window frame (on right) is eaten away and racked (photos-3, photos-4).
- 3. Roof is caved in at its center so that water pools and slowly leaks through ceiling and onto building floor (photos-2 bottom). Roof rafters are broken and eaves are rotted (photos-2, top). The plywood ceiling is severely water damaged and moldy (photos-4, top left).
- 4. Despite an attempt to shore-up the structure by adding interior framing, the entire structure leans to the right and to the rear (photos 5, top left; photo-1, bottom).

foundation, right side

2. repair the foundation (or replace it if it is too damaged)

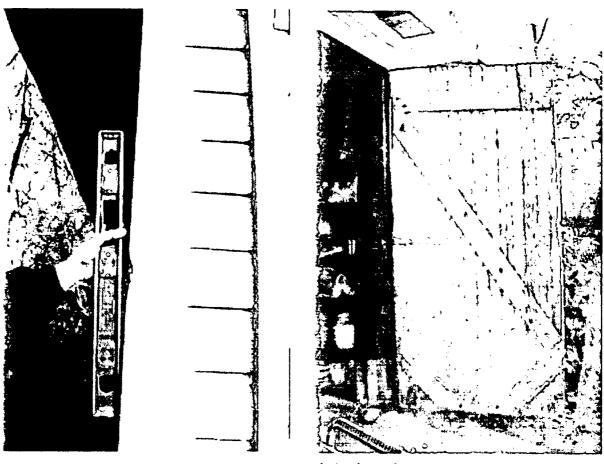
level held vertically, left side
