SUBJECT: Historic Area Work Permit # 1113502 - Roof replacement

Applicant: Elizabeth Baer
Address: 7200 Maple Avenue, Takoma Park, MD

Work Item 1: Roof replacement

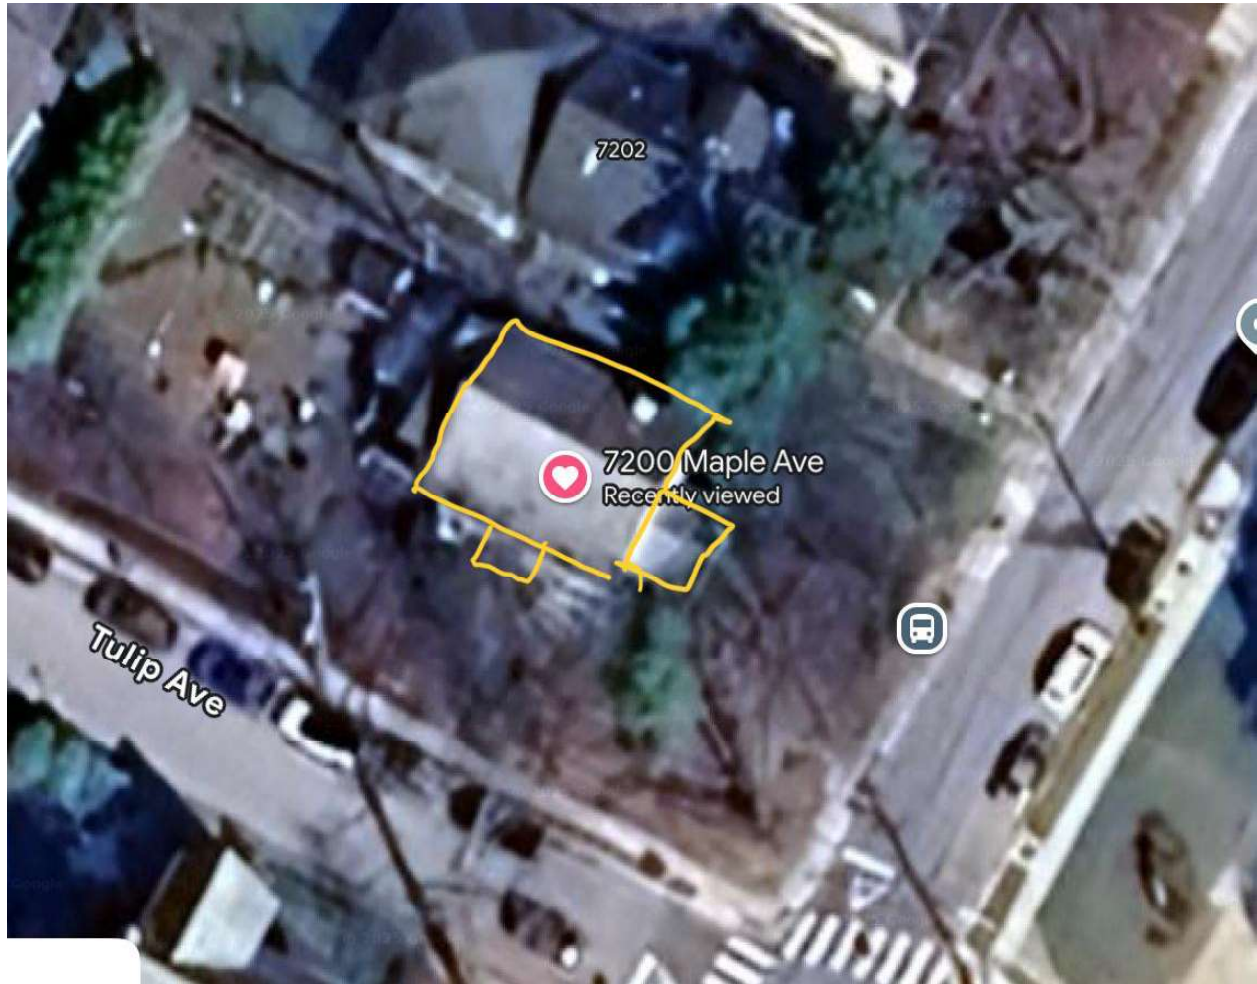
Portion of roof that was replaced

We repaired several portions of the roof of the primary house and ultimately replaced the entire roof in-kind, including roofing over the front sun porch (facing Maple Ave.) as well as the small roof over the entrance (facing Tulip Ave.). We initially planned to repair problematic areas, but in the course of repair, determined the roof should be replaced in-kind, but that is not part of the project.

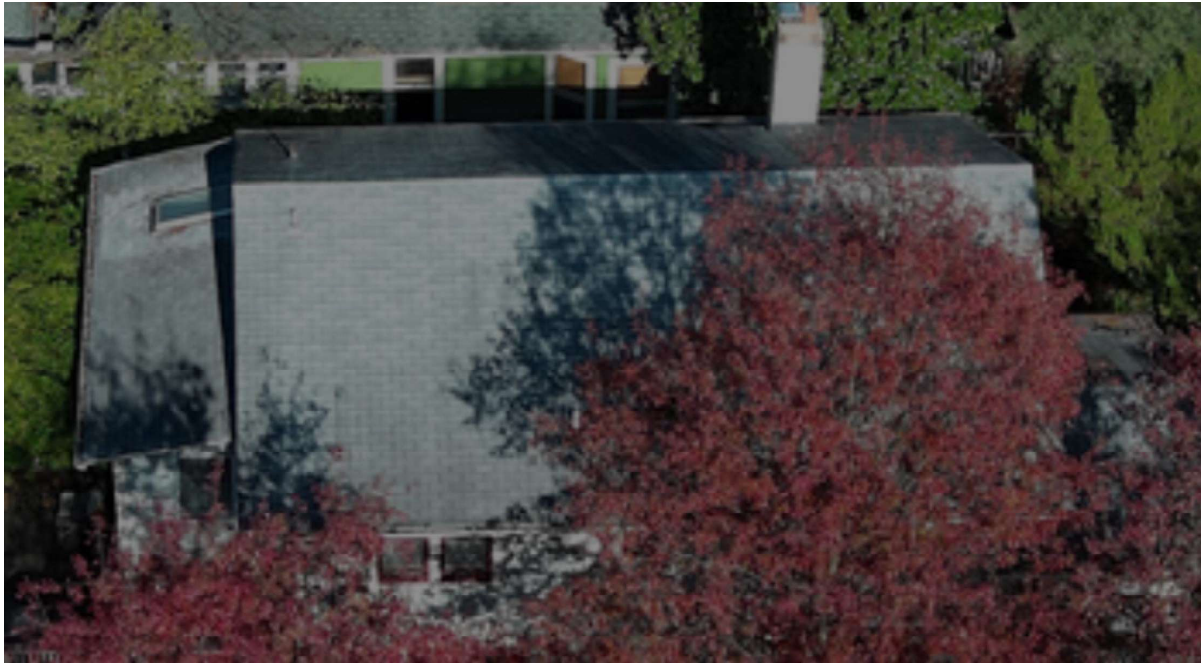
Google Earth image of roof before work was completed

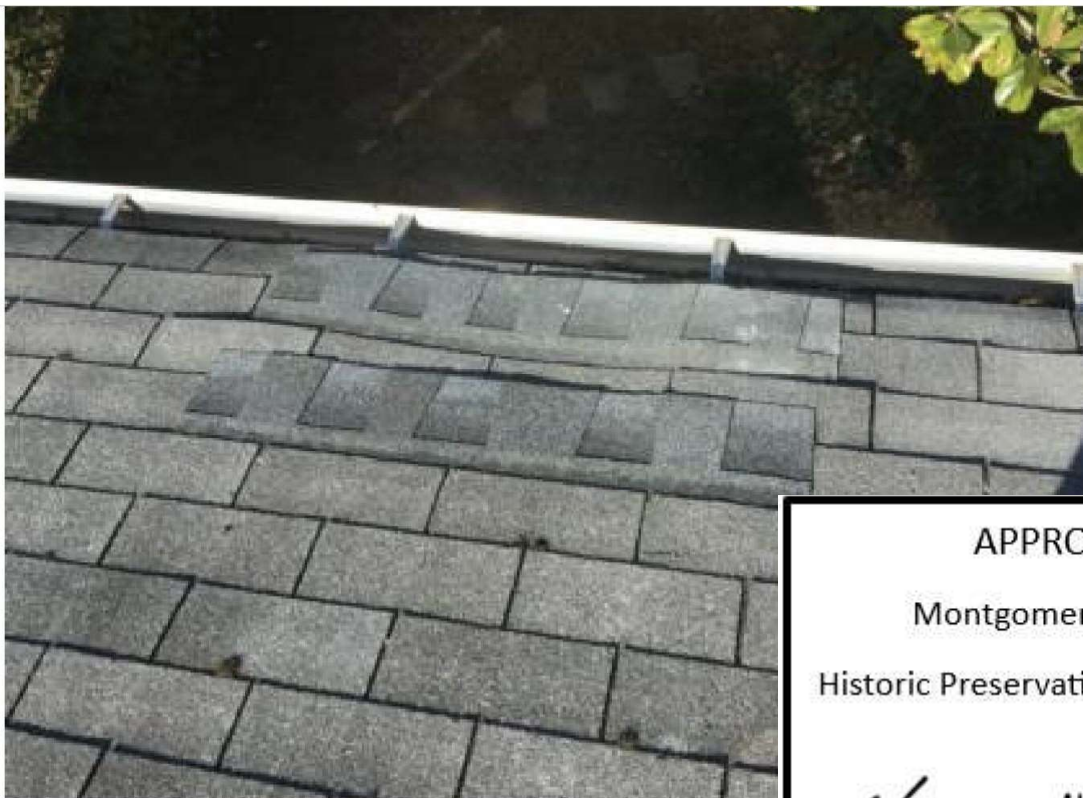
Sub-standard repairs made to old roof where leaking had occurred (atop old shingles)

We replaced areas where rotting wood was observed, repaired chimney flashing, and replaced all shingle with architectural asphalt shingle.

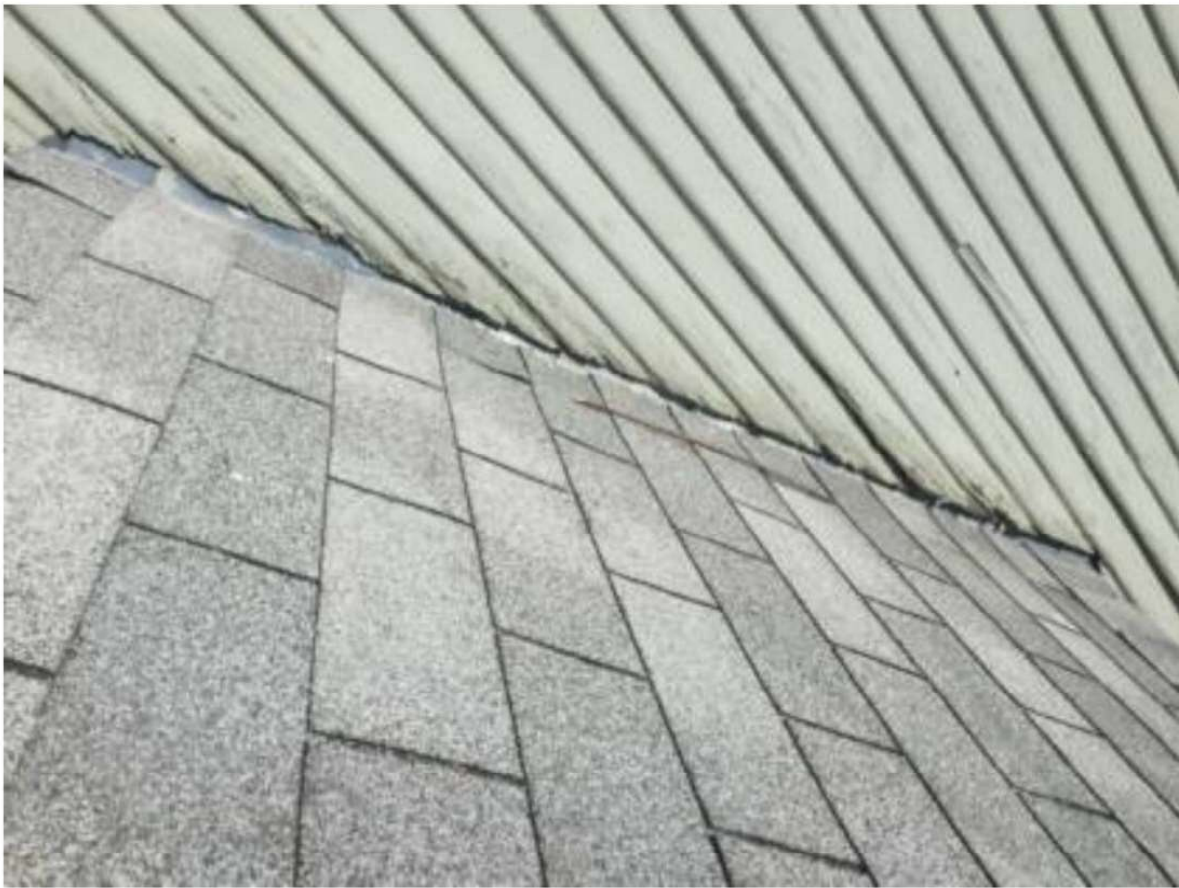
Shingles and failing flashing at Maple Ave. end of sun porch roof

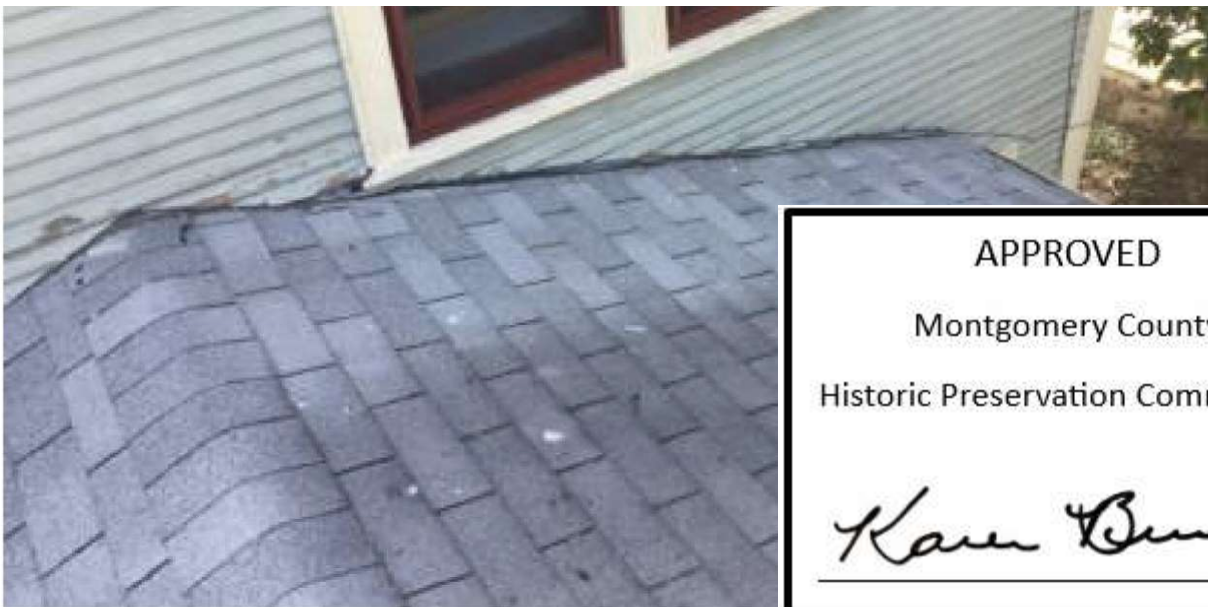
Shingles and failing flashing at Maple Ave. end of sun porch

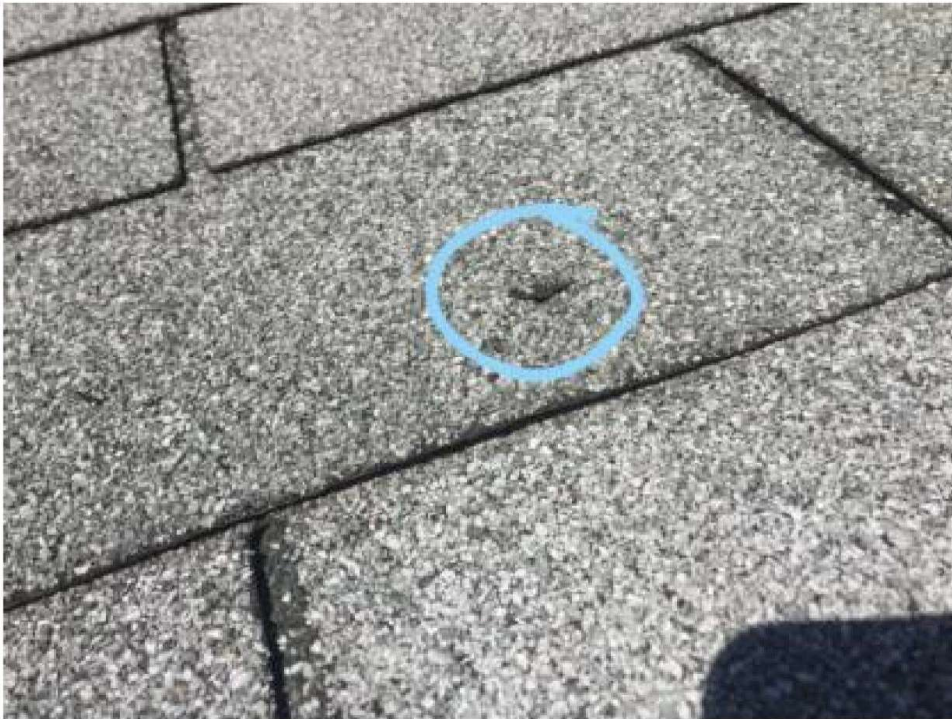
One of several "nail pops" observed

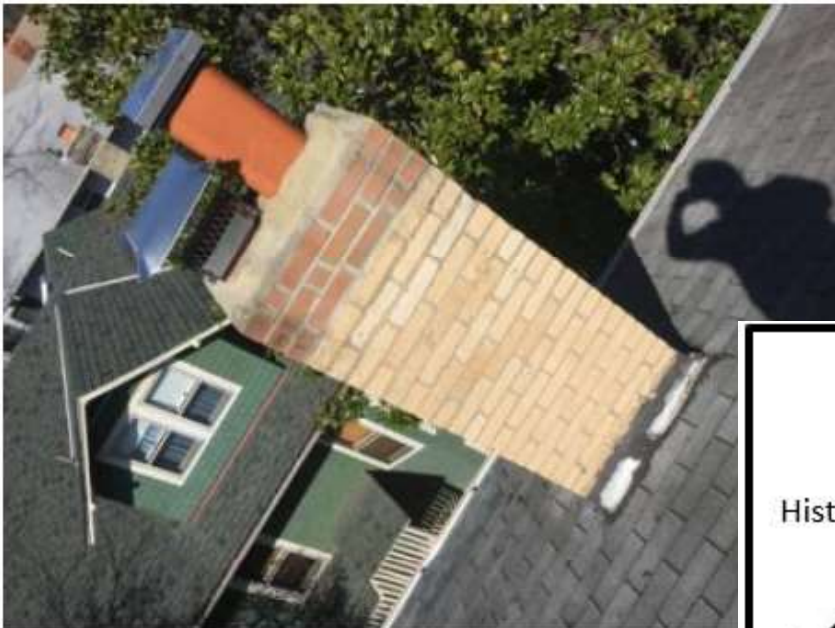
Poorly installed flashing at chimney

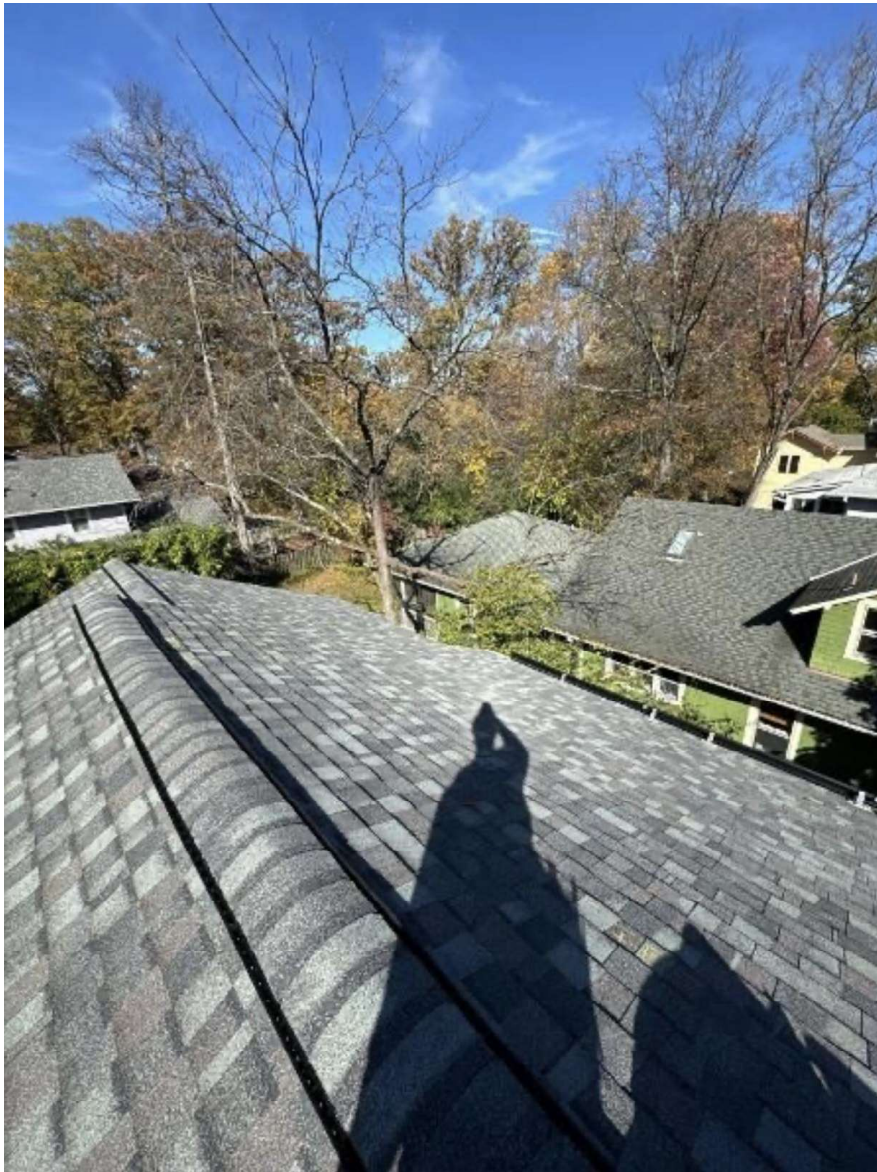
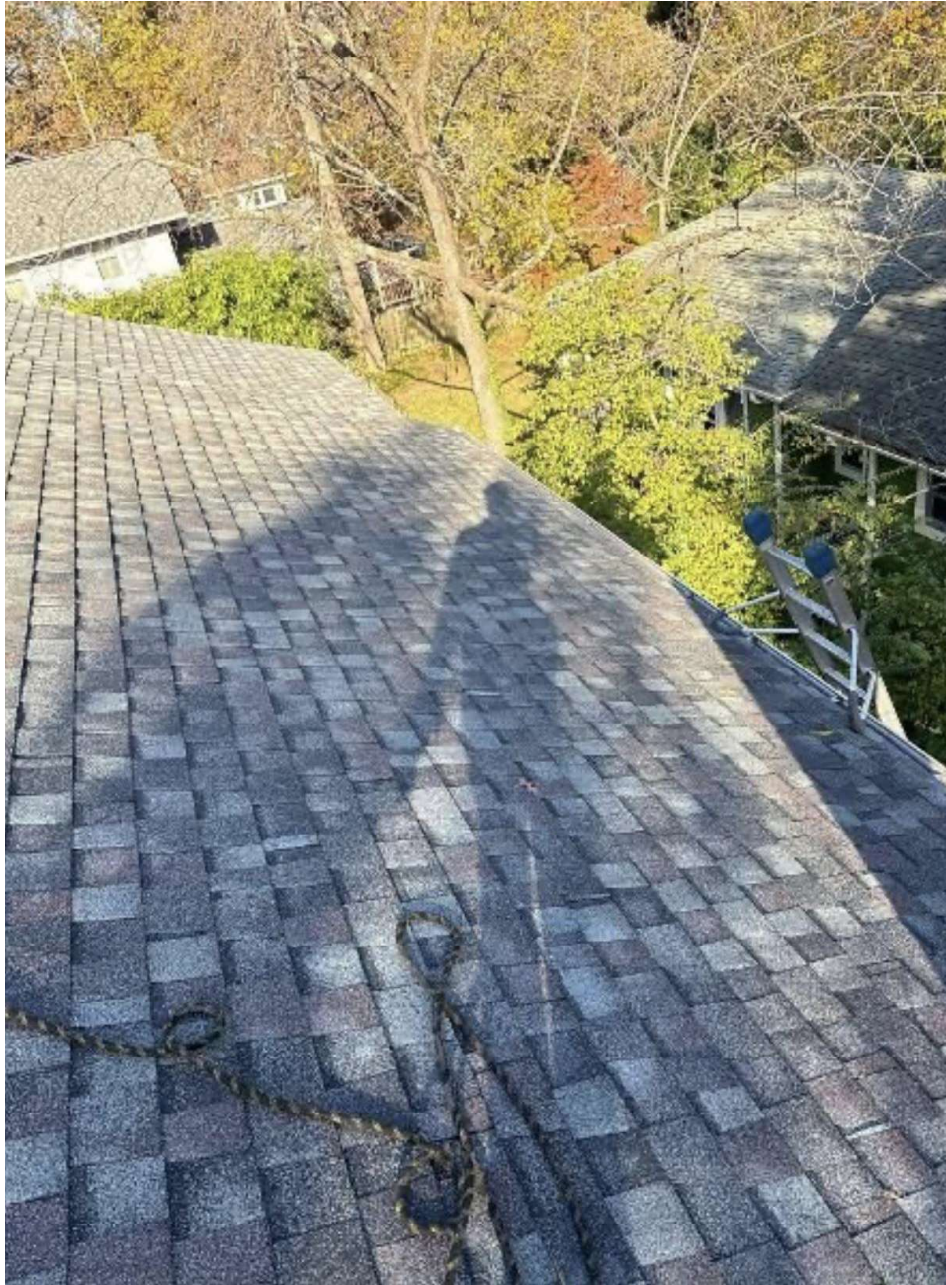
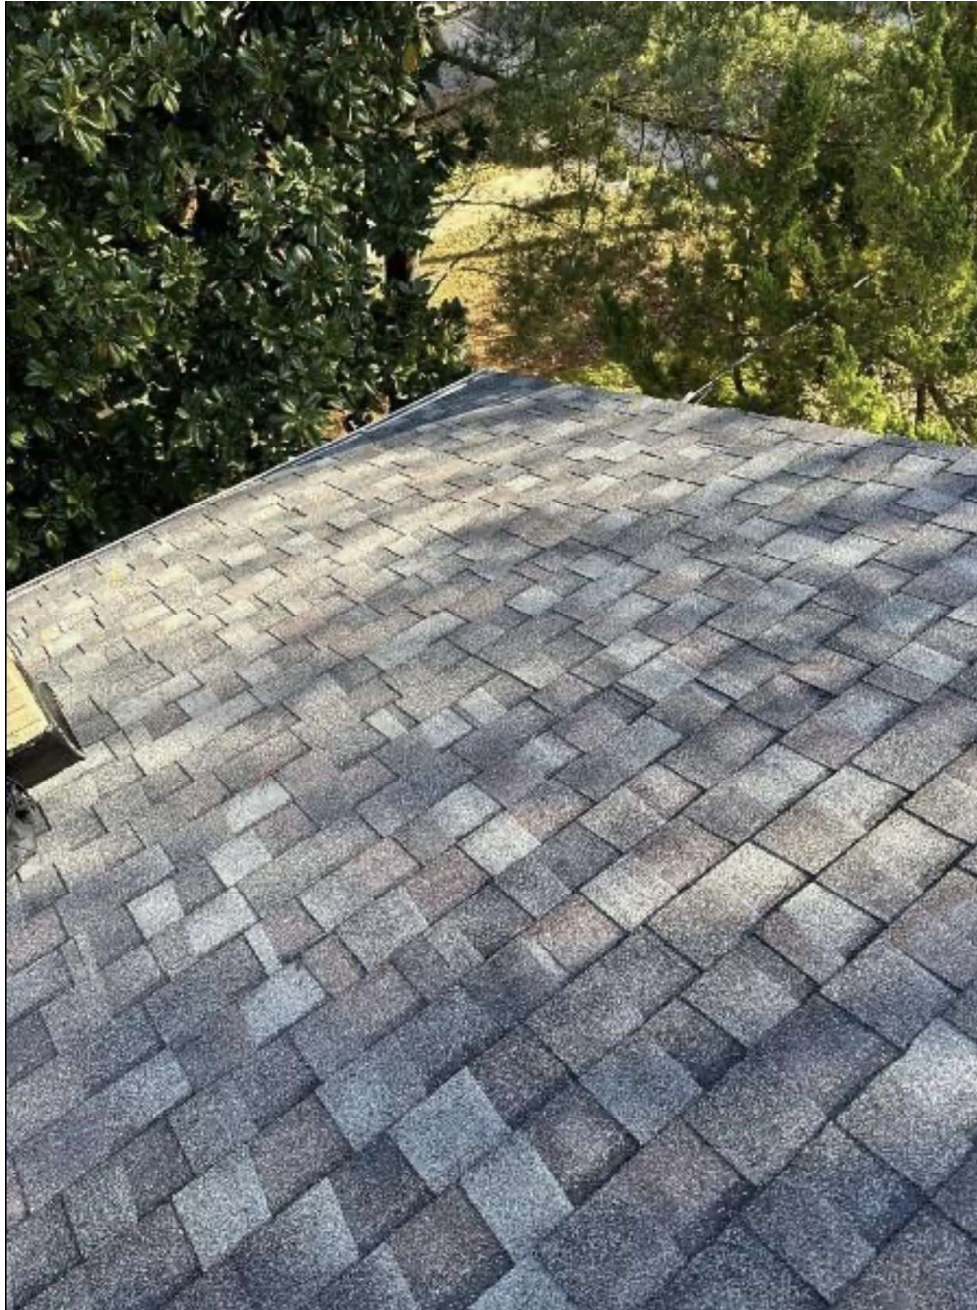
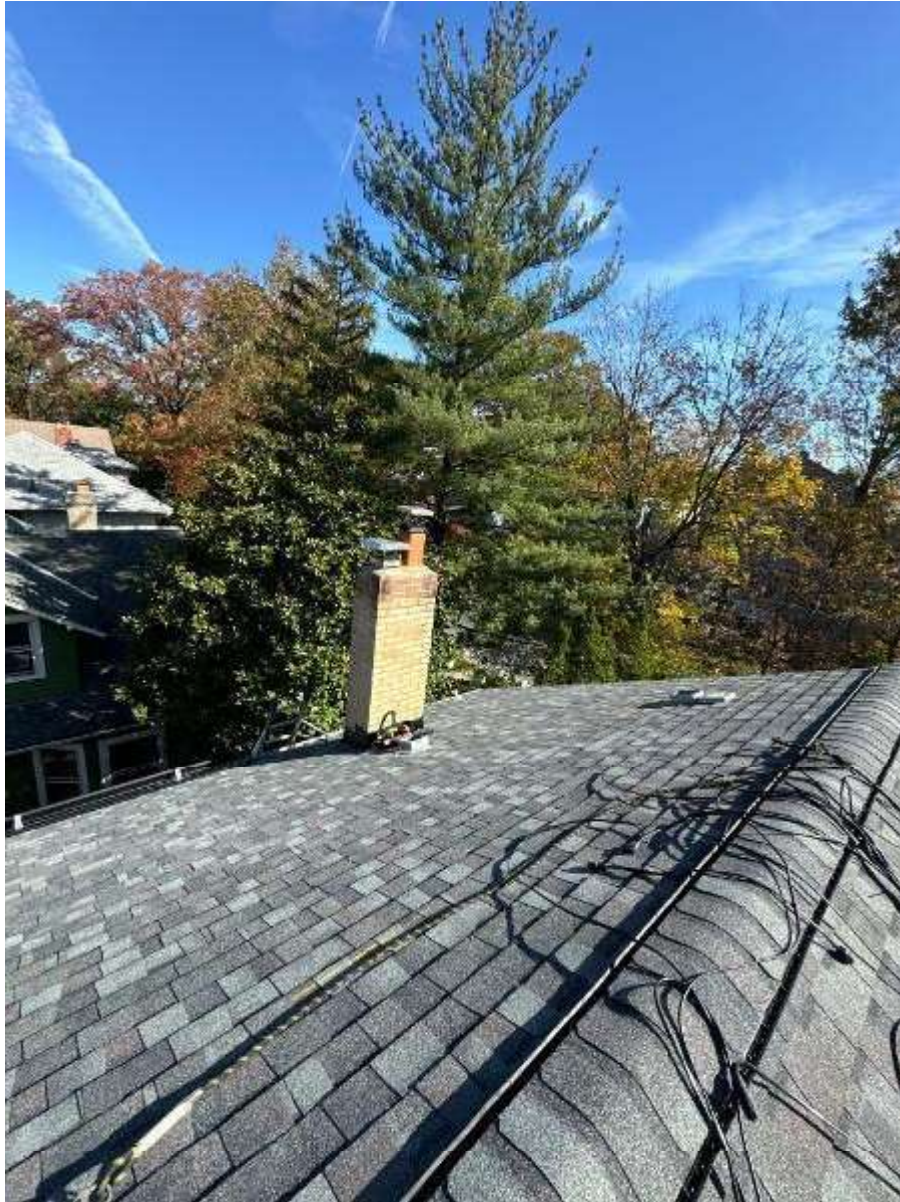
All photos show finished roof condition before installation of solar arrays

We replaced the roof in-kind with asphalt shingle.
