## HISTORIC PRESERVATION COMMISSION

## NARRATIVE FOR HISTORIC TAX CREDIT REPLACING ROOF

The four-square, three-story house with front porch at 7218 Maple Avenue, Takoma Park, MD 20912 was built in 1909. The fenced lot includes a small front yard, ample back yard and an adjacent gravel driveway.

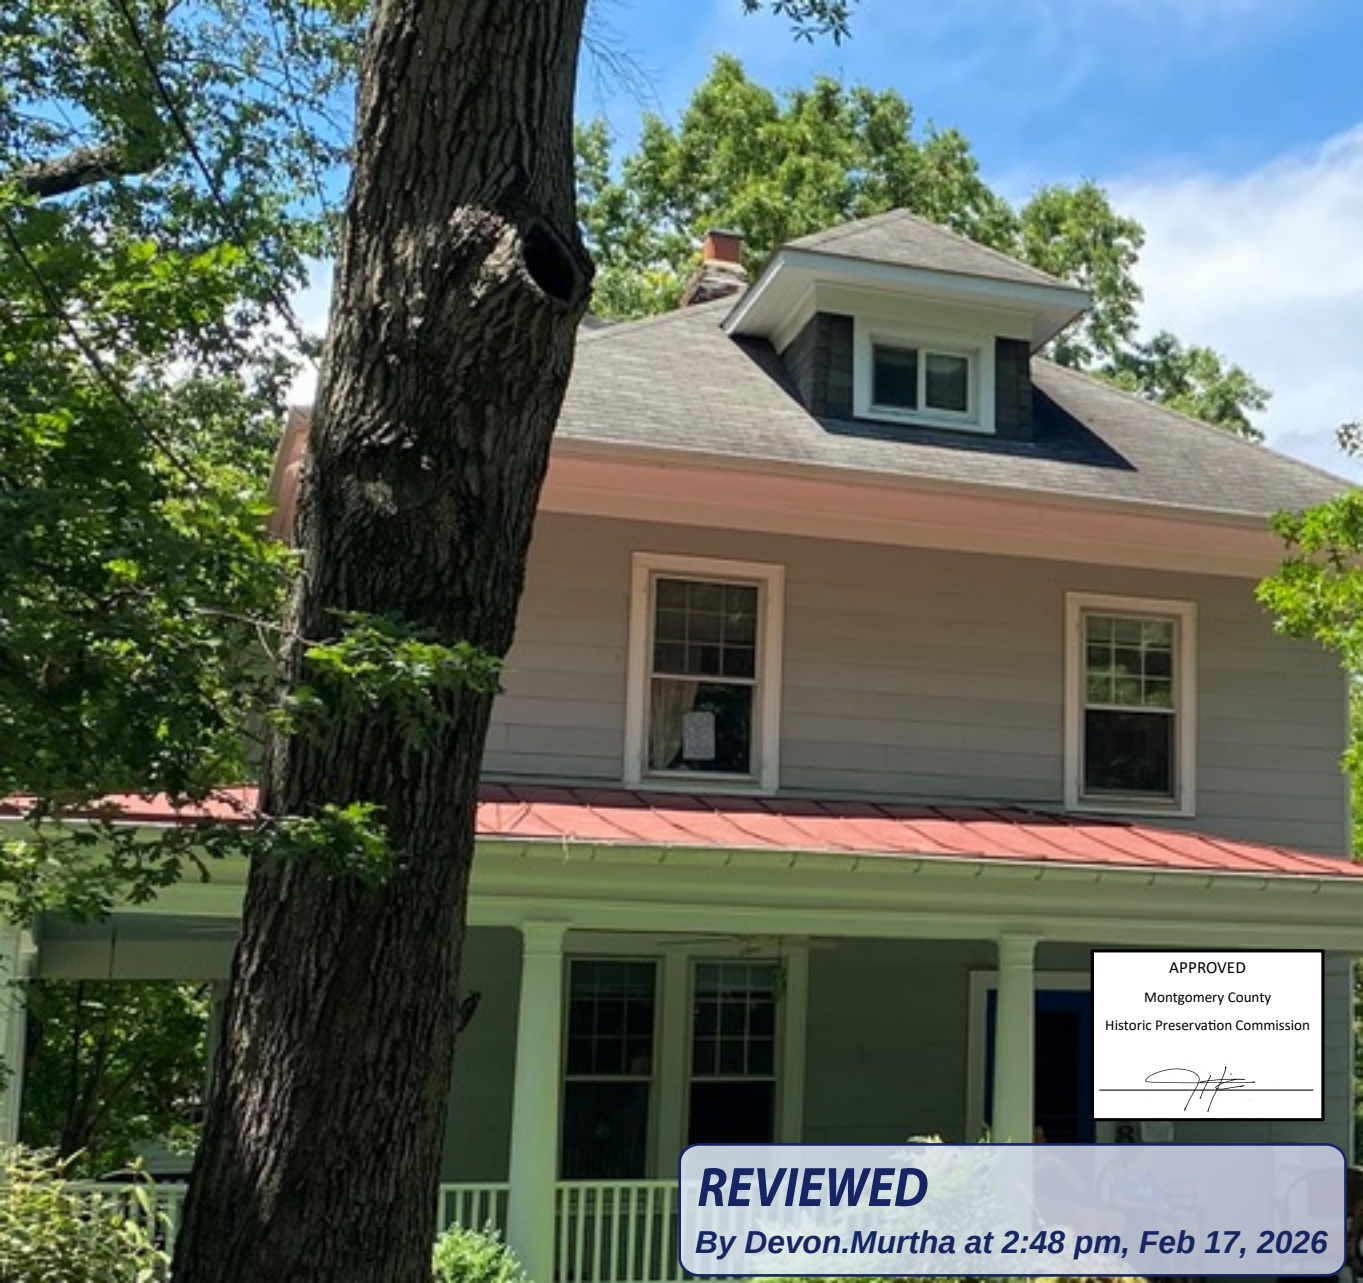
We purchased the house in 2008. By 2024, Our roof shingles were starting to fall apart in multiple areas, and rainwater was leaking into our attic. As a result, we had the entire top story roof replaced, along with a small copper section in the back of the house which was also leaking into our bedroom and damaging historic window frames.
