37/03-03AAA 58 Walnut Avenue
Takoma Park Historic District

SUBJECT: Historic Area Work Permit # 324581

HISTORIC PRESERVATION COMMISSION STAFF REPORT

PROPOSAL: Remove door/replace with window; replace asphalt wall shingling; repair roof.

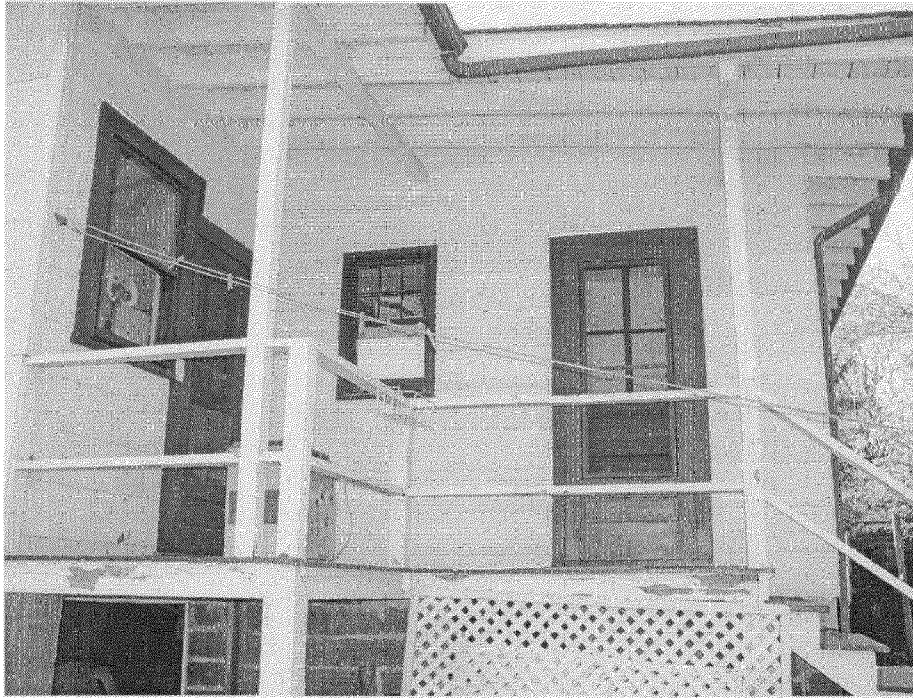
View of door to be removed from non-original, mid-20th-century addition, east elevation.

1. Remove a door from the last addition made at the rear to the house (considered a non-contributing addition in the case of this resource) and change the opening to a 20”-wide, 1/1 wood window. The existing adjacent window is currently 6/1, but the proposed drawings show it as a 1/1 window. (The majority of the house’s

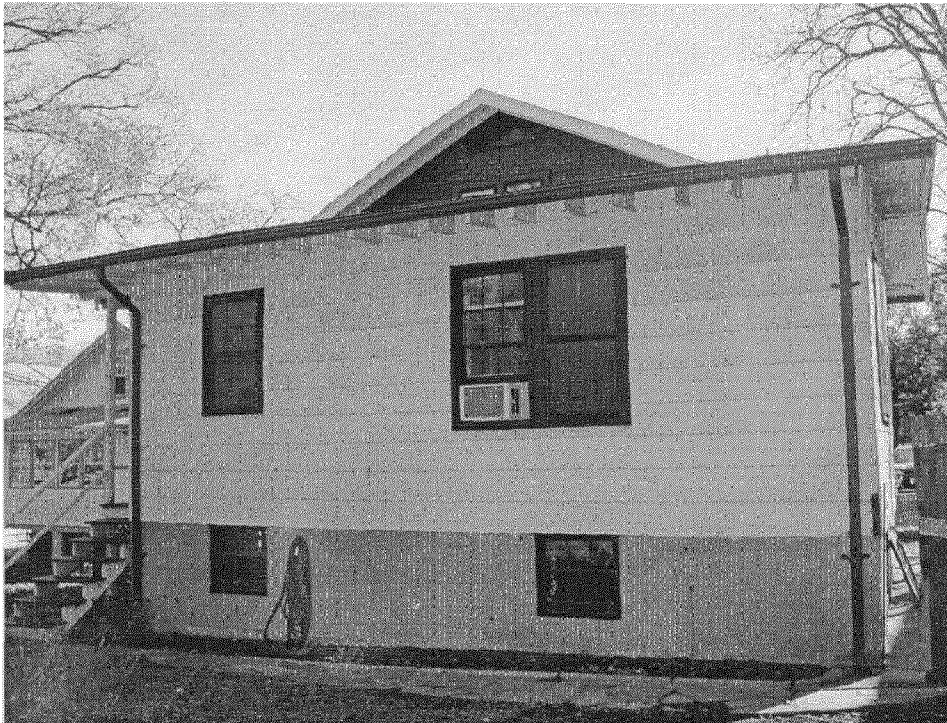
View of rear elevation of non-original elevation where hotel air unit will be placed between windows.

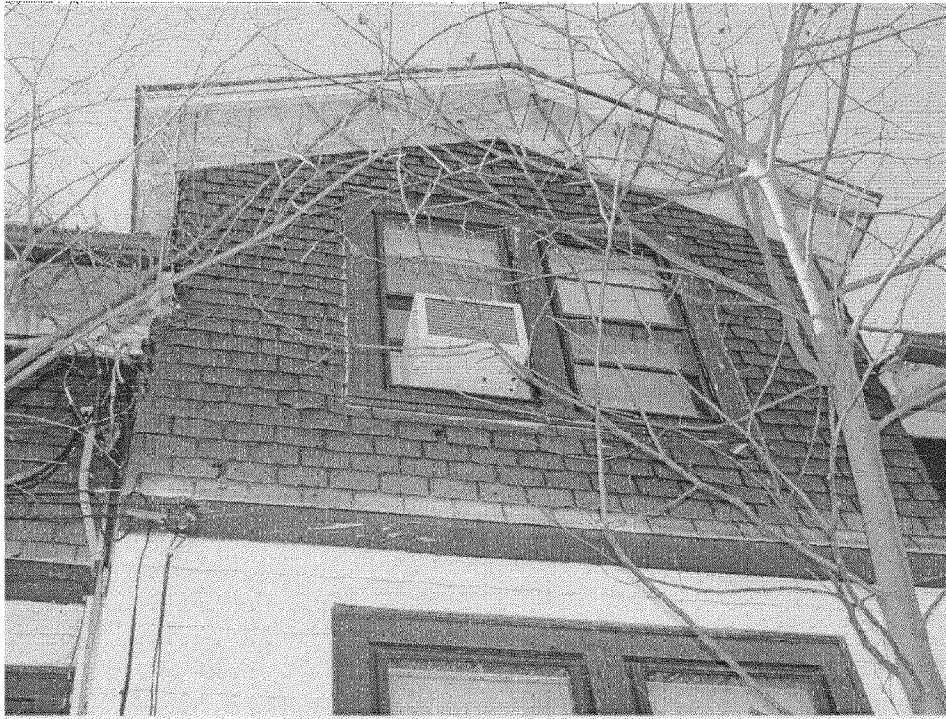
In a review of various books and reprints on Sears houses, staff found that any wall area typically above a gable return was considered part of the roof and was clad as a roof would have been clad. In the case of 58 Walnut, it appears that everything above the fascia board was clad as though it were a downward extension of the roof. Kit houses from the 1920s typically featured one of three roof/upper wall materials, depending on the owner's budget: 1) wood shakes, 2) "Oriental asphalt shingles," and 3) "Oriental slate-covered asphalt shingles," with black, dark green, or red slate being early surfacing ingredients. The term "oriental" in this context undoubtedly has more to do with advertising the material as "exotic," rather than the actual importation of the bituminous product from the East.

Asphalt shingling on upper wall surface

2. Add a ridge vent to the roof and holes at the underside of the soffit for better ventilation and replace gutters and downspouts where necessary with like, aluminum materials.
3. Replace the second-story, asphalt-shingle (conventional rectangular shape) wall material with a similar asphalt-shingle product.
4. Add central air to part of the house with exchanges located in the back or side yard. Add a "hotel-motel" air-conditioning unit to the rear wall of the mid-20th-century addition (granny suite) in between the two first-floor windows. The unit is approximately 3 ½' x 20" tall.

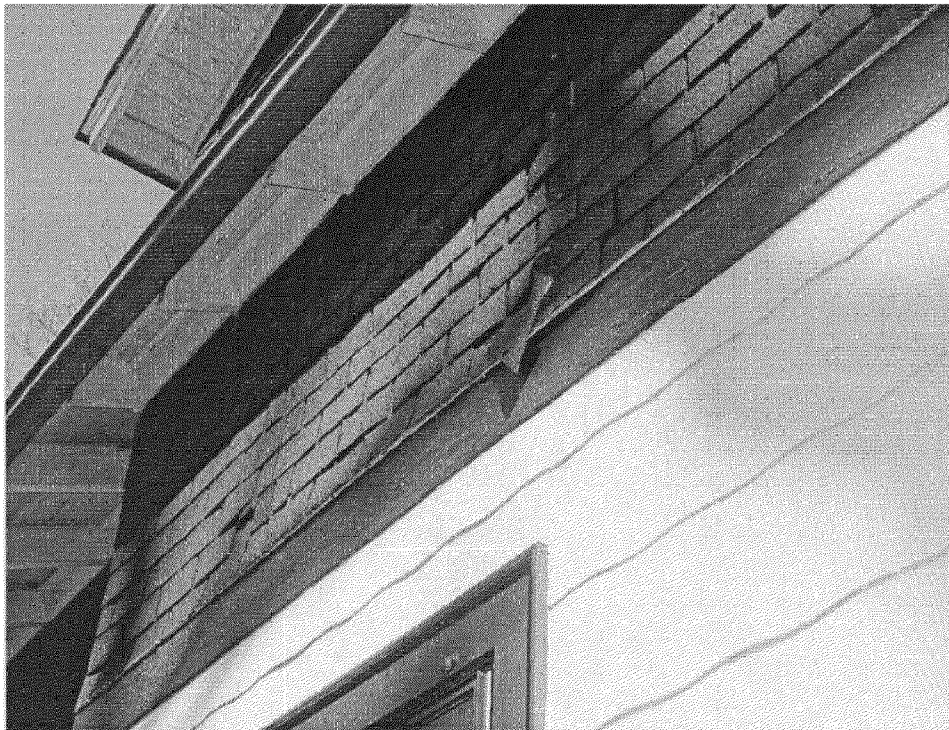
Asphalt shingling on upper wall showing damaged shingle, with asbestos siding below

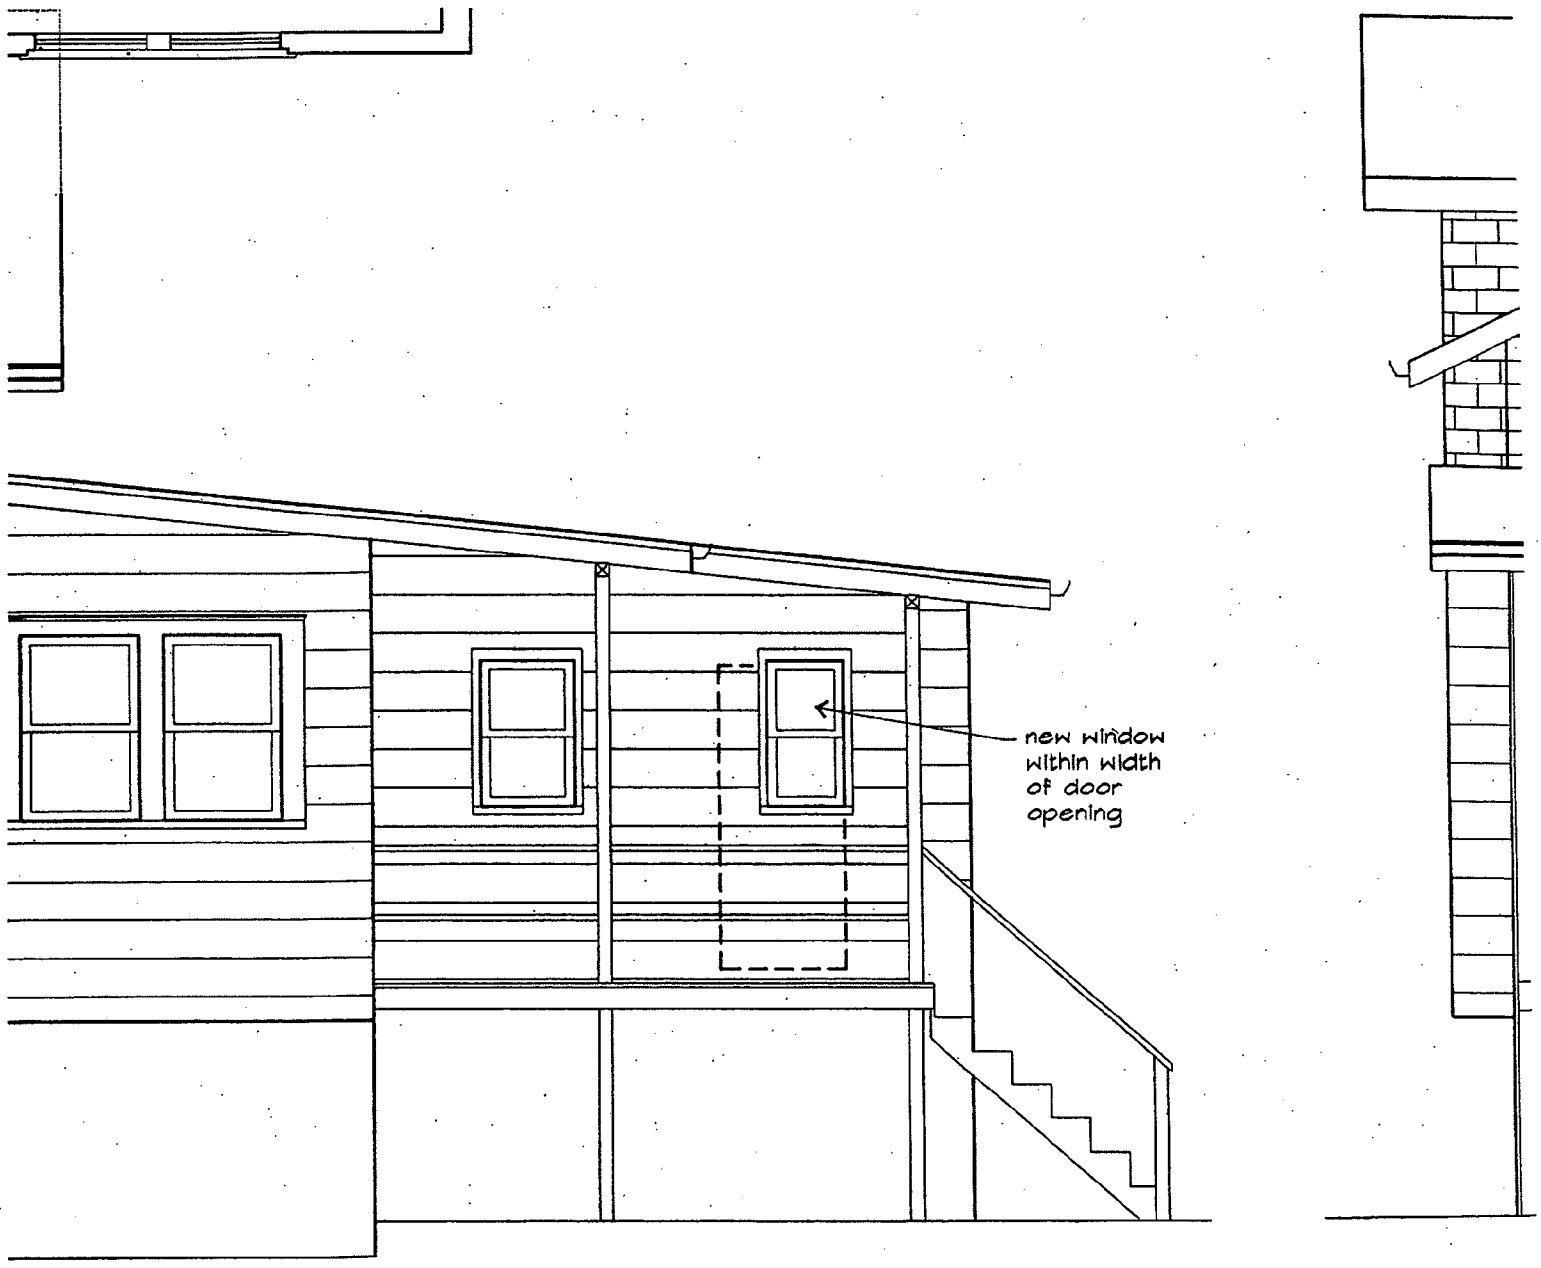
new window
within width
of door
opening

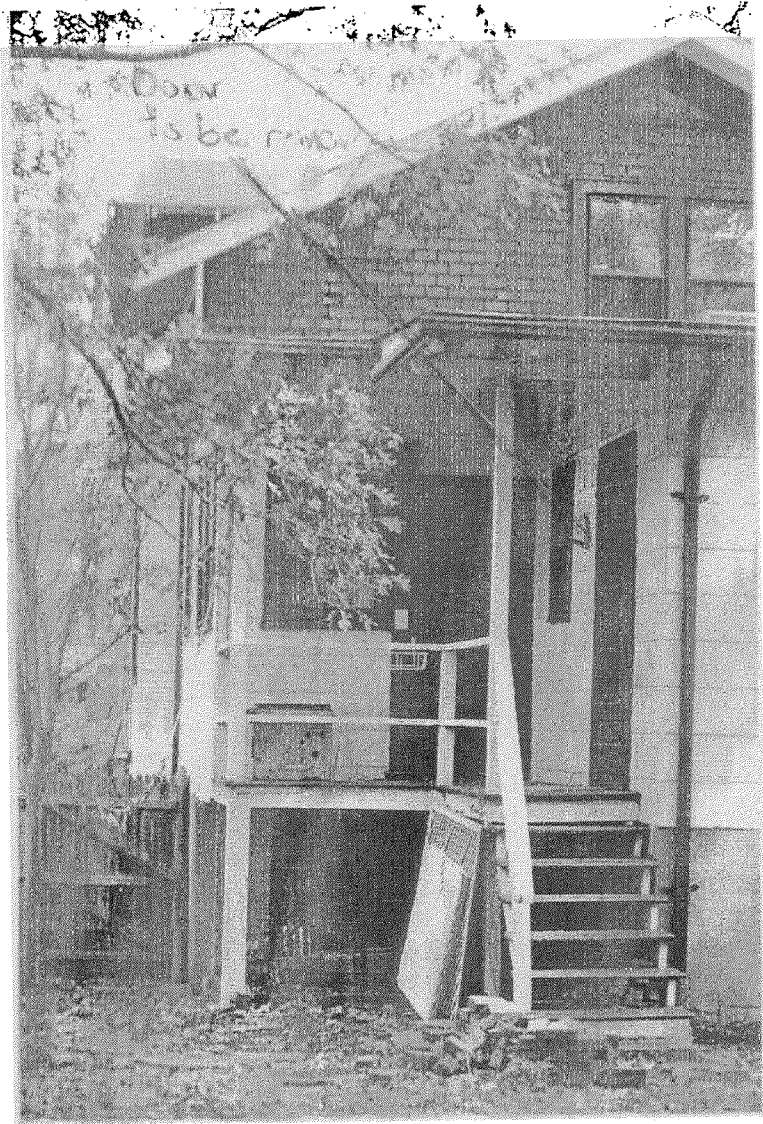
Last addition
Door to be
Removed

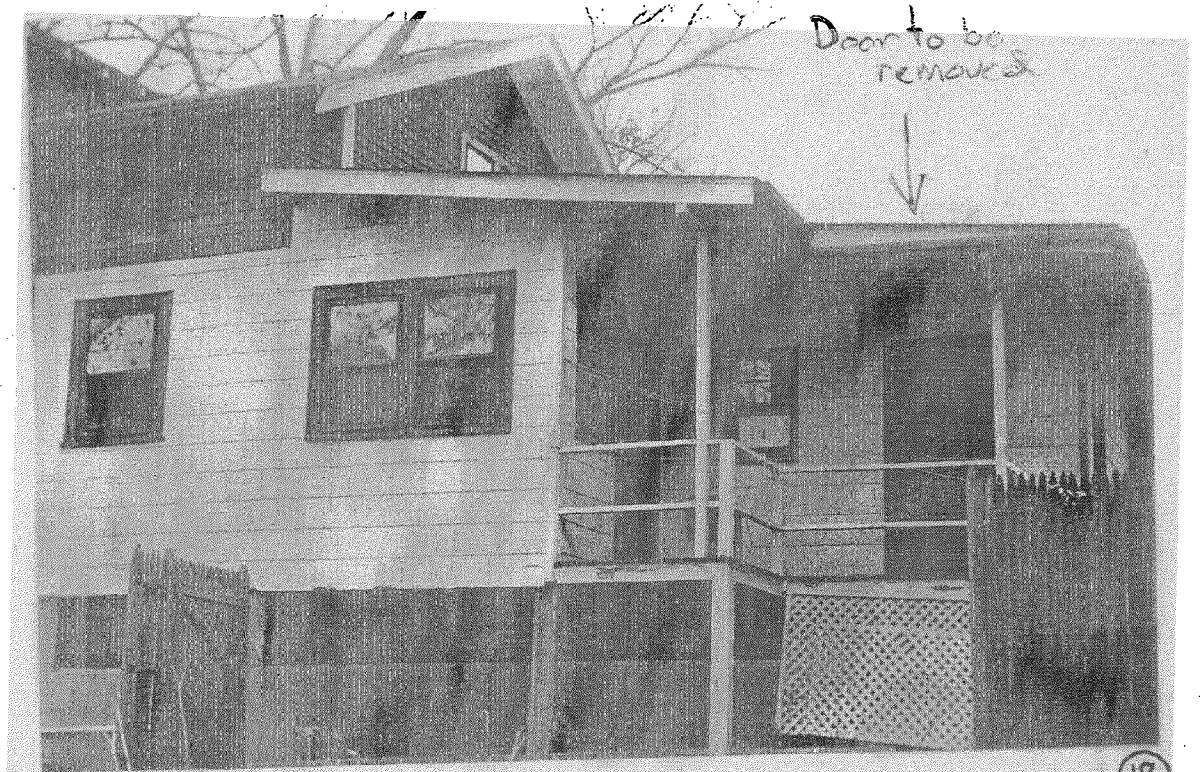
Condition of 2nd floor
shingles

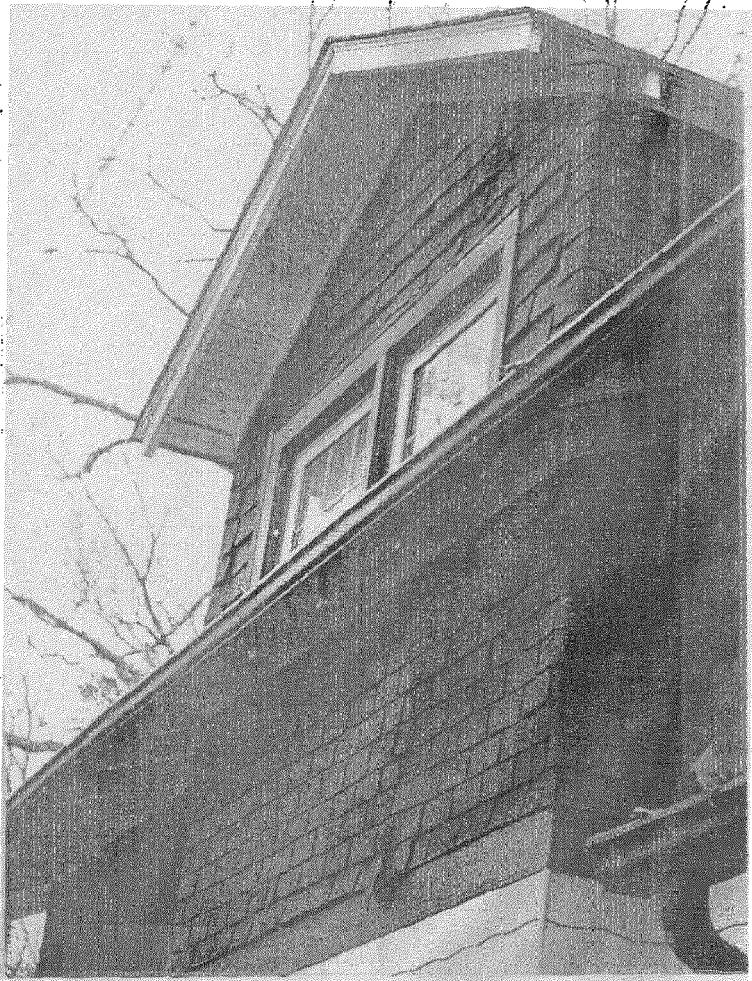
Condition of
shingles and
gutters

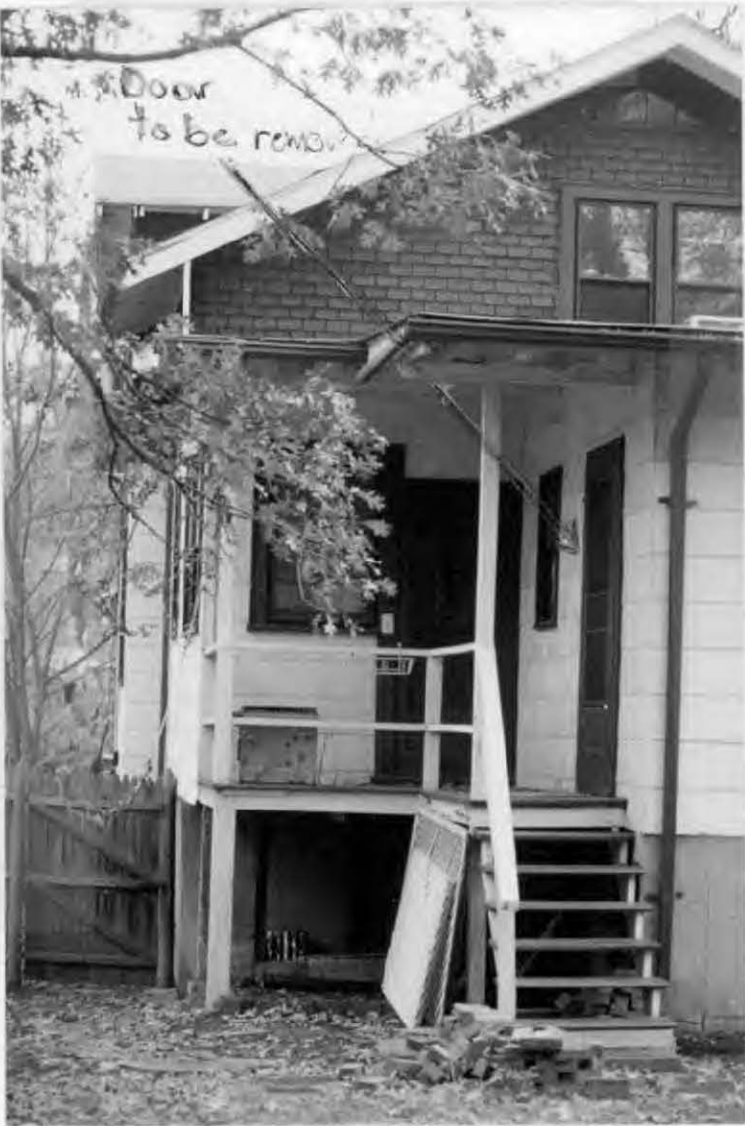
Last addition
Door to be
Removed

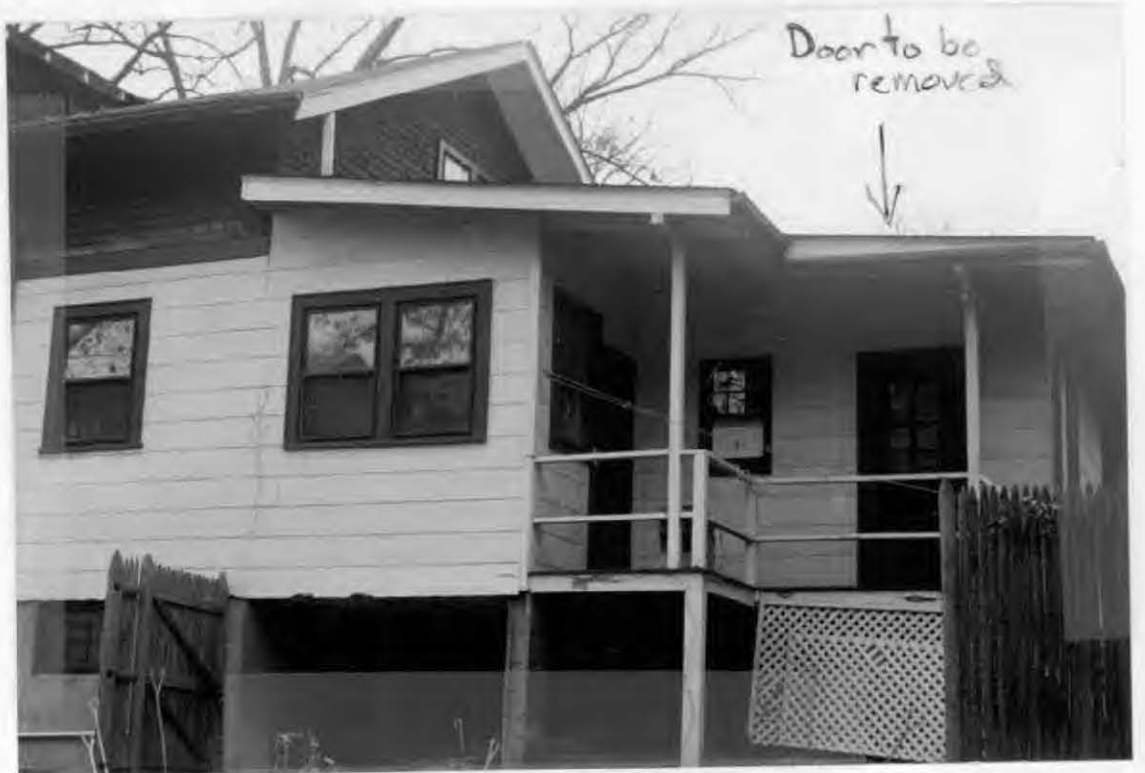
Condition of 2nd floor
shingles.

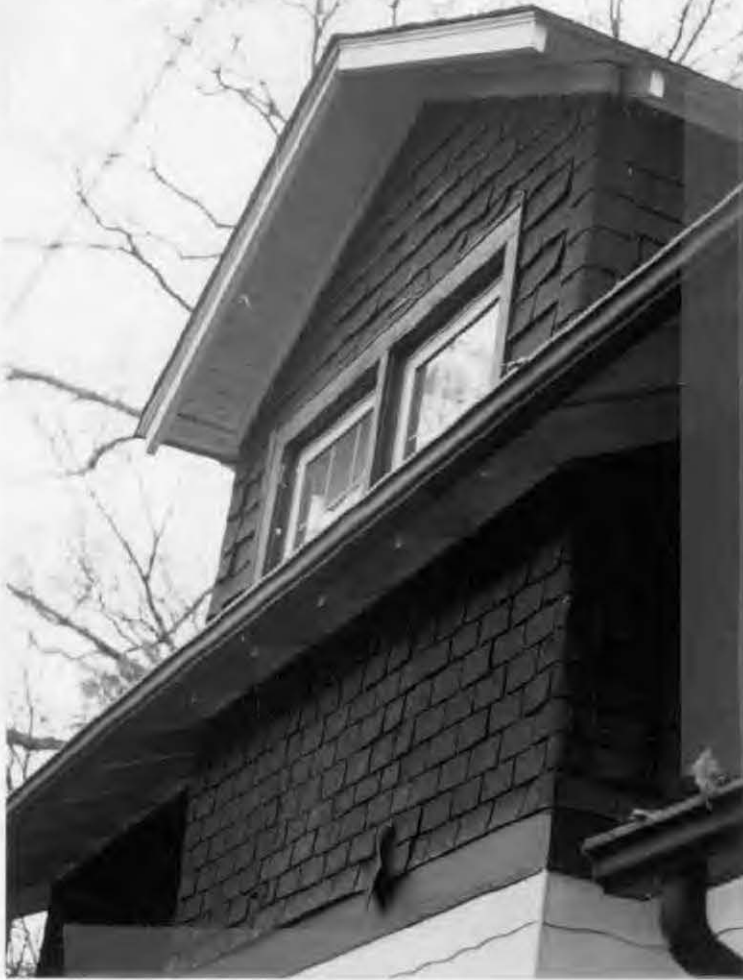
Condition of
shingles and
gutters

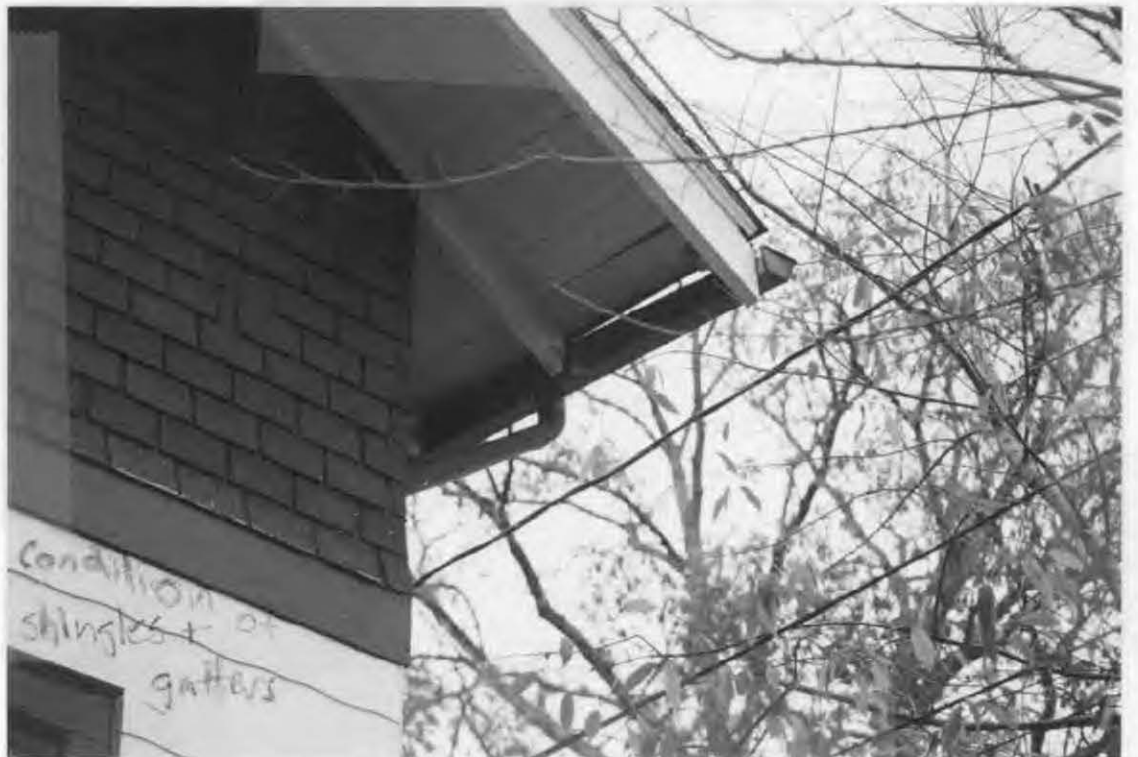
Condition of
shingles +
gutters

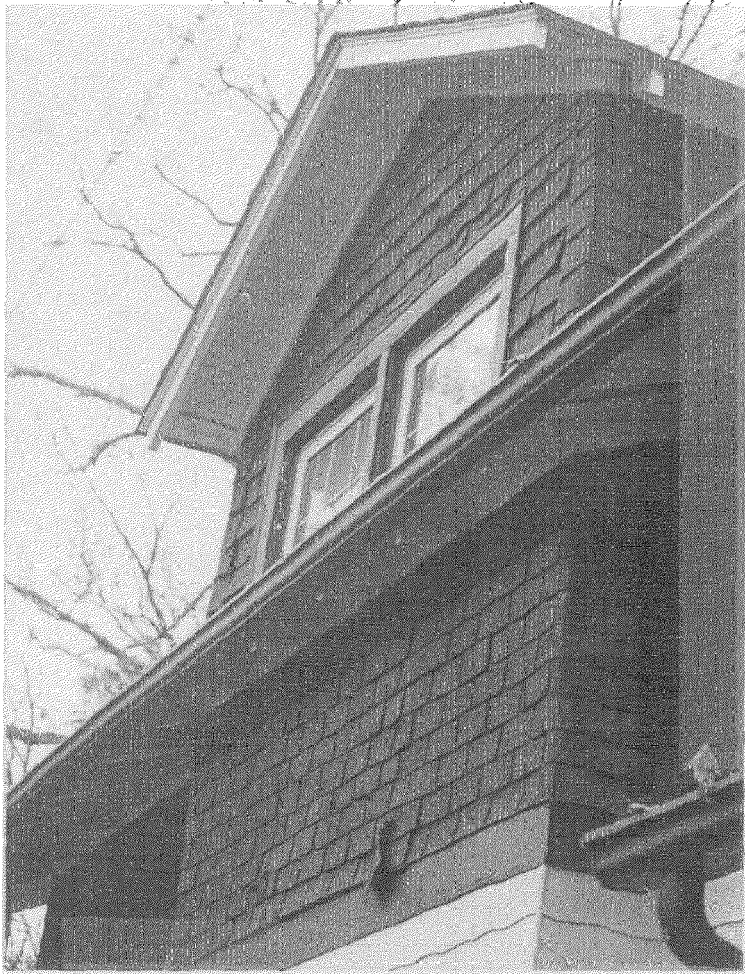
Condition of
shingles and
gutters
