37/3-96WW 7112 Sycamore Avenue
(Takoma Park Historic District)

Sumner Patch
7112 Sycamore Avenue
HPC 12/18/96.

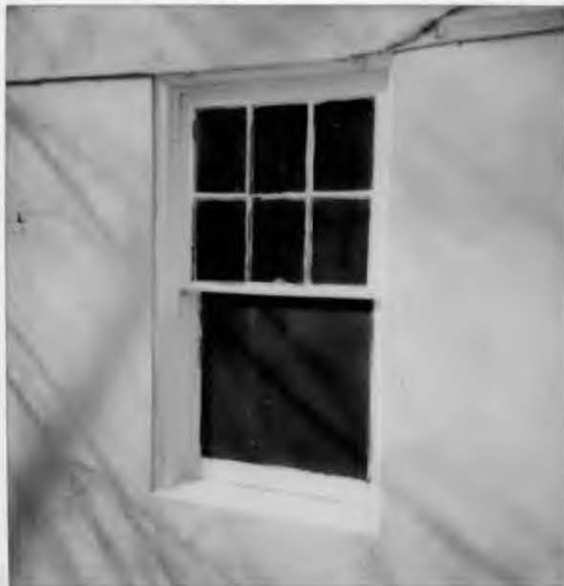
Patch, 7112 Sycamore Ave, TP
damage - rot of wood

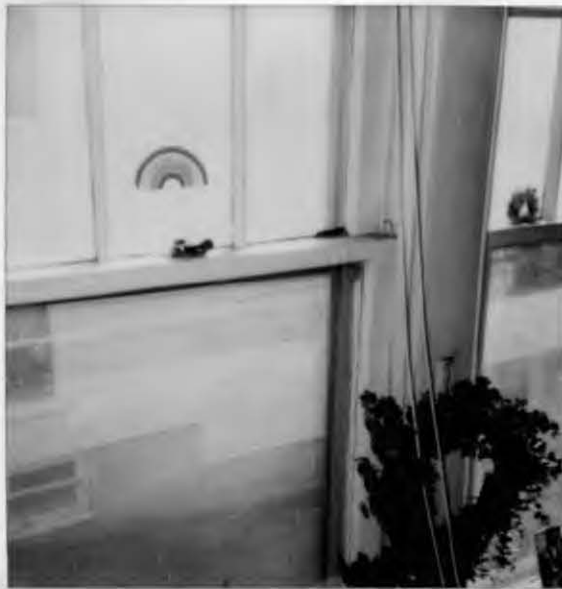
Patch - 7112 Sycamore Av T.P.
window is broken sash cords

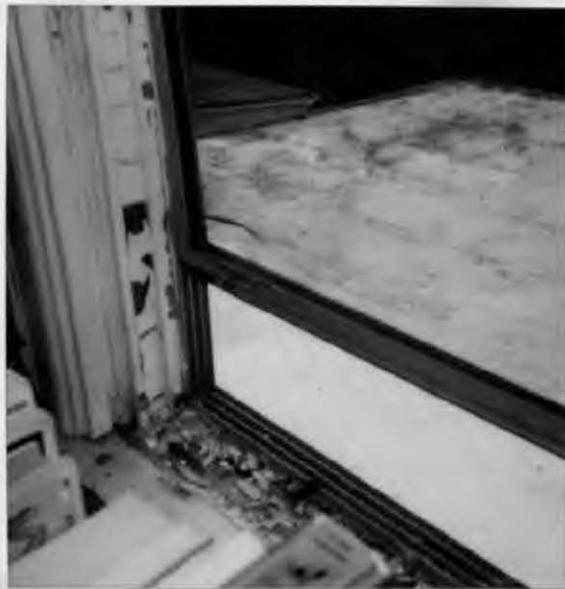
Patch, 7112 Sycamore Ave, TP
window will not hold paint
rot

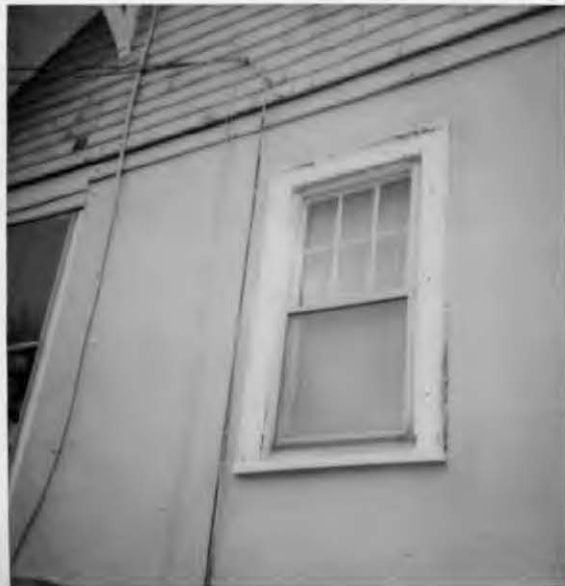
Patch - 7112 Sycamore Ave, TP
window will not hold paint - ventilators
installed.

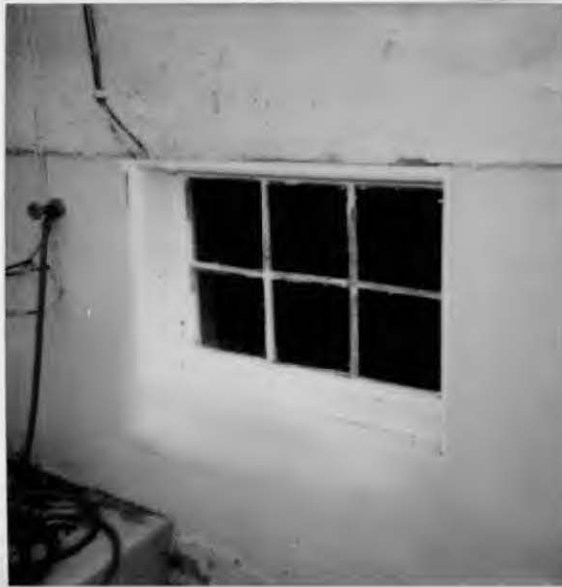
Patch, 7112 Sycamore Ave, TP
window will not hold paint/petty.
basement level

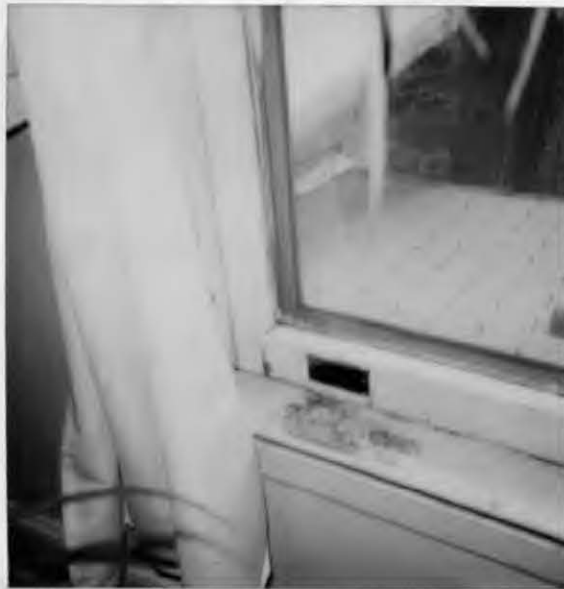
Patch, 7112 Sycamore Ave, TP
wood damage, rot
rust damage from window trim

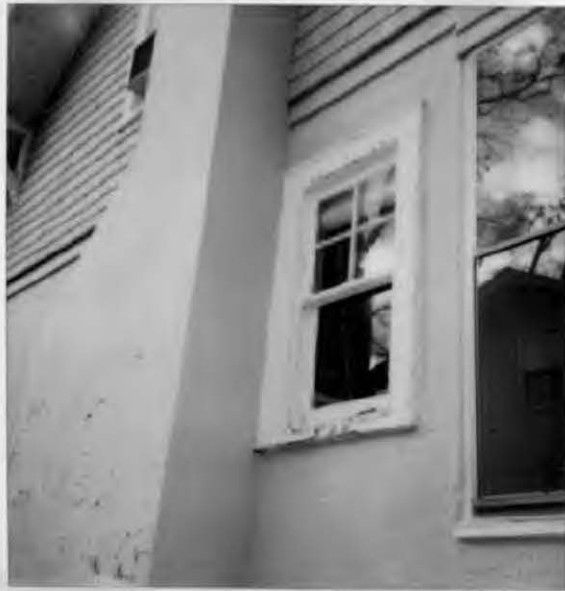
Patch, 7112 Sycamore Ave, TP
window will not hold paint or putty

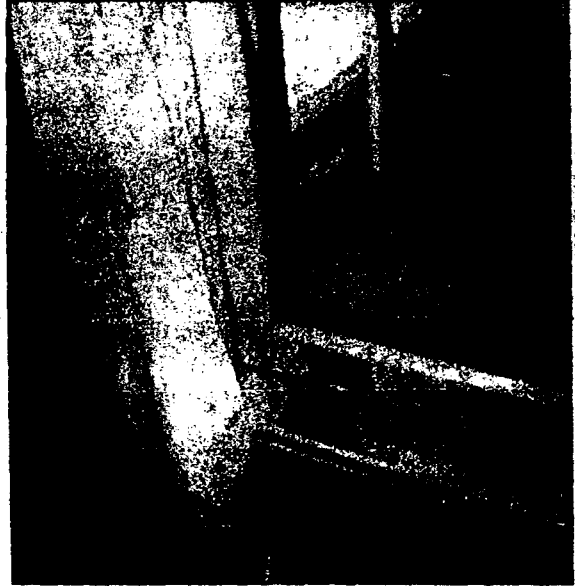
Patch, 7112 Sycamore Ave, TP
wood damage, rot
rust damage from window trim

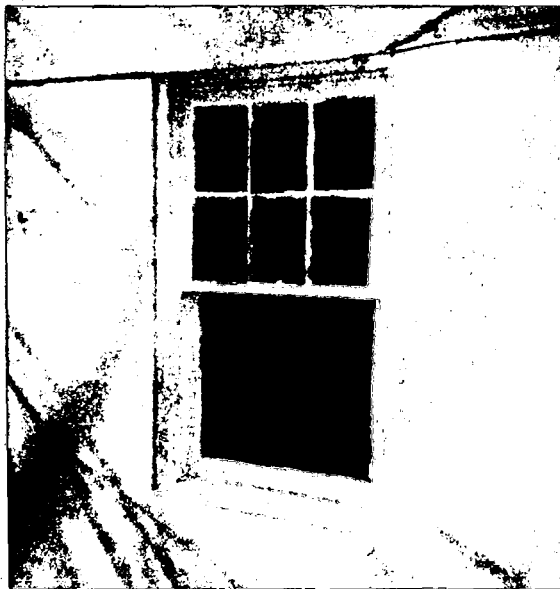
Patch, 7112 Sycamore Ave, TP
damage - rot of wood

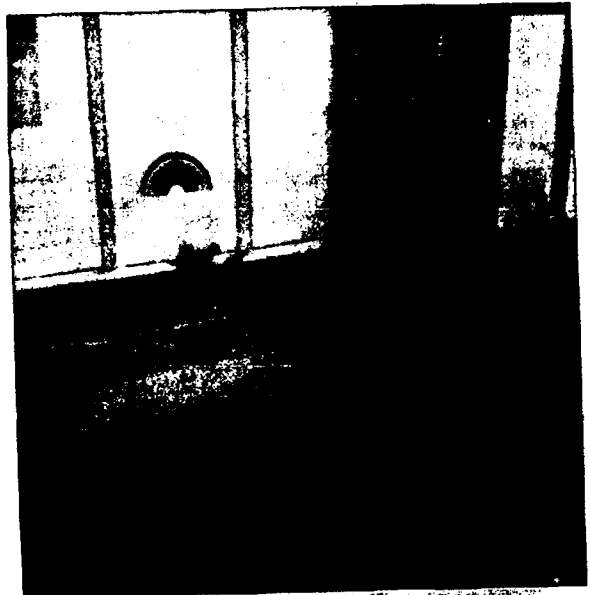
Patch - 7112 Sycamore Av T.P.
window - broken sash cords

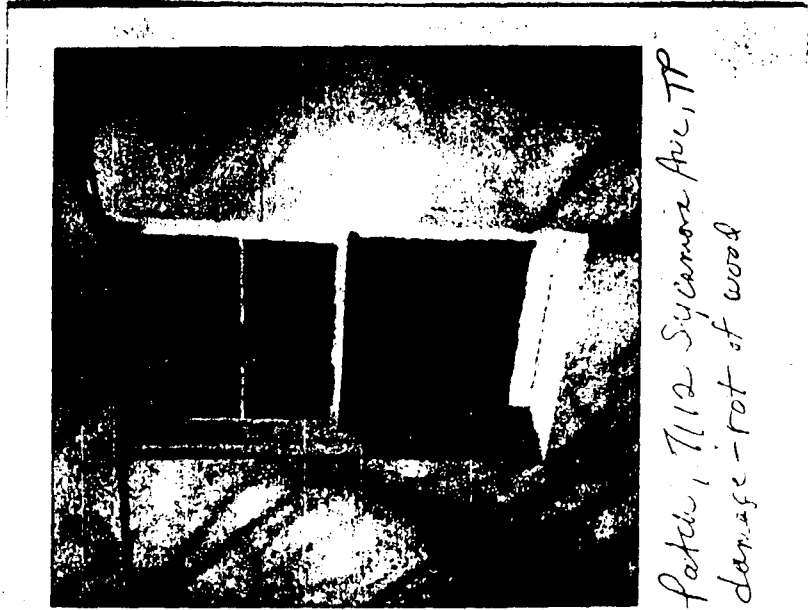
Patch, 7112 Sycamore Ave, TP
damage - rot of wood

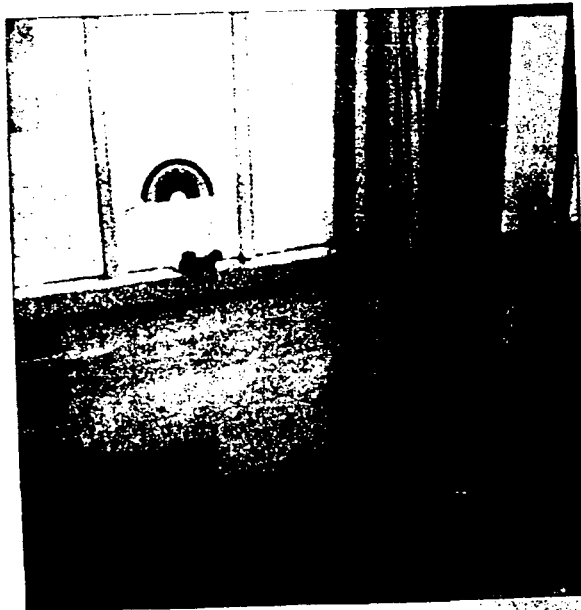
Patch - 7112 Sycamore Av TP,
window is broken sash cords

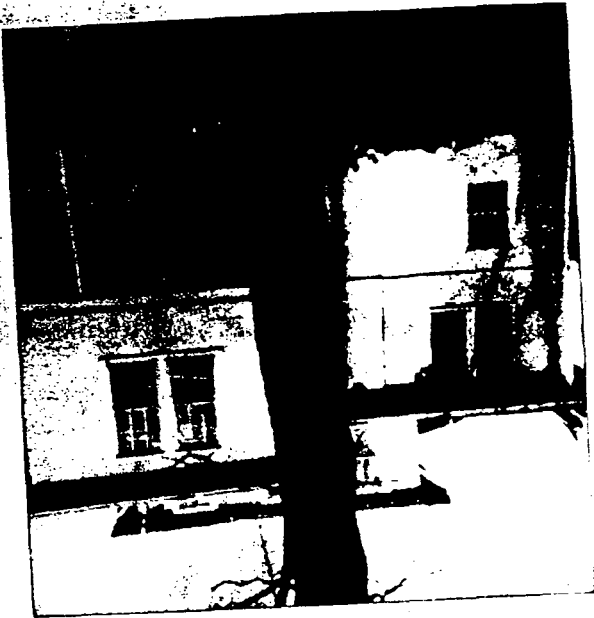
patch, 7112 Sycamore Ave, TP
wood damage, rot
rust damage from window trim
