#### HISTORIC PRESERVATION COMMISSION STAFF REPORT

CASE NUMBER: 31/7 - 89J

TYPE OF REVIEW: Retroactive HAWP

SITE/DISTRICT NAME: Capitol View Park PROPERTY ADDRESS: 10112 Capitol View

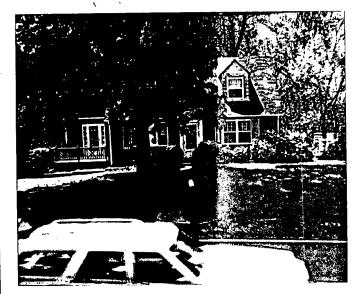
10112 CapitOL VIEW AND SILUGE SPRING, MD

Enclosed is the completed application for the Historic Area Work Permit and a photograph of the exterior of the house with most of the repairs completed. If you need additional documentation of these events, I can provide copies of damage estimates and claims. I also have photographs of the damage which you are welcome to view but which I must keep for insurance reasons. You can also verify the emergency power and phone line repairs with PEPCO and C&P Telephone. The total cost for all construction outlined above, treatment for damaged trees, and debris removal came to \$12,400 not including loss of personal property.
