10 Pine Avenue, Takoma Pk.
Preliminary Consultation

HISTORIC PRESERVATION COMMISSION STAFF REPORT

Address: 10 Pine Avenue

PROPOSAL: Demolish garage/build new garage

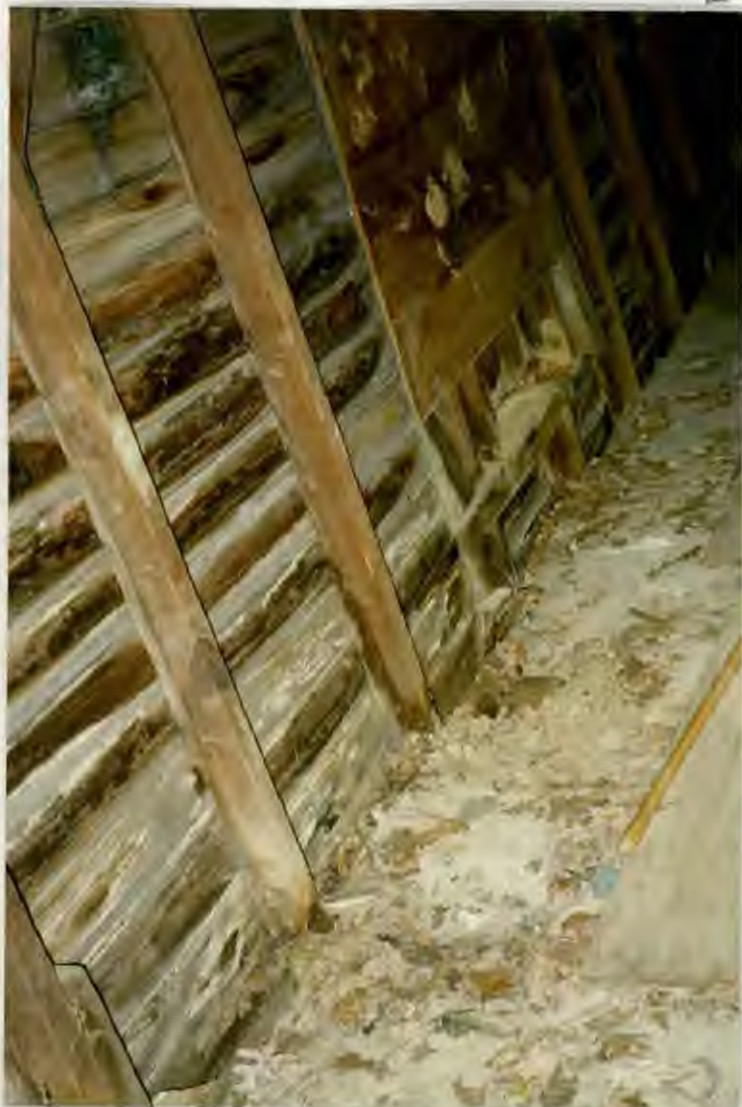
7

Interior of North Wall

Wood is wet and rotting.
Foundation is sunk well
below concrete slab 6"-8"

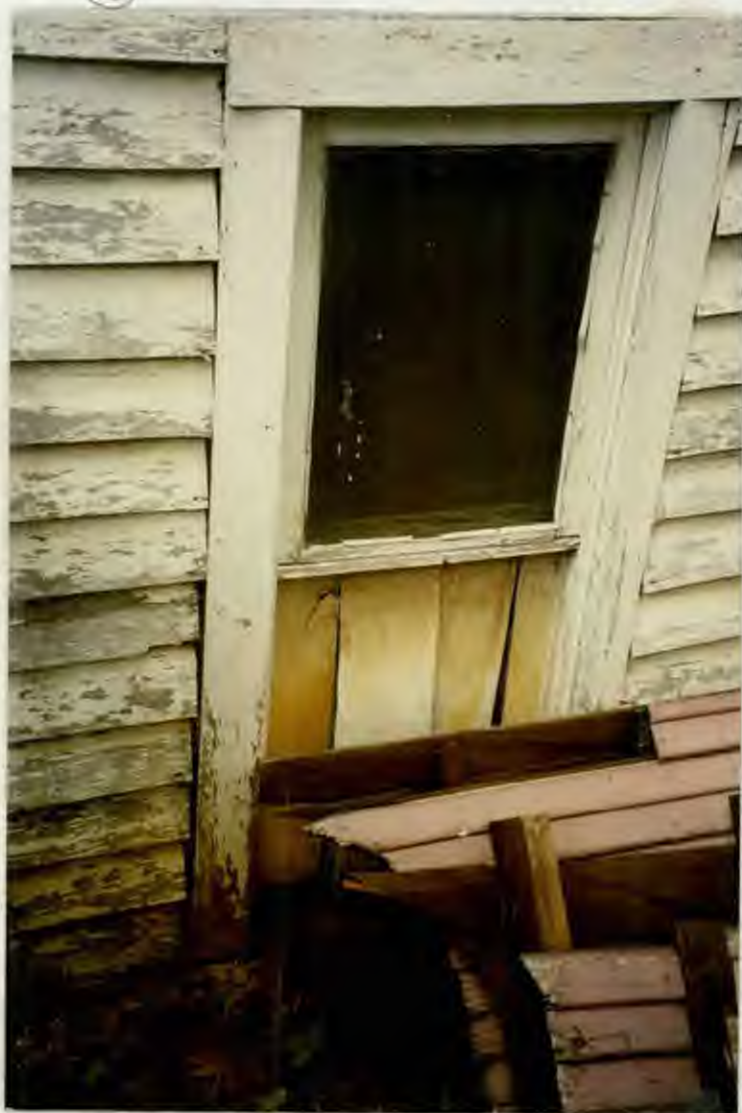
8

Exterior of North Wall

Grade is higher on outside
than concrete slab on inside.
Wood well covered by dirt.

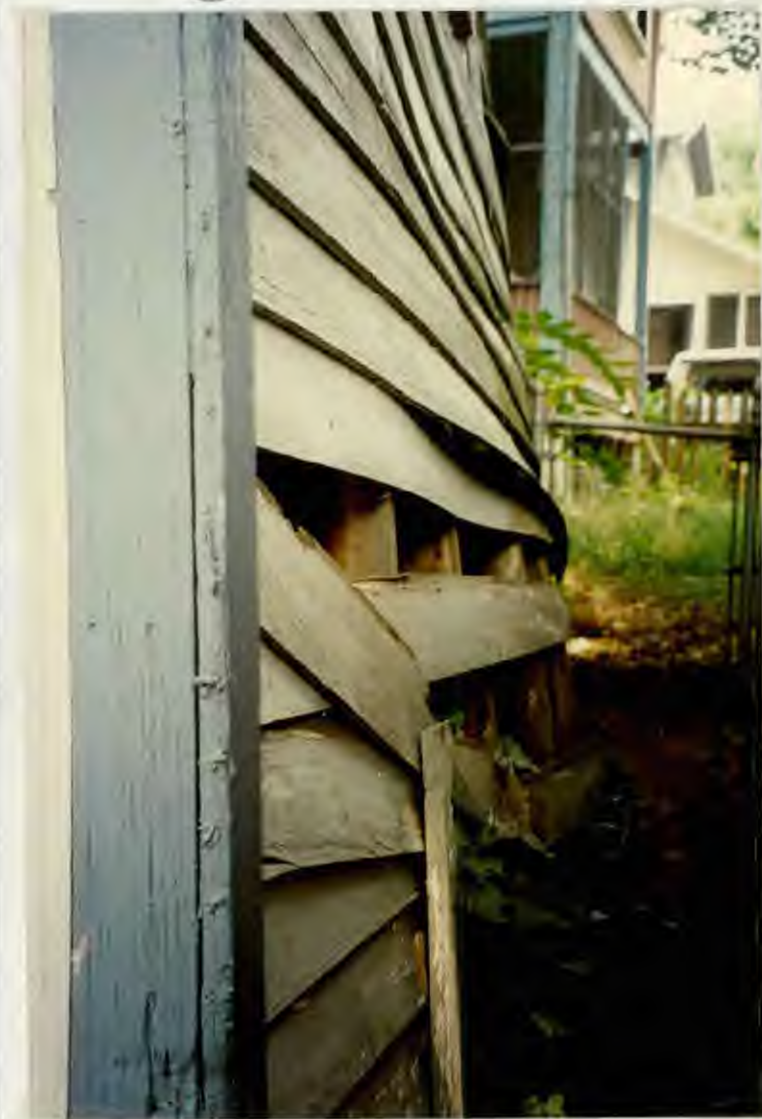
9

Signs of Fire damage
on boards behind exterior.

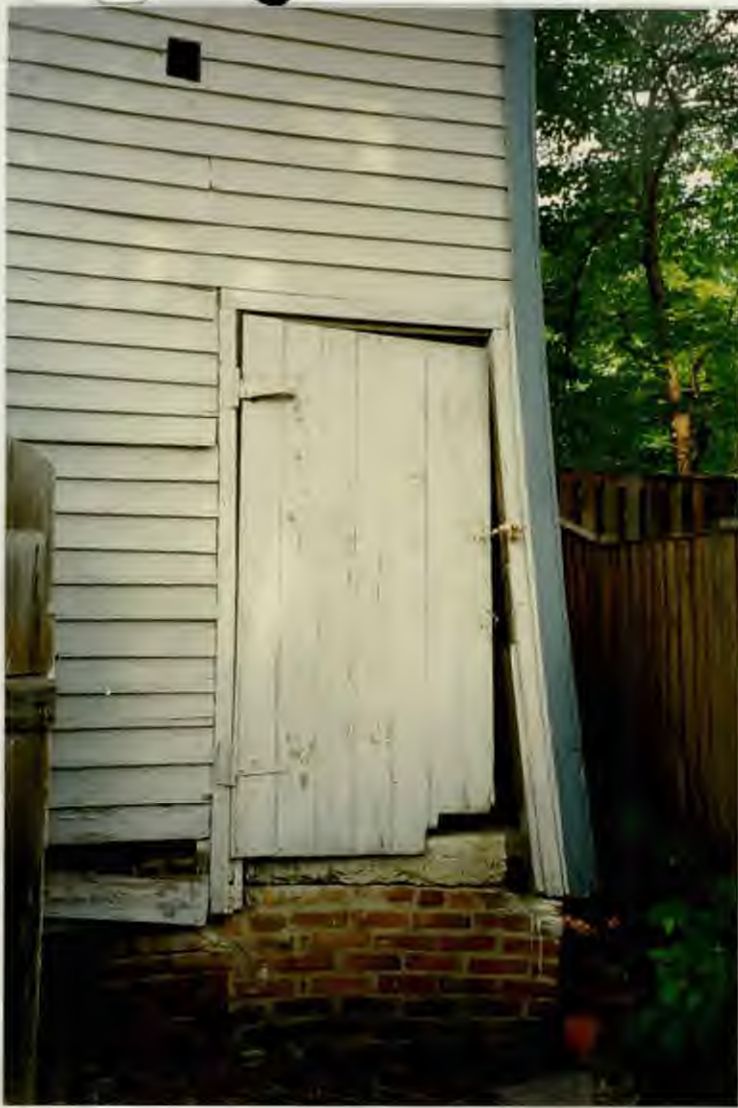
12

→
Foundation wall near SE corner is buckling out.

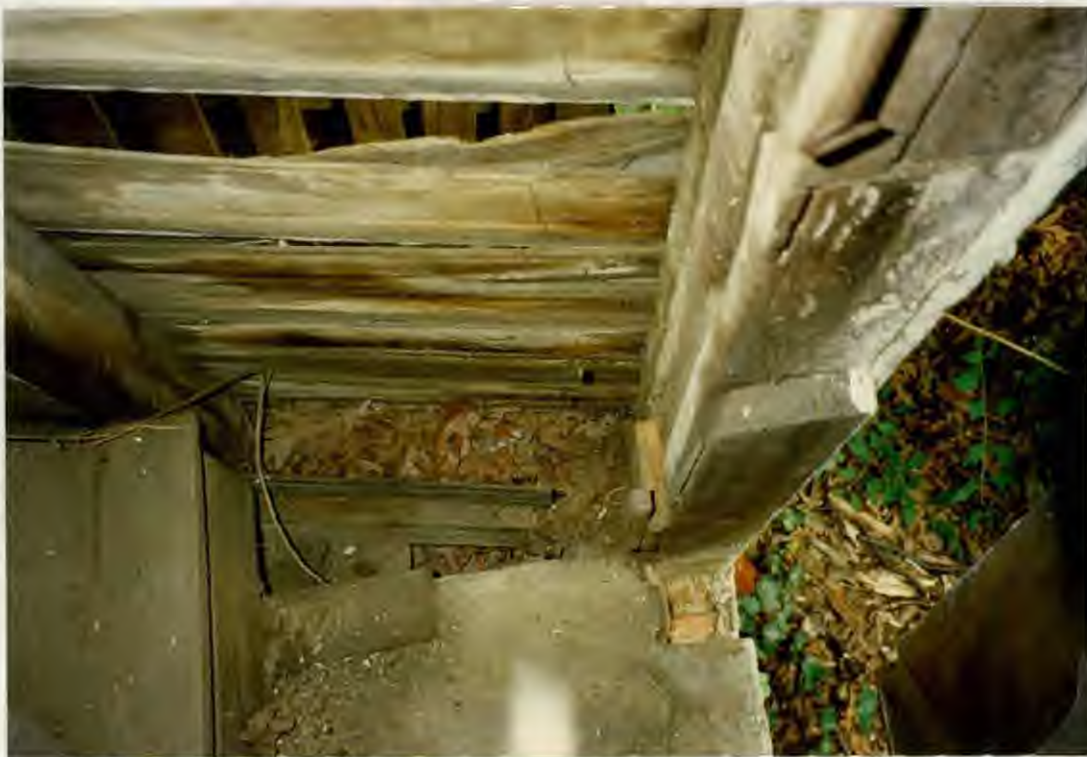
13

↑
SE corner foundation sinking - leading main support to be nearly off the foundation entirely.

Interior photo shows where support used to be

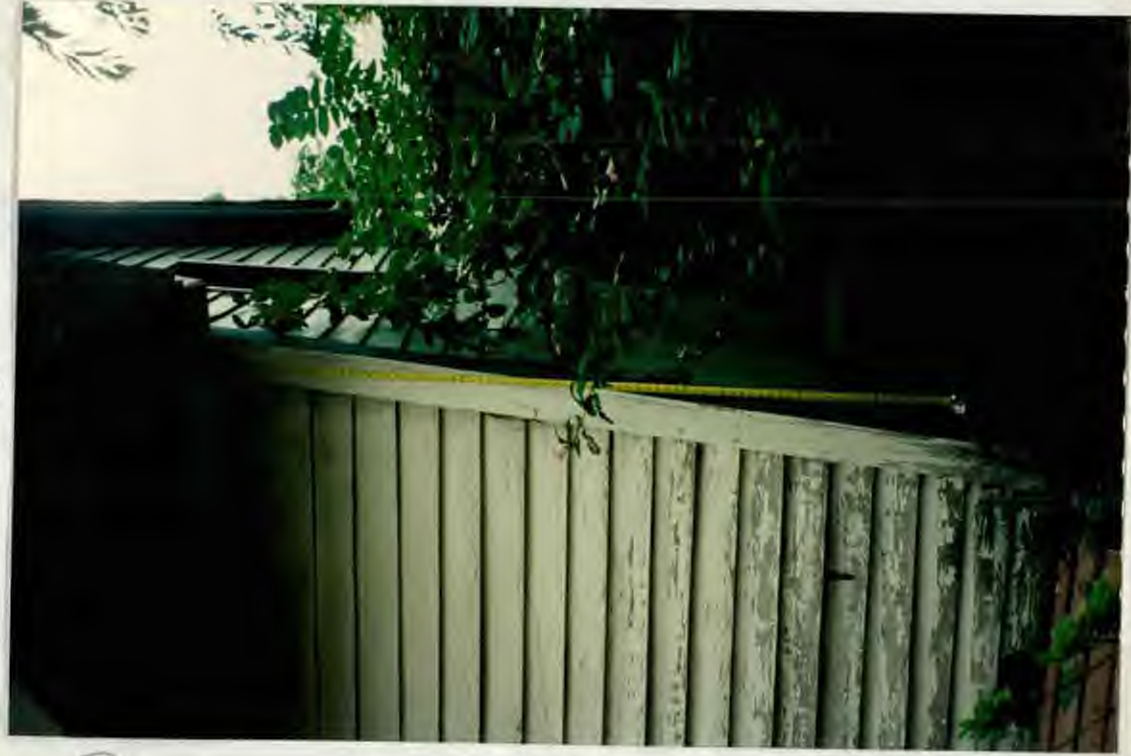
(14)

1) The building is in poor and unstable condition. The structure has failed to the extent that the building is racking, leaning towards the north and towards the west (see photograph #14). (31)

← NW exterior corner
support tilting forward.
(Note measuring tape
hanging vertically to
demonstrate slant
of structure.)

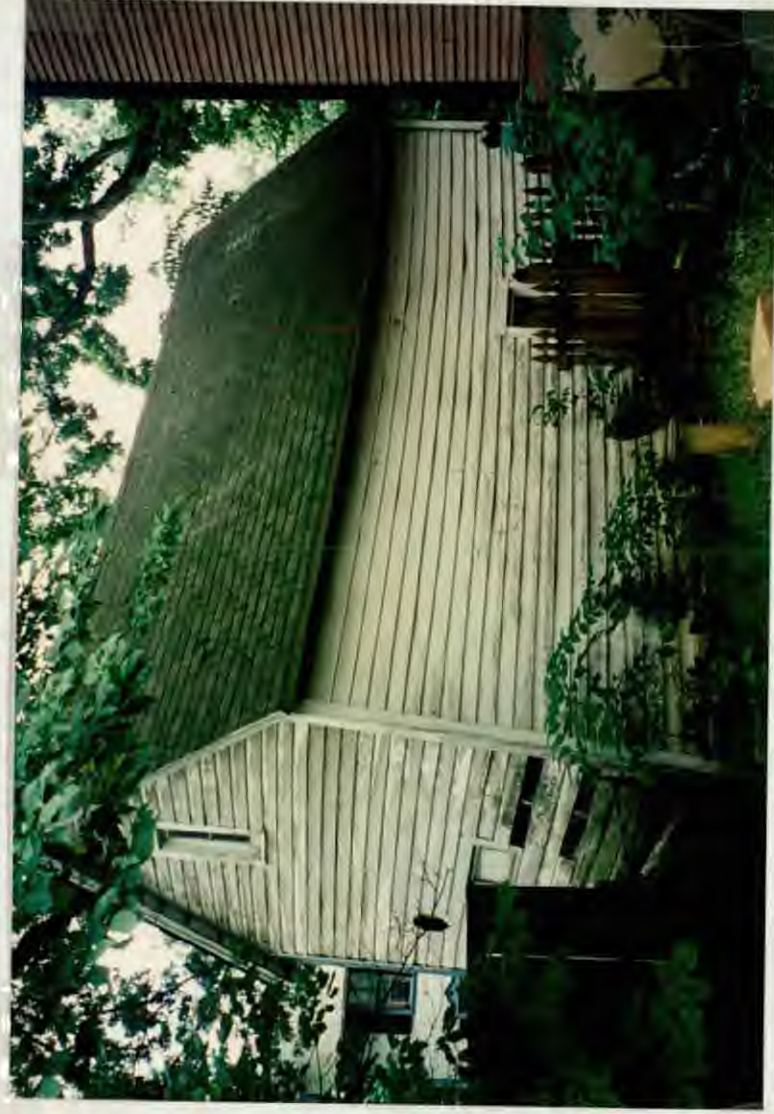
(15)

View From NE
(Note bow in
the roof line.)

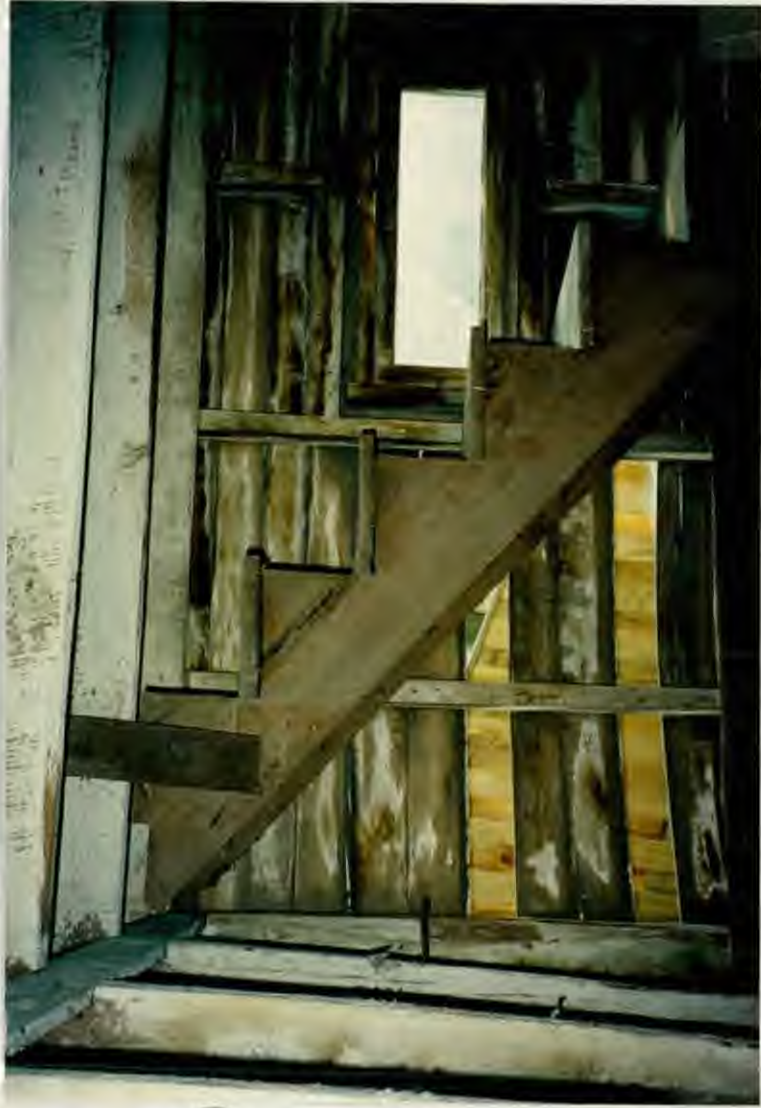
(Note →
Missing
Siding)
