20321 Darnestown Rd, Darnestown  
(Woodstock Equestrian Park)  
HPC Cax No  
Brewer Farm 12/38

SUBJECT: Historic Area Work Permit #500057, Demolition of historic multi-purpose barn/corncrib

Brewer farm (HP 12/38)  
Corncrib to be demolished.

**MONTGOMERY COUNTY HISTORIC PRESERVATION COMMISSION**  
**STAFF REPORT**

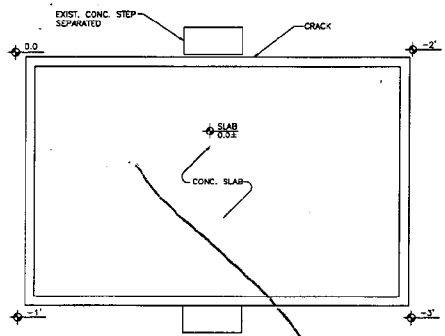
**CONCRETE SLAB PLAN**  
SCALE : 1/4"=1'-0"  
HISTORIC FARM OUTBUILDING

- 2- Concrete Foundation Walls, Garage Slab & Apron: We observed two major cracks on the foundation walls, on the south side of the building (Refer to drawing 1/S-1 for location of cracks). These cracks appear to be in the range of 3/32" to 1/8", and require repair. Other parts of the concrete foundation wall appeared to be in good condition

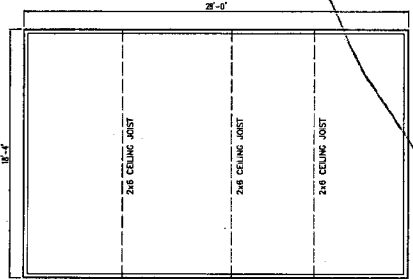
**CEILING JOIST LAYOUT PLAN**  
SCALE : 1/4"=1'-0"  
HISTORIC FARM OUTBUILDING

No hurricane ties were observed at the bearing points of rafters. We recommend installation of proper hurricane ties at all roof rafters. Additionally, there are 2x10 ceiling joists, spaced at 24", nailed to roof rafters and resting on the perimeter stud walls and garage door headers in the majority of the garage area. One of the ceiling joists has an 8' longitudinal through-thickness crack, which requires repair and reinforcement. (Refer to drawing 2/S-1 for location of broken ceiling joist.)

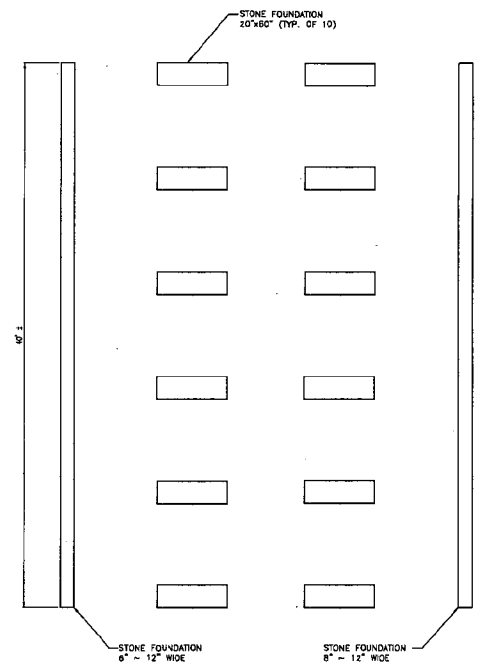
**FOUNDATION PLAN**  
SCALE : 1/4"=1'-0"  
HISTORIC BARN

- 1- Stone Foundation: The stone foundation comprises of a continuous 8" to 12" wide strip on either side of the barn, with individual 20"x60" stone pier footings in 2 rows in between. There are a total of 12 individual intermediate pier footings supporting the barn structure. Examination of the stone foundation showed that the continuous strip stone foundation on the north side of the barn is in acceptable condition. We observed some mortar joints that require re-pointing. Additionally, some minor vertical cracks were noticed on the exterior face of the stone foundation, which do not impact the structural integrity of the foundation at this time. There is general deterioration in the stone units, which has occurred due to weathering and aging of stone. The depth of the foundation is not known and could not be verified.

The strip foundation on the south side is severely damaged due to the pressure imposed by an existing tree, abutting the foundation. The pressure caused by the growth of the tree, has shifted the strip stone foundation inwards, dislocating the stone units and causing misalignment and damages to the super structure. Mortar joints in this strip are deteriorated and damaged due to this movement. Complete structural rehabilitation and stabilization must be performed prior to start of work on the super-structure.

Examination of the 12 individual stone piers between the two exterior strip footings, showed that these pier footings are in generally acceptable conditions, with some signs of weathering and aging, which is acceptable when considering the age of the building. Some mortar joints require re-pointing but no structural rehabilitation is required. The depth of the pier footings could not be verified in field, but is not believed to meet the frost depth requirements in accordance with the governing local codes. All stone foundations appear to require underpinning to meet the frost depth requirements.

- 2- Super-Structure: The super-structure is comprised of wood posts supporting wood beams along the interior pier foundation grid-lines, which in turn support roof rafters. The super-structure is deteriorated entirely and is on the verge of collapsing, and therefore can not be repaired or rehabilitated. As per project documents, the super-structure will be completely demolished and re-built anew.

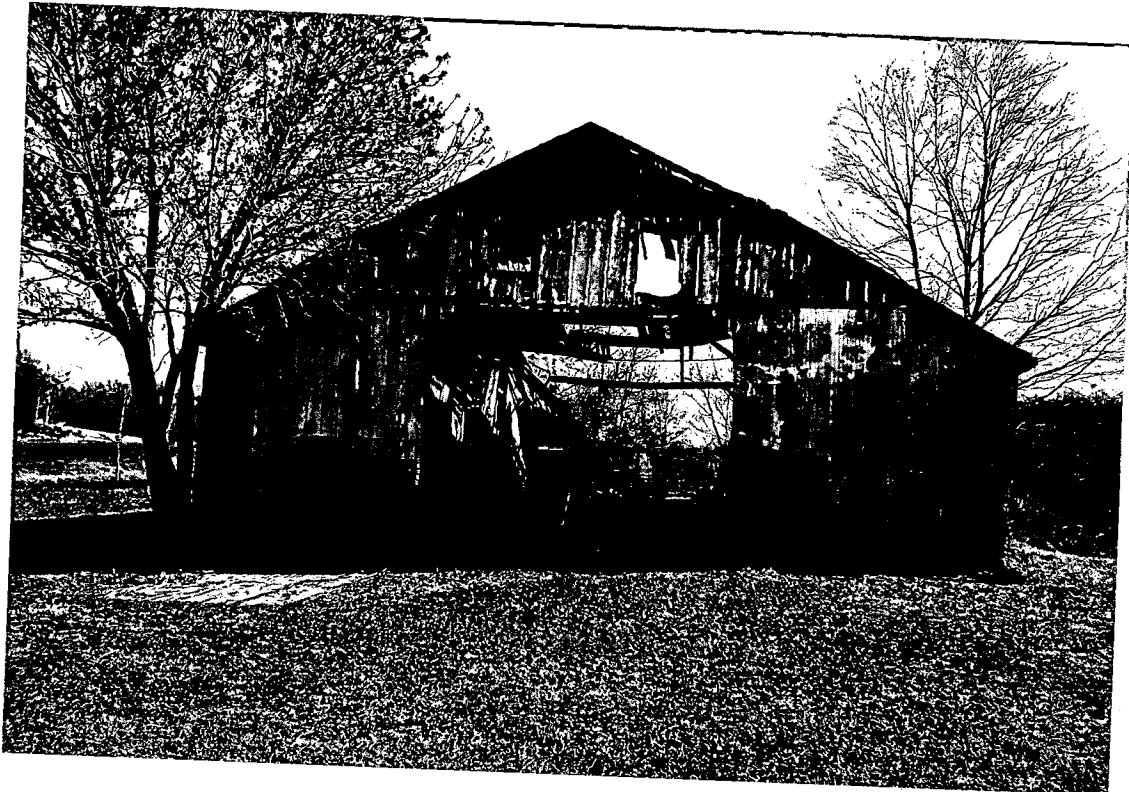
West elevation, looking east. Brewer Farm, Barn/Concrete  
Structure.

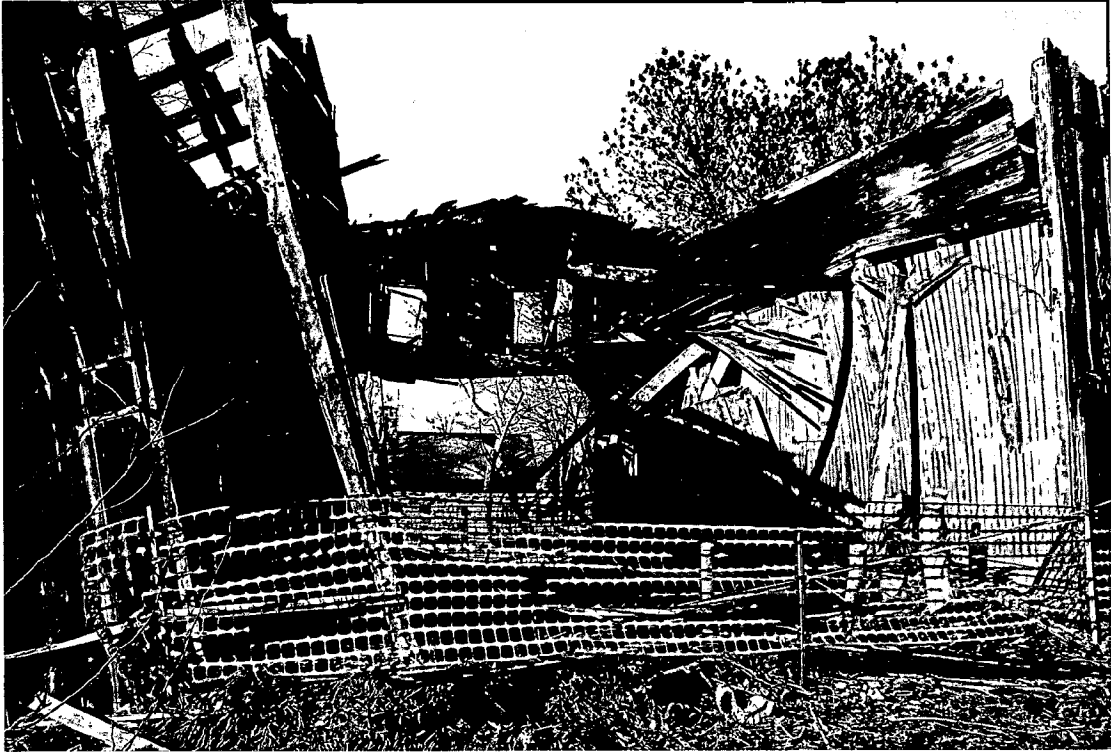
Brewer Farm, Barn Remnant Structure. East elevation,  
looking west.
