13/14-04A 22900 Whelan Lane

MP Site 13/14 Moneysworth Farm

SUBJECT: Historic Area Work Permit

# APPLICATION FOR HISTORIC AREA WORK PERMIT

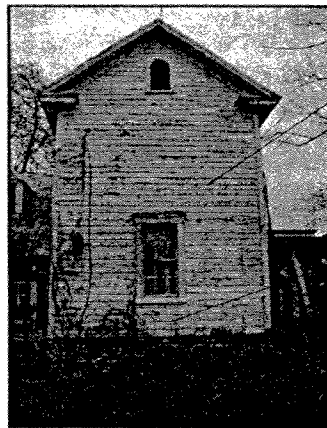
SIDING AND EXTERIOR TRIM ON GREEK REVIVAL ADDITION APPEARS TO BE IN GOOD CONDITION

EXTERMINATE BEES AND REMOVE NEST IN SOUTH HALL OF GREEK REVIVAL ADDITION

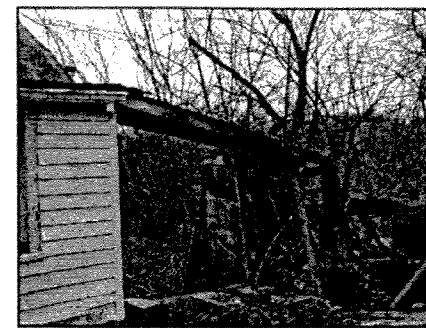
ROOF OVERHANGS EXTENDING TO MODERN WELL IN POOR CONDITION TO BE REMOVED

LARGE AMOUNT OF TRASH AND DEBRIS TO BE REMOVED

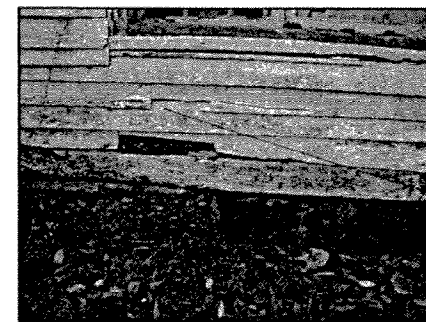
TRANSITION BETWEEN CONCRETE AND FIELD STONE FOUNDATION

RESTORE AREAS OF SIDING AND TRIM ON THE WEST END

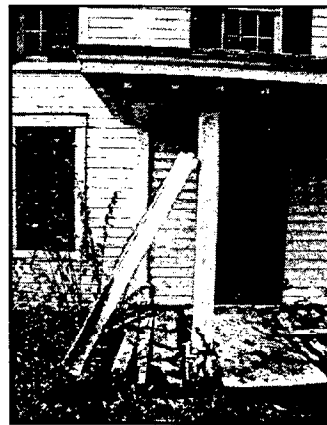
MISSING BRACKET ON CANOPY OVERHANGS, OTHERS STILL IN FAIR CONDITION

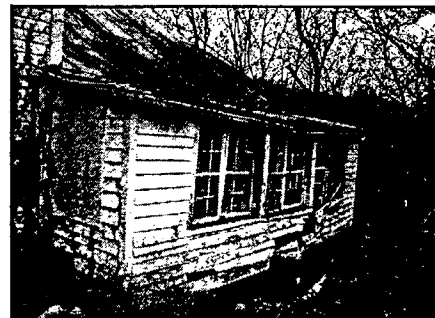
NORTH SHED ADDITION IN DISARRAY, TO BE REMOVED. KITCHEN BEHIND IS ALSO IN DISARRAY WITH PARTS OF THE CEILING HANGING DOWN AND LARGE AMOUNTS OF MOOD DECAY

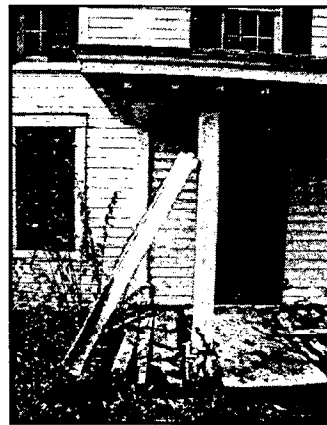
FLOOR BOARDS, FOUNDATIONS AND STRUCTURE NEED TO BE REPLACED. REFER TO DRAWING S/A&O.1

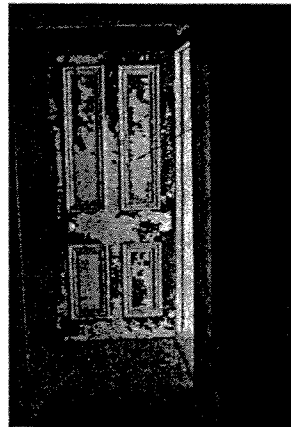
FRONT DOOR ALSO IN GOOD CONDITION. HARDWARE NEEDS TO BE REPLACED. RESTORE TO ORIGINAL CONDITION. PROVIDE NEW HARDWARE AND LOCKSETS

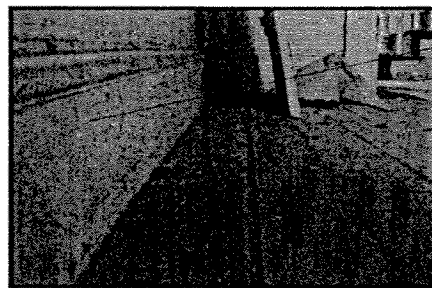
BASEBOARDS AND TRIM THROUGHOUT ARE IN GOOD CONDITION. FLOOR BOARDS IN NORTH PARLOR ARE NOT LEVEL AND ARE CUPPING. RESTORE BASEBOARDS AND MATCH TO ADJACENT SURFACES

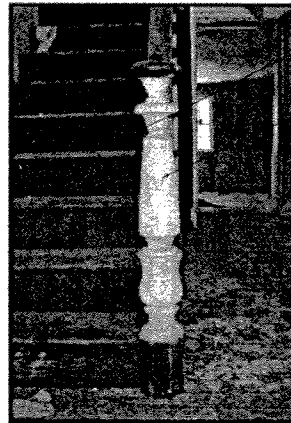
BALUSTER AND RAIL IN GOOD CONDITION

FLOOR BOARDS LEADING TO MAIN LIVING ROOM ARE CUPPING TO BE REMOVED FOR NEW FLOOR STRUCTURE

STAIRS IN GREEK REVIVAL ADDITION TO BE RESTORED TO ORIGINAL CONDITIONS

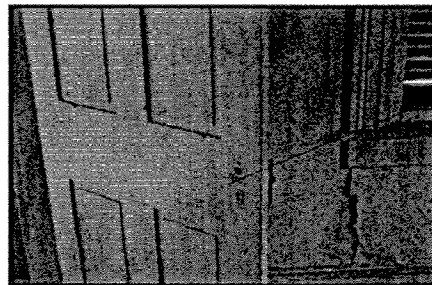
MAJORITY OF DOORS IN GREEK REVIVAL ADDITION ARE IN GOOD CONDITION. HARDWARE IS MISSING OR INOPERABLE ON SOME DOORS

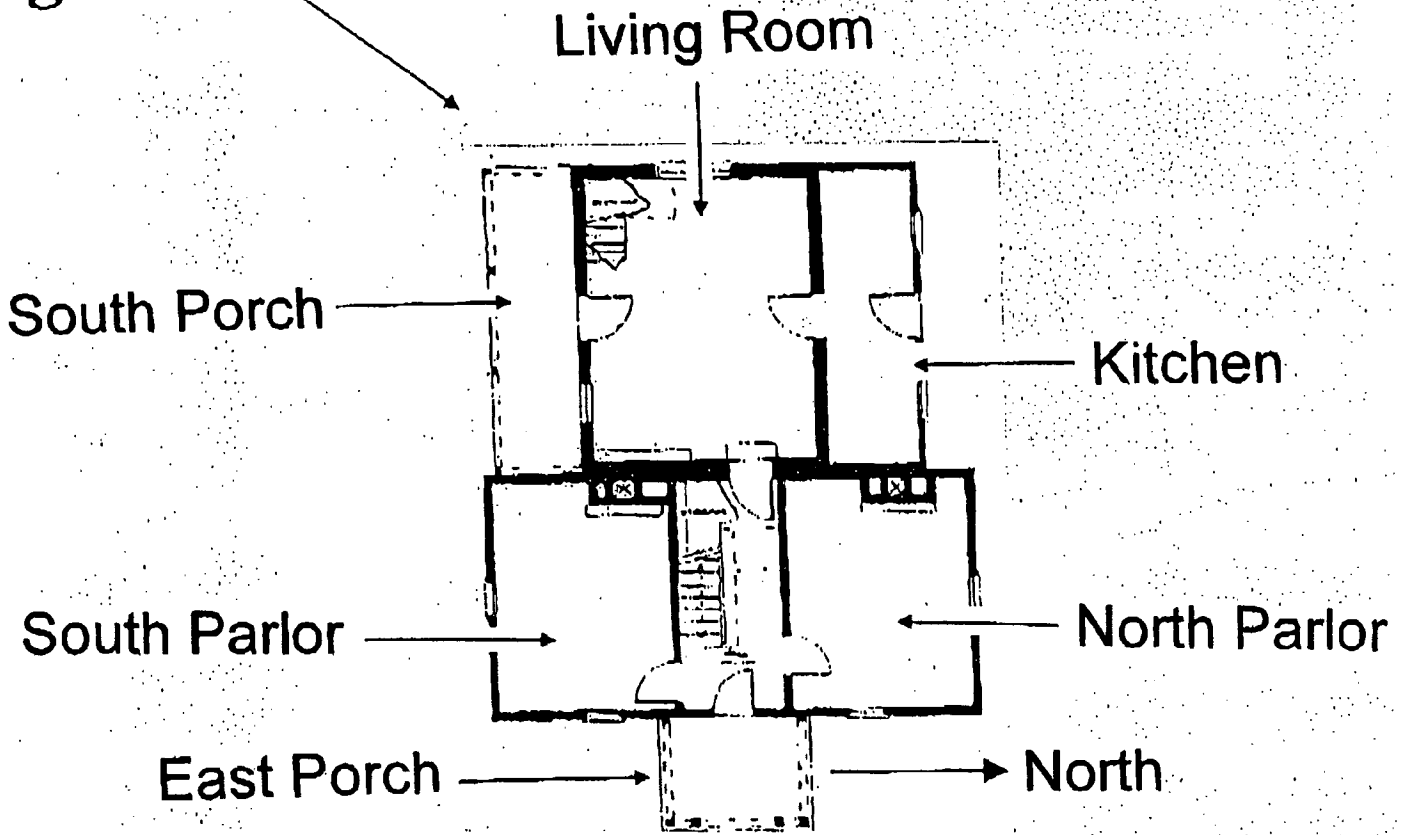
# Figure 1

1. The primary entrance where the east porch is connected to the house is in very bad condition. The floor and foundation of the porch is in need of repair. The columns that support the roof of the porch are not all standing. See first floor plan.

2. The right side of the house facing the corrections facility appears to have a termite infestation and also decay. The siding on the north side of the house adjacent to the corrections facility has major problems. The stud wall appears to have significant amount of decayed members. This means there is a need for further investigation after the wood siding is removed.

4. There is bee hive in the wall of the south parlor. These bees must be removed because of the damage that they may have done to the structure and will continue to do. Further investigation will be required in this area.

2. The floor and roof of the south porch is also in very bad condition. The roof cannot be salvaged. See first floor plan
3. The kitchen has major structural issues. This appears to be the area of the house with the largest problem including decay of the wood members and also termite infestation. The ceiling is falling and the roof system is damaged. See first floor plan.

4. The living quarters which is the main room of the original house does need further inspection to ensure that the whole floor is safe. There is three layers of material on the floor. The first appears to be a tar paper type material, the second looks like linoleum flooring and the third appears to be some straw matting. These layers of material are not good for the floor because the layers are keeping moisture from escaping the wood and in time this will cause the wood to decay. See first floor plan.

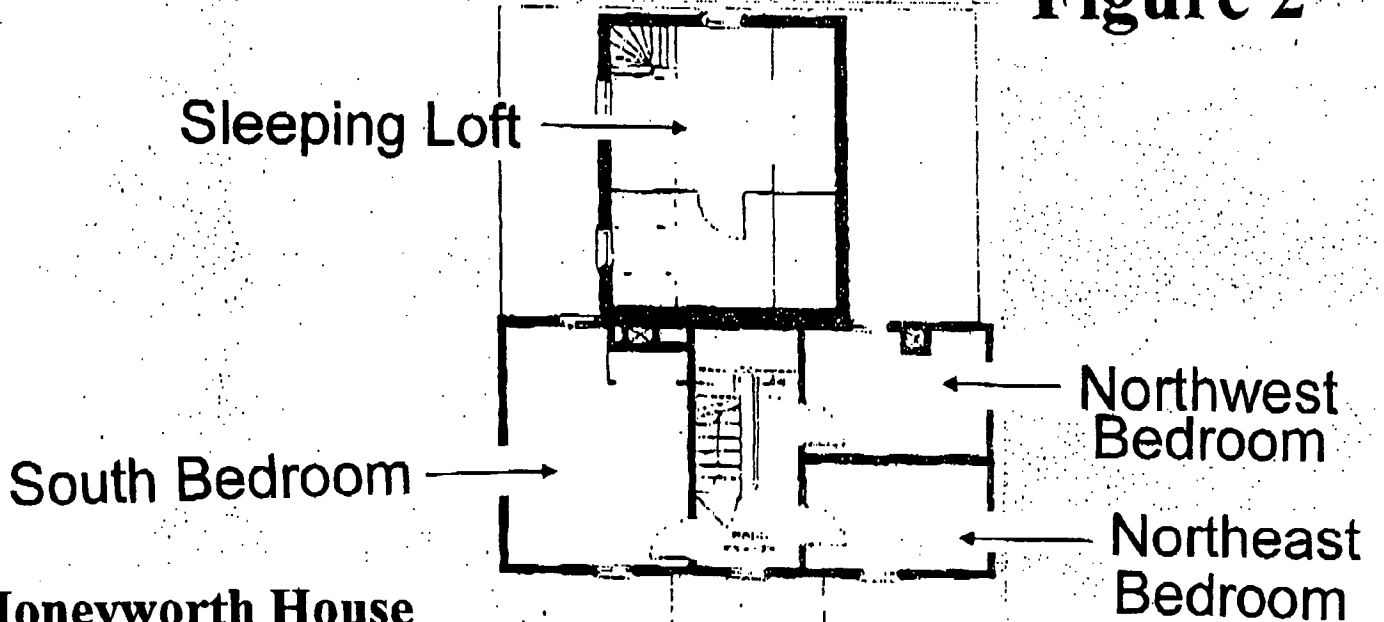
# Figure 2

5. The second story over the living room in the center of the house is in satisfactory condition. The floor is not completely stable but the walls and ceiling are intact. The stairs up to the second floor need to be reinforced to minimize the amount of deflection when using them. See second floor plan.

6. The second story of the house that is accessible near the front door appears to be structurally sound. The stairway appears to be in good condition. Some of the floors of the second story rooms need to be checked because of the deflection that occurs by just walking on the floor planks. The walls and ceilings for this part of the house are intact. See second floor plan.
