22/25-06A 5867 Muncaster Mill Rd
J.H. Cashell Farm, 22/25

STABILIZATION PLAN

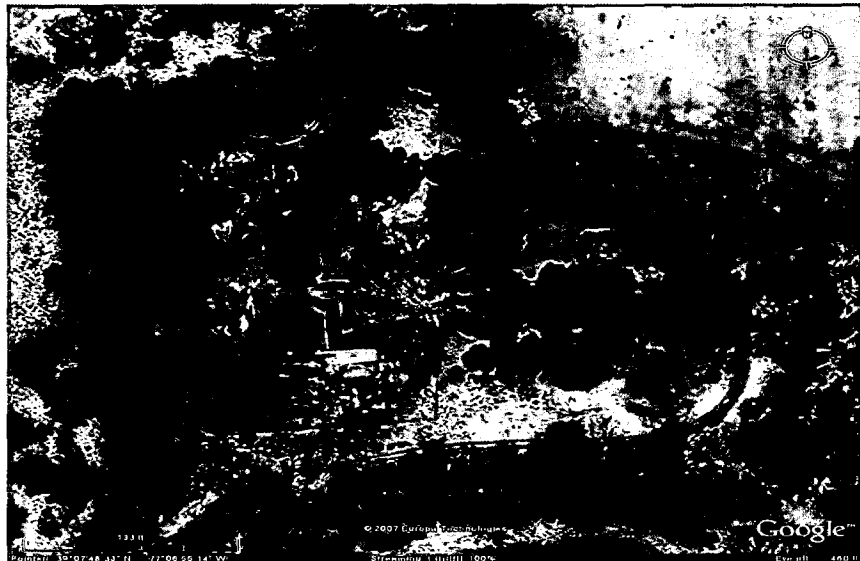
SECTION III. PROPERTY DESCRIPTION AND STABILIZATION PLAN (Continued)

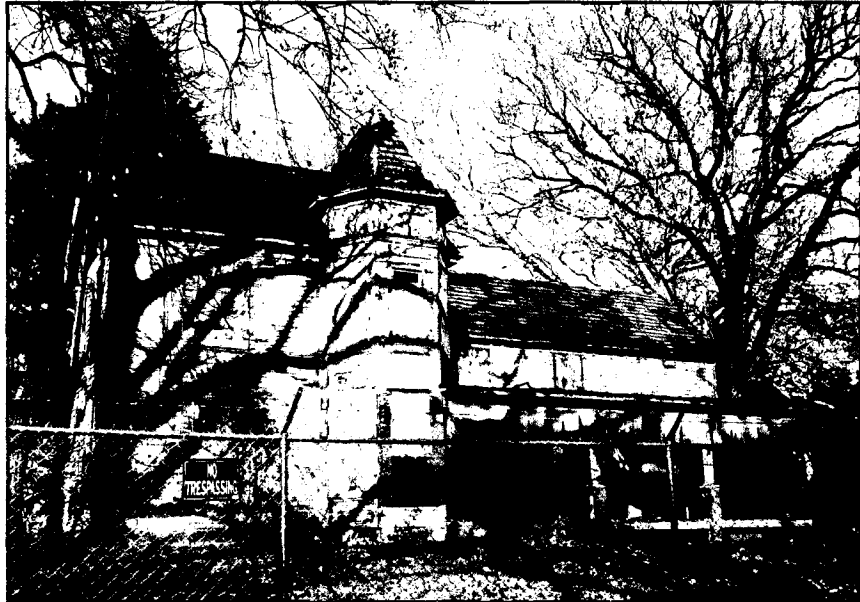
Chain link fence & Specimen Trees

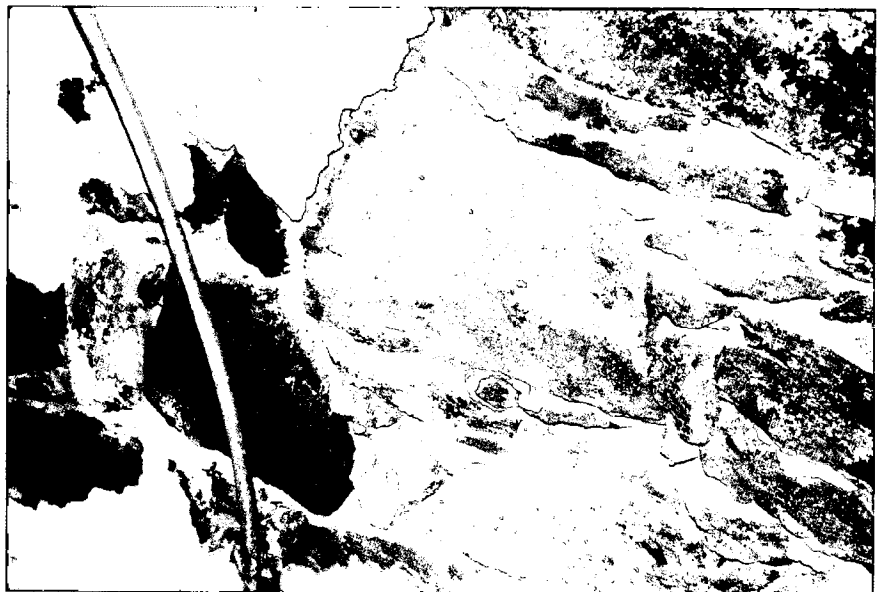
Stone Foundation Wall

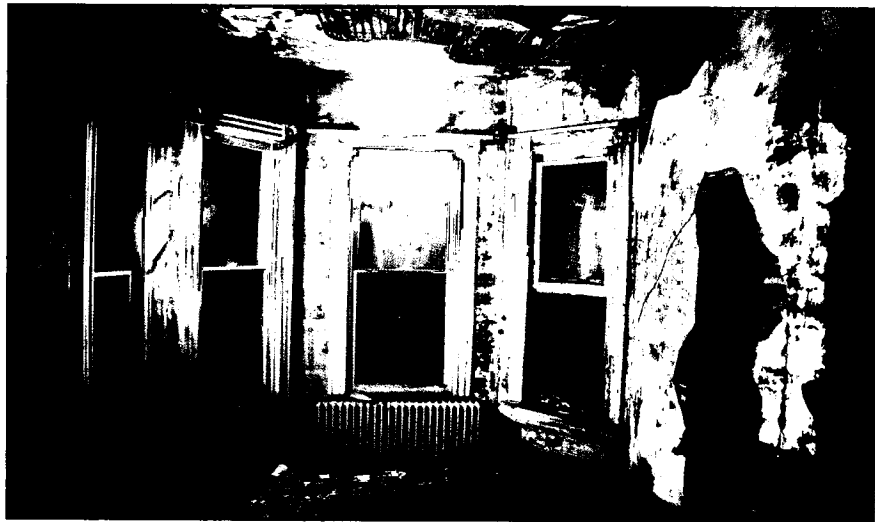
Windows in Stair hall

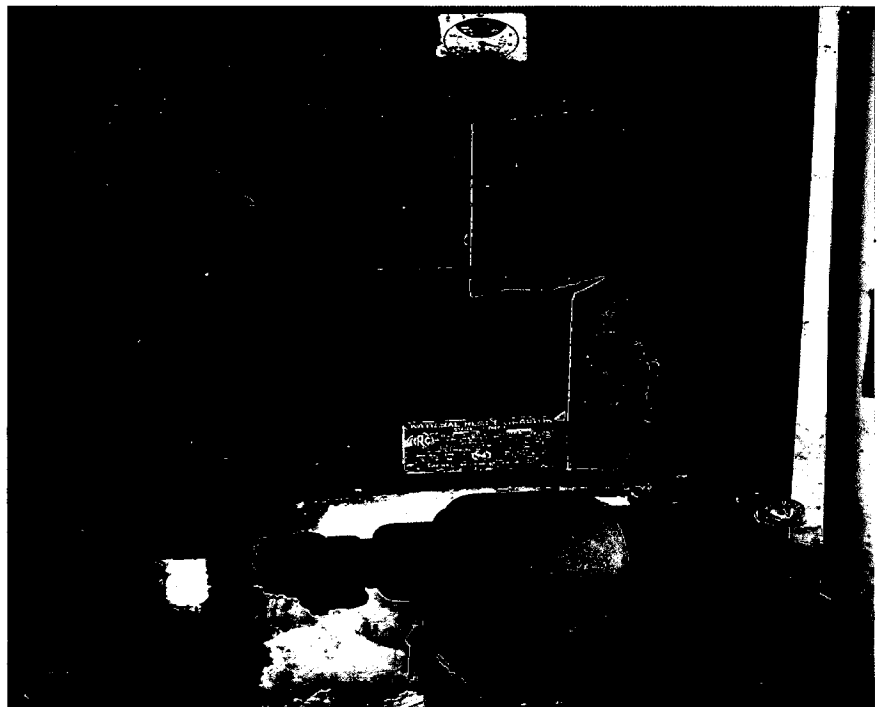
SECTION III. PROPERTY DESCRIPTION AND STABILIZATION PLAN (Continued)

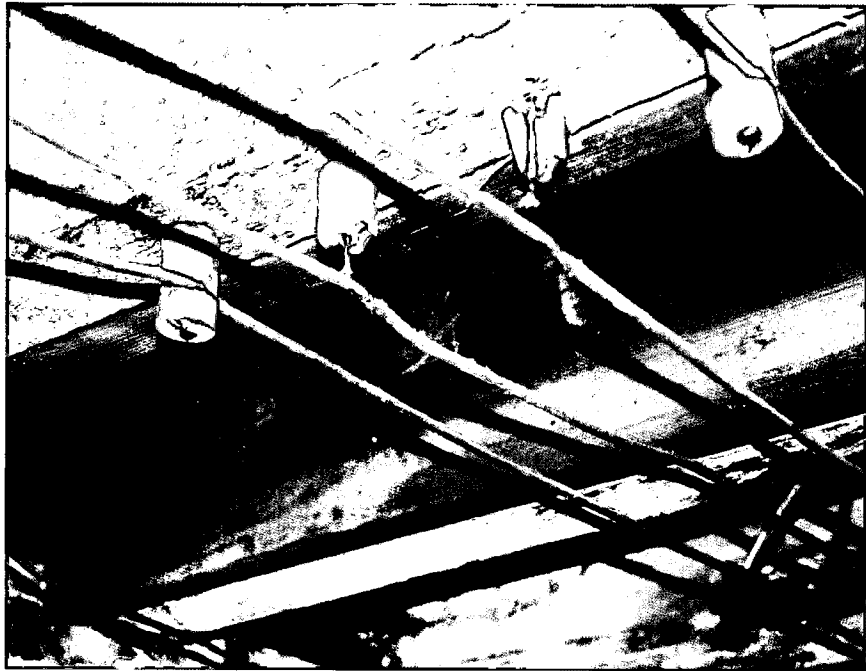
Knob -and-Tube wiring

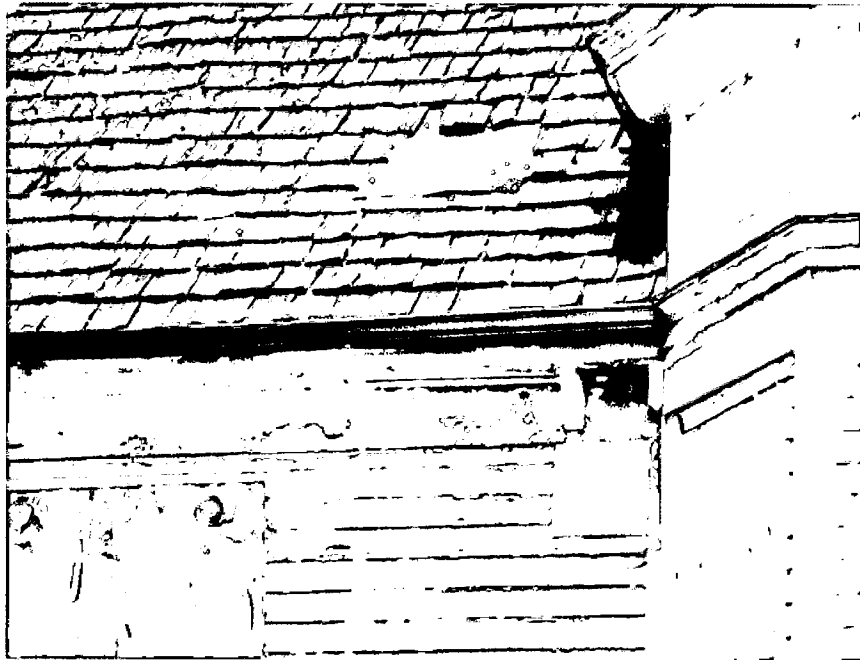
Roof and wall patches.

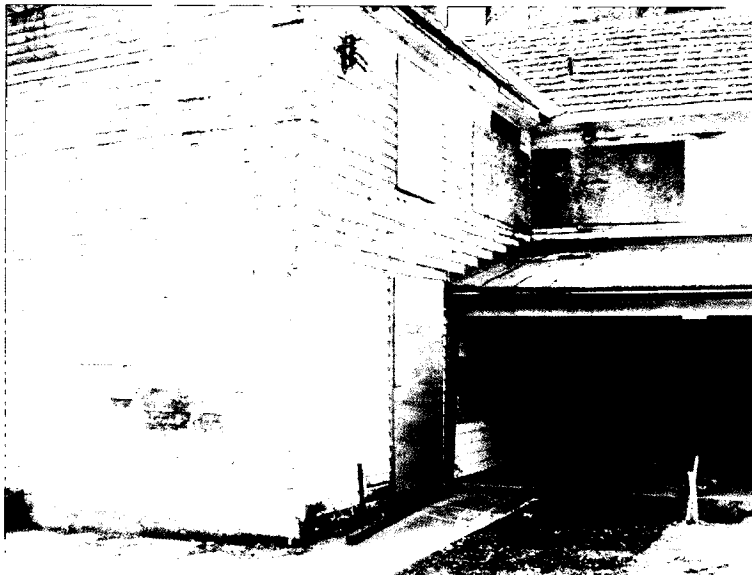
Sealed holes in north wall

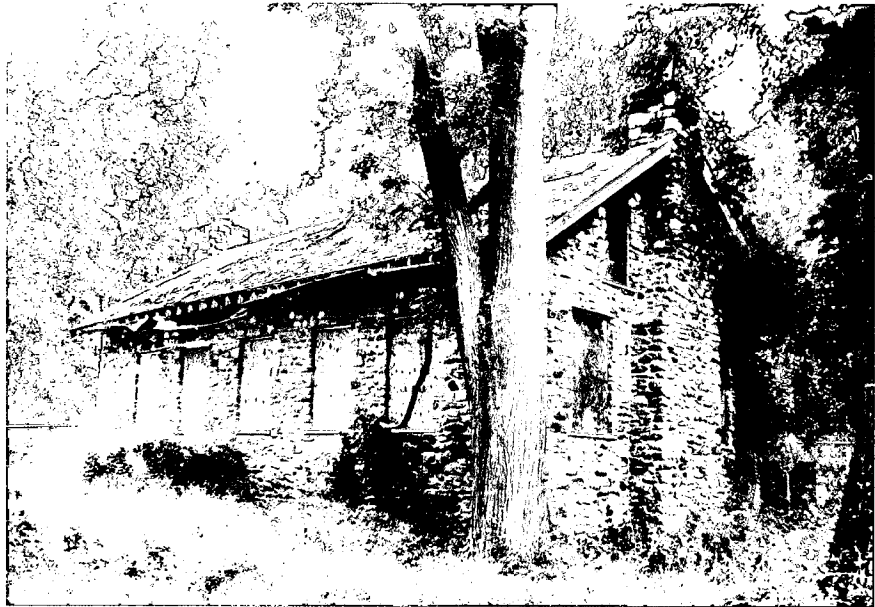
Stone House view from Southwest before emergency stabilization

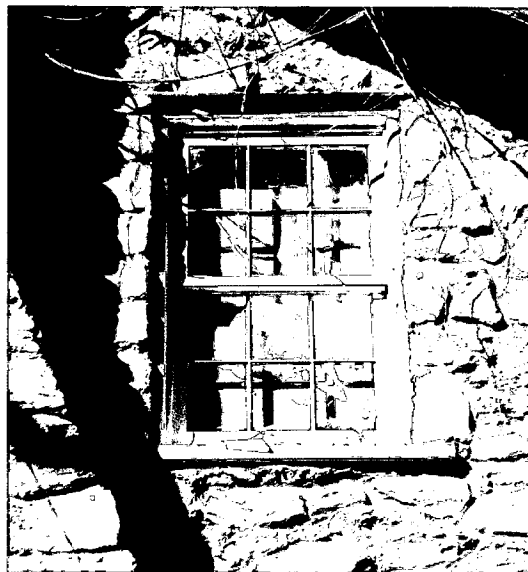
Exterior doors: Six-over-Six windows
None observed.

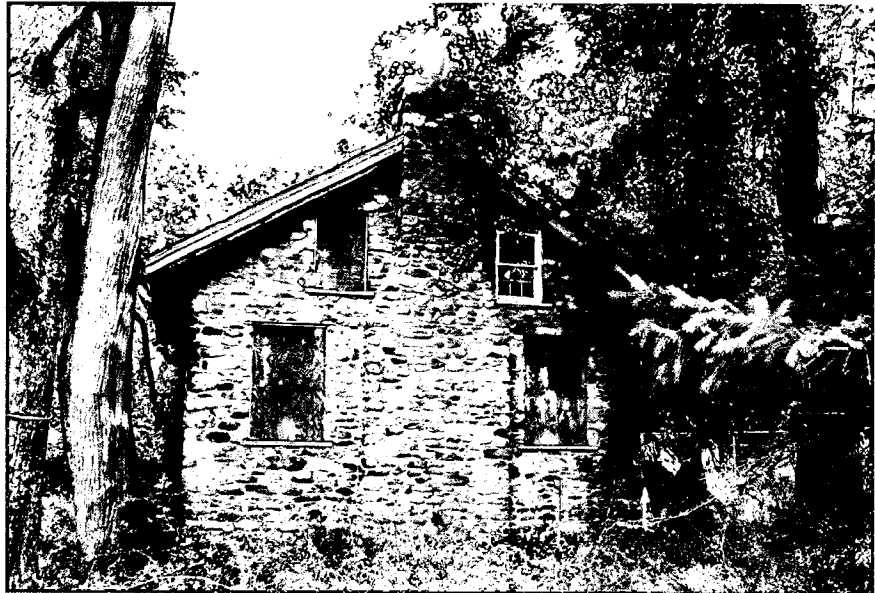
South Facade with chimney before emergency stabilization

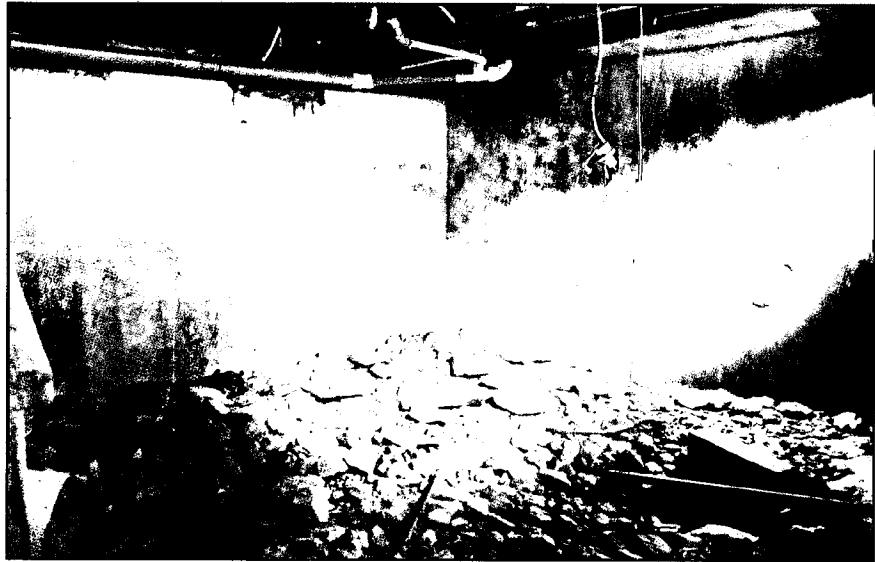
SECTION III. PROPERTY DESCRIPTION AND STABILIZATION PLAN (Continued)

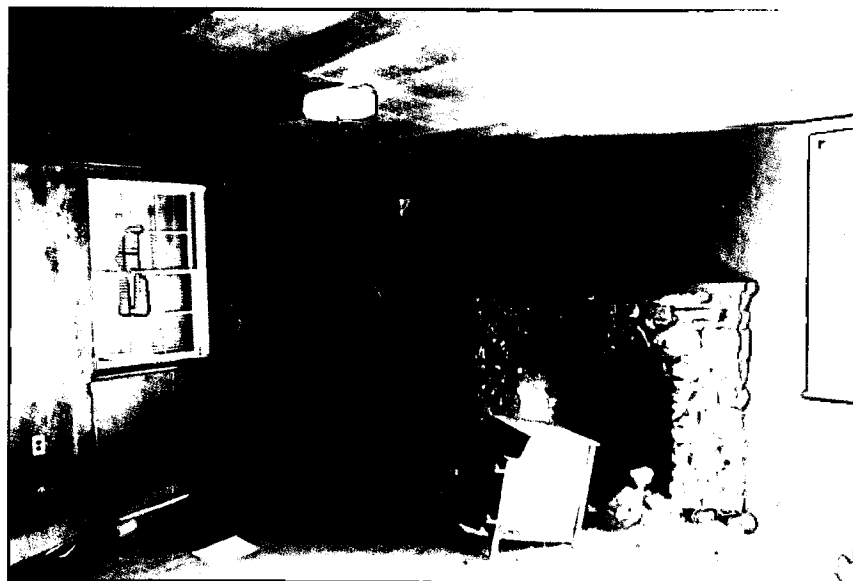
South room with Fireplace

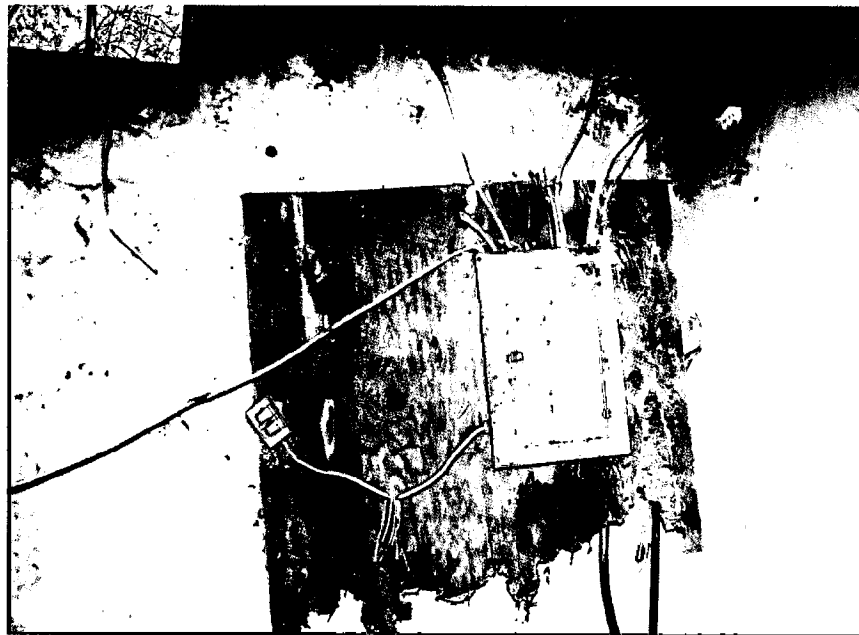
Electrical panel box

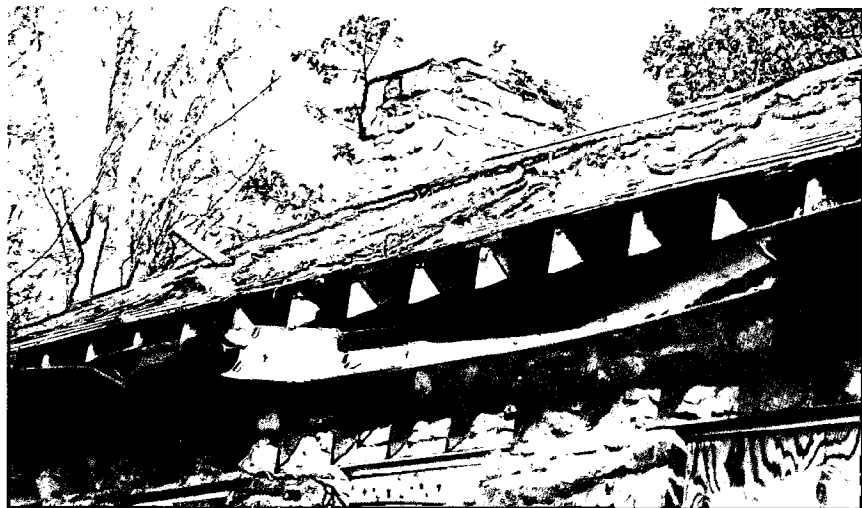
Collapsed gutter at stone house

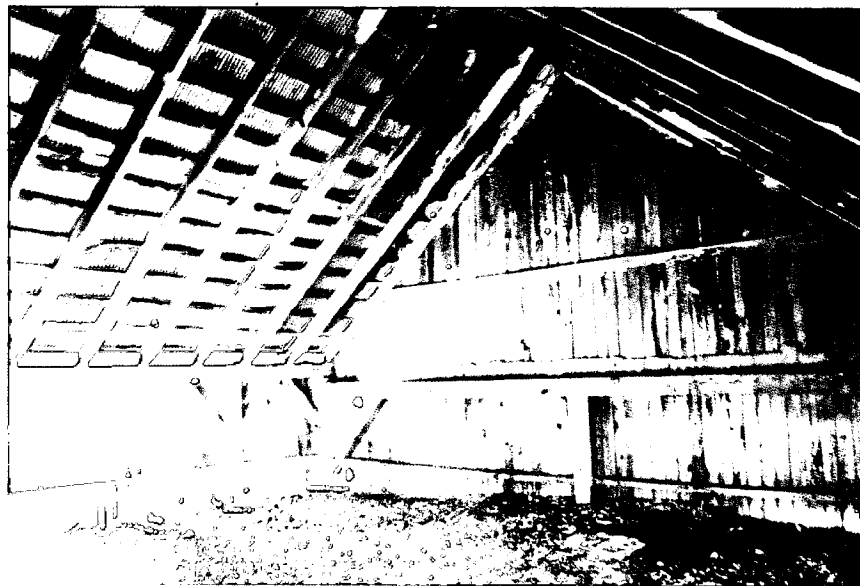
- Structure: The foundation walls are cast concrete. The framing is timber-framed with nailed connections. The ground floor is dirt. The loft floor is sawn joists supported on timber girts and girders.
- Exterior walls: Exterior walls are vertical tongue-and-groove wood siding.
- Windows: There are no windows.
- Exterior doors: The exterior door at the loft level is plank. No other doors are extant.
- Roofing Systems: The roof covering is corrugated tin.
- Chimneys: There are no chimneys.
- Insulation: No insulation was noted

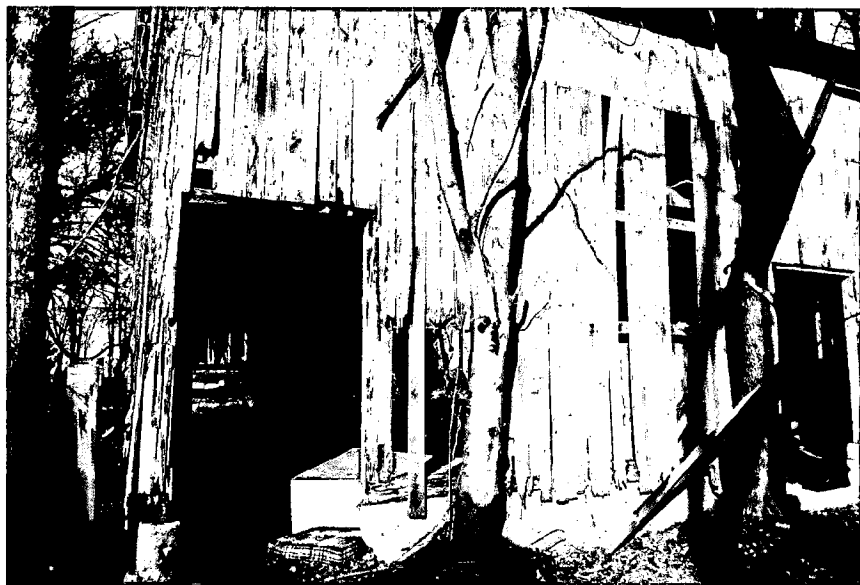
Deteriorated & missing barn siding before emergency stabilization

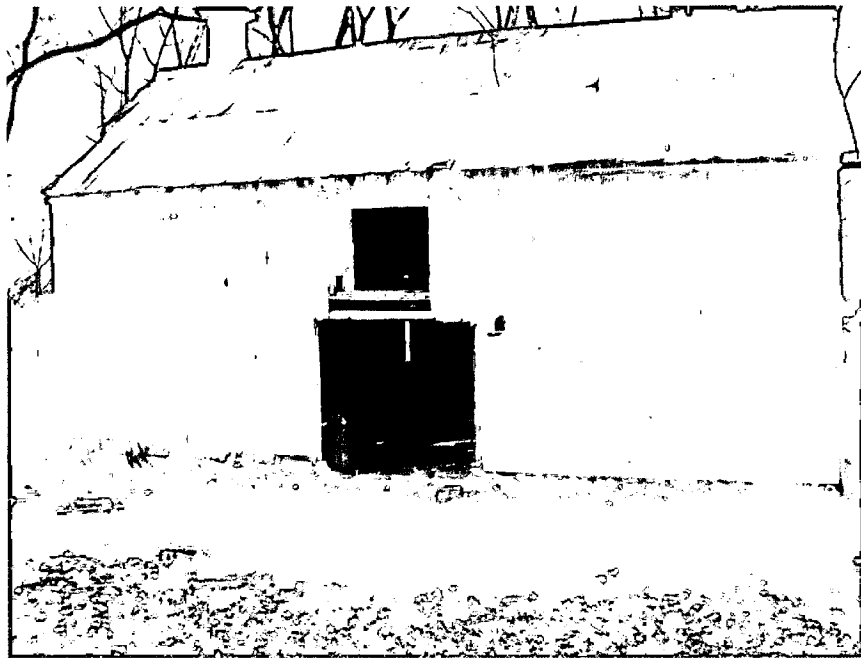
Barn north façade after plywood installation

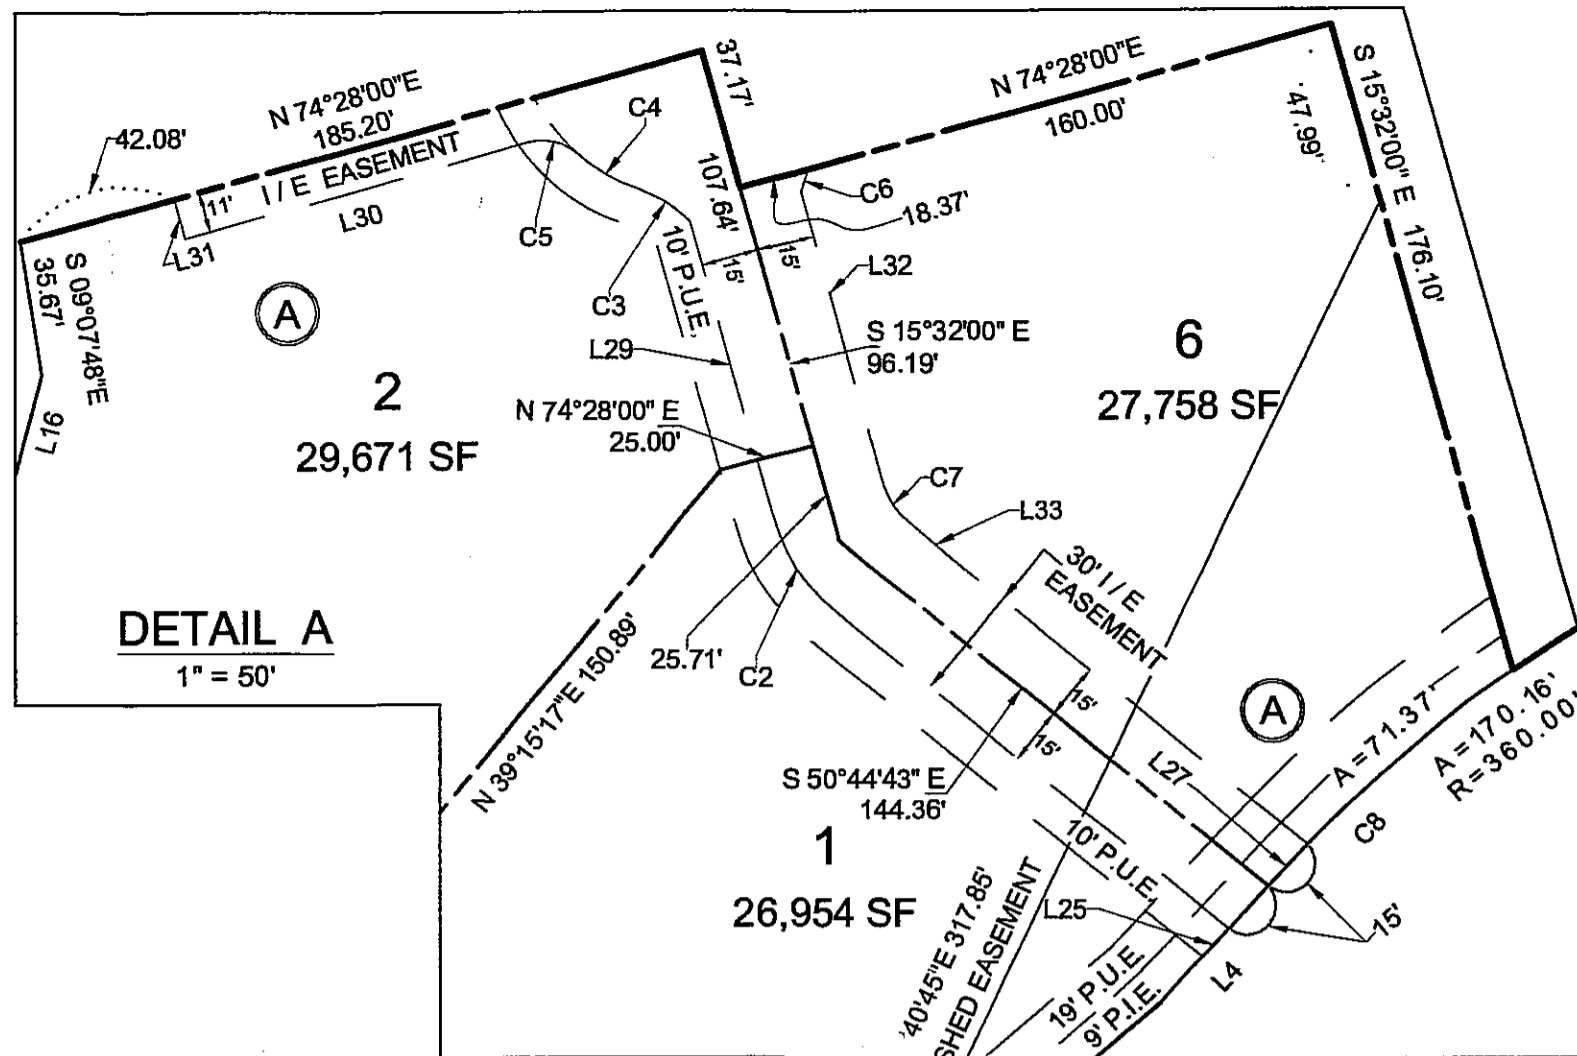
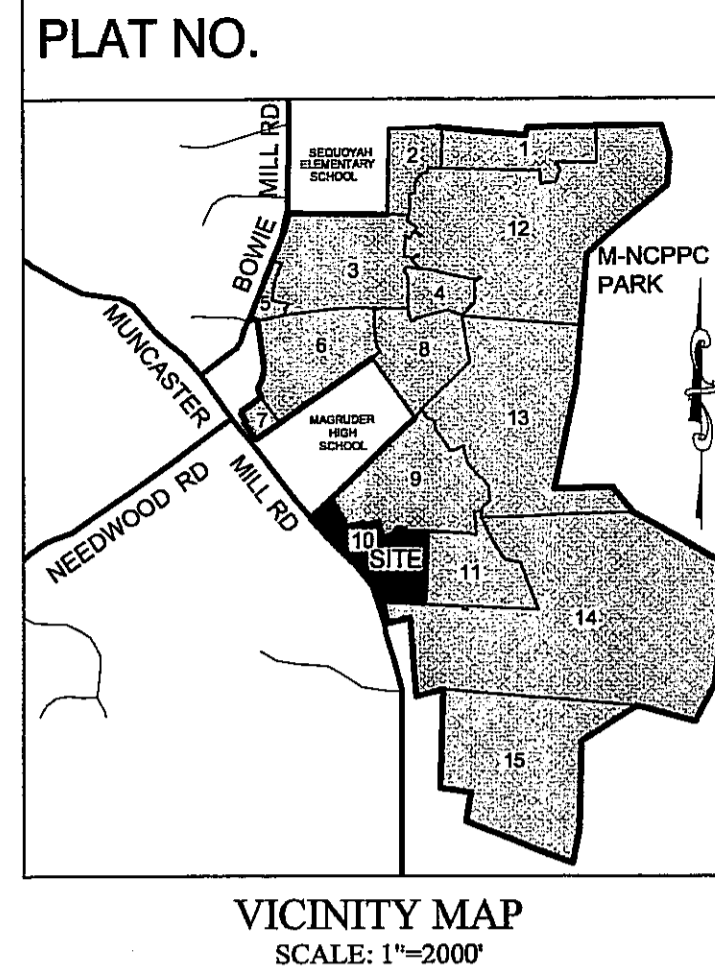
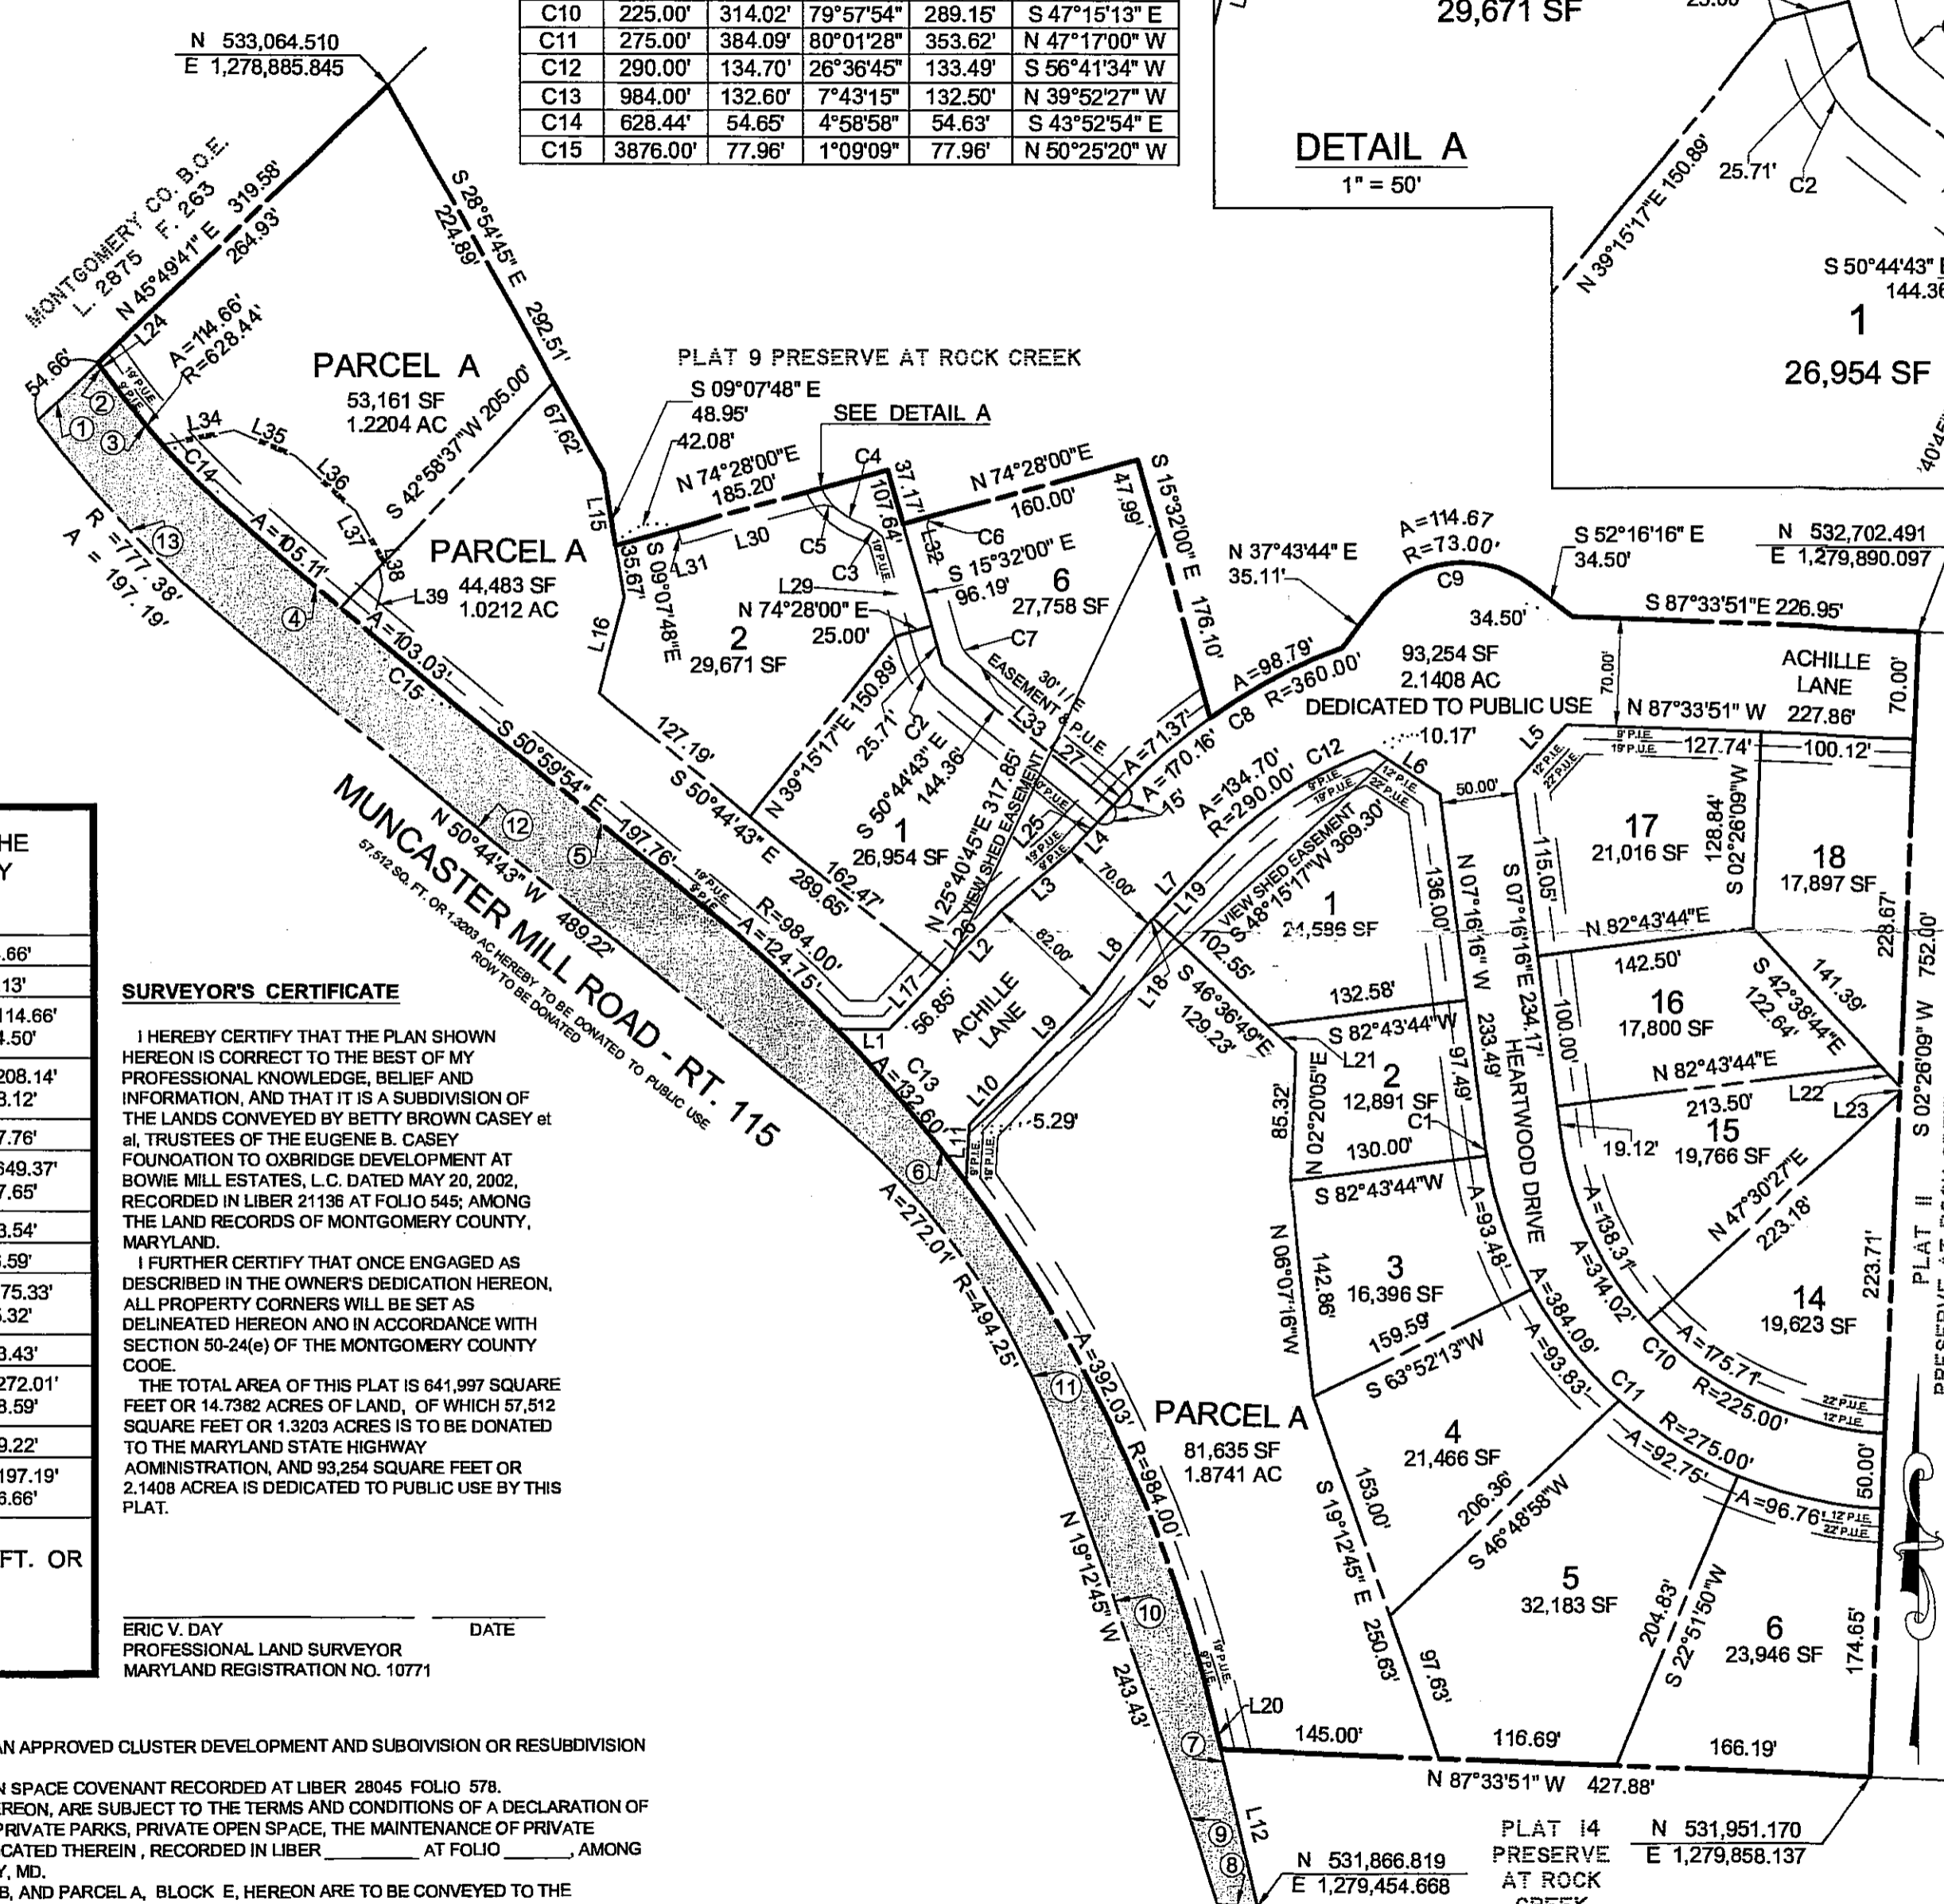
Curve	Radius	Length	Delta	Chord	Chord Bear.
C1	275.00'	7.27'	1°30'54"	7.27'	N 08°01'43" W
C2	50.00'	30.73'	35°12'43"	30.25'	N 33°08'21" W
C3	34.00'	16.44'	27°41'55"	16.28'	N 57°27'18" W
C4	46.00'	18.16'	22°37'21"	18.04'	N 59°59'36" W
C5	14.00'	13.90'	56°52'04"	13.33'	N 77°06'57" W
C6	34.00'	6.16'	10°22'51"	6.15'	S 17°43'46" W
C7	20.00'	12.29'	35°12'43"	12.10'	S 33°08'21" E
C8	360.00'	170.16'	27°04'55"	168.58'	N 56°55'39" E
C9	73.00'	114.67'	90°00'00"	103.24'	N 82°43'44" E
C10	225.00'	314.02'	79°57'54"	289.15'	S 47°15'13" E
C11	275.00'	384.09'	80°01'28"	353.62'	N 47°17'00" E
C12	290.00'	134.70'	26°36'45"	133.49'	S 56°41'34" W
C13	984.00'	132.60'	7°43'15"	132.50'	N 39°52'27" W
C14	628.44'	54.65'	4°58'58"	54.63'	S 43°52'54" E
C15	3876.00'	77.96'	1°09'09"	77.96'	N 50°25'20" W

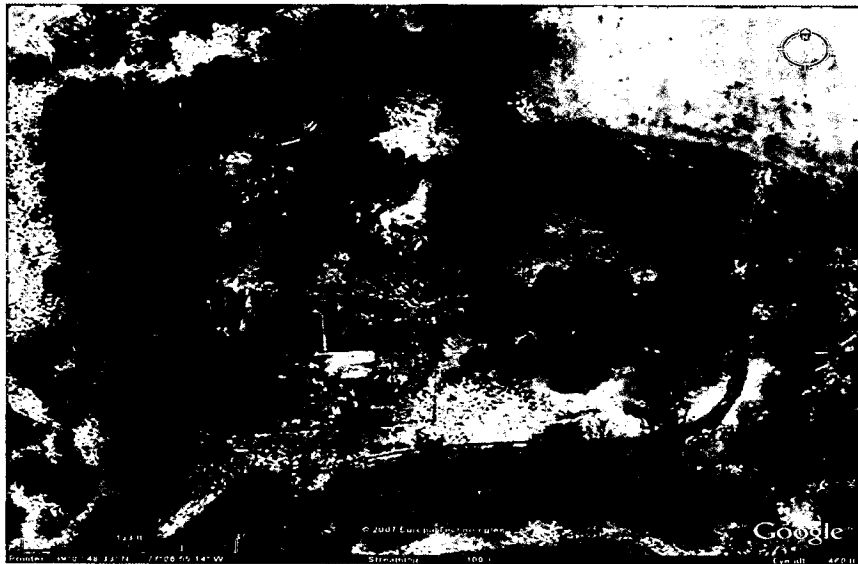
SECTION III. PROPERTY DESCRIPTION AND STABILIZATION PLAN (Continued)

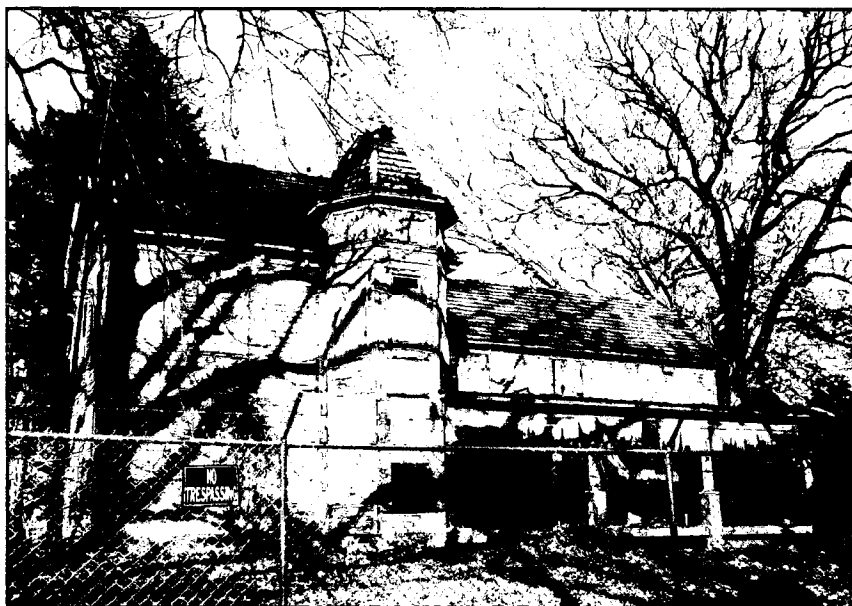
Chain link fence & Specimen Trees

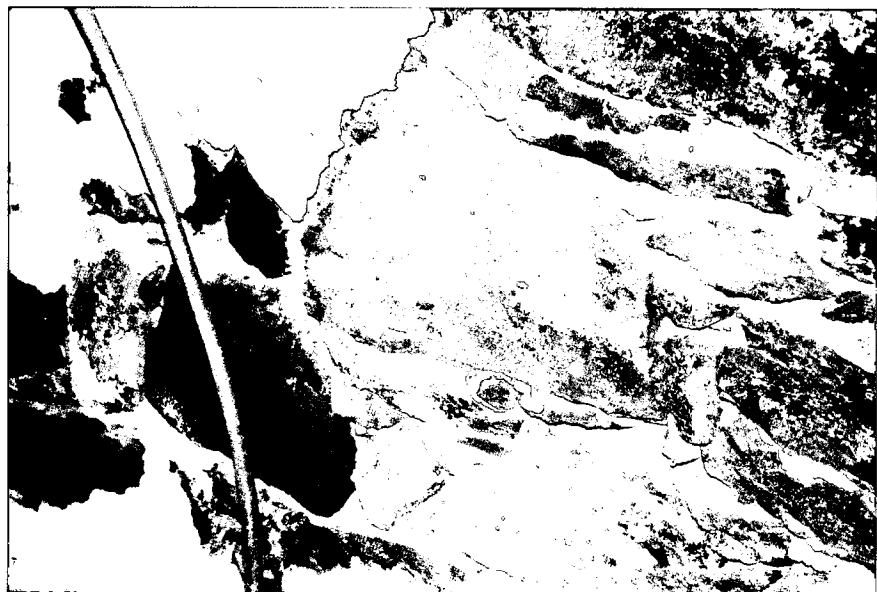
Stone Foundation Wall

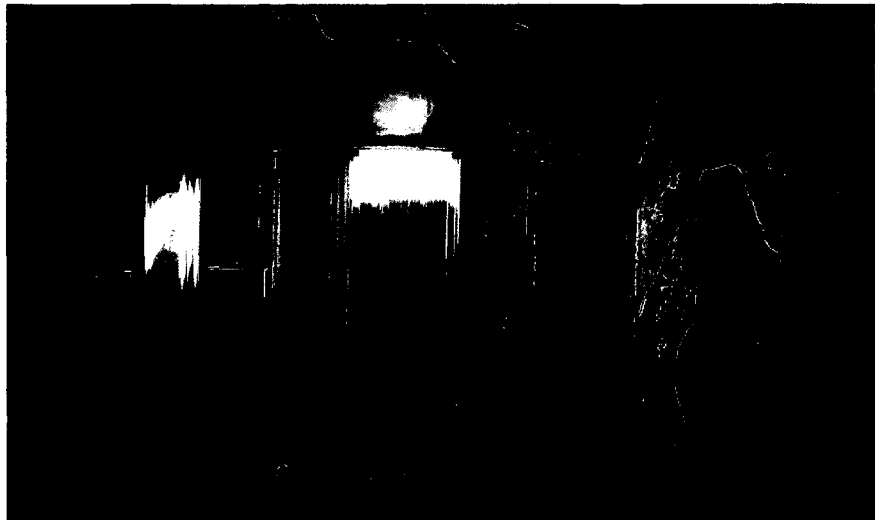
Windows in Stair hall

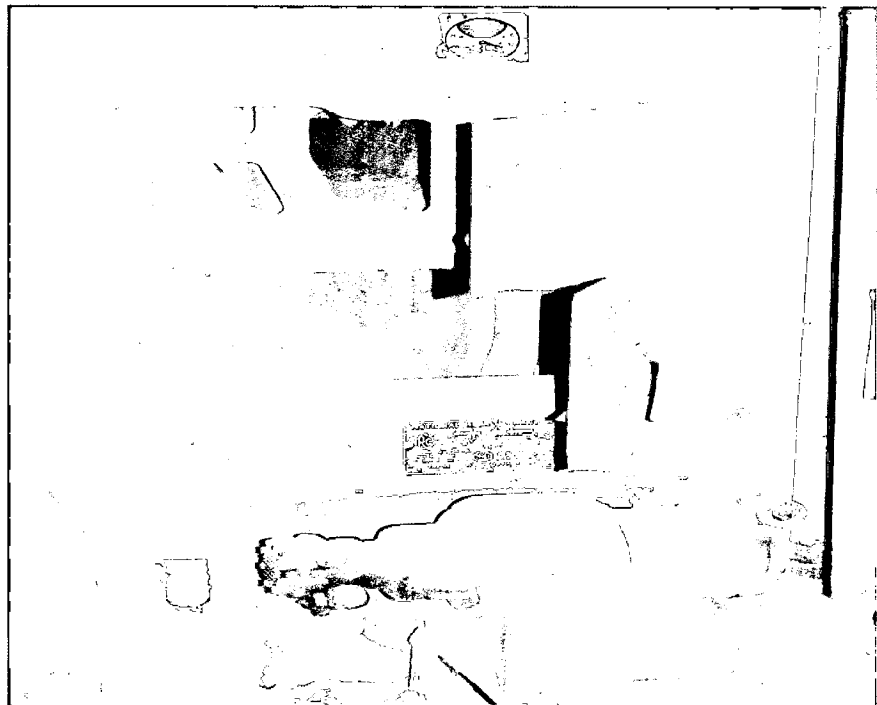
SECTION III. PROPERTY DESCRIPTION AND STABILIZATION PLAN (Continued)

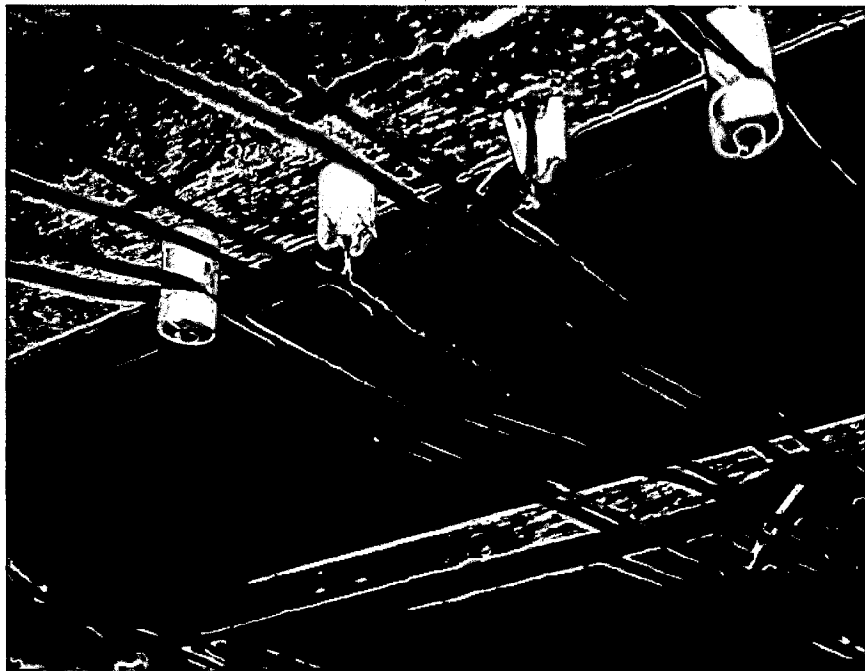
Knob -and-Tube wiring

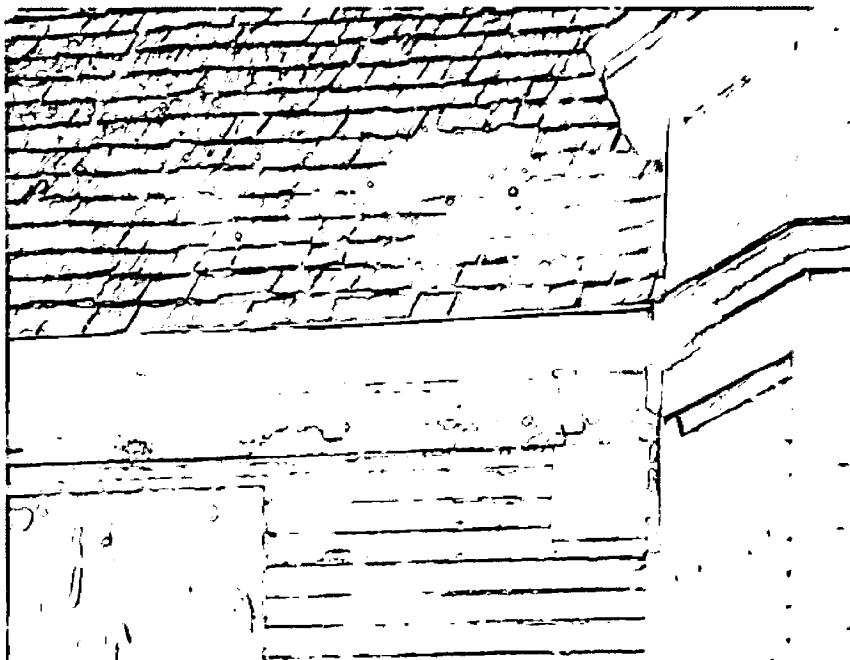
Roof and wall patches.

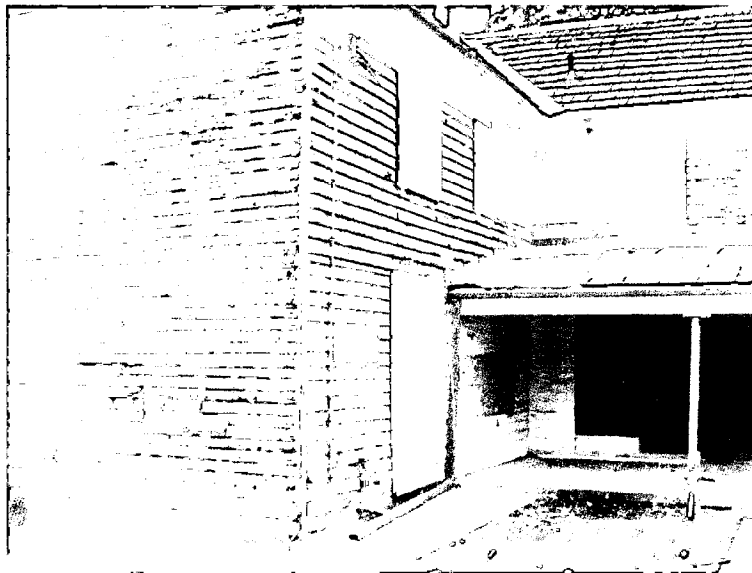
Sealed holes in north wall

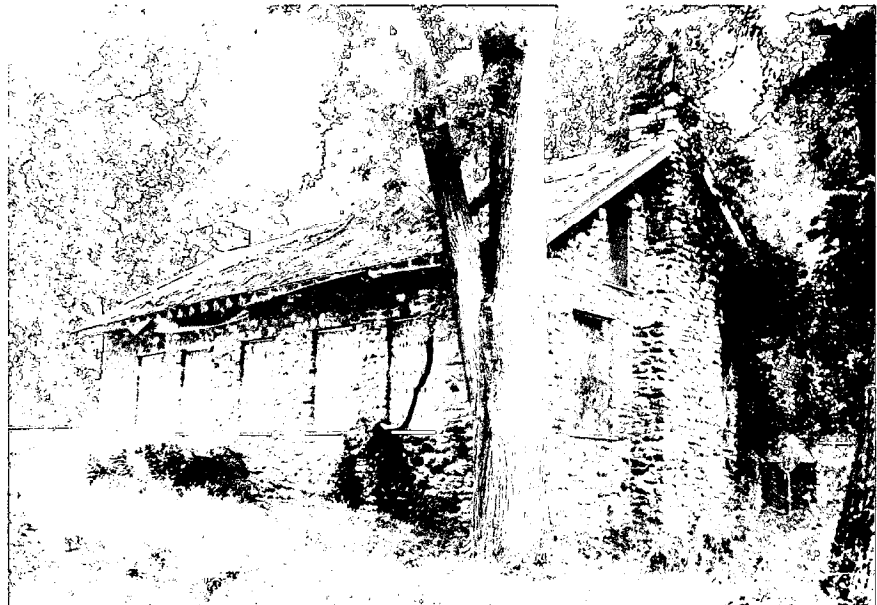
Stone House view from Southwest before emergency stabilization

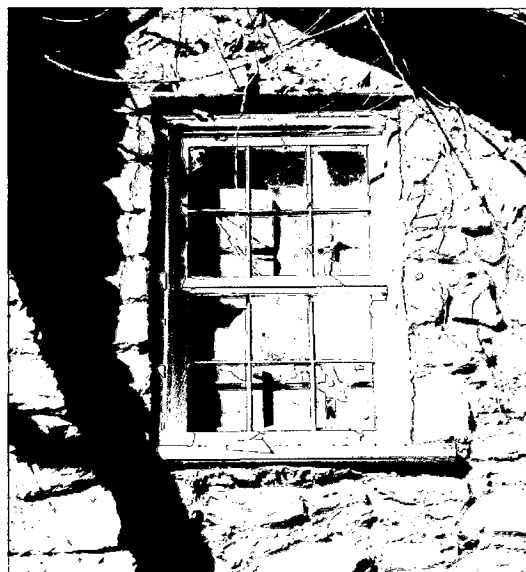
Exterior doors: Six-over-Six windows
None observed.

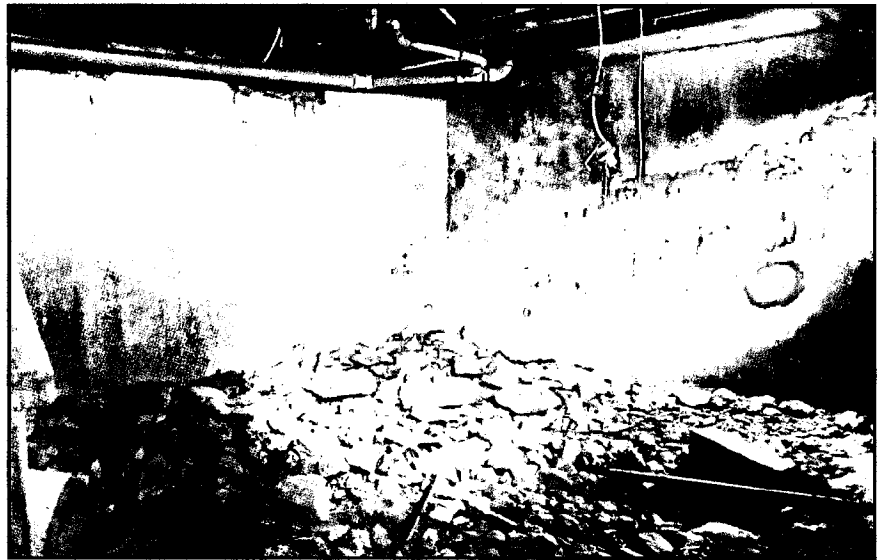
SECTION III. PROPERTY DESCRIPTION AND STABILIZATION PLAN (Continued)

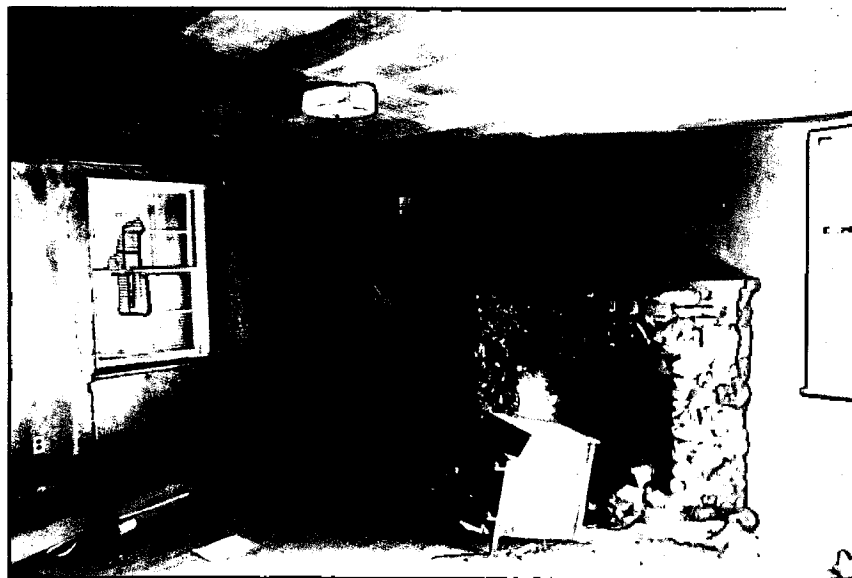
South room with Fireplace

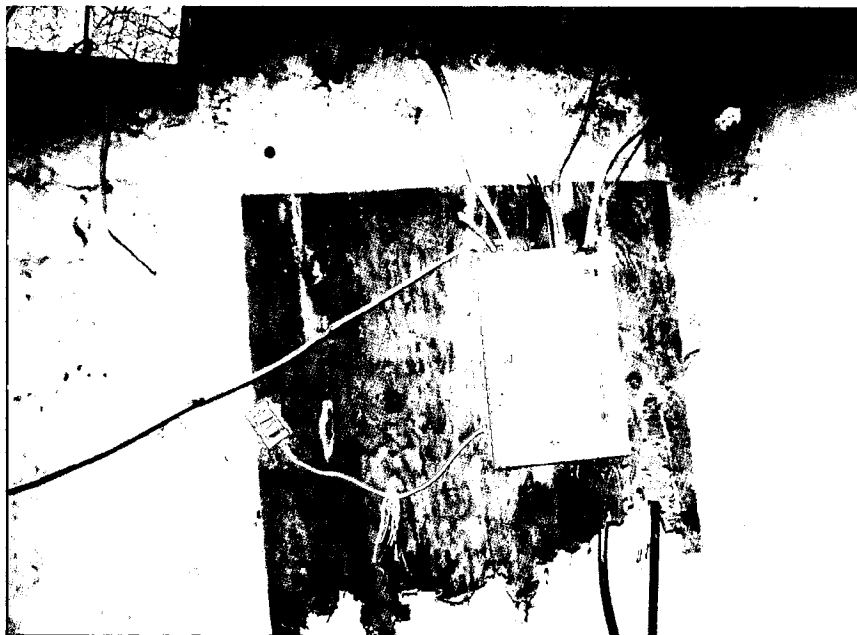
Electrical panel box

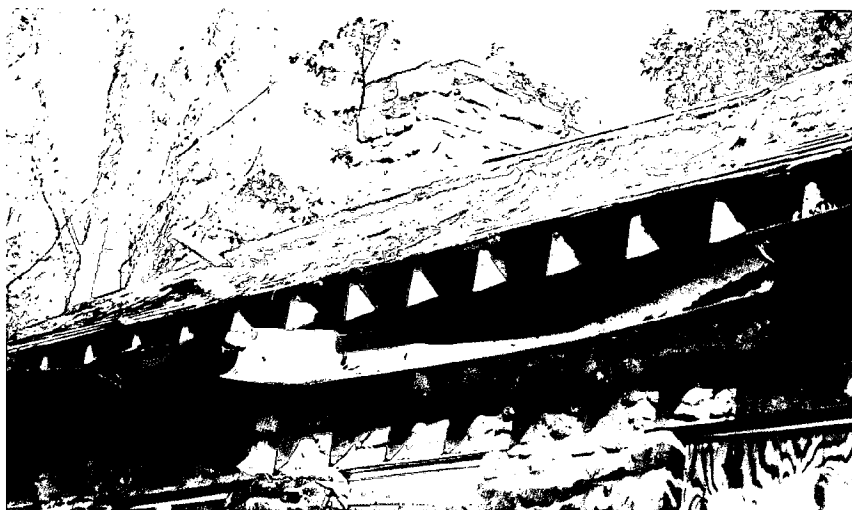
Collapsed gutter at stone house
