22/25-06A 5867 Muncaster Mill Rd
J.H. Cashell Farm, 22/25

STABILIZATION PLAN

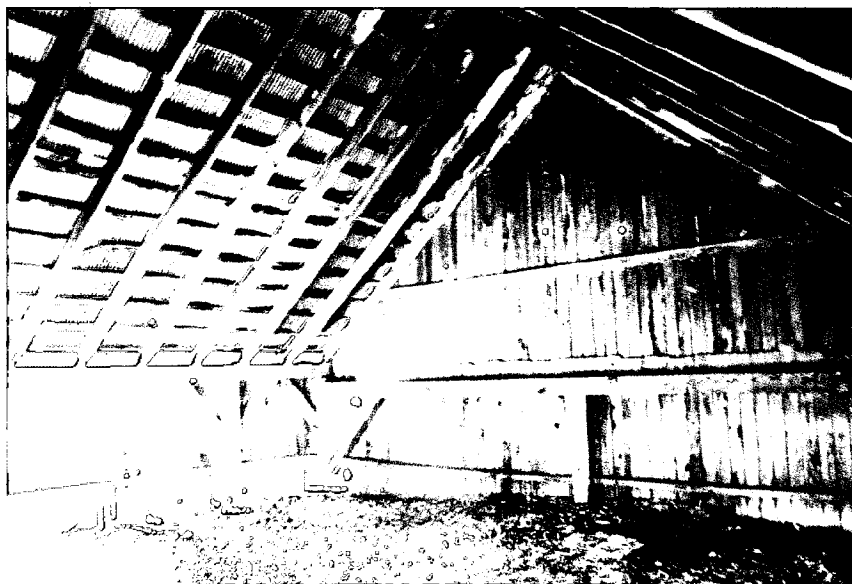
- Structure: The foundation walls are cast concrete. The framing is timber-framed with nailed connections. The ground floor is dirt. The loft floor is sawn joists supported on timber girts and girders.
- Exterior walls: Exterior walls are vertical tongue-and-groove wood siding.
- Windows: There are no windows.
- Exterior doors: The exterior door at the loft level is plank. No other doors are extant.
- Roofing Systems: The roof covering is corrugated tin.
- Chimneys: There are no chimneys.
- Insulation: No insulation was noted

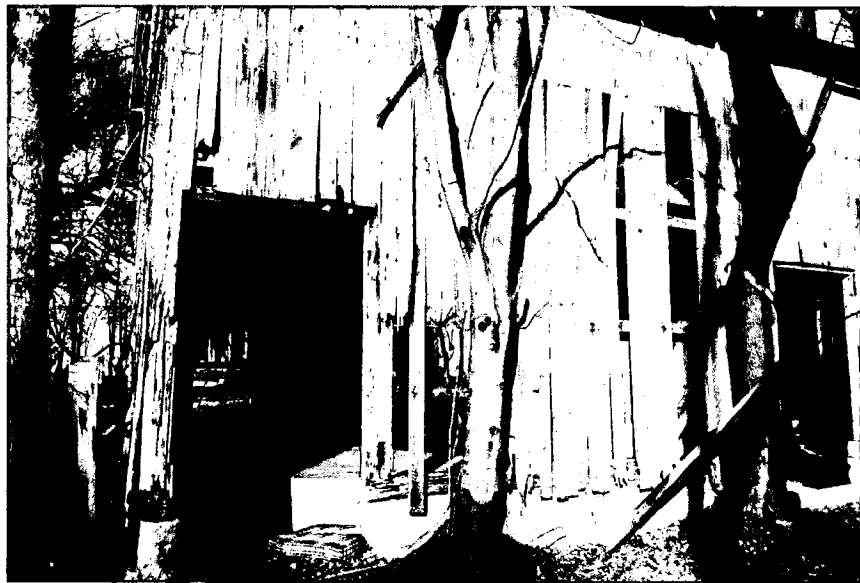
Deteriorated & missing barn siding before emergency stabilization

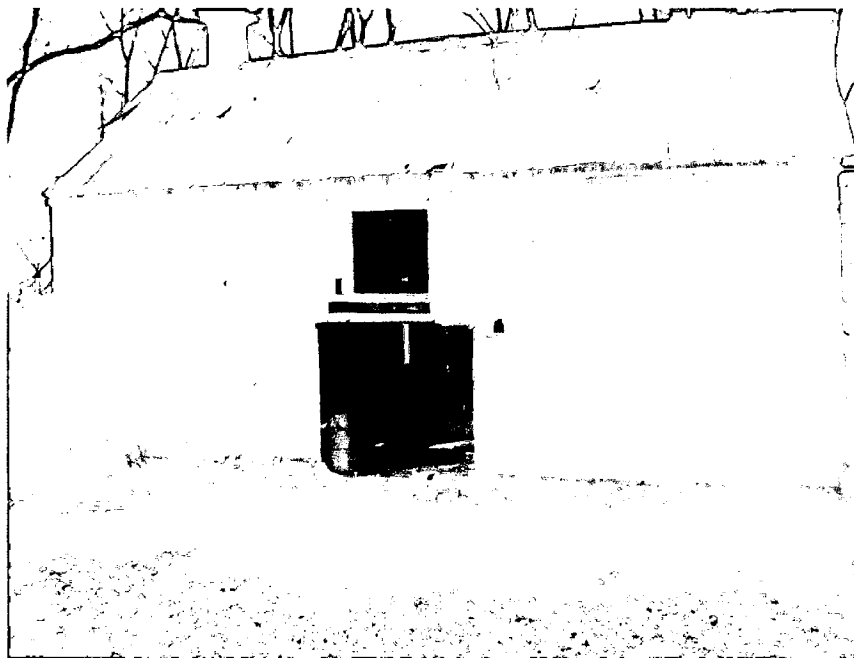
Barn north façade after plywood installation
