23/29-03A RETROACTIVE 5929 Sundown Road
Laytonsville

(Master Plan Site #23/29 Fair Hill II)

HISTORIC PRESERVATION COMMISSION STAFF REPORT

PROPOSAL: Window Replacement

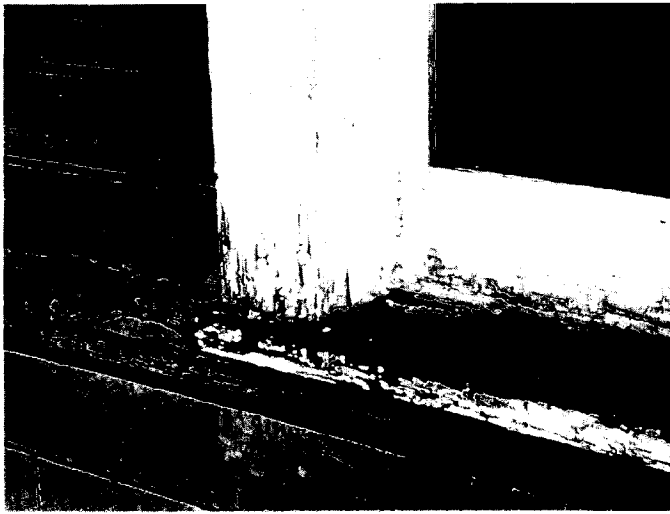
Figure 3. Deterioration of poorly maintained windows usually begins on horizontal surfaces and at joints where water can collect and saturate the wood. The problem areas are clearly indicated by paint failure due to moisture. Photo: Baird M. Smith, AIA
