HPC #34/08-03A Julius Marlow House
Master Plan Site 34/08

SUBJECT: Historic Area Work Permit

HISTORIC PRESERVATION COMMISSION STAFF REPORT

Gloria Marconi, Owner
The Julius Marlow House, c. 1790
2525 Musgrove Road
Silver Spring, MD 20904

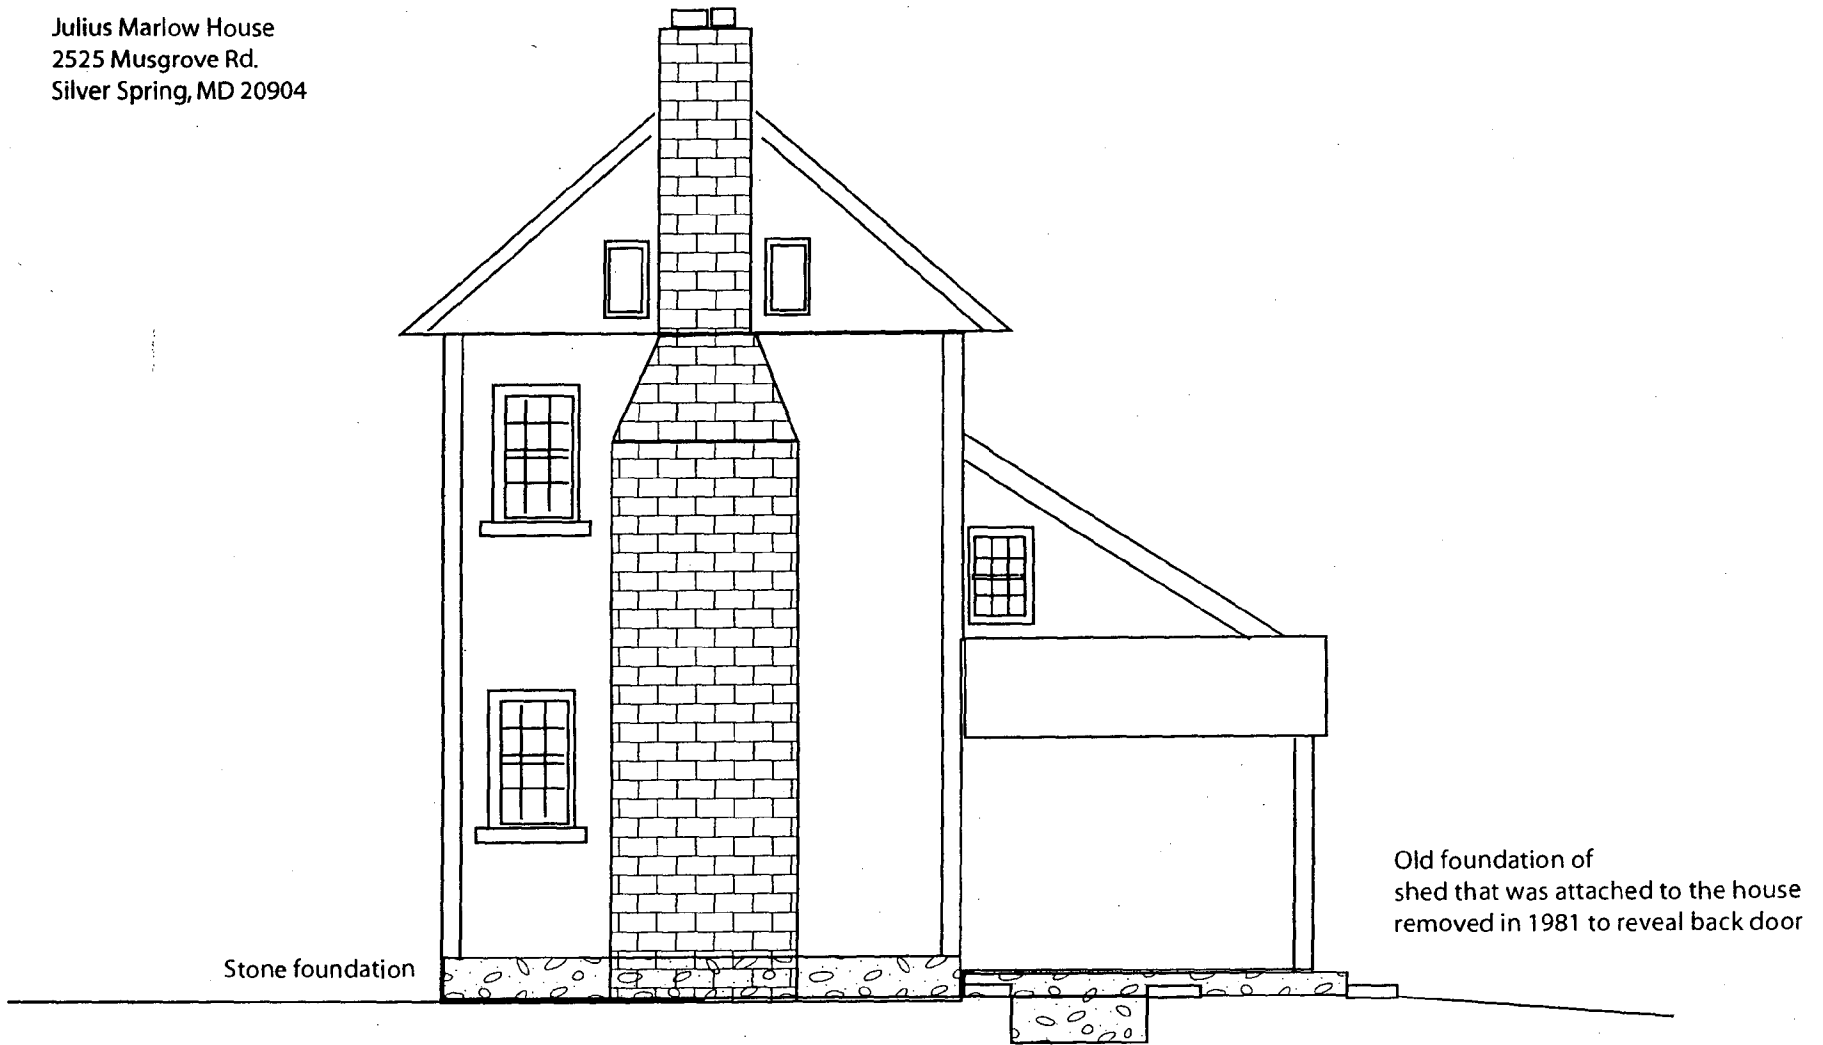
West Elevation

Stone foundation

Old foundation of
shed that was attached to the house
removed in 1981 to reveal back door

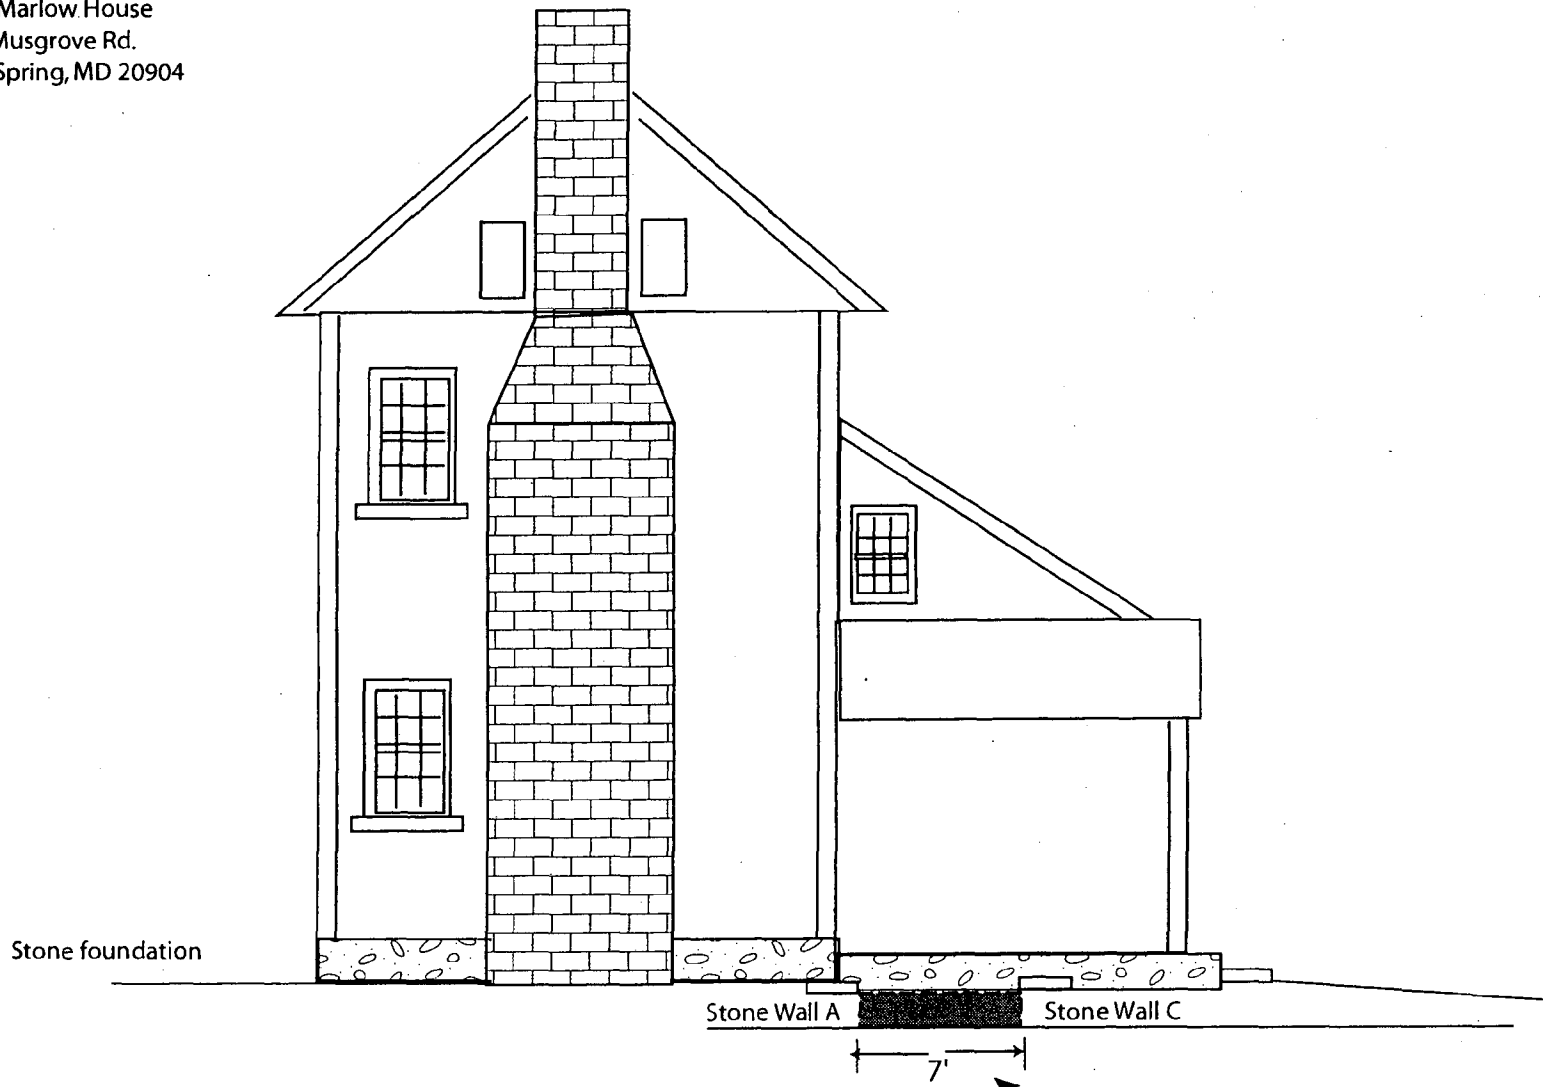
Proposed West Elevation

Stone wall B will
have an opening for storage

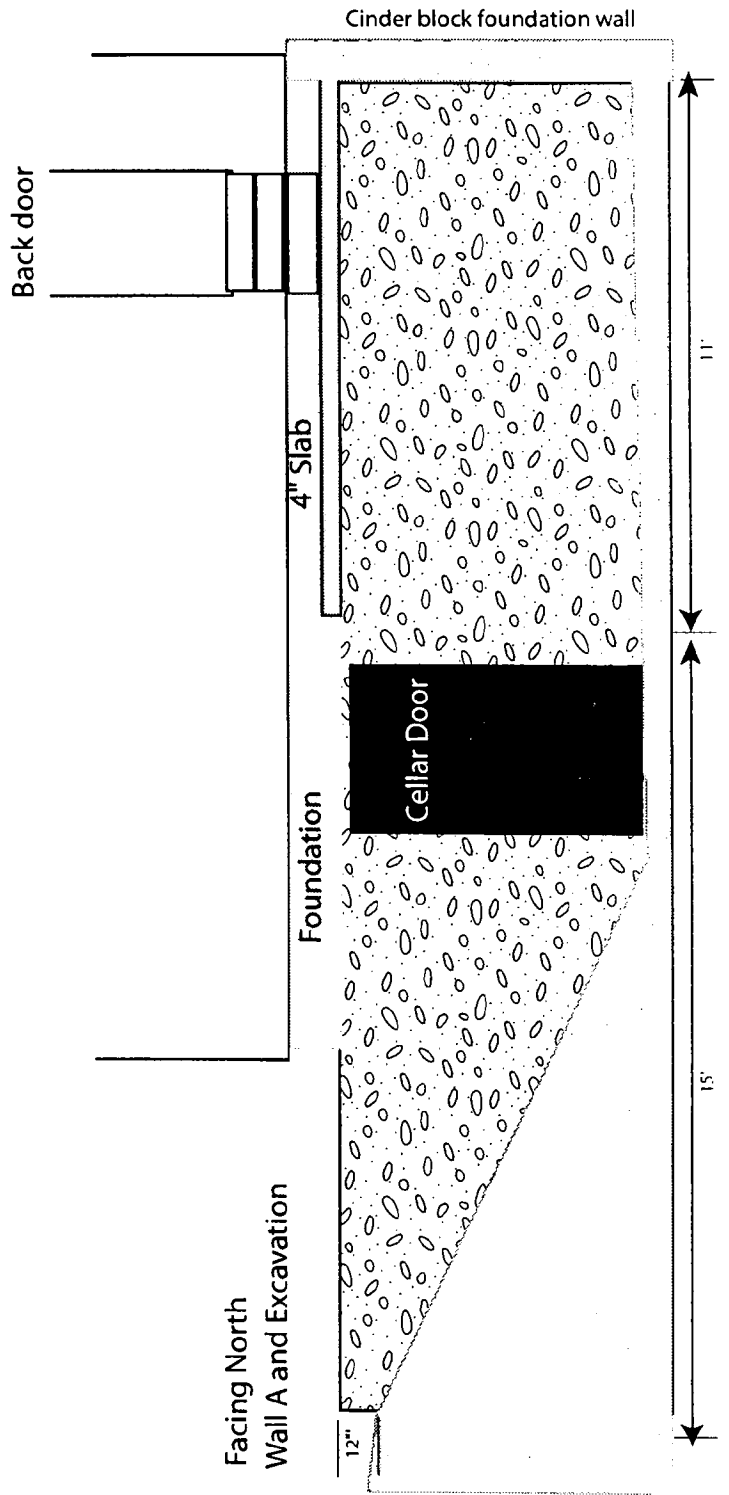
Facing North
Wall A and Excavation

c. Stone walls outside of basement are falling down and one wall, (Wall A) carried away part of the foundation wall when it fell. The other two (B&C) are bulging, cracked and leaning over and must be replaced. These walls are around 50 years old and were put up by a former owner, Mr. Bushnell.

c. Stone walls: Rebuild the walls of rubble stone approximately 14" thick, recycling as much as possible and where not possible using similar type stones. The walls will have weep holes (which they do not have at present and which no doubt caused them to break). The corner of the house where the fallen wall has pulled away some of the foundation stone will be rebuilt with matching stone and mortar. I would like to excavate behind Wall B and create an opening that will be large enough for the lawn tractor and other outdoor tools. Presently there are no suitable sheds or structures on the property and no garage. This would be an unobtrusive solution and would vastly improve things. The area immediately outside the back door needs to be paved over since water is also leaking into the basement from somewhere in that area. Pouring a reinforced cement slab and then covering it with fieldstone to match the existing steps would be a good solution. Wall C, which is leaning over needs to be straightened out. The walls follow the sloping path that leads down to the cellar entrance and vary in height from 8' near the house to approx. 6" at the farthest point

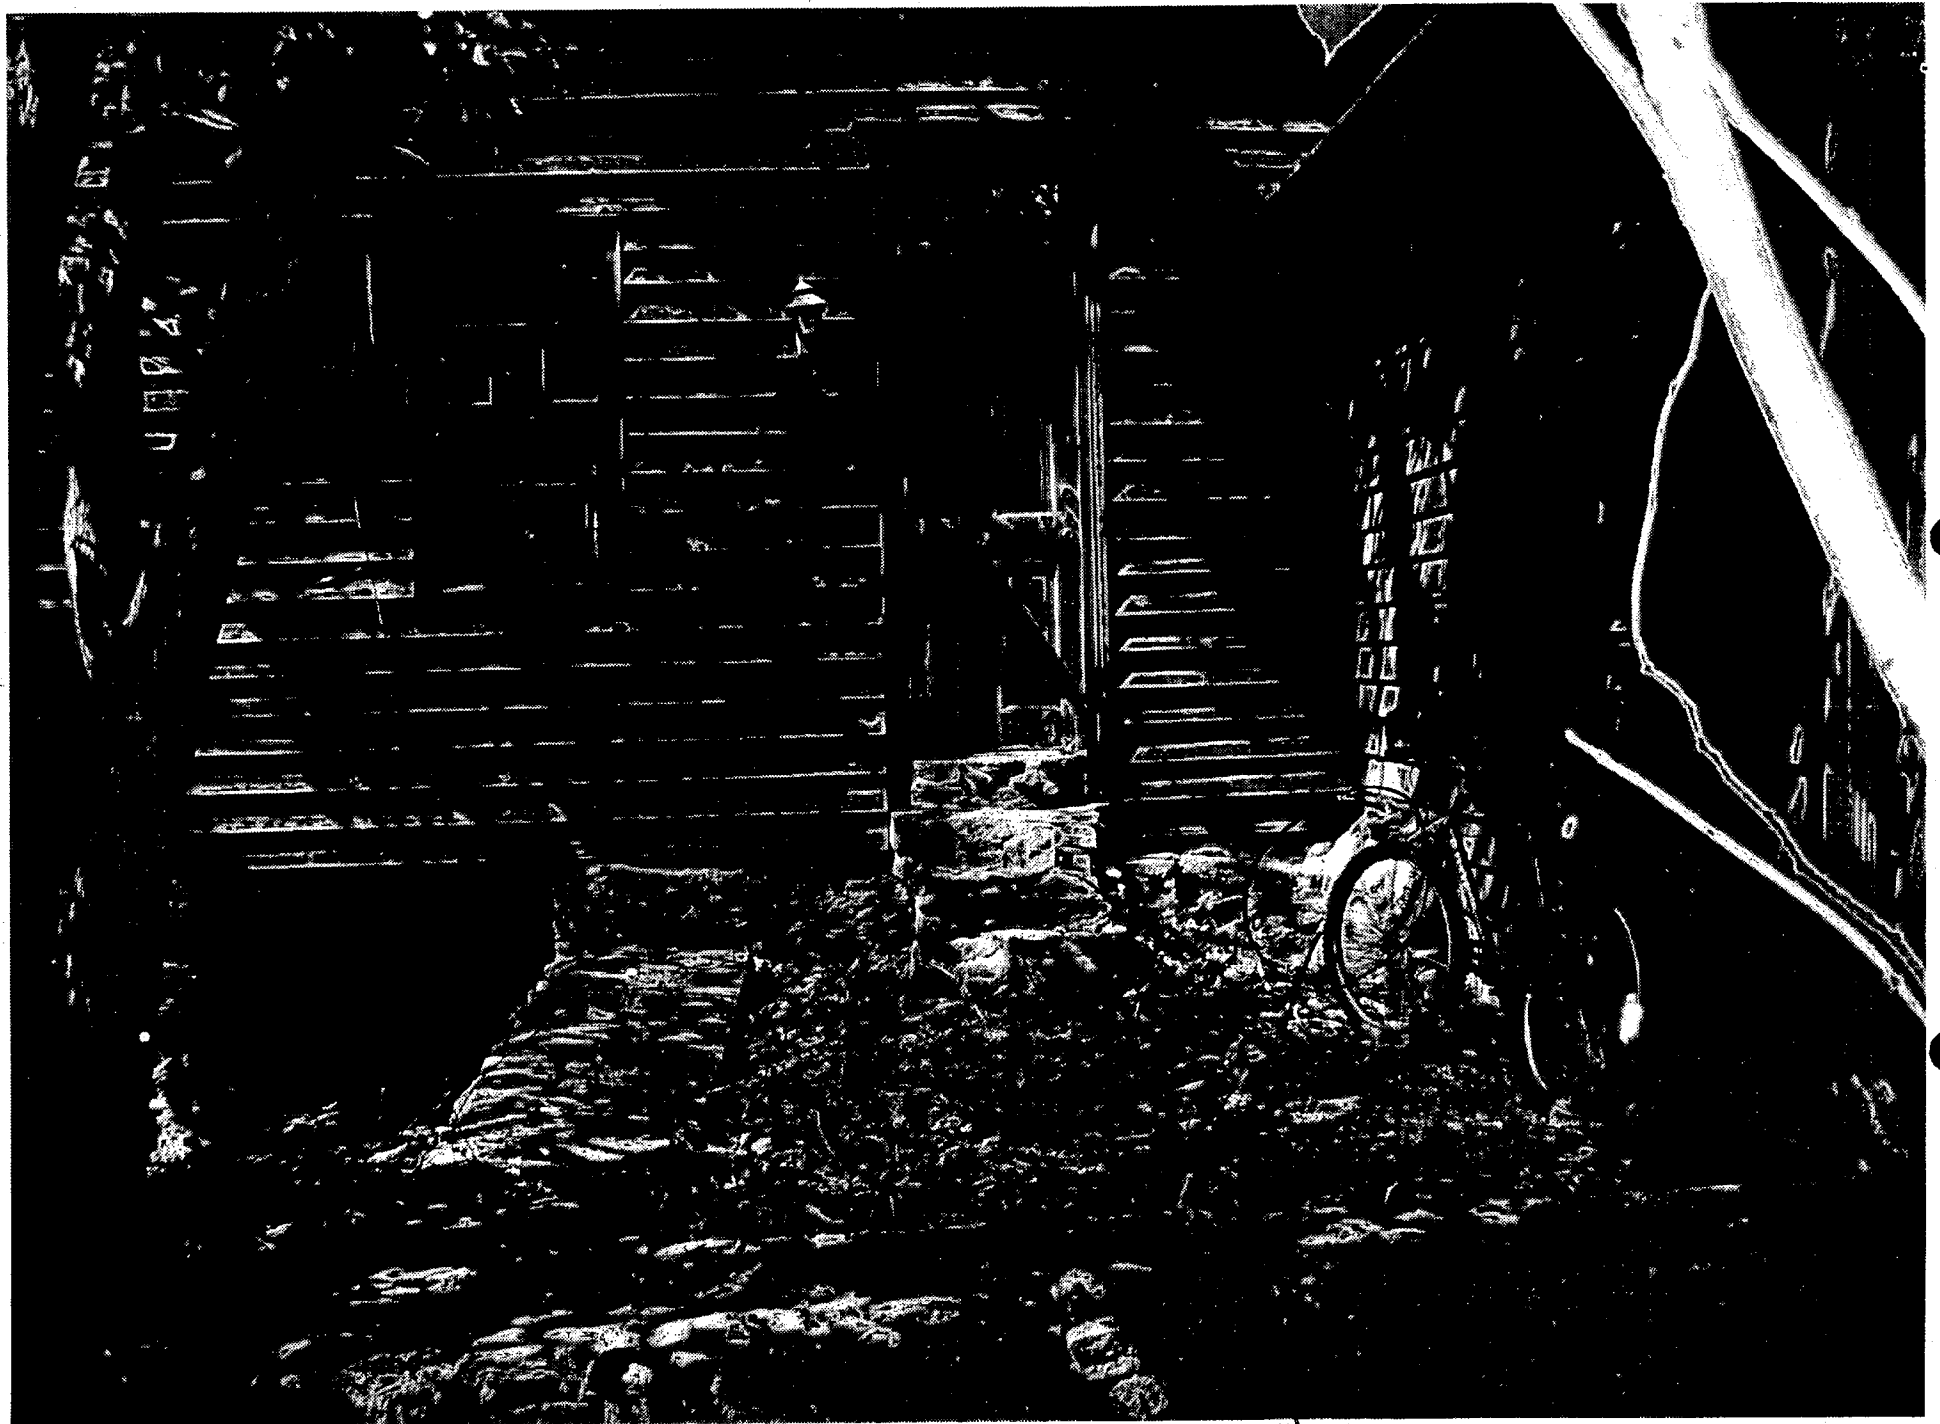
(12)

BACK DOOR - OLD FOUNDATION

WATER LEAKING INTO BASEMENT

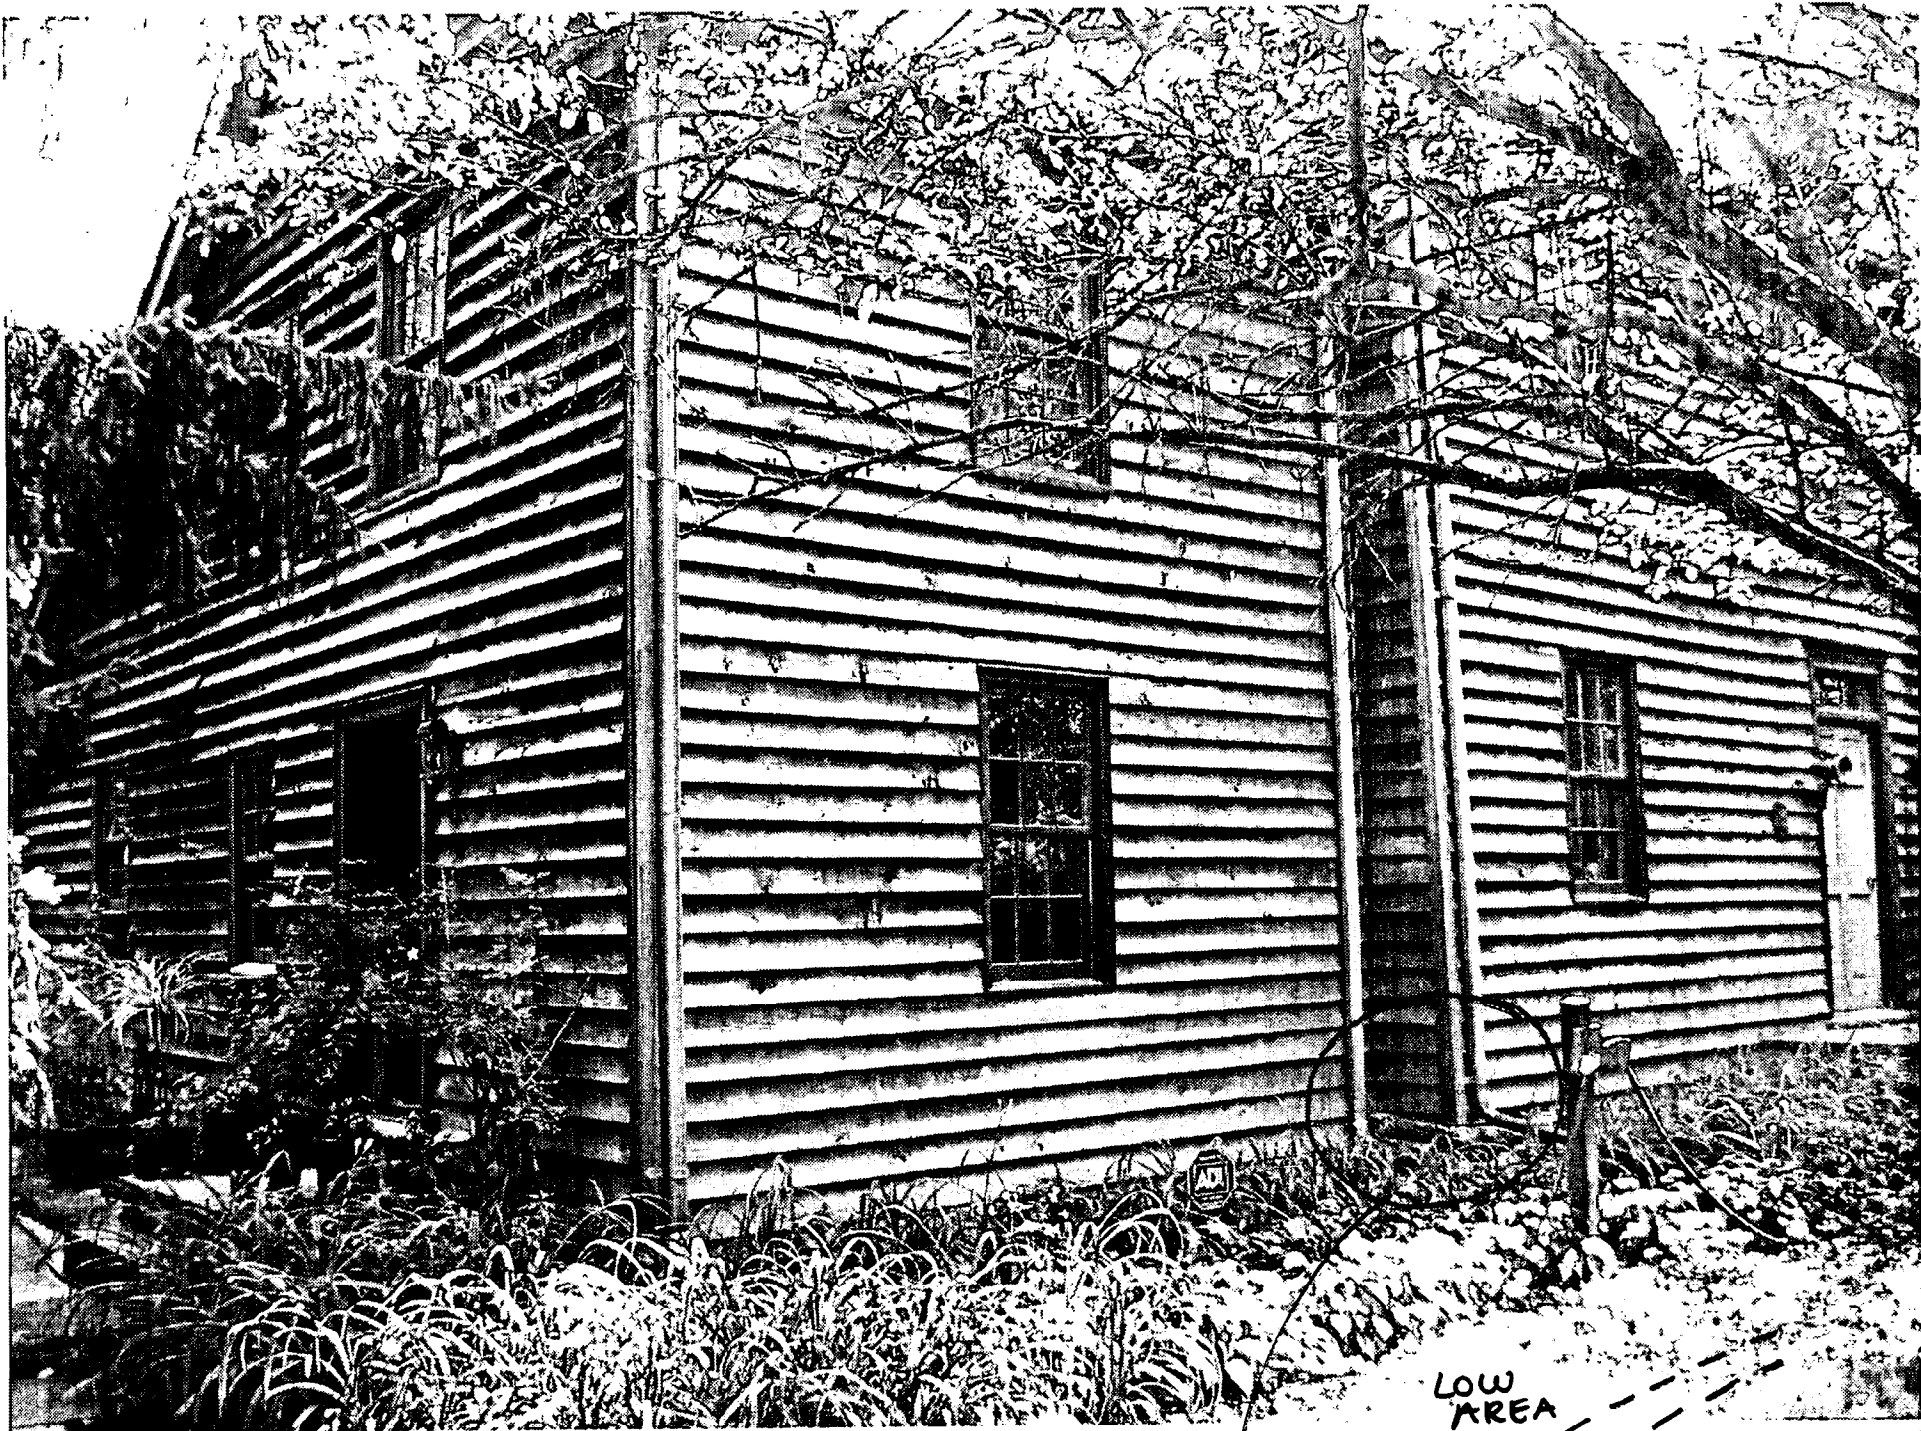
NORTH FRONT AND EAST FACADE.

LOW AREA
DRAINAGE WILL GO
AREA OF WORST WATER PROBLEM HERE

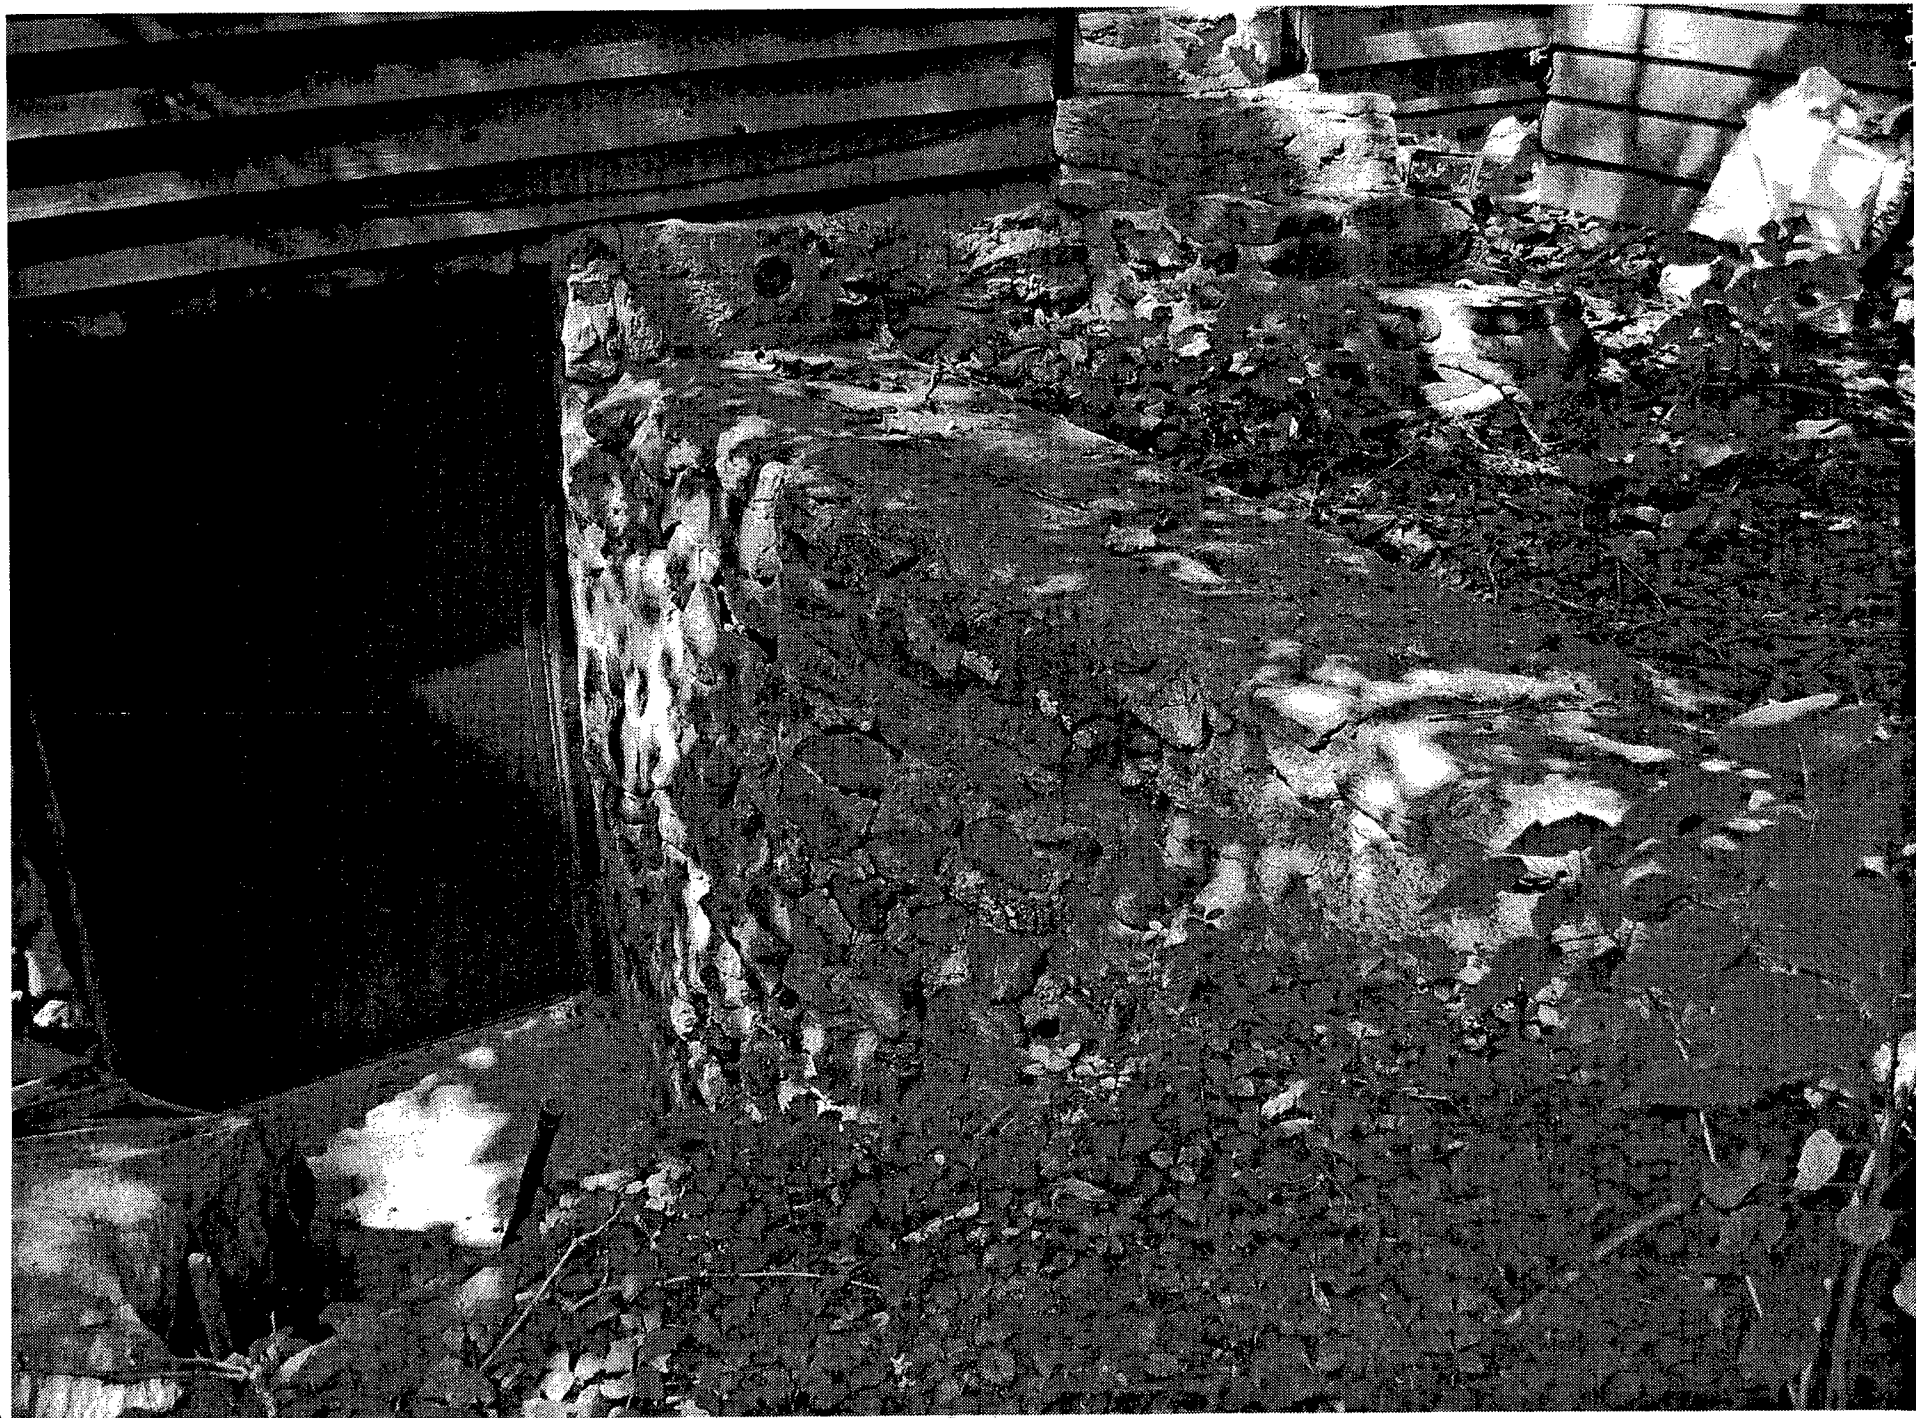
28
WALL B + CELLAR DOOR, ALSO OLD ^{SHED} LAUNDRY ROOM FOUNDATION -
