37/3-02EE 15 Montgomery Ave.
(Takoma Park Historic District)

HISTORIC PRESERVATION COMMISSION STAFF REPORT

Restoration of 15 Montgomery Ave., Takoma Park, MD 20912 (Takoma Park Historic District)

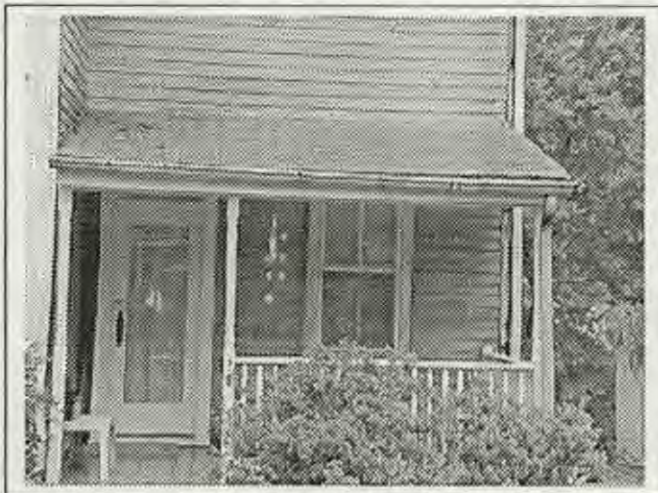
Here is a picture of our current front porch and front door. You can see the wood strip that is a different color, showing change in roof level. We plan to restore roof to what we believe was the original roof line.

Current porch structure in bad shape. Plan to tear down existing porch and rebuild to same style with above trim.

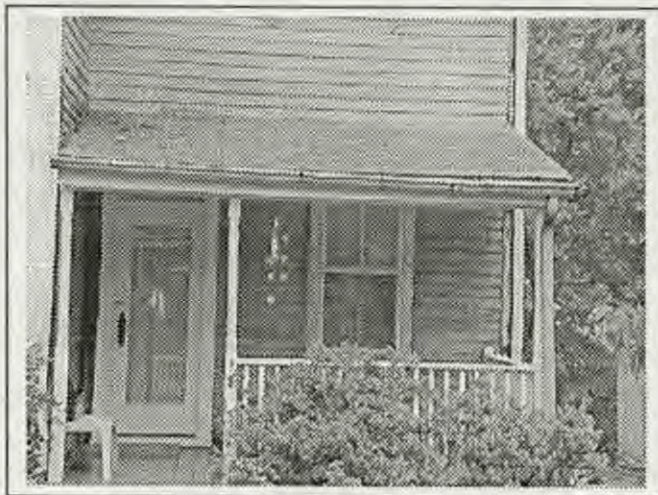
Here is a picture of our current front porch and front door. You can see the wood strip that is a different color, showing change in roof level. We plan to restore roof to what we believe was the original roof line.

Current porch structure in bad shape. Plan to tear down existing porch and rebuild to same style with above trim.

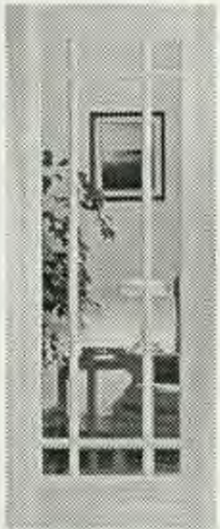
New back door- replacing door that was installed
in 1986 as part of a new addition.

Old door is badly damaged. Wood rotting.

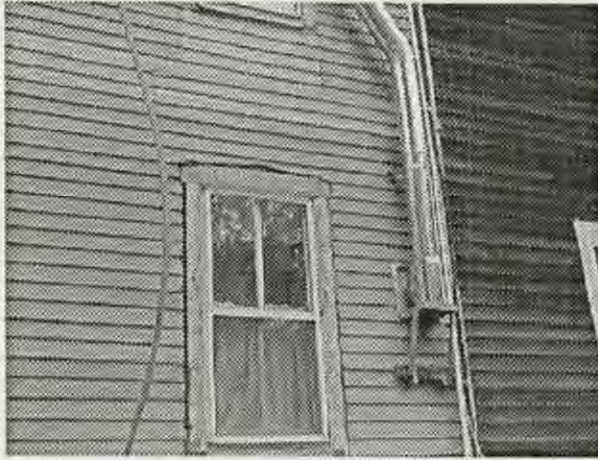
Outline of window decorative trim.

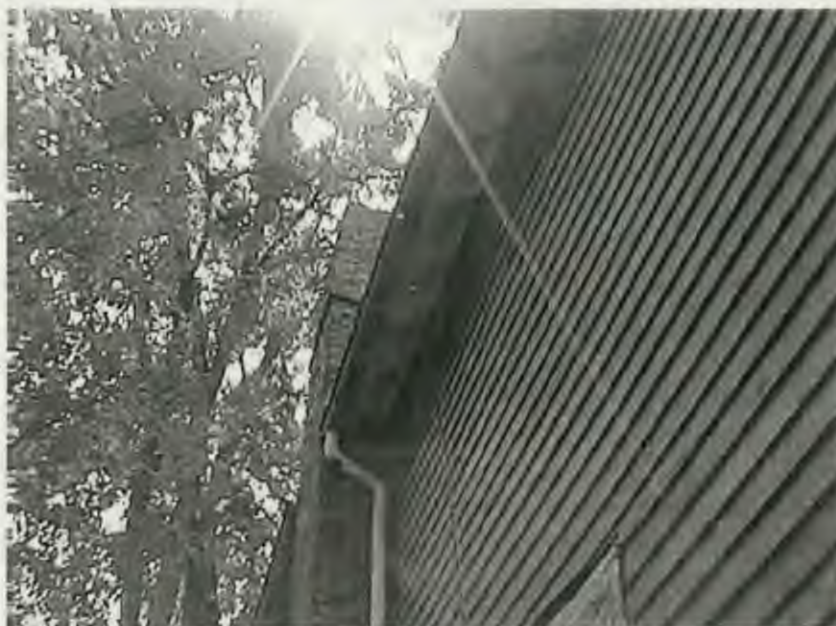
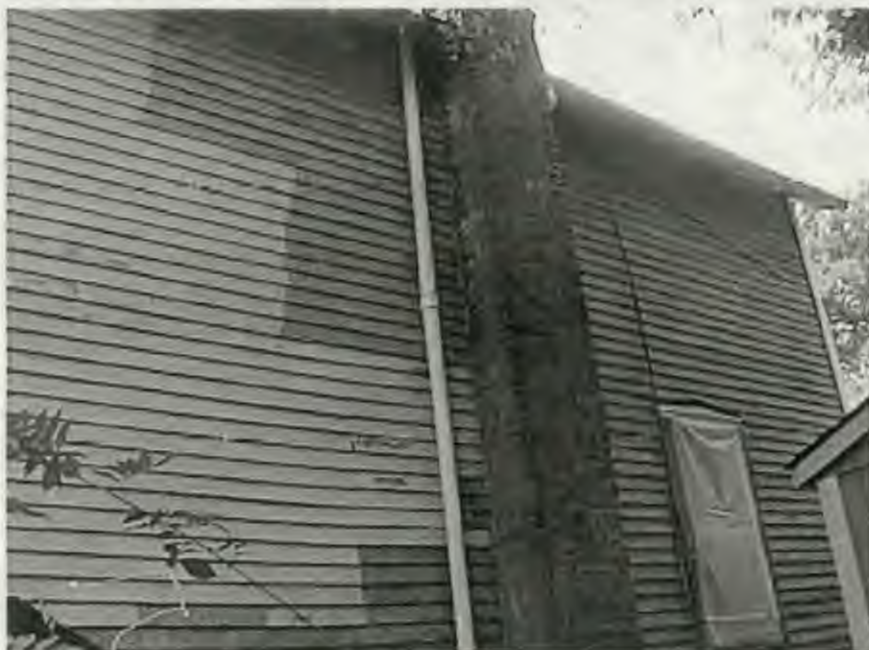
Side of house

Difficult to photograph because 17 Montgomery Ave. House is so close.

Top picture shows chimney with extension.

Bottom picture shows rest of side (with lead paint removal in progress).

The chimney bricks are loose and need to be stabilized. In addition, an extension to the chimney was added that does not match the original chimney brickwork. We are contracting with a mason to remove the extension and restore the original brickwork.

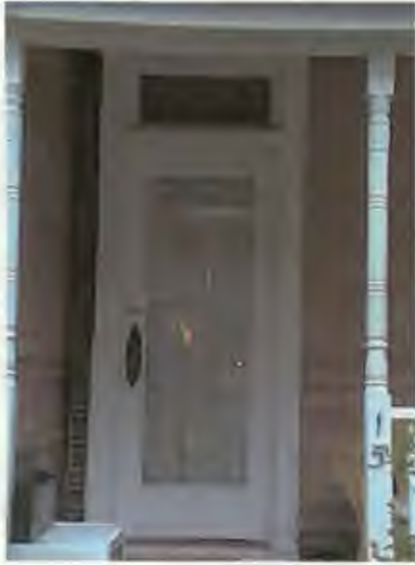
Current front door.
a transom

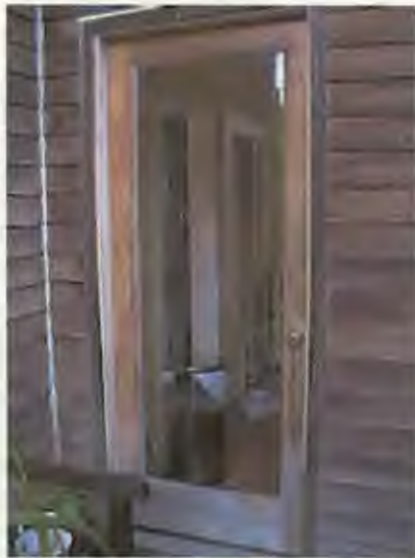
Current back door.

↑ heavy damage

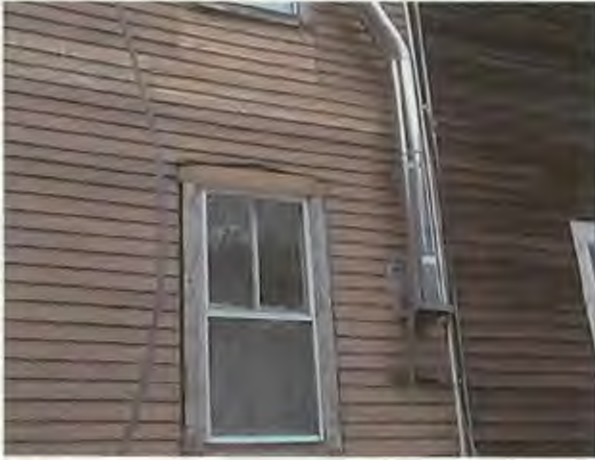
Outline of window decorative trim.

*(revealed after siding
was removed)*

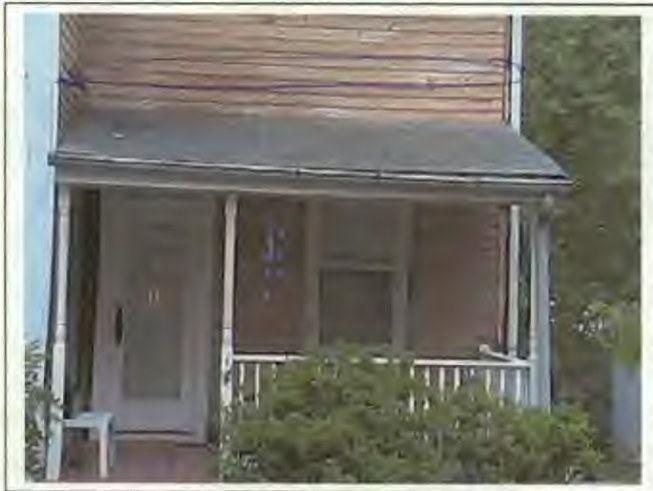
Here is a picture of our current front porch and front door. You can see the wood strip that is a different color, showing change in roof level. We plan to restore roof to what we believe was the original roof line.

Current porch structure in bad shape. Plan to tear down existing porch and rebuild to same style with above trim.

We need to take down this porch -
Roof area very damaged -
we plan to rebuild it - some
space + design - 2ft. higher
where we believe it
was built on the original
house.

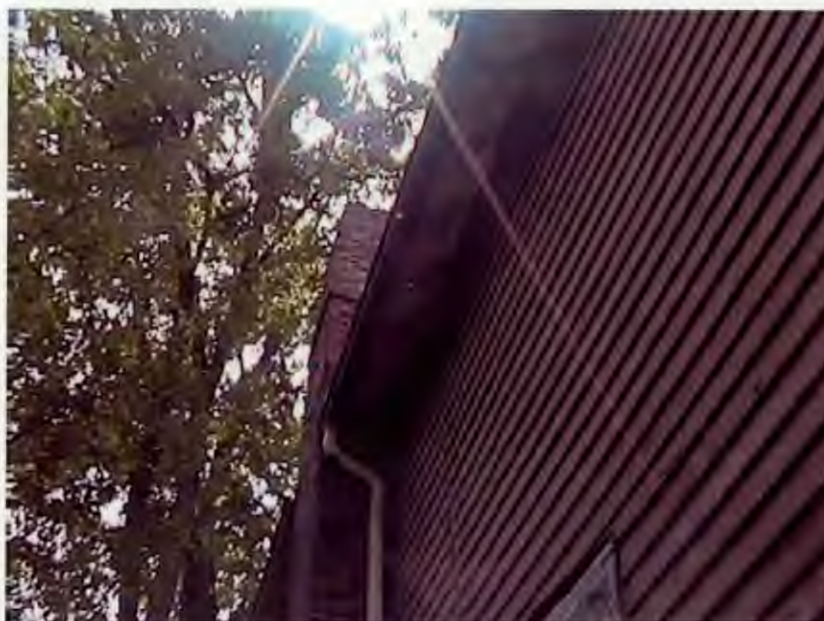
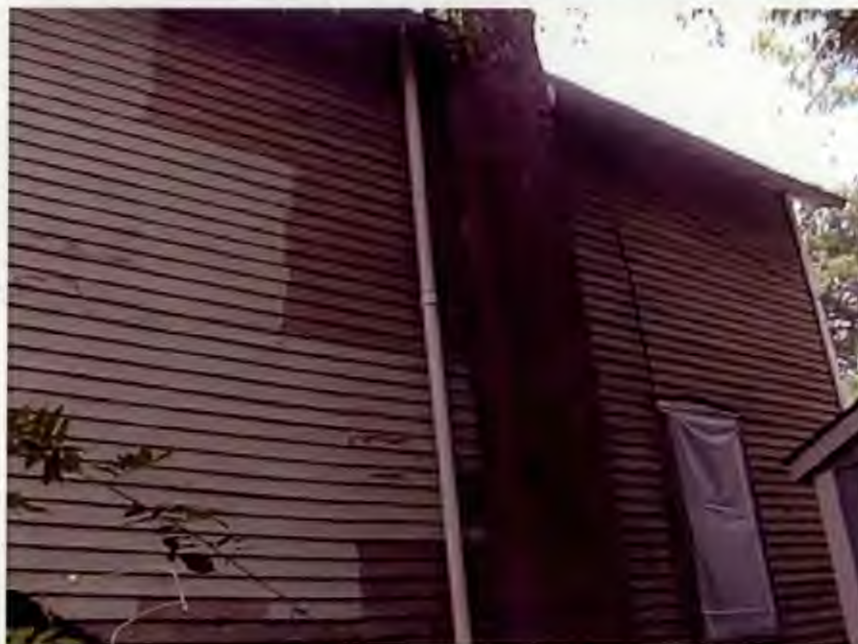
Side of house

Difficult to photograph because 17 Montgomery Ave. House is so close.

Top picture shows chimney with extension.

Bottom picture shows rest of side (with lead paint removal in progress).
