306 Market Street  
Brookville

HAWP 23/65-08A

SUBJECT: **Stop Work Order:** Historic Area Work Permit #518318 - 306 Market Street, Brookeville.

**PROPOSAL:** Window and door replacement and other alterations

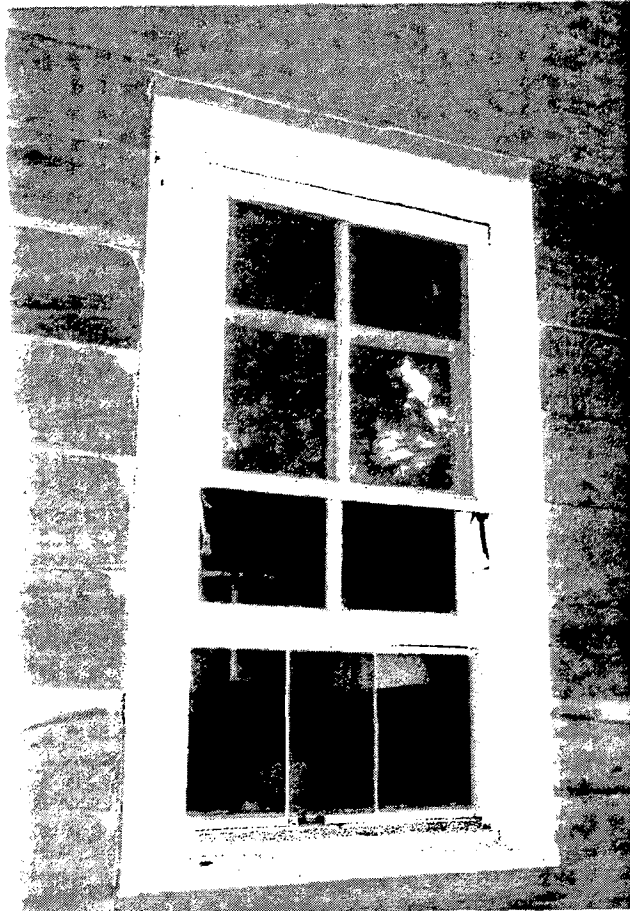
W8 2' 5 3/8" x 4 1/2"

The wood and glass window has true divided light (2 over 2 paned), is damaged and does not close properly or lock. The window will be replaced by a 6 over 6 paned simulated divided light, wood and glass Jeldwen Energy Star with screen. The wood will be stained cedar to match the cedar siding.

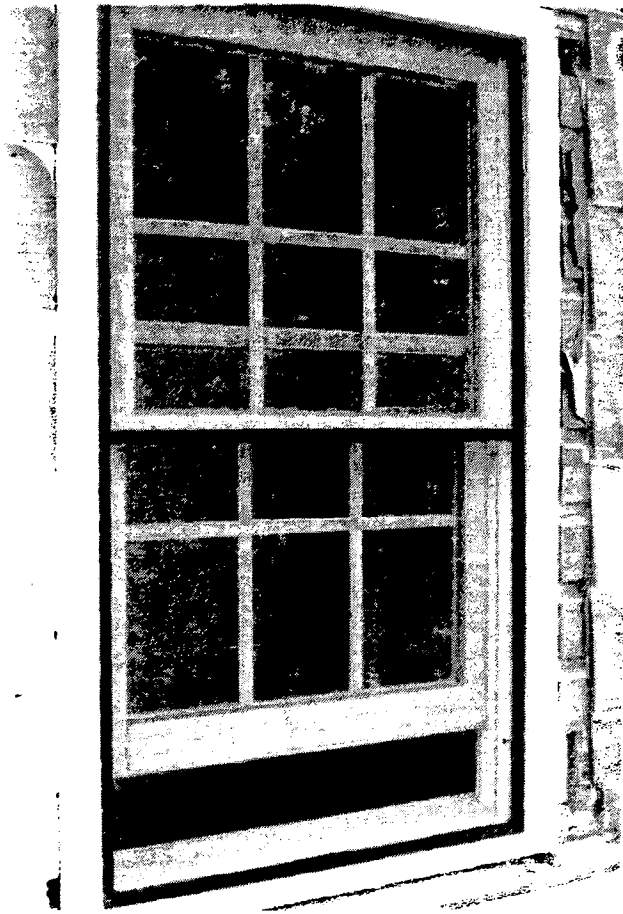
W12 2' 5 3/8" X 4 1/2"

The 6 over 6 true divided light wood and glass window was broken and did not open. There were also large gaps between window and frame. Condition poor. The window will be replaced by a 6 over 6 paned simulated divided light, wood and glass Jeldwen Energy Star with screen. The wood will be stained cedar to match the cedar siding.

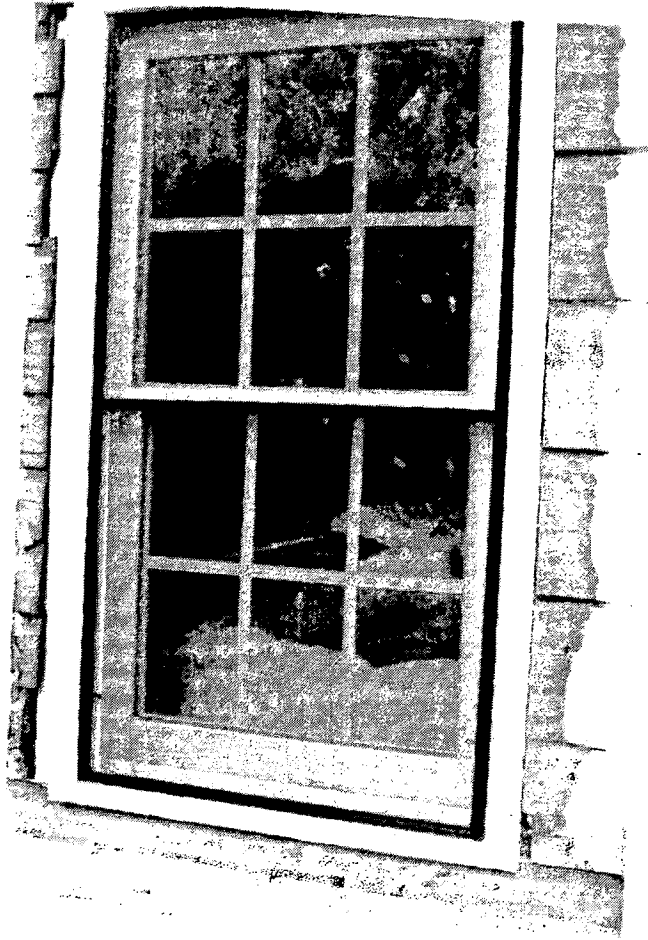
W13 2' 5 3/8" X 4 1/2"

The 6 over 6 true divided light wood and glass window was broken and did not open. There were also large gaps between window and frame. Condition poor. The window will be replaced by a 6 over 6 paned simulated divided light, wood and glass Jeldwen Energy Star with screen. The wood will be stained cedar to match the cedar siding.

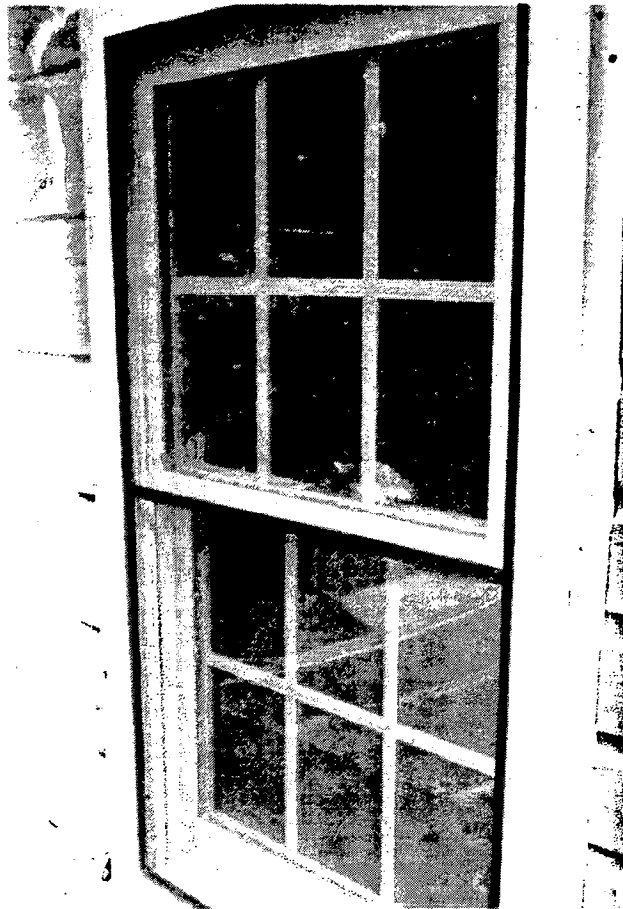
W14 2' 5 3/8" X 4 1/2"

The 6 over 6 true divided light wood and glass window is damaged and does not close properly. There Condition poor. The window will be replaced by a 6 over 6 paned simulated divided light, wood and glass Jeldwen Energy Star with screen. The wood will be stained cedar to match the cedar siding.

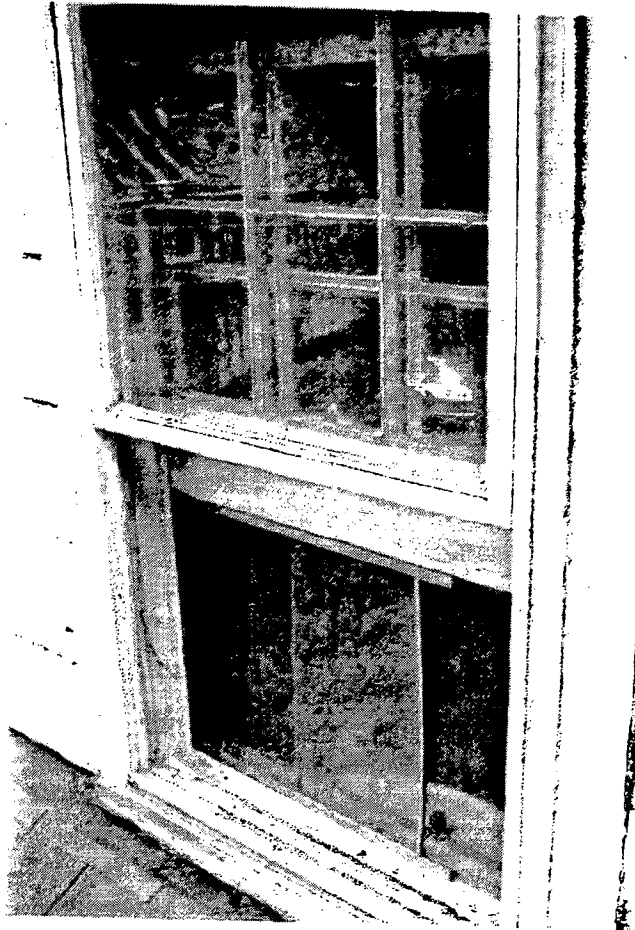
W15 2' x 2'

The 4 paned true divided light wood and glass framed window was broken and did not close. There were also large gaps between window and frame that allowed cold air & insects inside. The windows were replaced by a 4 paned wood and glass Jeldwen Energy Star simulated divided light windows without screen. The wood will be stained cedar to match the cedar siding.

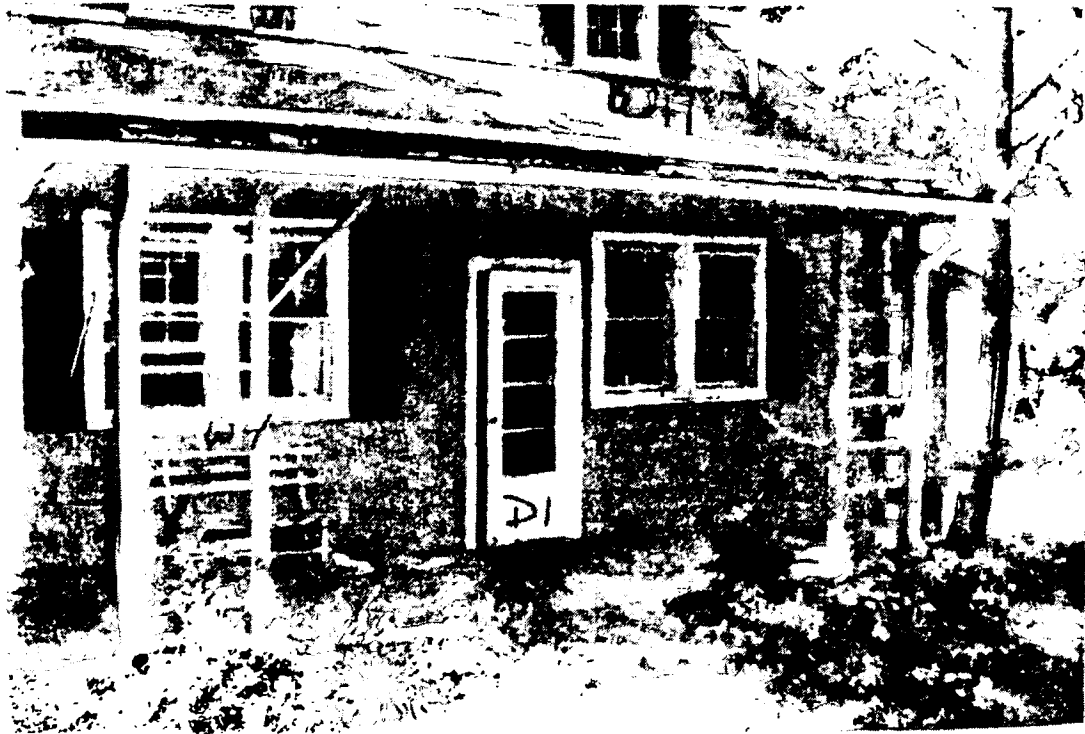
East Porch

We removed damaged trellises on the east porch. We moved a porch post already in existence on each side to the front so there are now 3 supporting posts (each post is 4"x4").

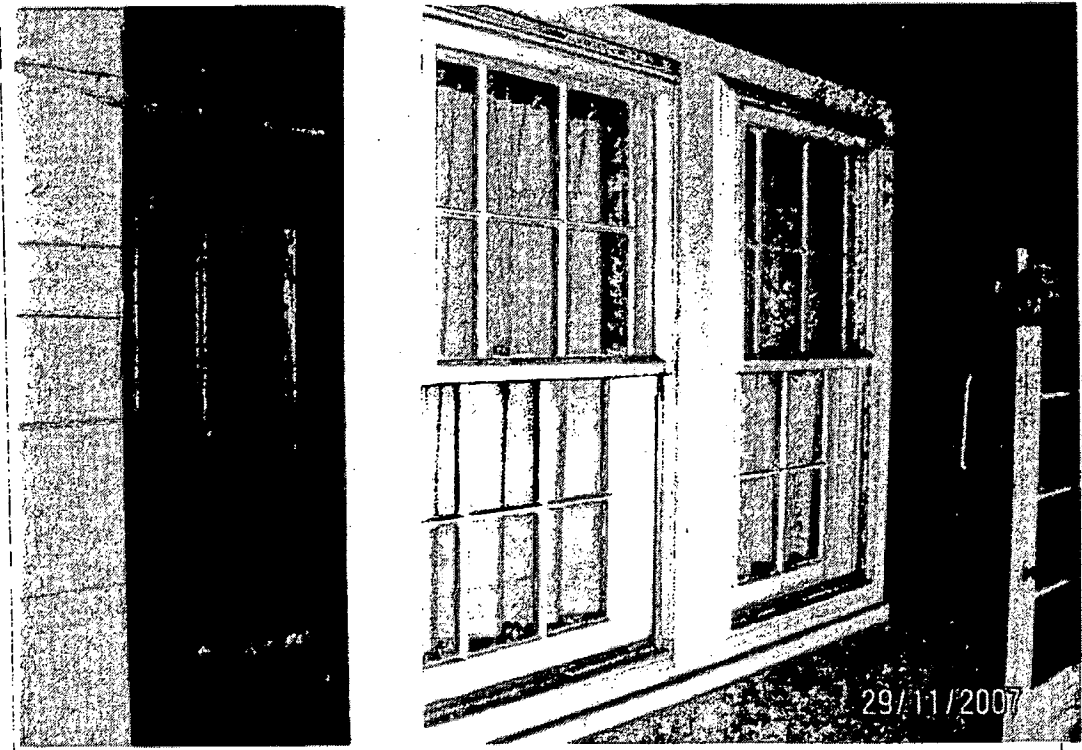
W4

Detail: Shutters (remove - not original)

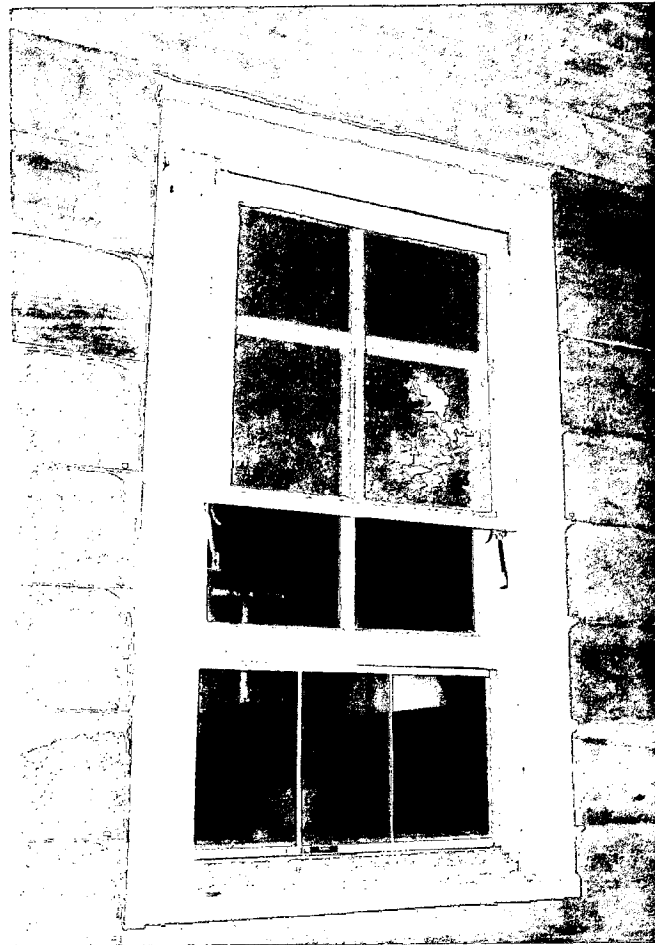
W8 2' 5 3/8" x 4 1/2"

The wood and glass window has true divided light (2 over 2 paned), is damaged and does not close properly or lock. The window will be replaced by a 6 over 6 paned simulated divided light, wood and glass Jeldwen Energy Star with screen. The wood will be stained cedar to match the cedar siding.

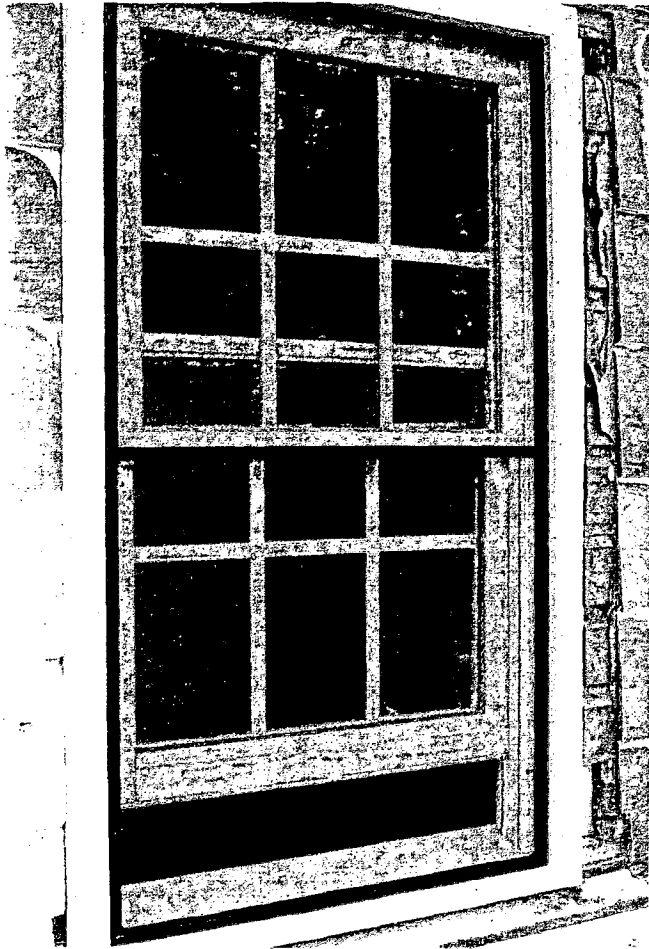
W12 2' 5 3/8" X 4 1/2"

The 6 over 6 true divided light wood and glass window was broken and did not open. There were also large gaps between window and frame. Condition poor. The window will be replaced by a 6 over 6 paned simulated divided light, wood and glass Jeldwen Energy Star with screen. The wood will be stained cedar to match the cedar siding.

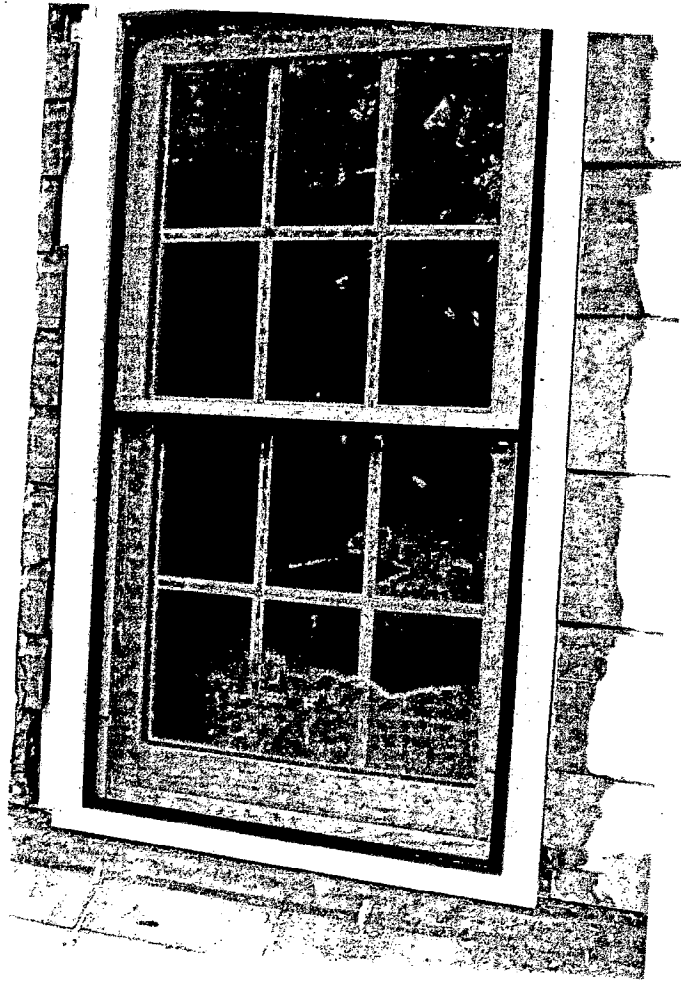
W13 2' 5 3/8" X 4 1/2"

The 6 over 6 true divided light wood and glass window was broken and did not open. There were also large gaps between window and frame. Condition poor. The window will be replaced by a 6 over 6 paned simulated divided light, wood and glass Jeldwen Energy Star with screen. The wood will be stained cedar to match the cedar siding.

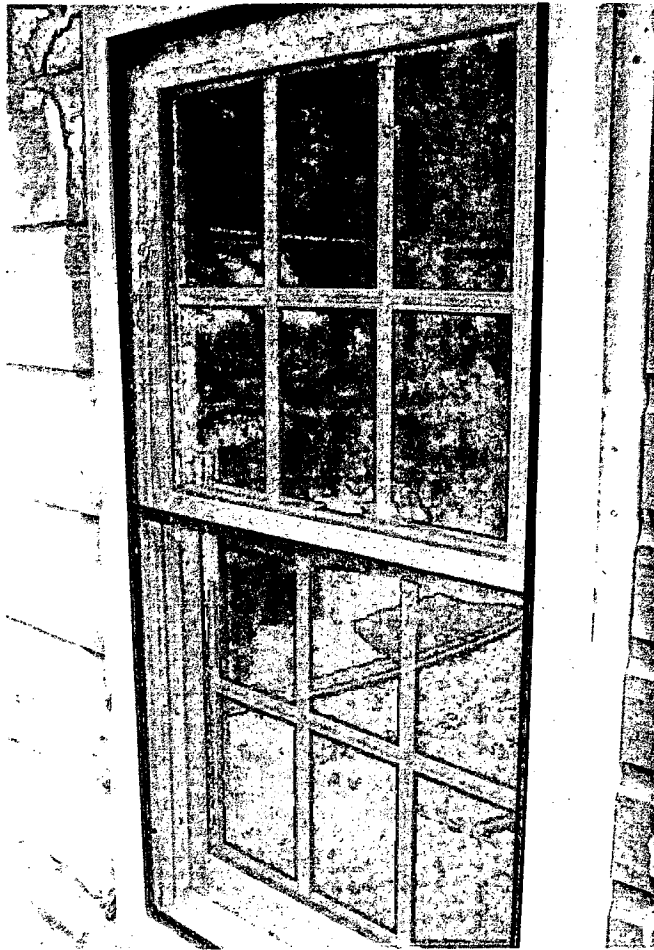
W14 2' 5 3/8" X 4 1/2"

The 6 over 6 true divided light wood and glass window is damaged and does not close properly. There Condition poor. The window will be replaced by a 6 over 6 paned simulated divided light, wood and glass Jeldwen Energy Star with screen. The wood will be stained cedar to match the cedar siding.

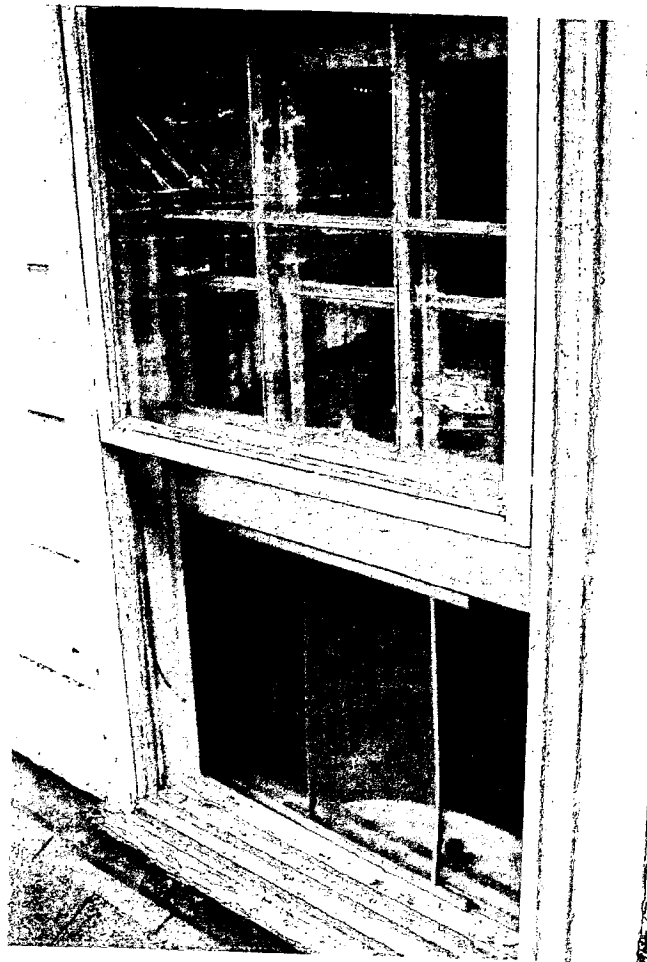
W15 2' x 2'

The 4 paned true divided light wood and glass framed window was broken and did not close. There were also large gaps between window and frame that allowed cold air & insects inside. The windows were replaced by a 4 paned wood and glass Jeldwen Energy Star simulated divided light windows without screen. The wood will be stained cedar to match the cedar siding.

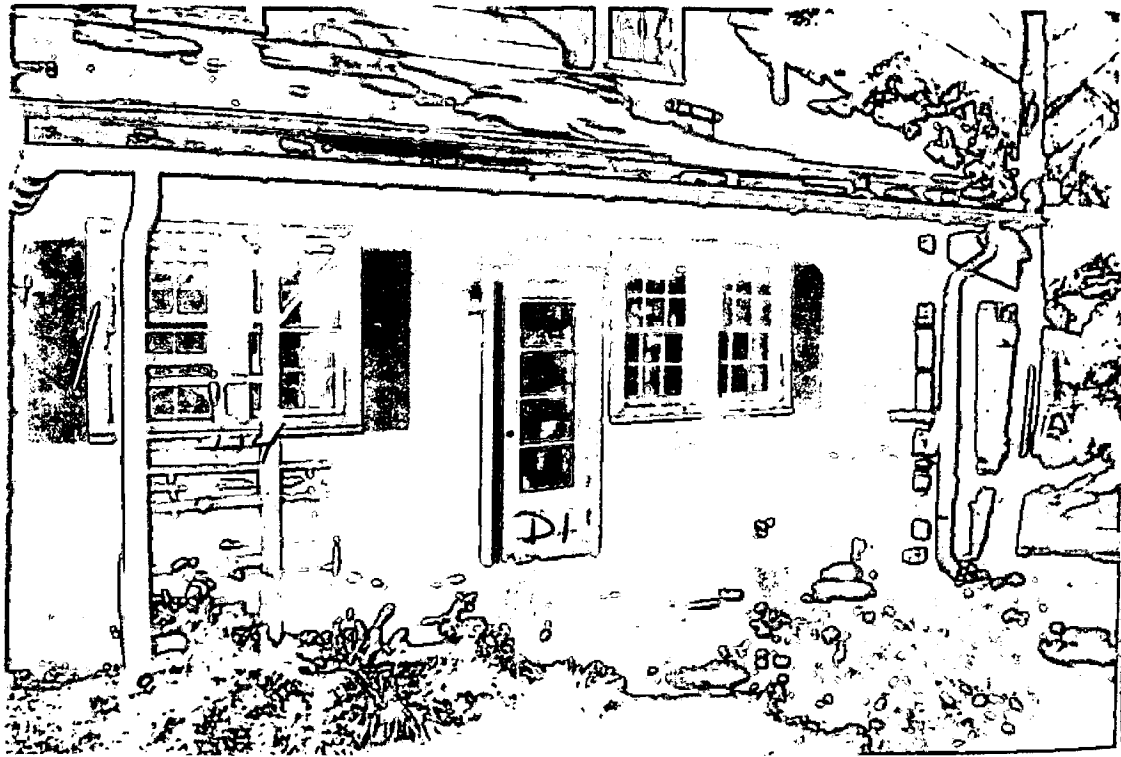
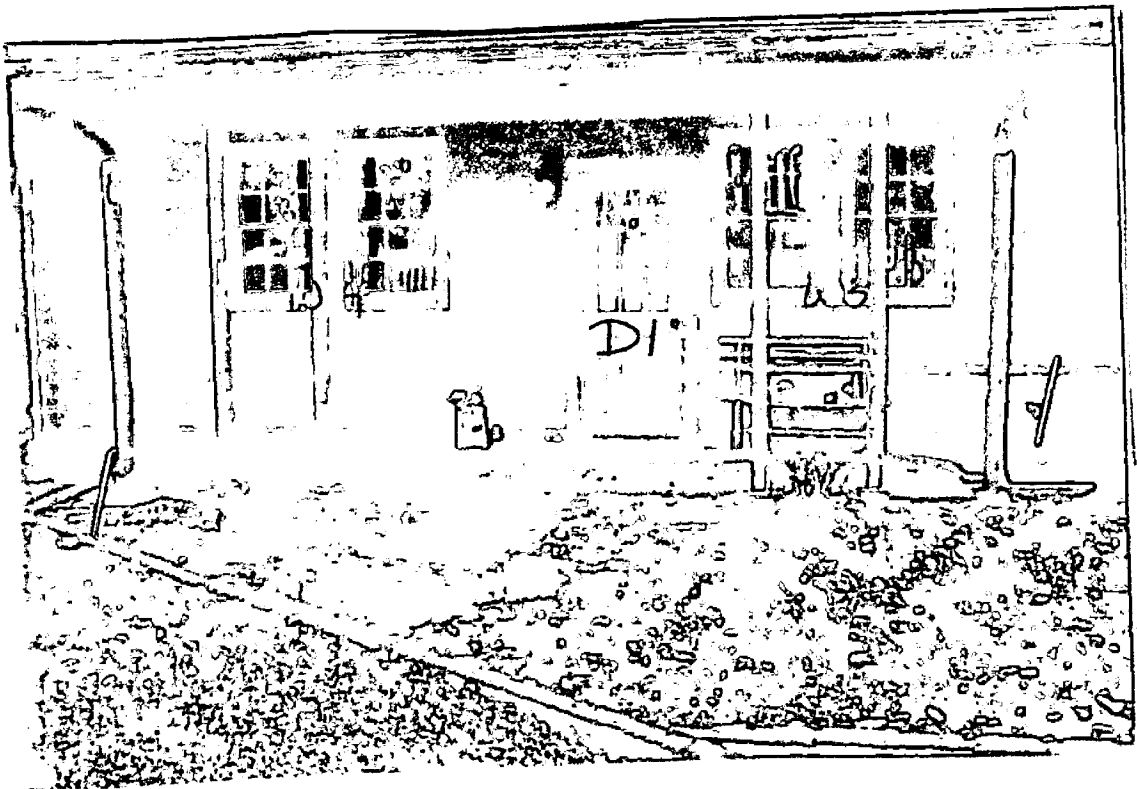
East Porch

We removed damaged trellises on the east porch. We moved a porch post already in existence on each side to the front so there are now 3 supporting posts (each post is 4"x4").

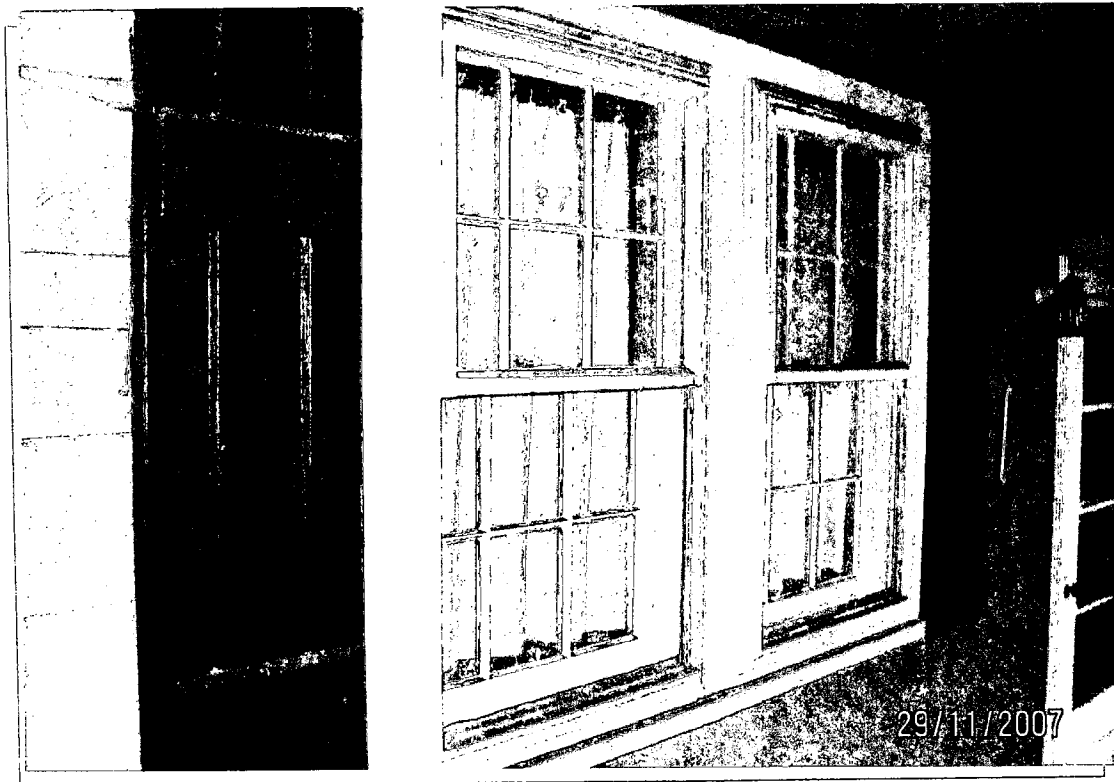
w4

Detail: Shutters (remove - not original)

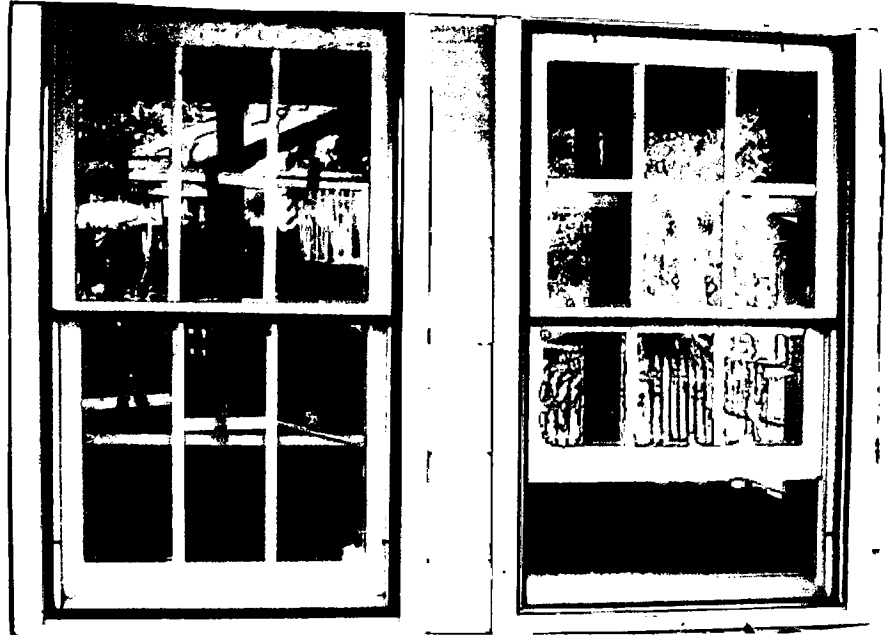
W4 2' 5 3/8" x 4 1/2" (2 each)

The 6 x 6 true divided light wood and glass framed windows were damaged and one of the windows did not open. The second was held together by duct tape on the inside. There were also large gaps between window and frame that allowed cold air & insects inside. The windows were replaced by a 6 over 6 wood and glass Jeldwen Energy Star simulated divided light windows with screen. The wood will be stained cedar to match the cedar siding.

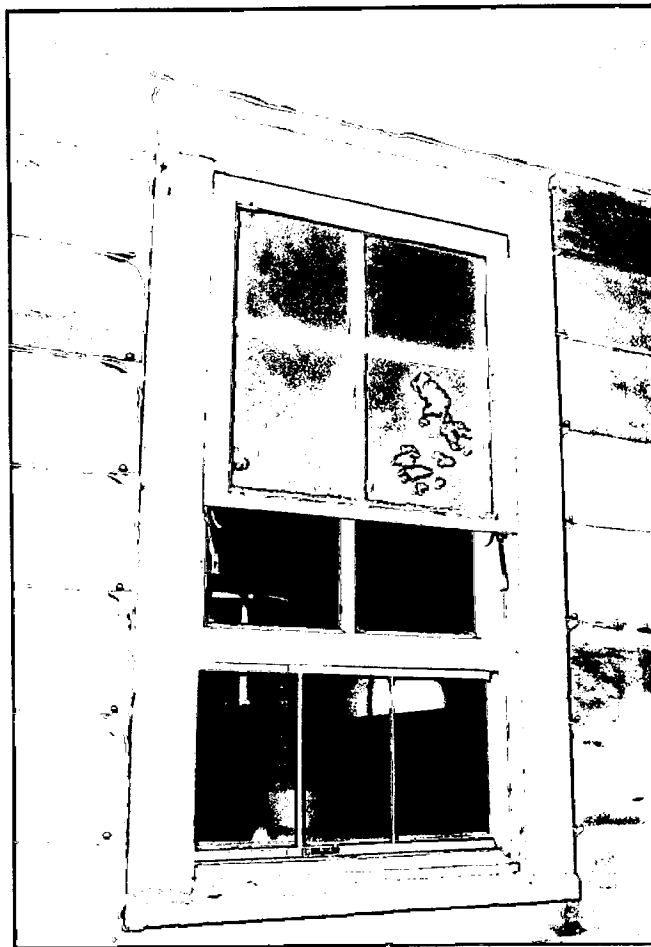
W8 2' 5 3/8" x 4 1/2"

The wood and glass window has true divided light (2 over 2 paned), is damaged and does not close properly or lock. The window will be replaced by a 6 over 6 paned simulated divided light, wood and glass Jeldwen Energy Star with screen. The wood will be stained cedar to match the cedar siding.

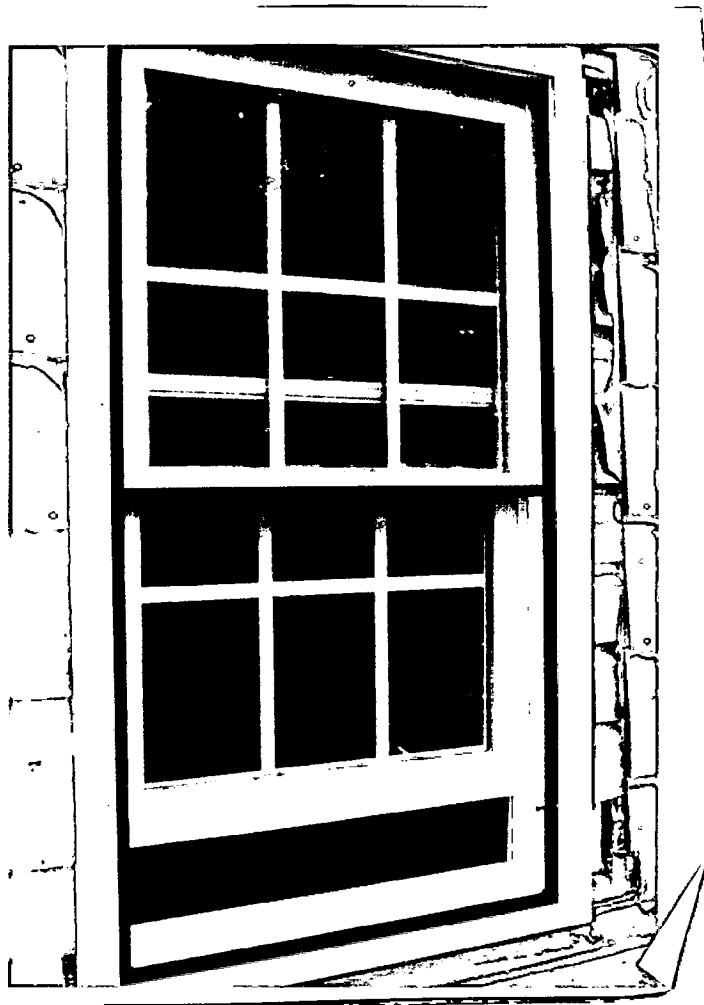
W12 2' 5 3/8" X 4 1/2"

The 6 over 6 true divided light wood and glass window was broken and did not open. There were also large gaps between window and frame. Condition poor. The window will be replaced by a 6 over 6 paned simulated divided light, wood and glass Jeldwen Energy Star with screen. The wood will be stained cedar to match the cedar siding.

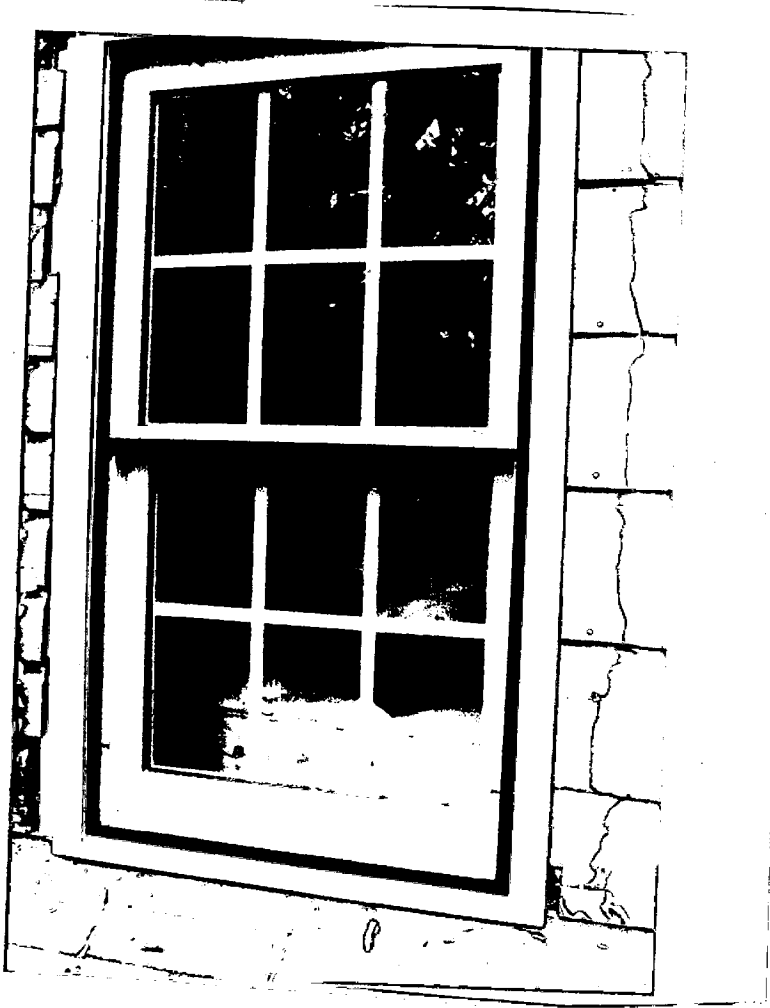
W13 2' 5 3/8" X 4 1/2"

The 6 over 6 true divided light wood and glass window was broken and did not open. There were also large gaps between window and frame. Condition poor. The window will be replaced by a 6 over 6 paned simulated divided light, wood and glass Jeldwen Energy Star with screen. The wood will be stained cedar to match the cedar siding.

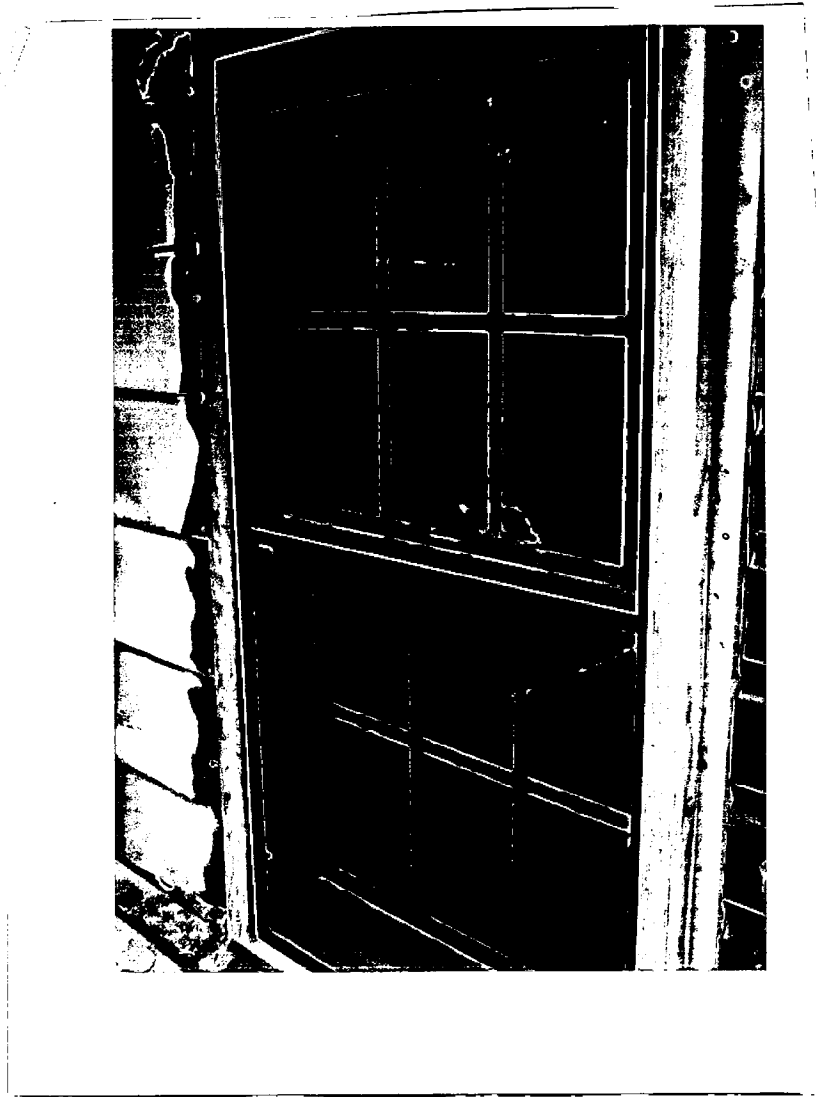
W14 2' 5 3/8" X 4 1/2"

The 6 over 6 true divided light wood and glass window is damaged and does not close properly. There Condition poor. The window will be replaced by a 6 over 6 paned simulated divided light, wood and glass Jeldwen Energy Star with screen. The wood will be stained cedar to match the cedar siding.

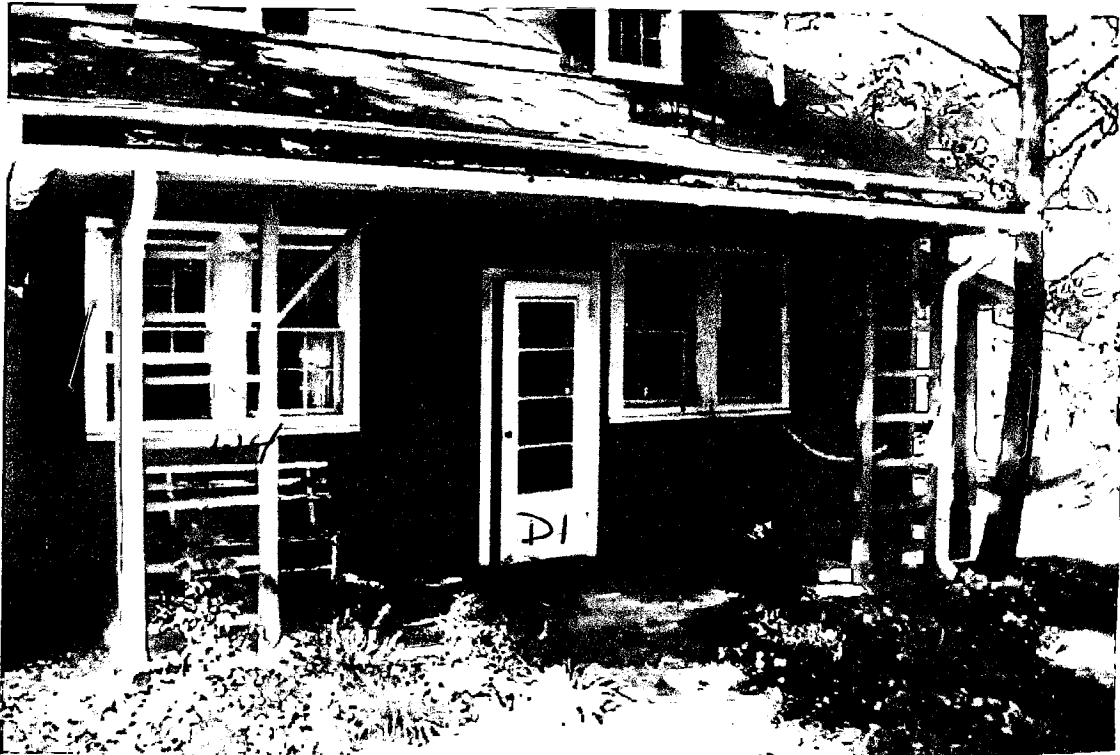
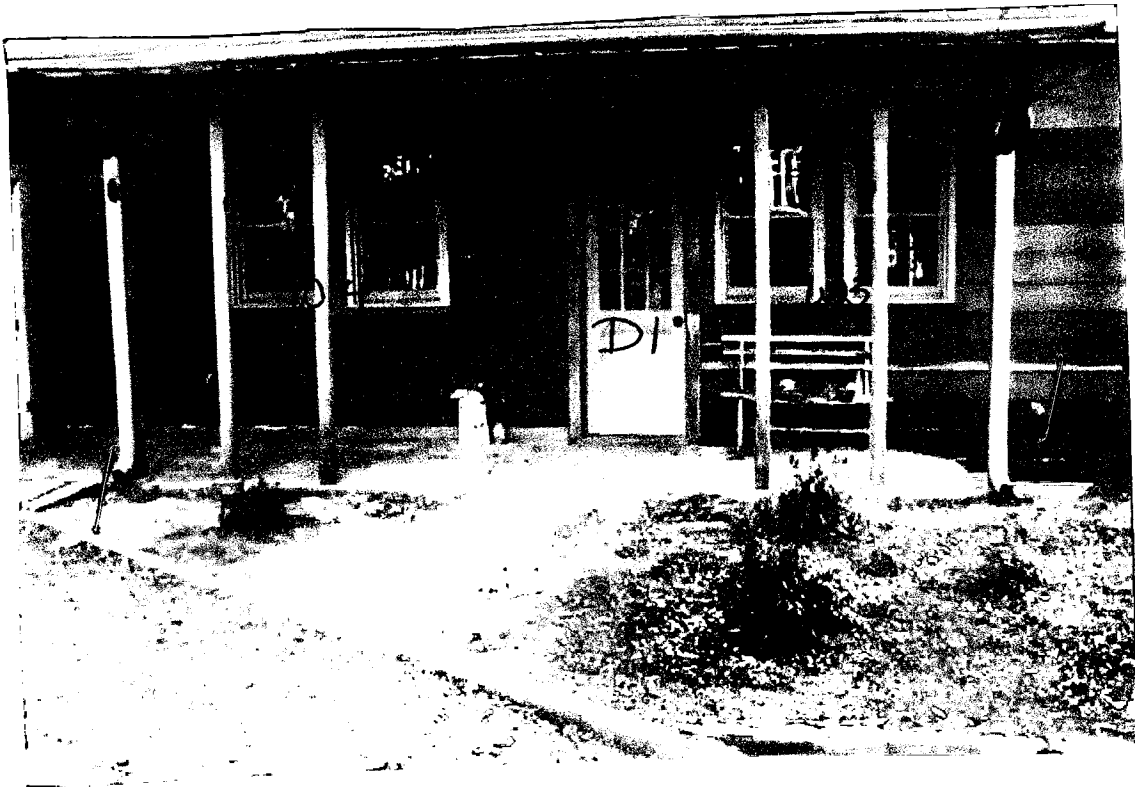
We removed damaged trellises on the east porch. We moved a porch post already in existence on each side to the front so there are now 3 supporting posts (each post is 4"x4").
