**MARYLAND HISTORICAL TRUST
DETERMINATION OF ELIGIBILITY FORM**

Property Name: William Shaw House Inventory Number: M:13-21

Project: Cabin Branch Mixed Use Planned Development Agency: U.S. Army Corps of Engineers

Continuation Sheets
Maryland Historical Trust
Determination of Eligibility Form
Wm Shaw House
M:13-21

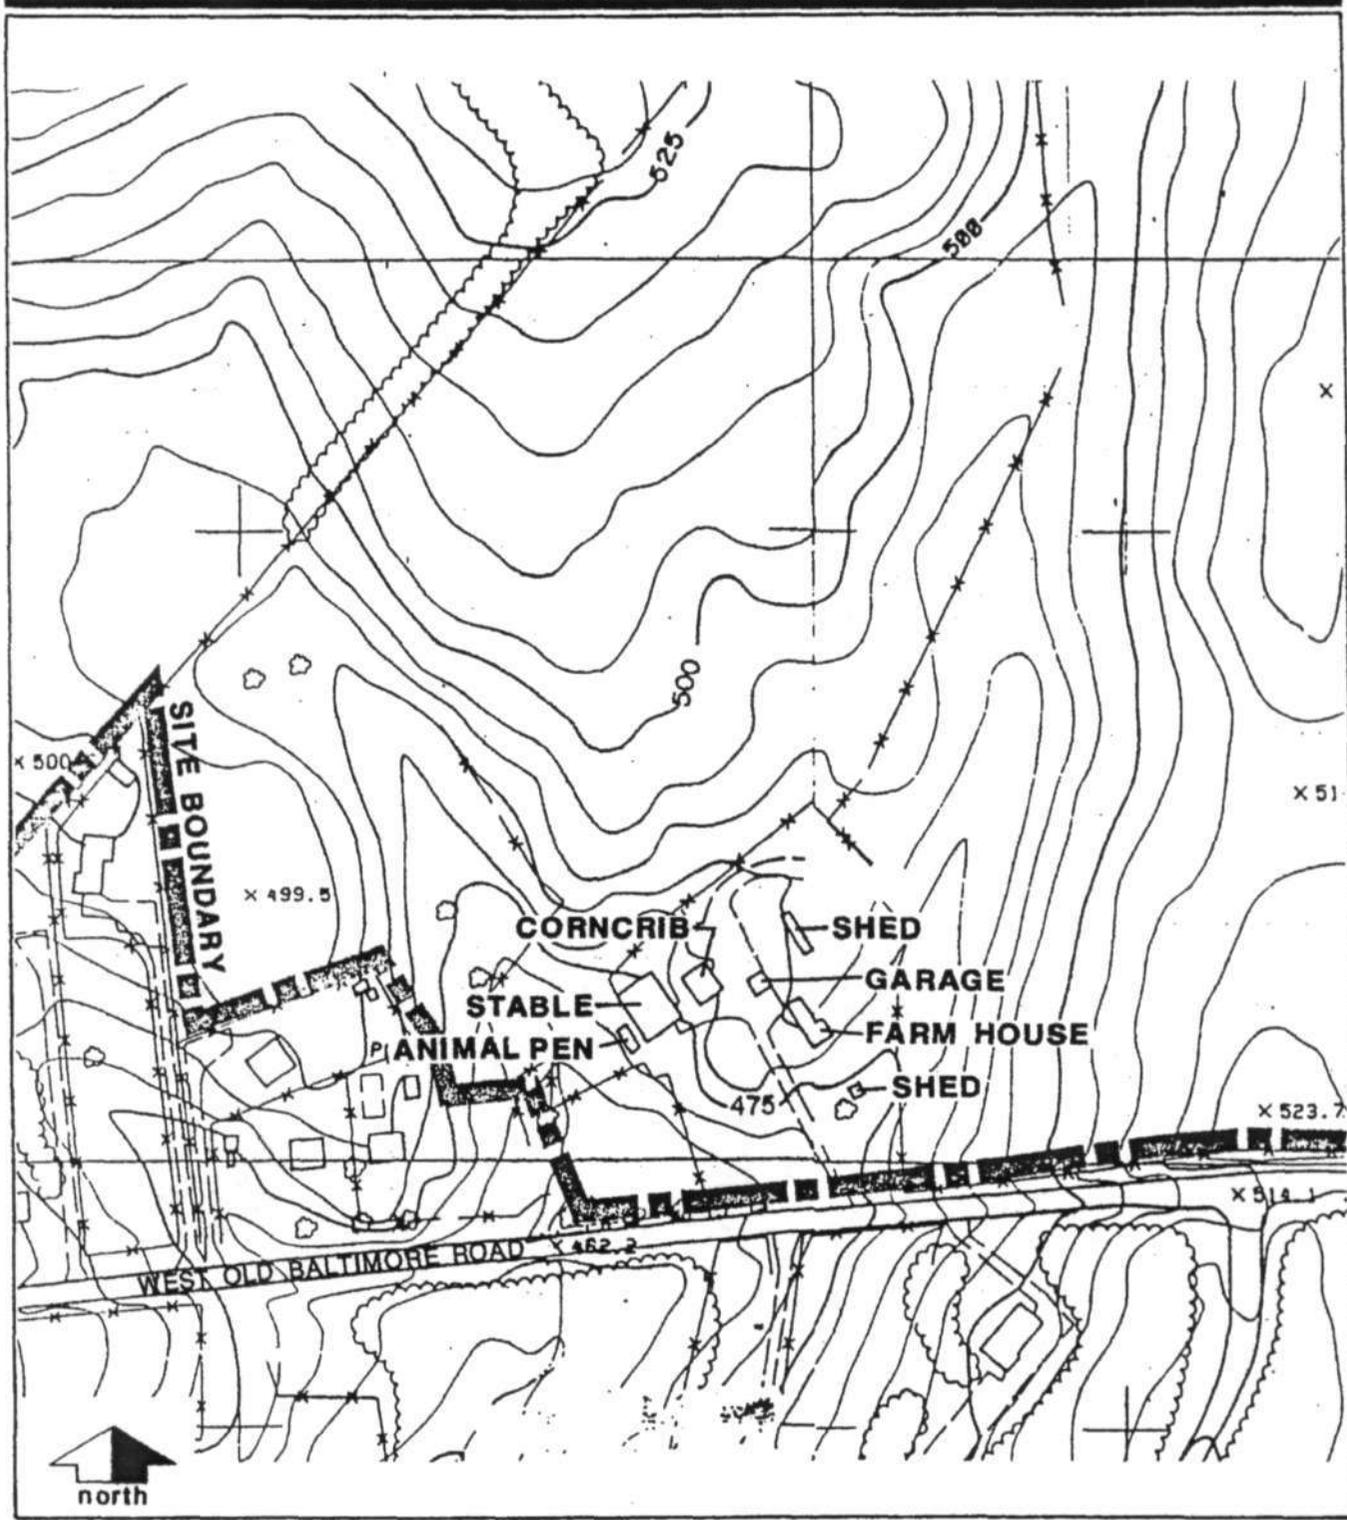
Figure 3

The structure farthest to the west is a small, three bay horse stable with the gable end facing south (labeled an "animal pen" on the 1994 site plan prepared by Greenhorne & O'Mara). This wood frame structure resting on a concrete foundation has split (horizontally) doors on the east elevation. The pen walls are plaster or concrete on metal lath. Approximately five feet to the east is the stable, which consists of two parts. At the east end is a 1 1/2 story gabled structure with the gable end facing south. The main entrance to the building is in this section of the building. Attached to this section on the west is a lower structure with a gable roof running perpendicular to that of the main block. The main block sits on a concrete foundation while the wing sits on concrete block. Both structures are wood frame, covered in wood siding, but the main block is vertical board and batten, while the wing has horizontal siding. The floor is concrete and dirt and the space is divided into a series of pens opening off the L-shaped corridor. Both of these corrugated metal roof structures are neglected, but appear stable.

William Shaw Farm Site Plan

Greenhorne & O'Mara
 Report (1994)

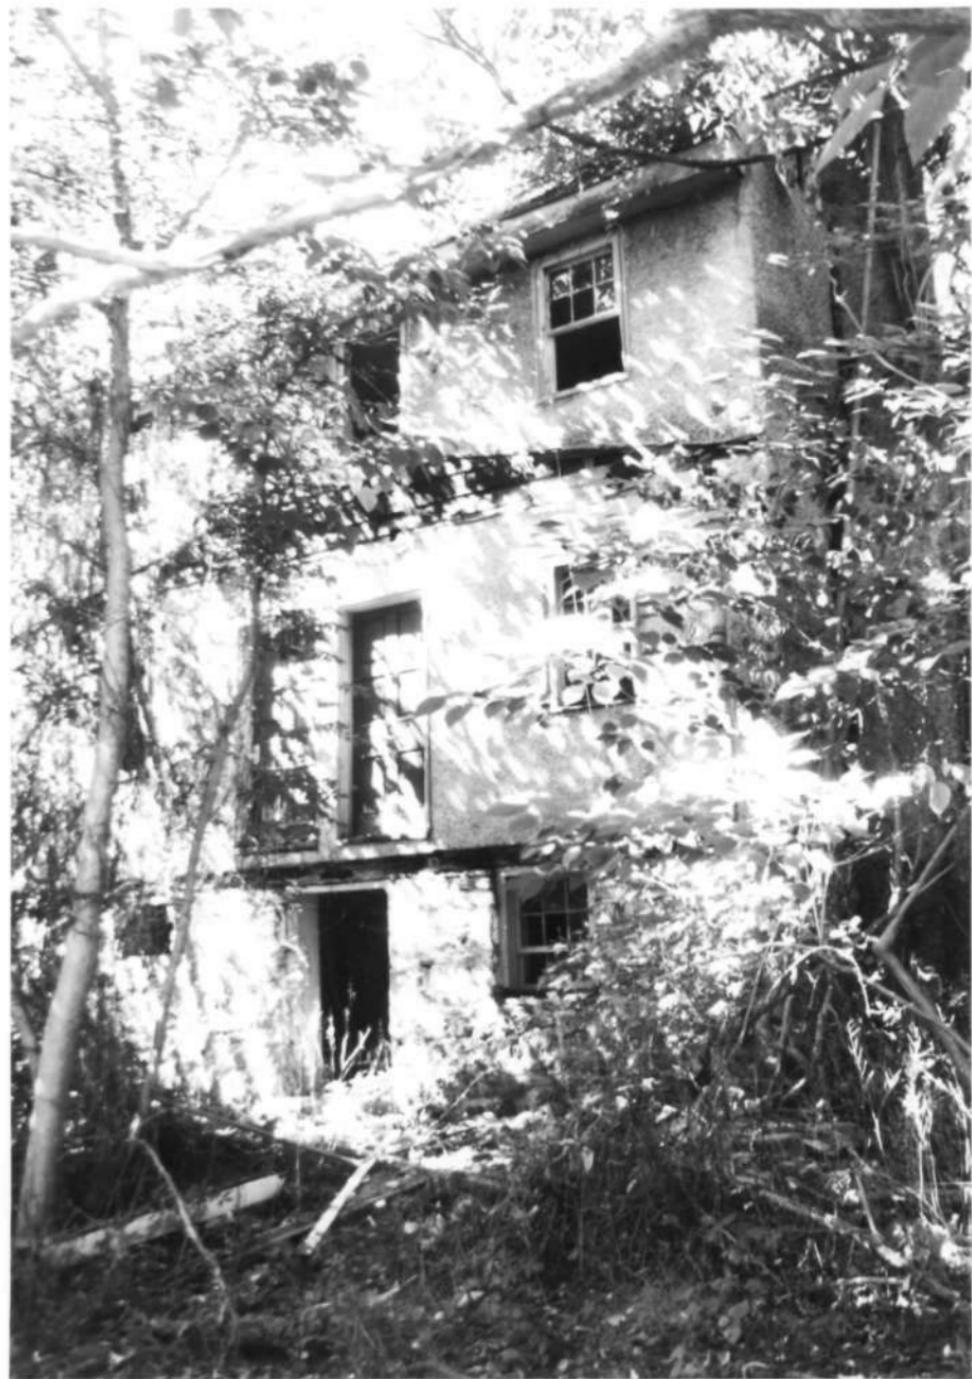
M: 13-21

As the land falls off steeply to the south, the main block is three stories. The first story, which is only above ground and exposed on the south elevation is the only section of the house not covered in stucco. This stone and mortar wall has a center door and flanking windows, the one to the left (when facing the house) is a small nearly square window. The one to the right is a double hung window of perhaps six over three. The windows above and in the rest of the house are six over six.

main (south)
façade

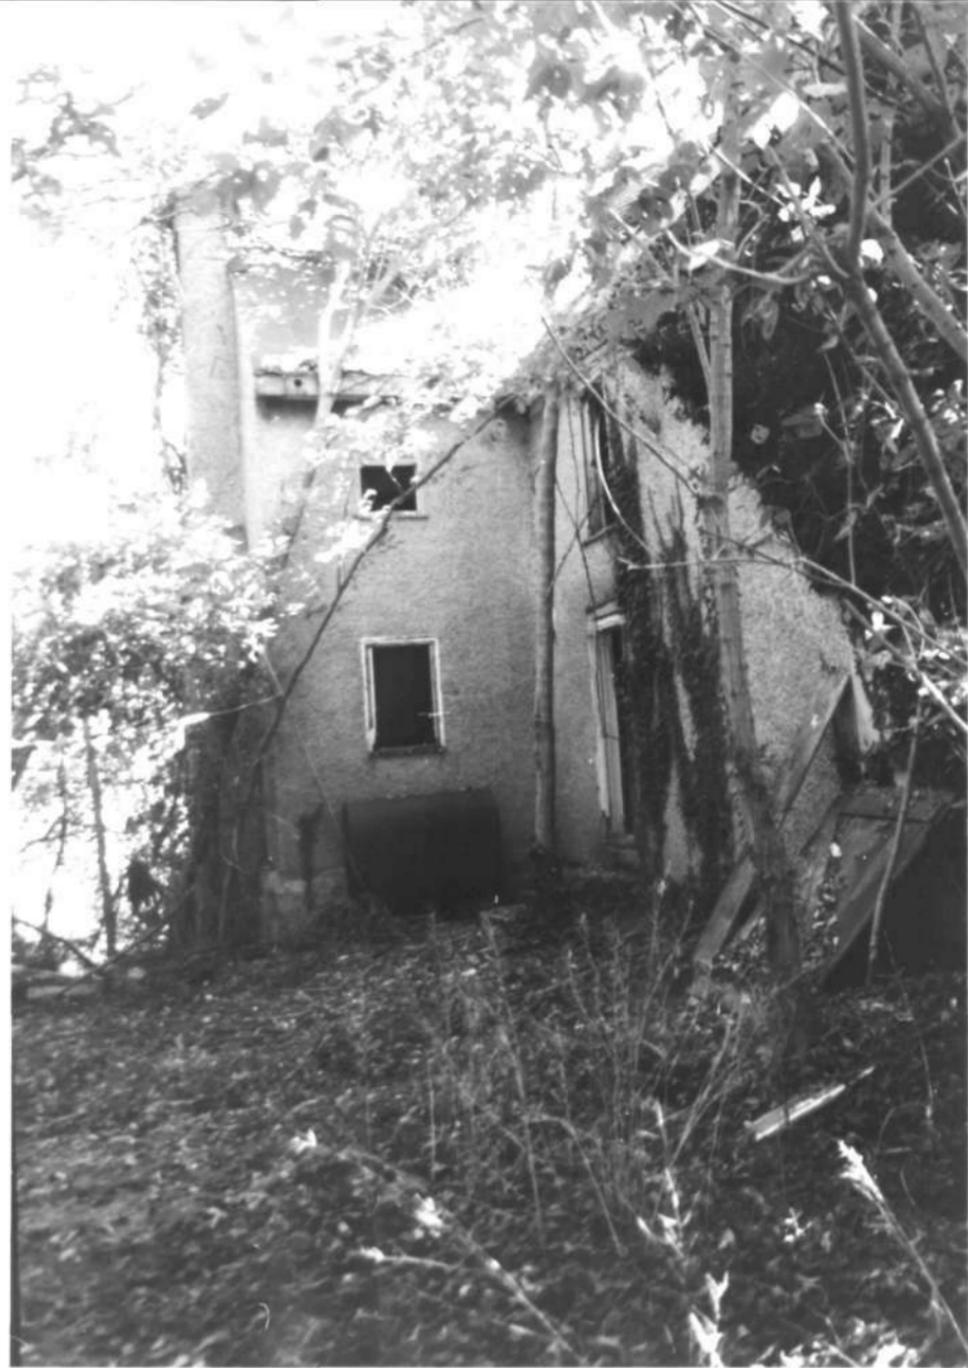
M:13-21
Wm. Shaw
House
13601 Old
West
Baltimore
Red
Bowieburg
Montgomery
Co.

east facade
of ell &
north facade
of original
house
(main)

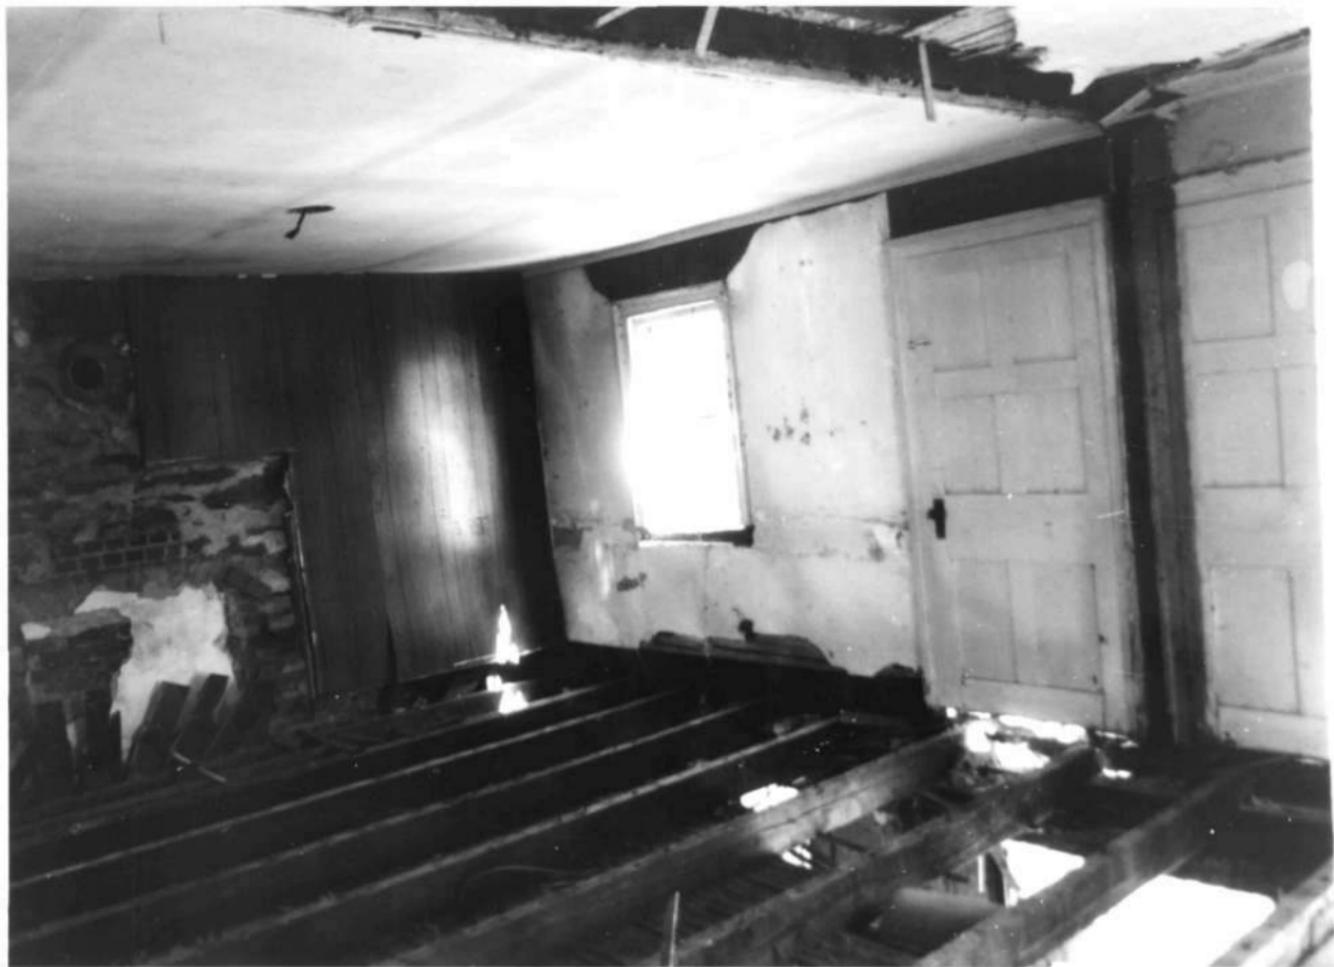
M-13-21

The interior of the main block is in horrible shape and the rear wing is only slightly better. In the main block, the second floor is essentially gone, with only some of the floor rafters in place. The stairs from the second to the third floors in the main block are gone, as are partitions between rooms on the third floor. It appears that the second floor consisted of two rooms with a tight stair chamber at the rear. The third floor appears to have had in addition to a stair chamber two or three bedrooms and a small bathroom. On the second and third floors openings were cut connecting the main block and rear wing. The basement is one room with two small windows at the rear wall. The window to the right opens to the outside, while the left window is obstructed by the rear wing, confirming that the wing is a later addition.

Looking se
at 2nd
floor
original
house
(main)

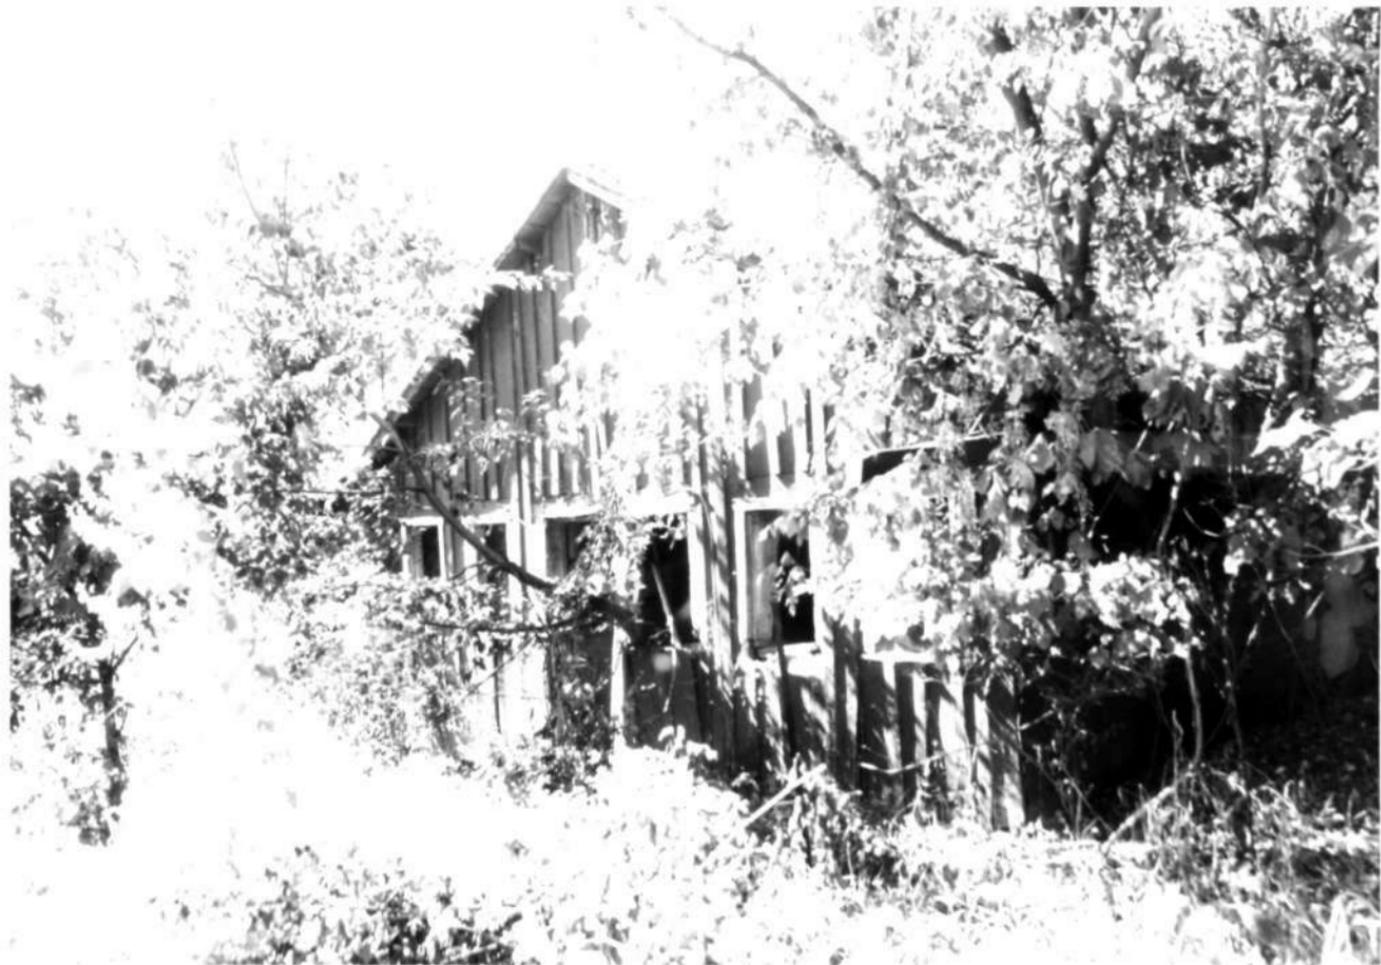
M:13-21
WM SHAW
HOUSE

BARN
SOUTH FACADE

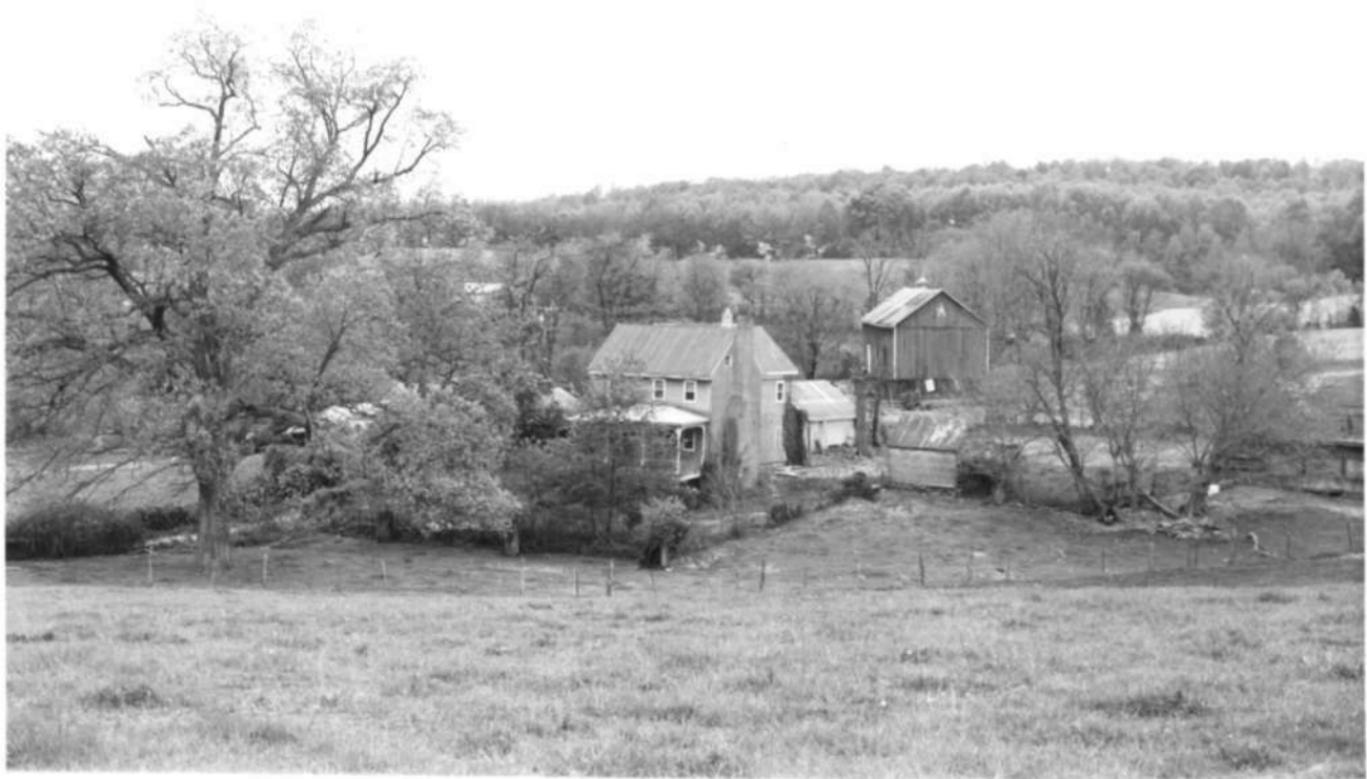
M: #13-21

The house is a two story structure, presently covered with stucco. The main (south) facade is four bays, the two center bays being doorways. At the east end is a one story fireplace with a large stack. The windows are 6/6 double hung sash. Across the front is a one story porch with bracketed posts and jigsaw work decoration.

FACADE SE

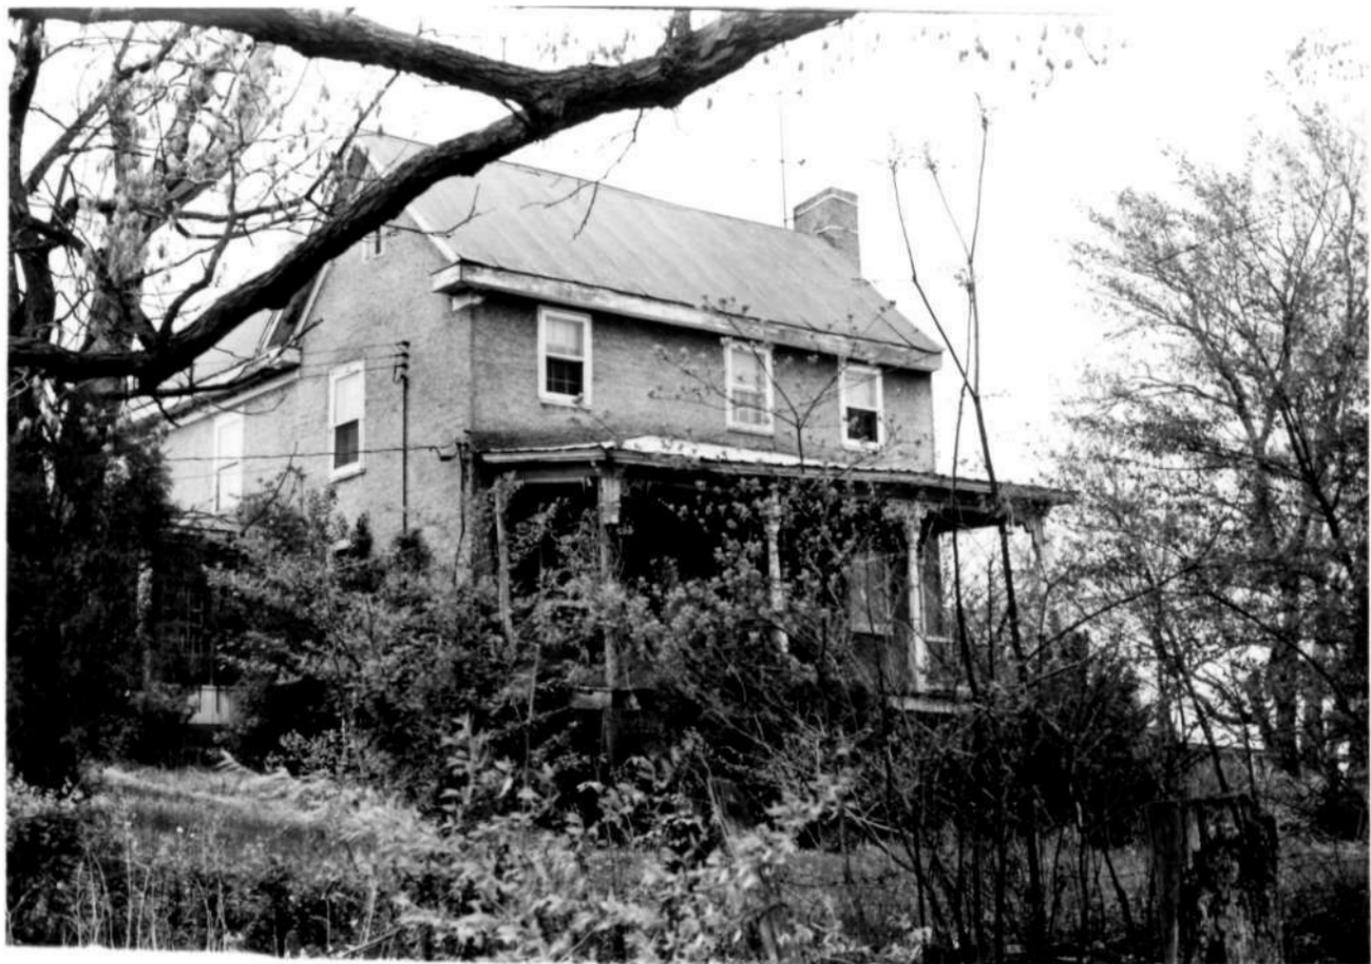
M: #13-21

FACADE SW

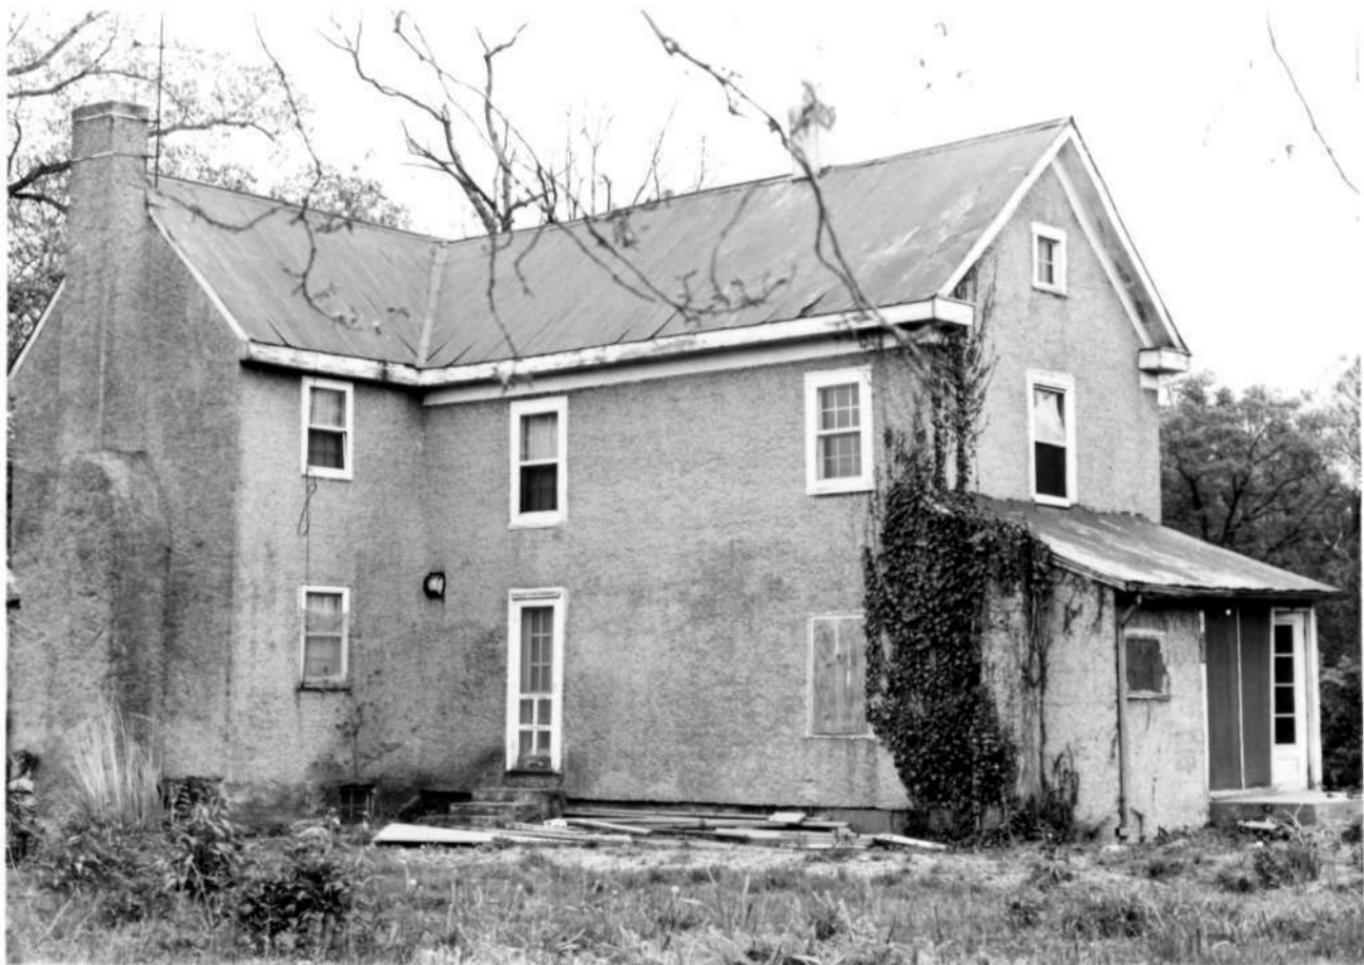
M: #13-21

A two story el extends to the north. It has a central chimney.

FACADE NE

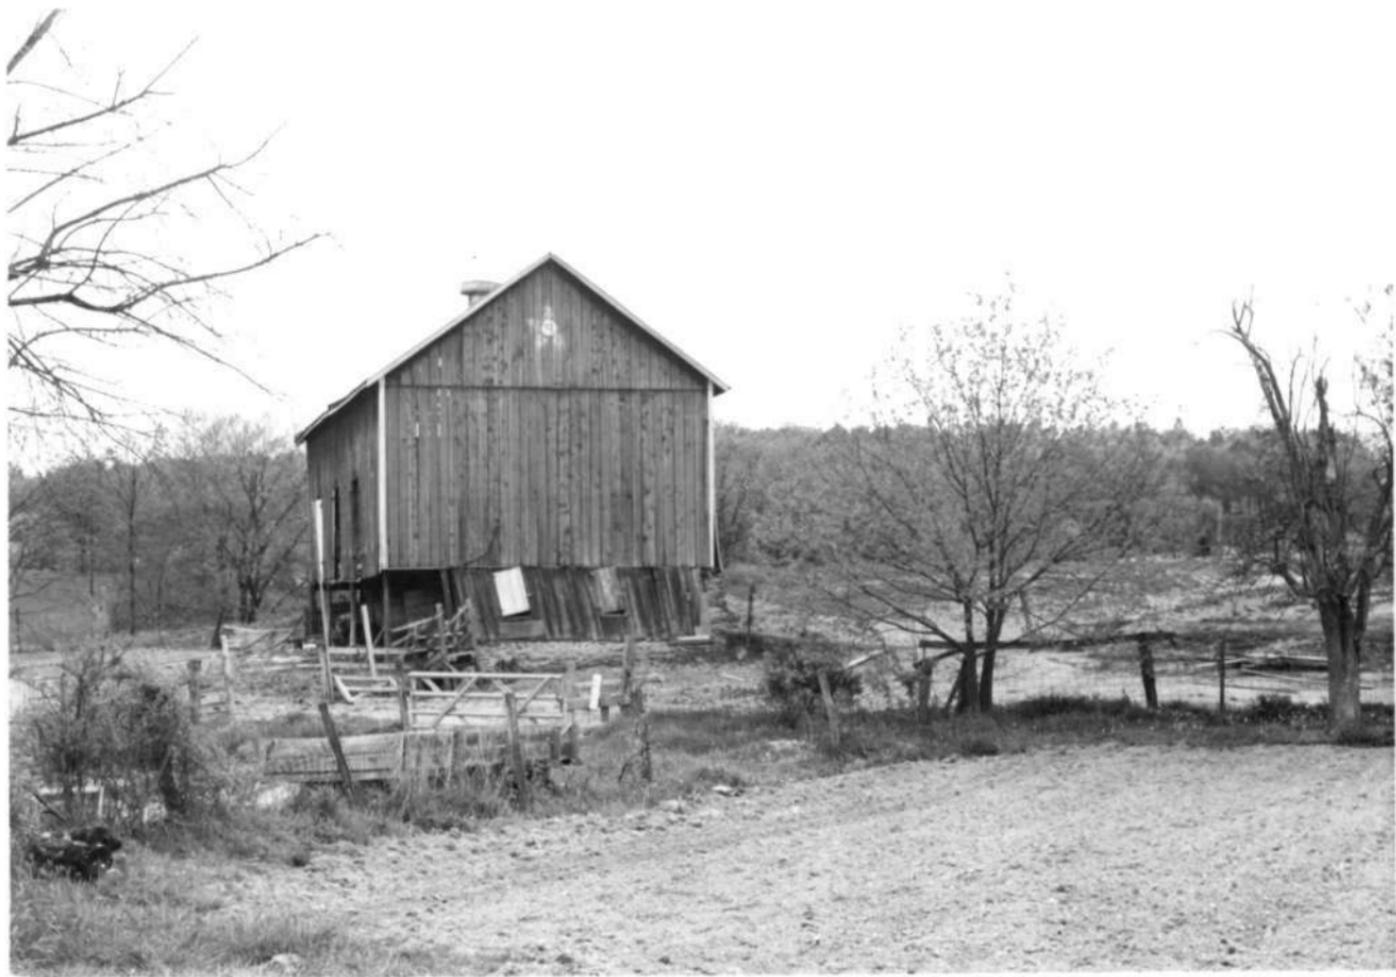
M: #13-21

NAME WM SHAW HOUSE - BARN

FACADE S

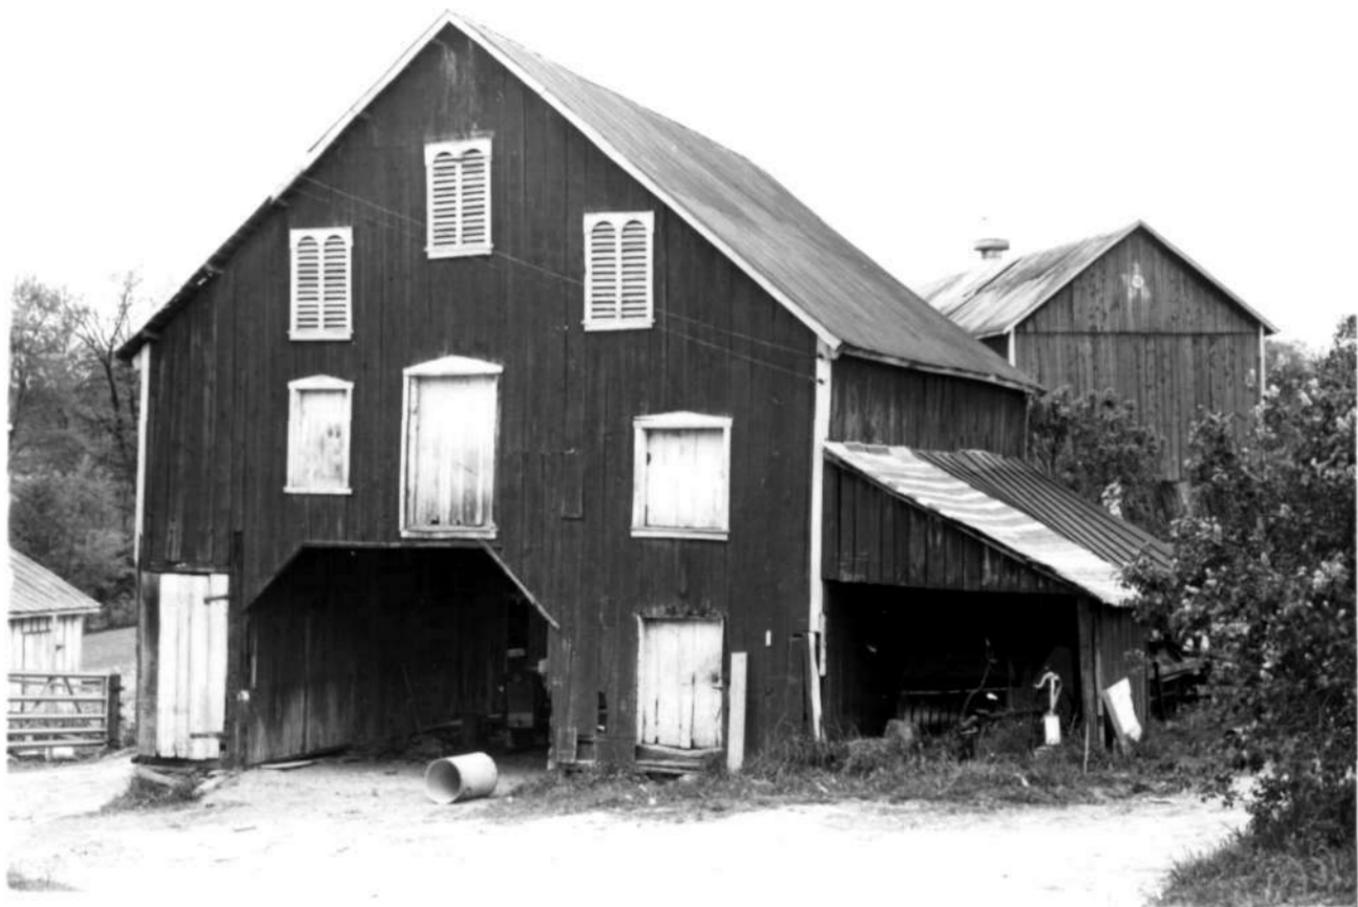
M: #13-21

North of the house is a double corncrib with louvered windows; the openings are square headed, each with two arched louvered panels. Part of the building is log and part is frame. There is also a frame bankbarn on a stone foundation.

NAME WM SHAW HOUSE - CORN CRIB & BARN
