Ground Penetrating Radar Survey
To Detect Possible Graves
At the
Waters Family Cemetery Site
Germantown, Maryland

September 2017

Introduction

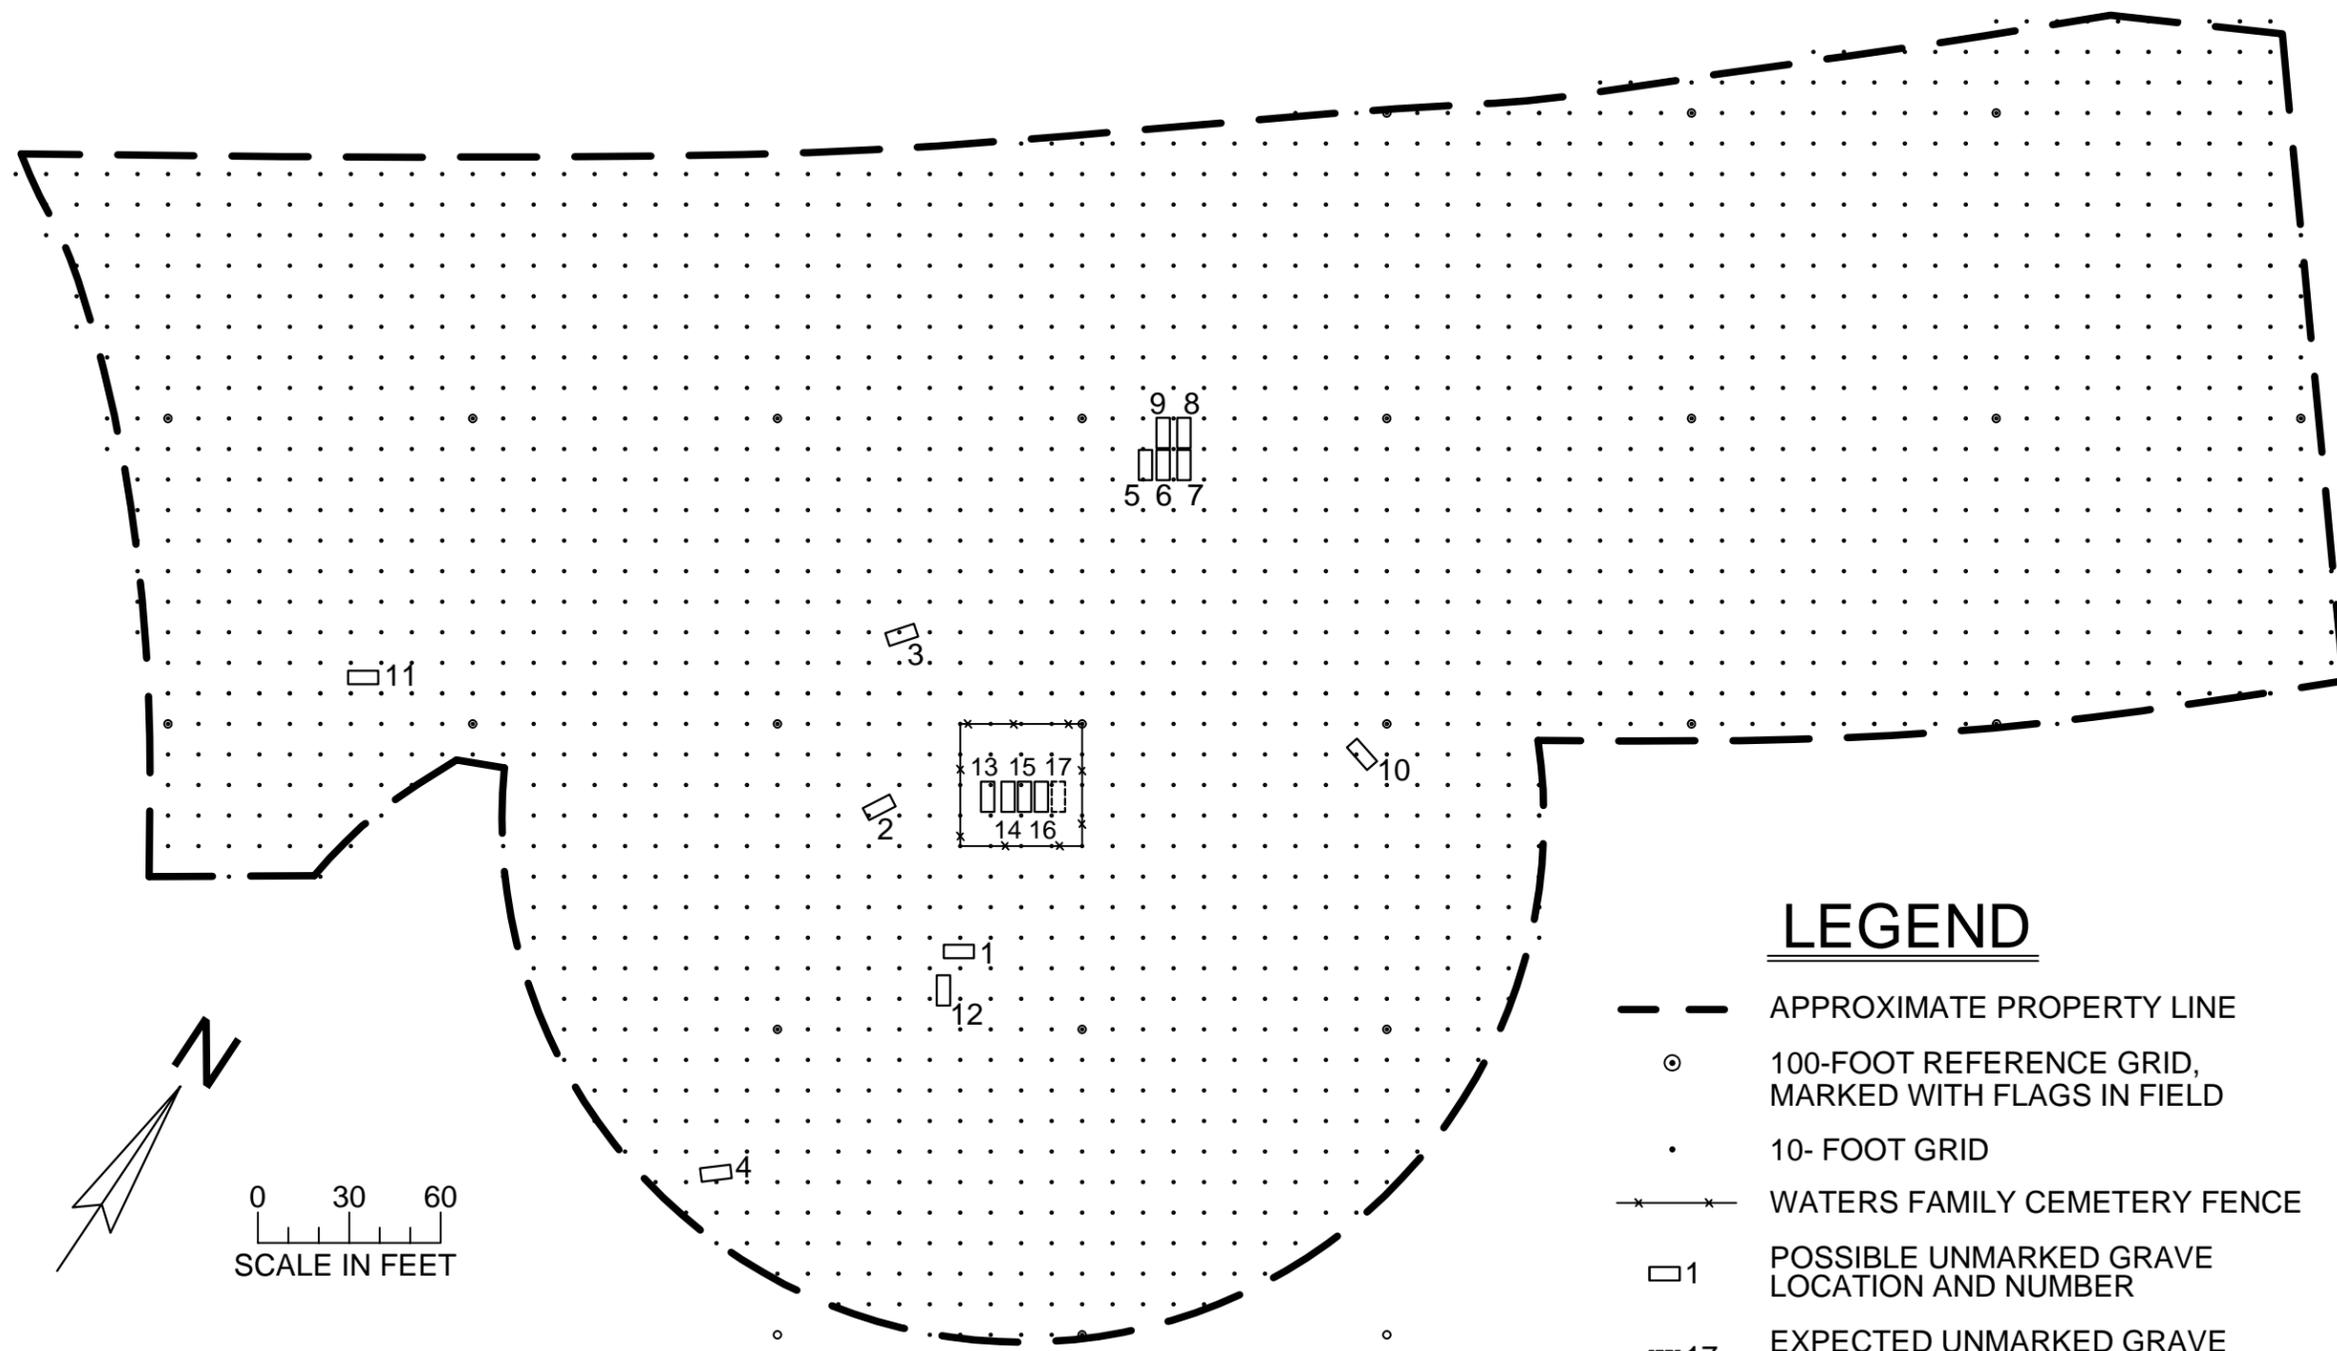
DEWBERRY CONSULTANTS, LLC Client: 2101 GAITHER ROAD, ROCKVILLE, MD			
		Title: GROUND PENETRATING RADAR (GPR) SURVEY OF WATERS FAMILY CEMETERY SITE, GERMANTOWN, MD			
Prepared By	SRD	08/18/2017	SIZE B	DWG NO. 16067-1	FIG. NO. FIGURE 1
Approved By	PPT	08/18/2017	SCALE 1" = 60'		SHEET 1 of 1

Twelve possible GPR grave anomalies were detected in the survey area outside of the fenced area (see Figure 1). The location of each of the twelve GPR grave anomalies outside the fenced area was painted on the ground with orange paint and a numbered yellow flag was placed in the grave anomaly. Photographs of the twelve anomaly locations are included with this report.

Four graves were located and marked out with paint inside the fenced area with a possible fifth grave located under a tree (see Figure 1). A photograph is included in the report showing these graves.

The locations of the GPR anomalies representing possible graves were plotted on an AutoCAD map of the survey area (Figure 1). Each anomaly location was drawn and numbered on the AutoCAD map as it was in the field.

GeoModel, Inc. recommends that all of the GPR grave anomalies be further investigated to confirm that the GPR anomalies are graves and not other natural or manmade features. It is recommended that an archaeological firm be retained to examine each possible grave burial site to determine whether each GPR anomaly is a grave site.

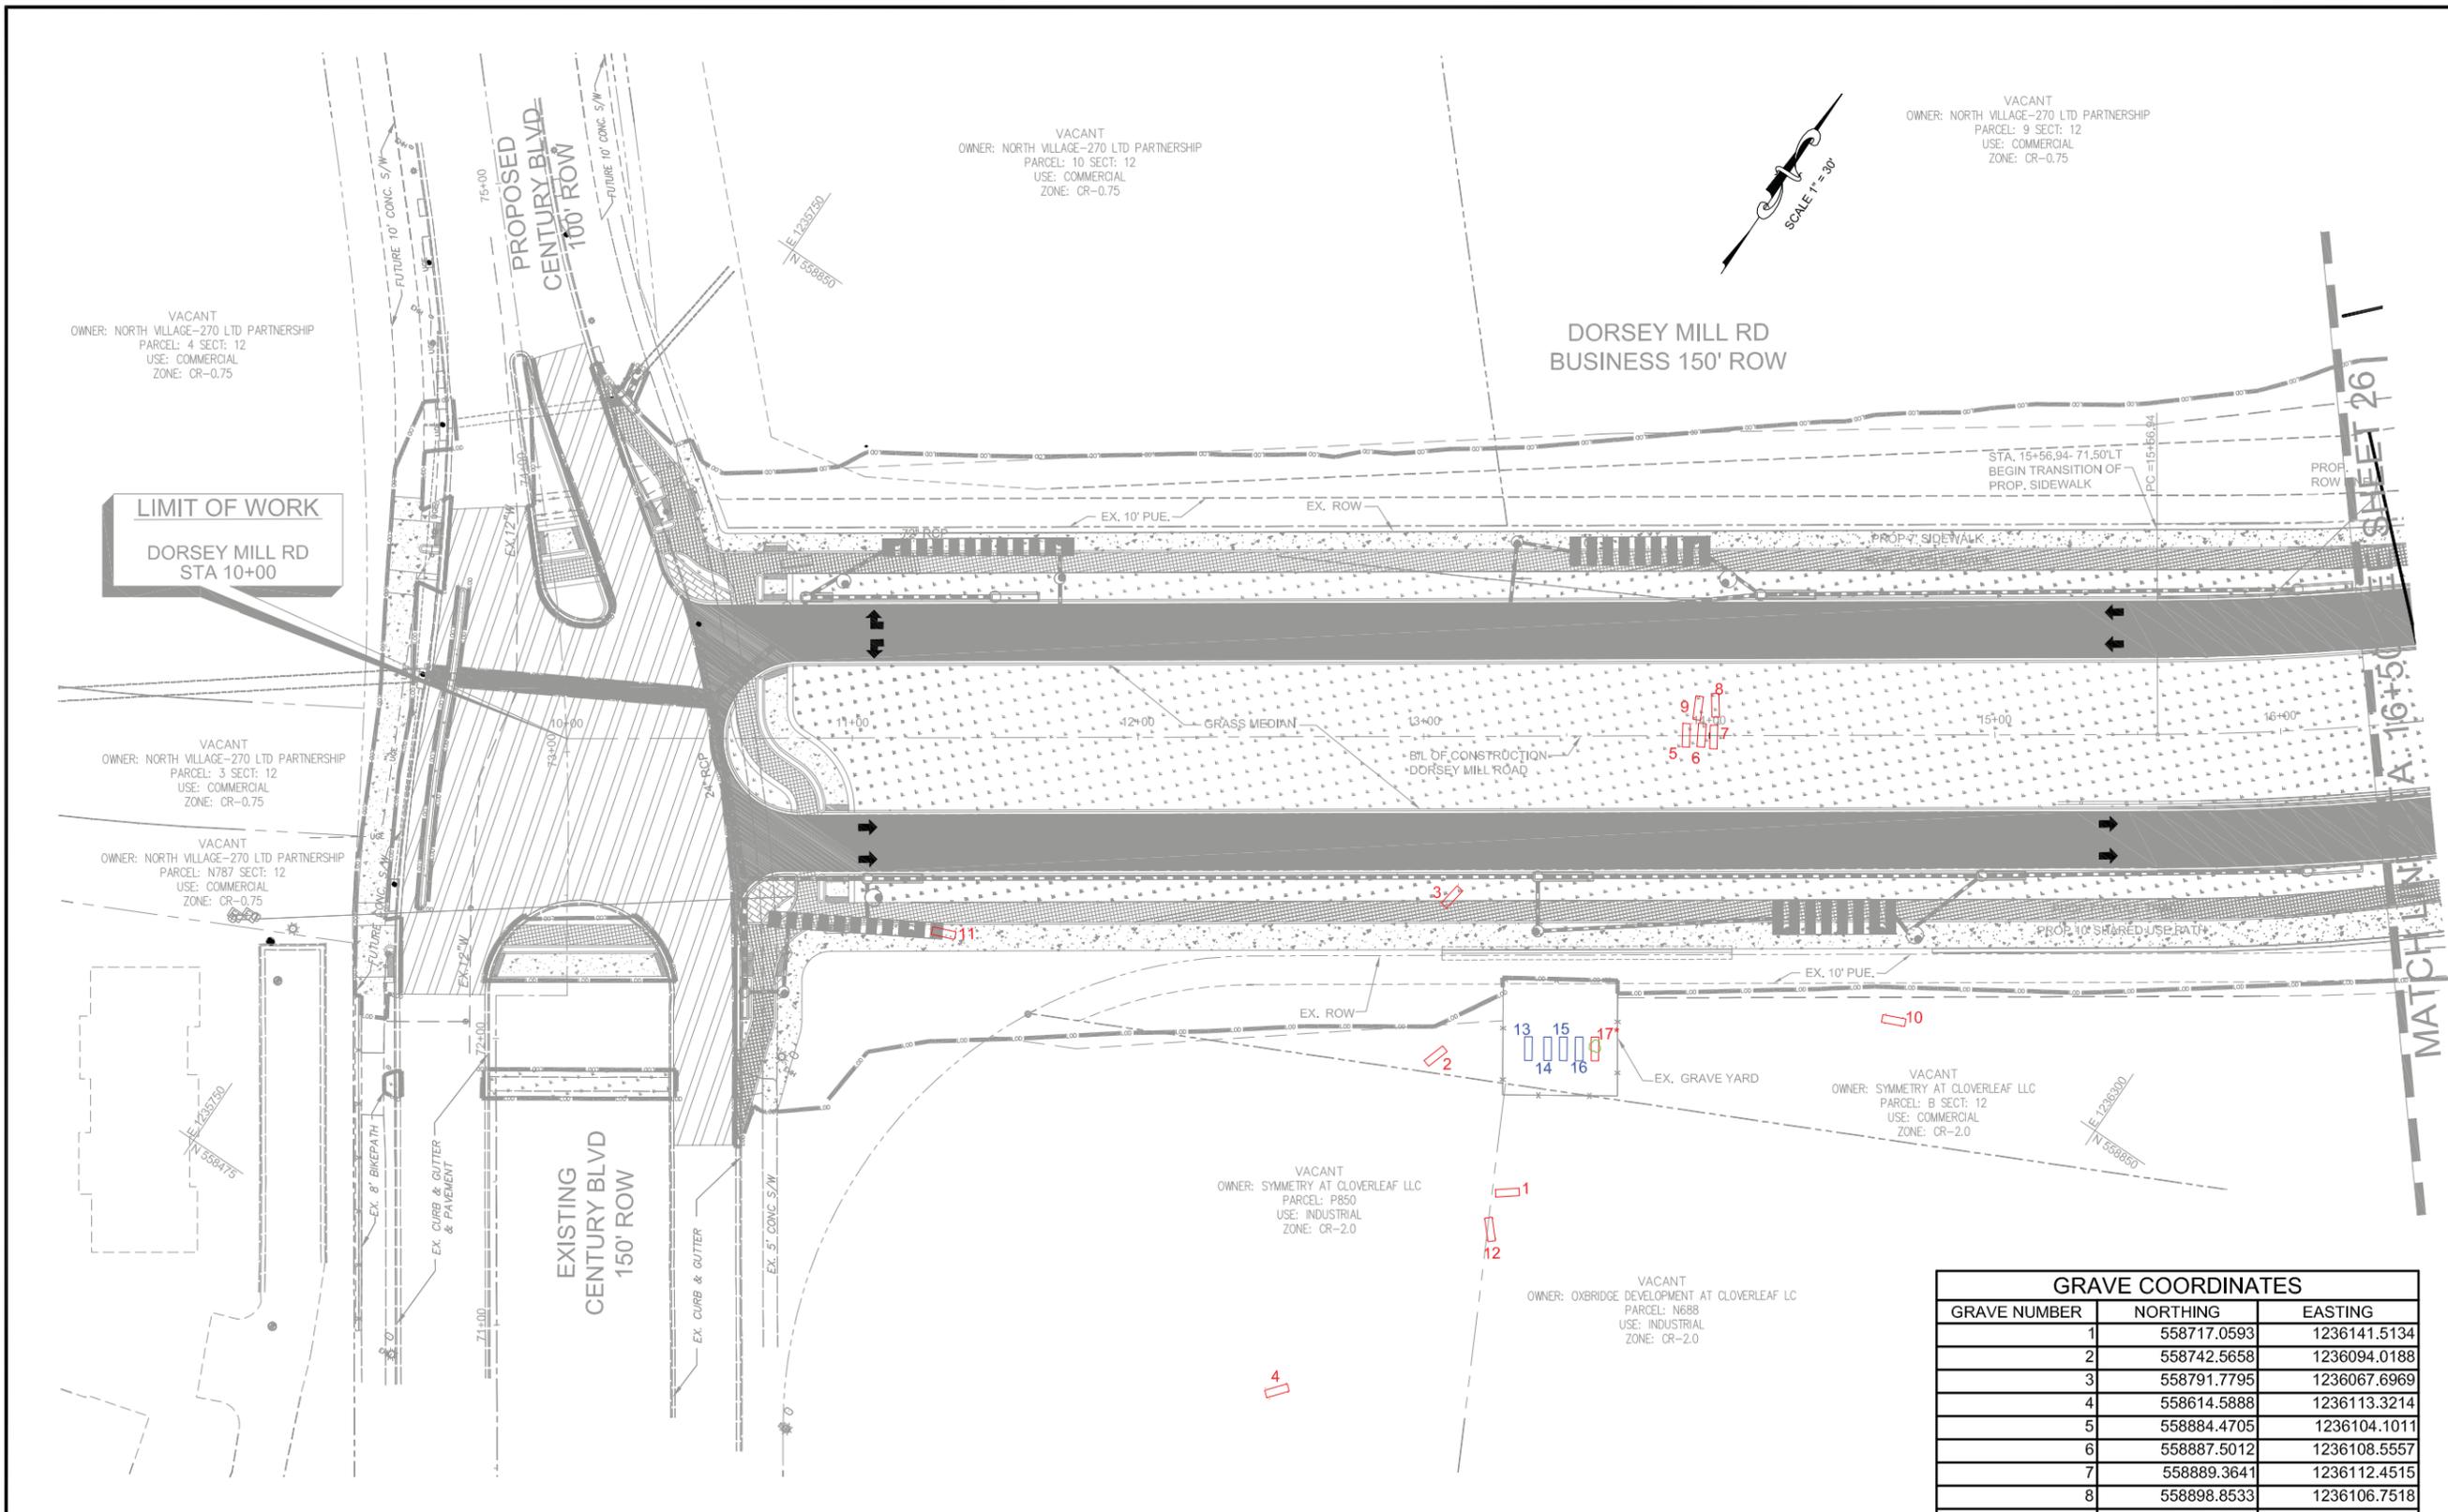
* POSSIBLE LOCATION OF GRAVE SITE. EQUIPMENT READING MAY NOT BE ACCURATE DUE TO TREE IN THAT LOCATION.
