M-14-3

circa 1800

ETCHISON-WARFIELD LOG HOUSE

## INVENTORY FORM FOR STATE HISTORIC SITES SURVEY

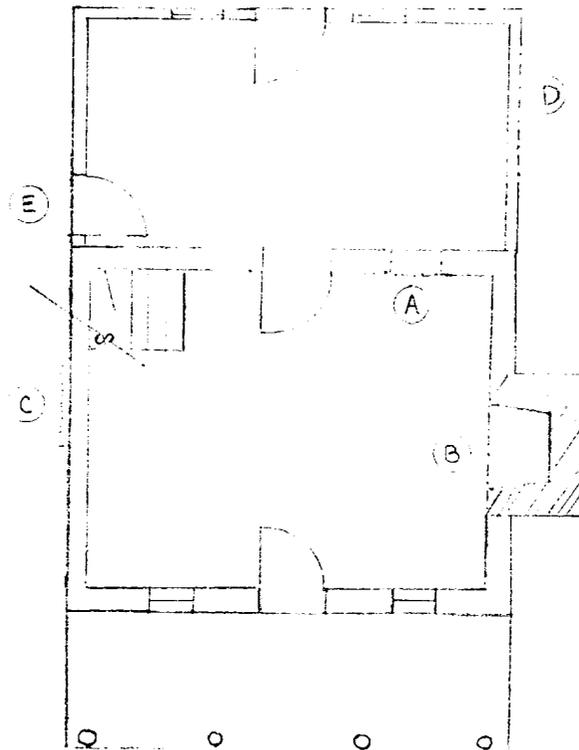
- A. CRACKS IN PLASTER INDICATE PRESENCE OF EARLIER WINDOW
- B. FIREPLACE COVERED UP AND ADAPTED FOR STOVE PIPE
- C. DUGOUT AREA OF EARTH AND STONE LEADING TO CELLAR
- D. EVIDENCE INDICATING LOCATION OF EARLIER STONE CHIMNEY
- E. DOOR LEADING TO EAST KITCHEN WING

The original south exterior wall is still visible as the partition wall between the north and south rooms. On its inner and outer faces it is plastered to a boxed cornice with a beaded board fascia. This south facade consists of a central doorway of vertical beaded boards similar to the door of the north facade. Cracks in the plaster on the interior of the wall indicate that a window may have originally flanked the door on the southwest side. (See Plan 1.)

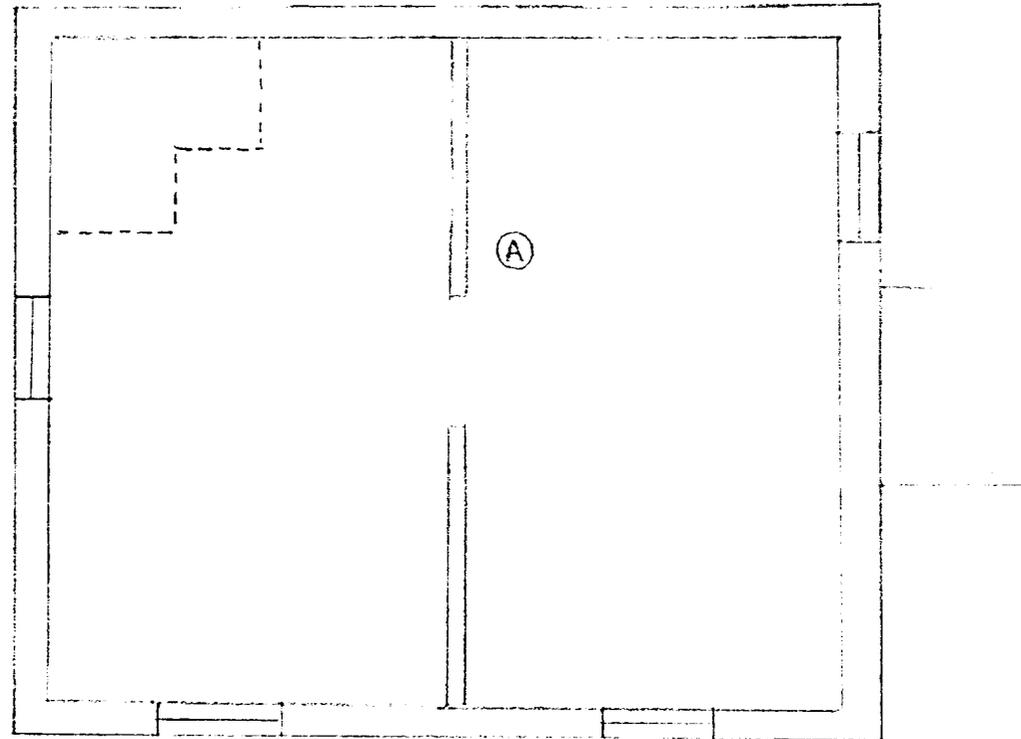
LOFT

A. BEADEL BOARD  
PARTITION WALL

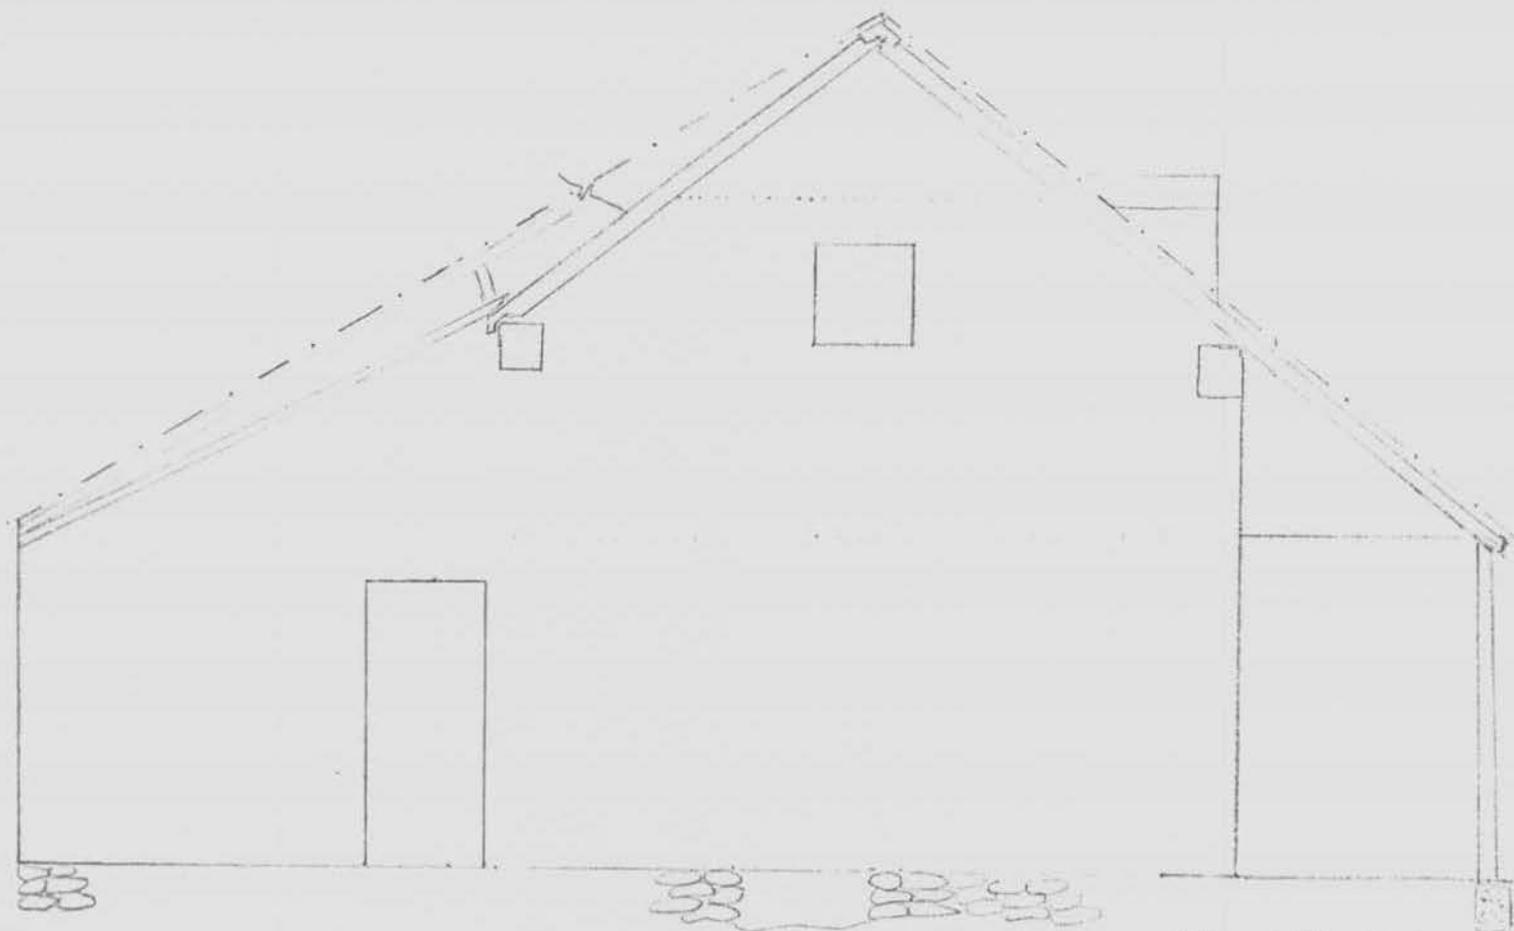
SECTION: ROOF CONSTRUCTION

EAST GABLE END

Rather than roofing the addition with an extension of the original south roof slope, which would cause a visual break in the roof line, an entirely new roof was constructed over the earlier roof. (See Plan 3.) The upper rafters of this roof were nailed to the original roof at the ridge and extend to the rear wall of the addition. Wide weatherboards were used to cover the open space between this upper roof line and the original south slope. (See H.A.B.S. photo 3.)

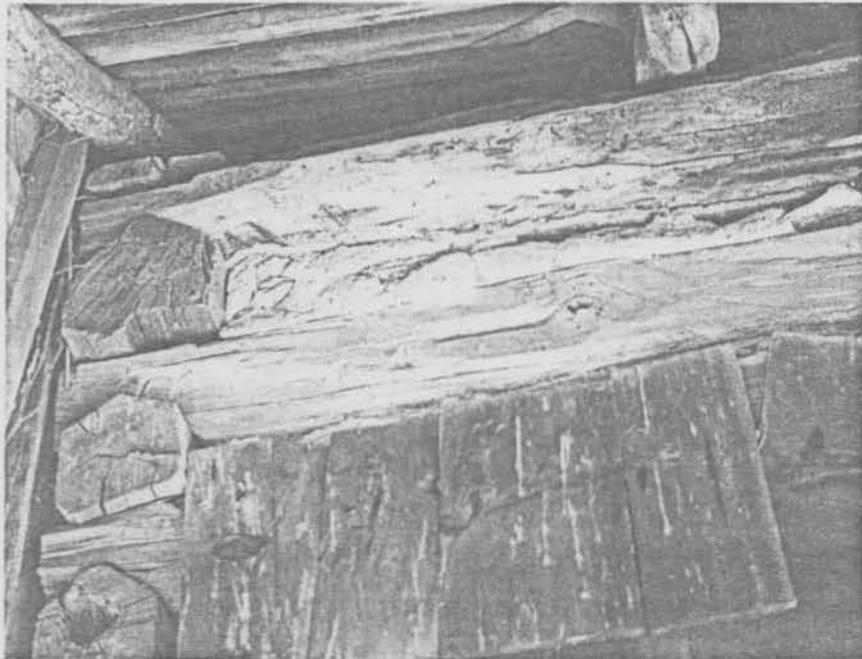
4

Detail of log construction. Northeast corner beneath porch roof. (Shingles covering façade above doorhead also visible) March 1981

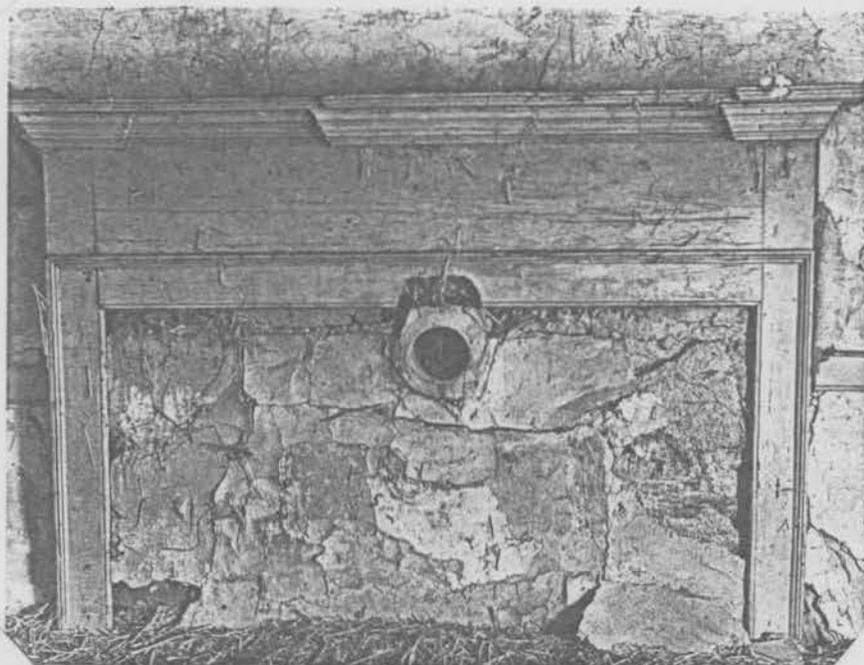
5

Detail of Fireplace, March 1981.

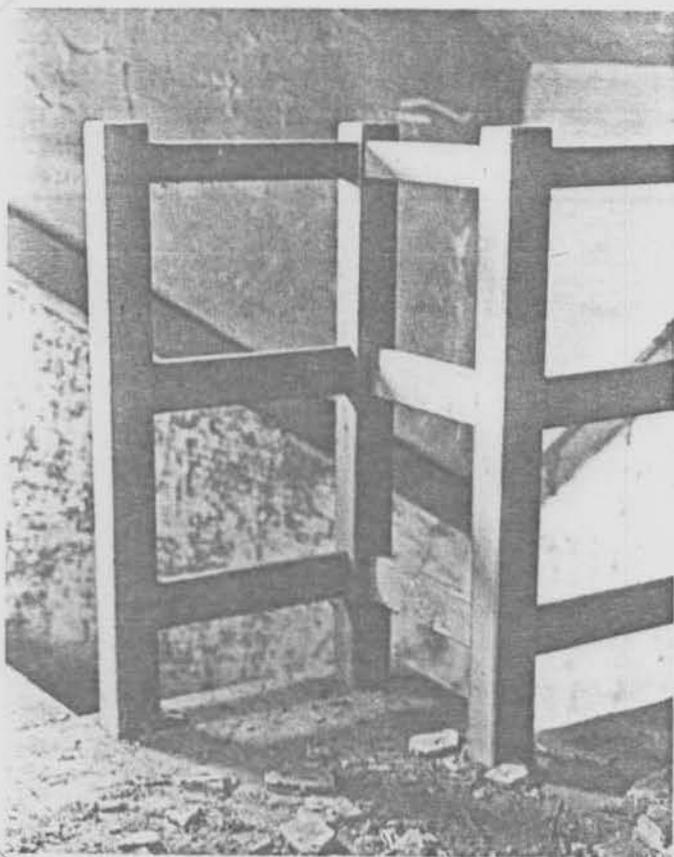
6

Detail of balustrade and chair rail, loft room, southeast corner, March 1981.

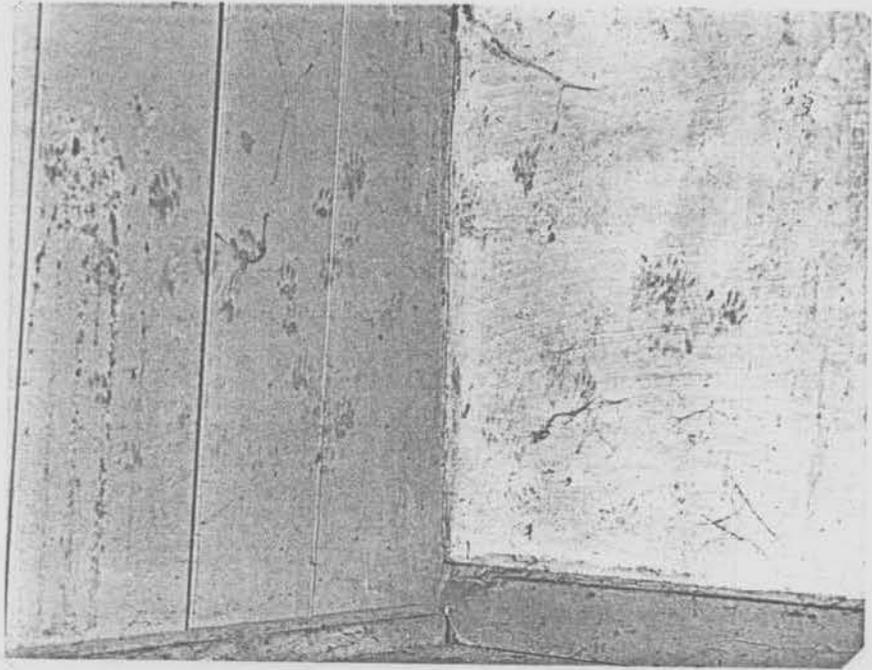
7

Detail of southeast corner of West loft room showing partition wall and baseboards.

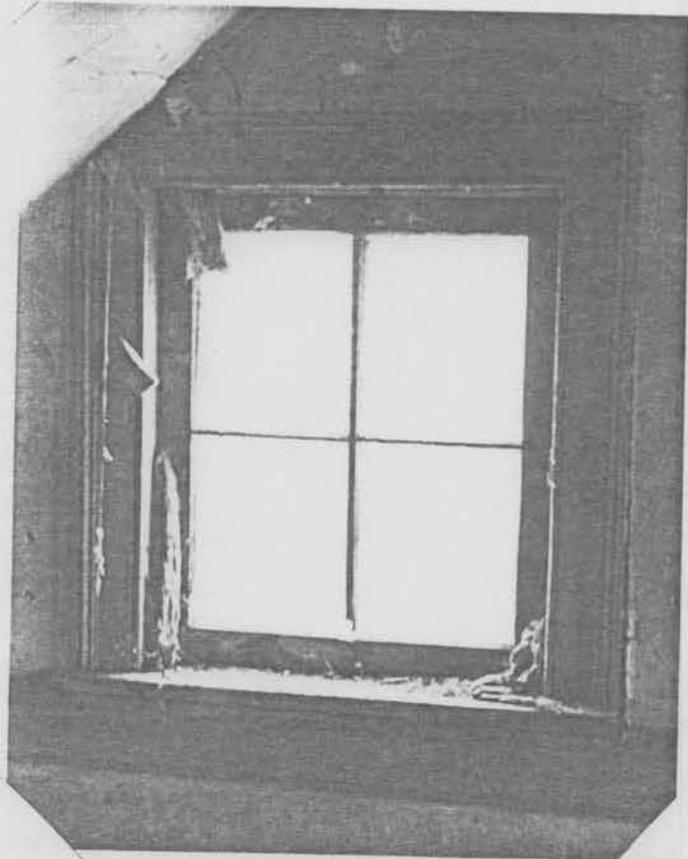
8

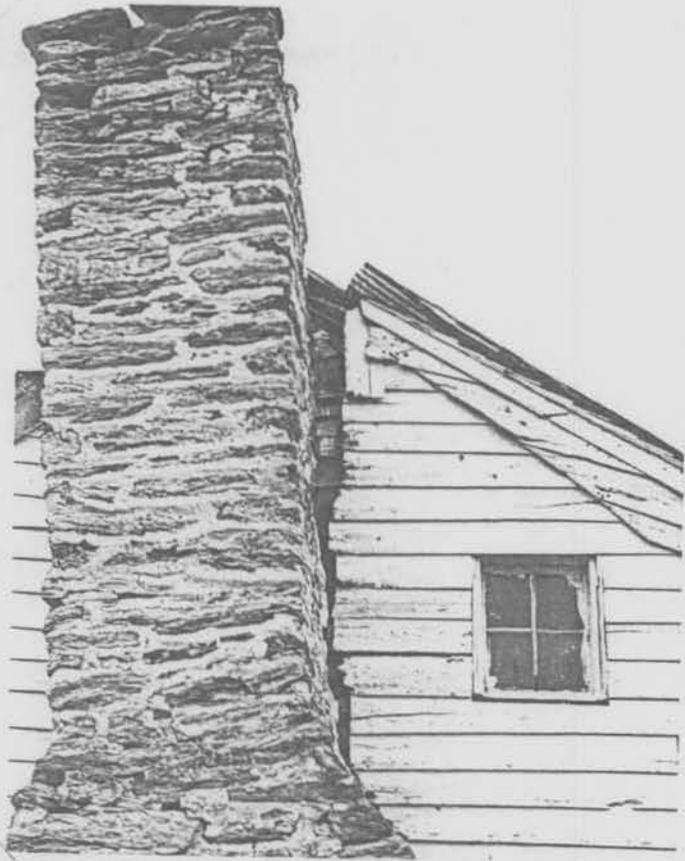
9

Detail of west gable end. Earlier weather-board siding and roof line of north log section visible to right of chimney. March 1981

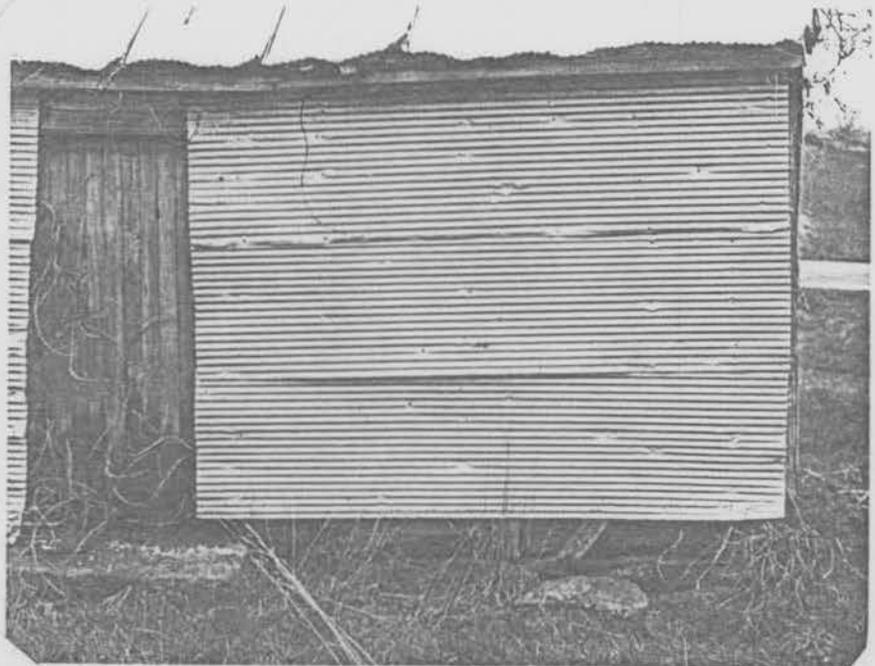
10

View Northeast. Detail of rear façade of shed addition showing central doorway. Frame wall

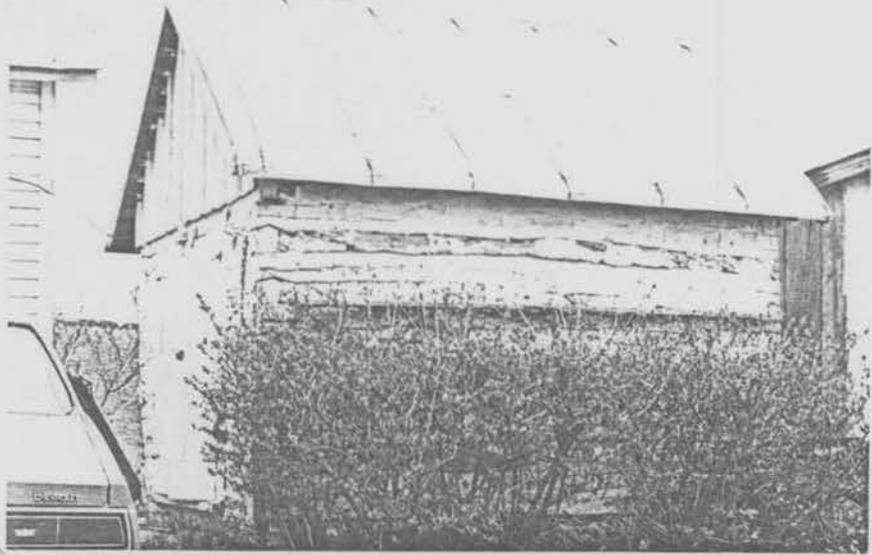
17

View North. Meathouse, North side of  
Rte. 108, behind I-house built by Basil  
Warfield 1893. March 1981.

house must have been built at a later date. One small meat house stands behind the Victorian I house built by Basil Warfield in 1893. The meat house is built of V-notched log construction, as were the two tobacco houses, and stands on a fieldstone foundation. The gable roof is covered with tin and part of the facade is covered with "board and batten". It is possible that this meat house is the one mentioned in the resurvey of 1814. However, it is more likely that the meat house and tobacco house were built by Lloyd Etchison between 1854 and his death in 1878. (See photographs 15 - 18.)

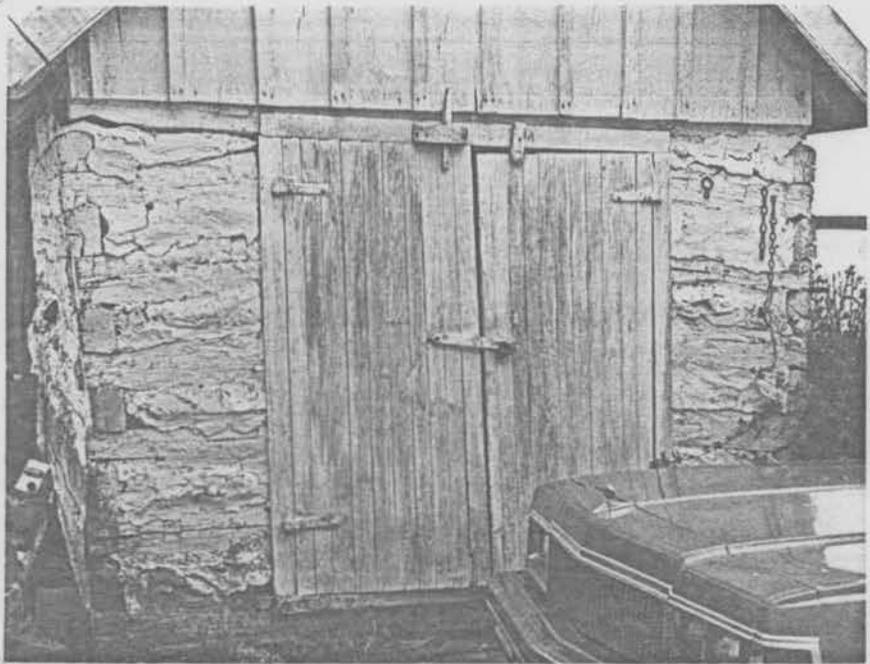
18

Detail of doorway and log construction.  
Meathouse. March 1981.
