SUBJECT: Historic Area Work Permit #984396 - Hardscape alterations and tree removal

HAWP Application 984396 for the Reconstruction of a Stacked Stone Wall And Landscaping the Area above It

National Park Seminary
Attachment to application for HAWP related to the restoration
of a historic stacked stone wall and landscaping the slope above it.

National Park Seminary
HWAP Application 983791 for the Installation
of a RainScapes Conservation Landscape

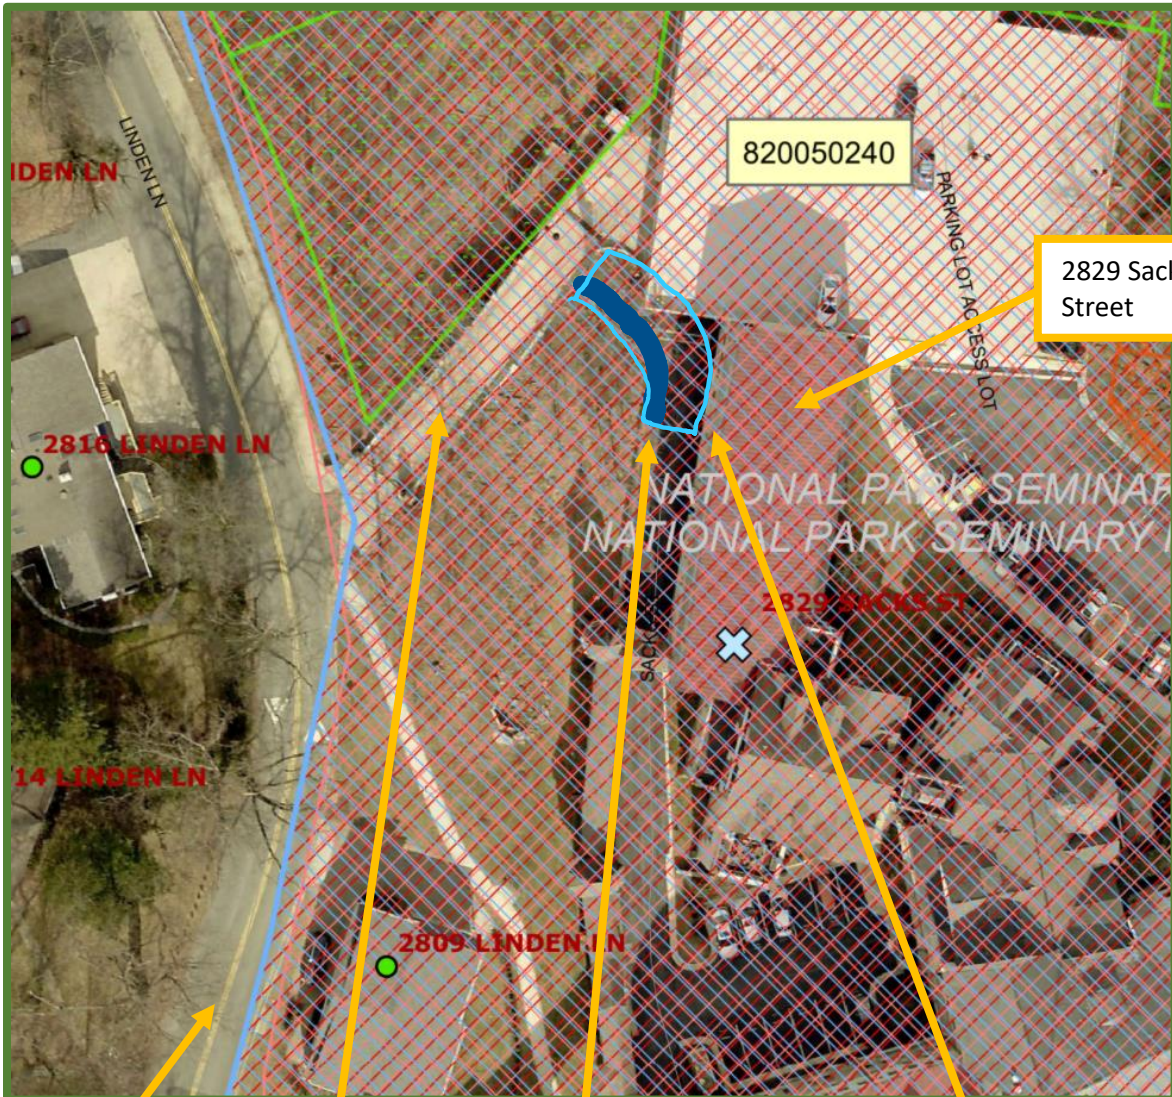
Aerial View of the Project Area

The dark blue stripe
indicates the stone wall.

The light blue line
delineates the
boundaries of the

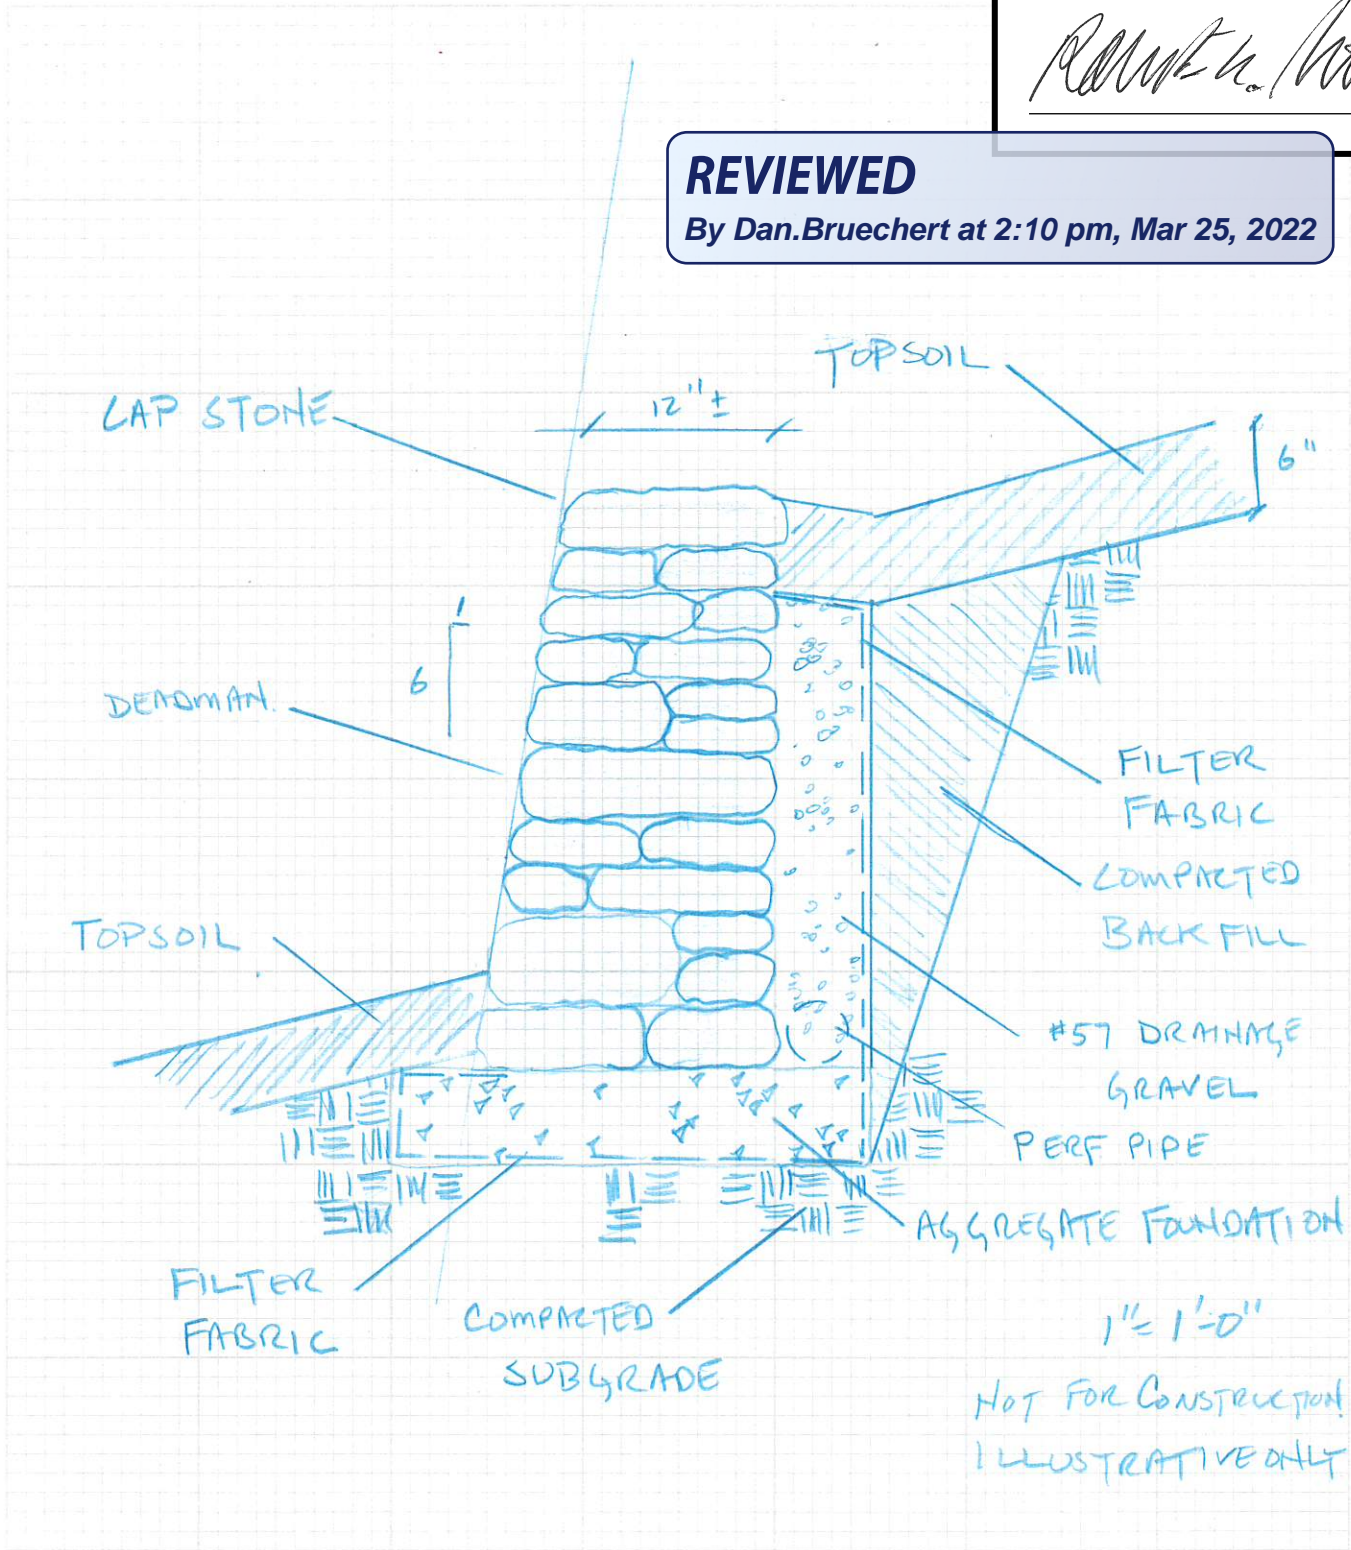
PROJECT NPS S.O.W. # _____
 COMPUTED _____ DATE 2/5/21
 CHECKED _____ SHEET 1 OF 1

The wall will be reconstructed per the engineer's drawing.

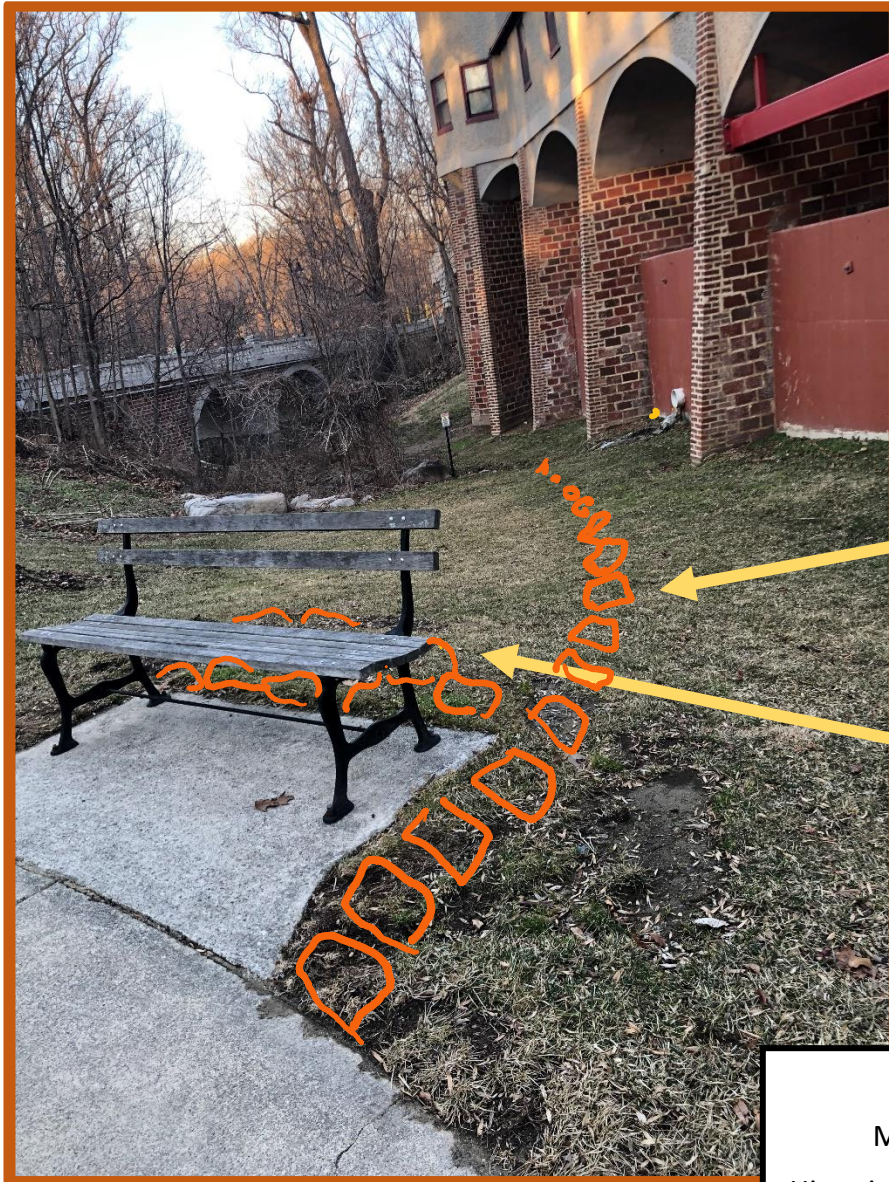
Stone Landing by Existing Bench and Stepping Stone Pathway

Stepping stones

Stone landing

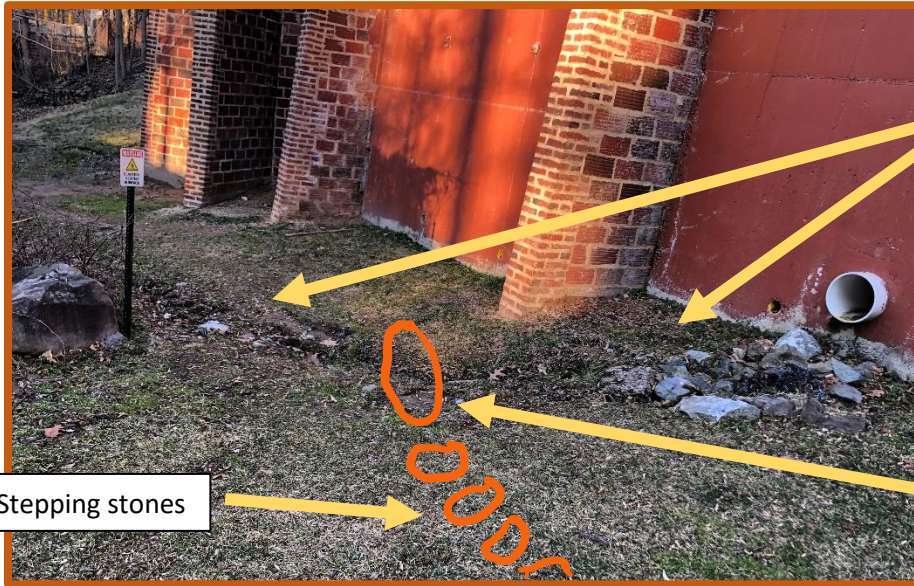
River Rock Swale and Flagstone Bridge; Pipe Extension

Rock swale

Stepping stones

Flagstone bridge

Rock swale will direct runoff from Sacks Street to the ravine; flagstone bridge to be placed over the swale.

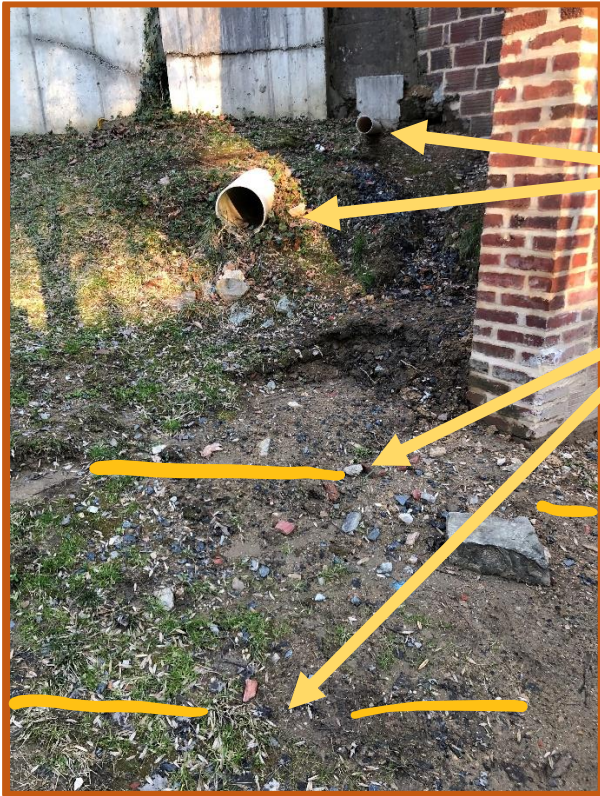
Drainpipes

Location of pathway

Polyurethane extensions to be added to existing drainpipes to redirect outflow under the new pathway to the ravine below.
