MEMORANDUM

SUBJECT: Historic Area Work Permit # 993420: New doors

Address: 5701 Achille Lane, Rockville

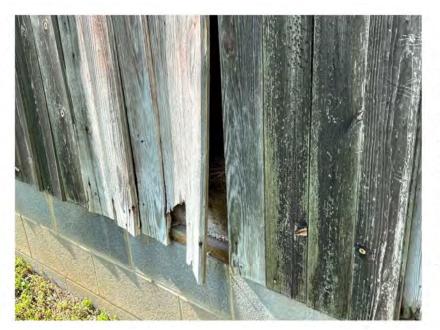
Figure 3.

South Elevation: Peeling and Deteriorating Siding

The elements have taken a toll on the siding — especially on the south elevation of the barn, which receives sun for a majority of the day. Salvageable boards are proposed to be better-secured while new boards are patched-in where boards are beyond repair.

Proposed approach will be similar to what is seen in figure 2, above.

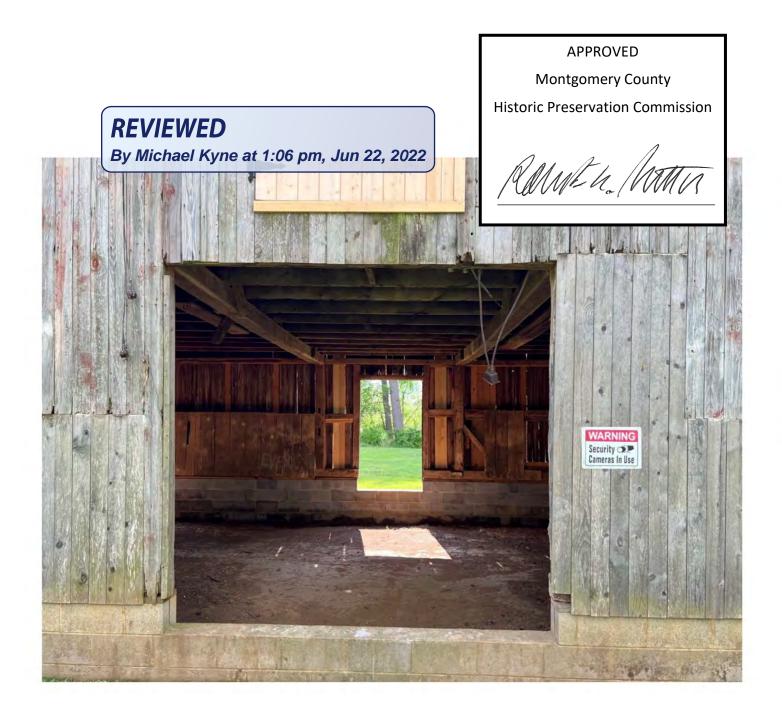
Figure 4.

West Elevation: Large Doorway Opening. Location of Proposed Replacement Sliding Door

A new board-and-batten sliding door, constructed of white pine and utilizing typical agricultural sliding door hardware, is proposed to be restored to this opening.

The proposed door would overhang the cutout in the concrete block foundation to provide a full seal of the opening.

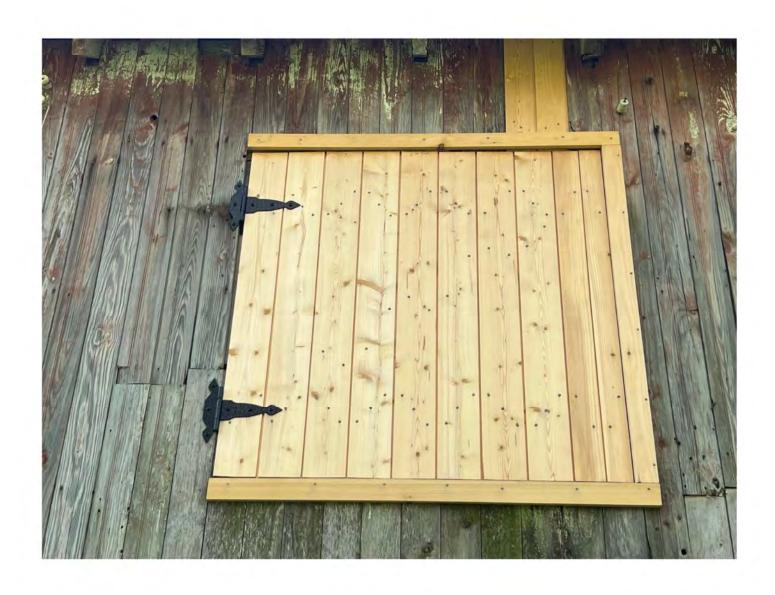
Figure 5.

Proof-Of-Concept Hayloft Door: Example of Doors to be Constructed

This board-and-batten white pine door was constructed in 2021 as a proof of concept. It restored a doorway to the hayloft opening in an effort to keep out the elements and a burgeoning vulture population.

The proposed doors would be constructed of the same materials in a similar manner.

The same type of gate hinges would be used for the three swinging doors on the west side.

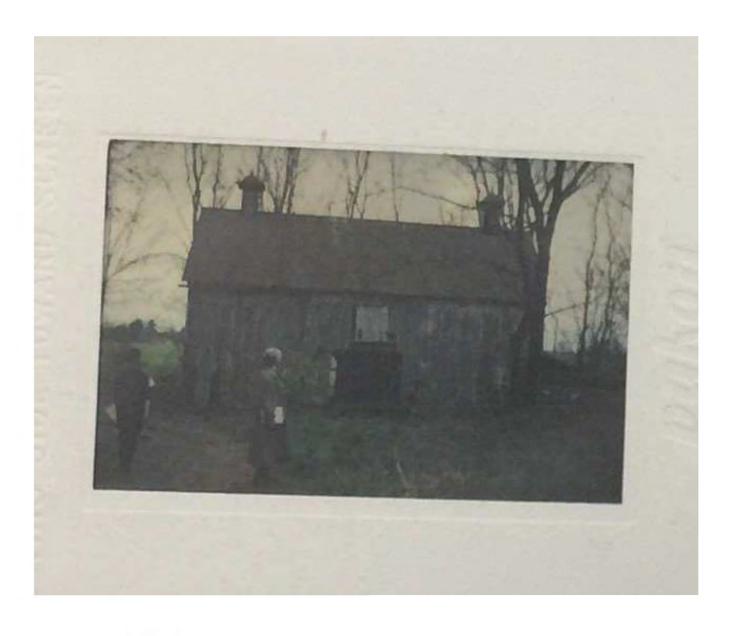
Figure 6. Historic Photograph: Circa 1990s showing hayloft door

This photograph was provided by homebuilder Stanley Martin to the homeowner at the time of the 2017 property purchase. The homeowner believes this slide to have come from the Historic Preservation Commission archives but has no further information.

Based on adjacent material, the homeowner believes this was taken during a 1990s assessment of the property for historic preservation purposes.

What appears to be a board-and-batten door is seen here over the east elevation, covering the hayloft. The large opening is without a door.
