HISTORIC PRESERVATION COMMISSION

SUBJECT: Historic Area Work Permit #880114: Roof replacement

Applicant: Tobias Herman and Kristine Lui Address: 26038 Frederick Road, Clarksburg

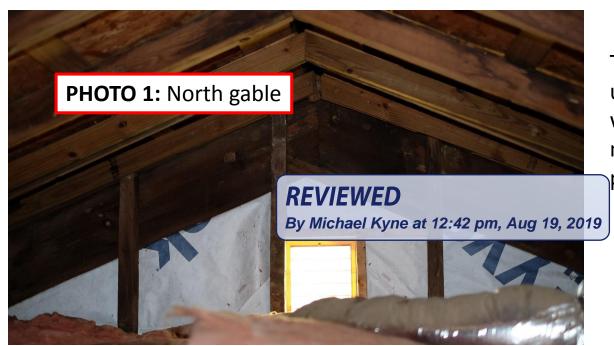
The exact age of our roof is unknown. However, the attic was obviously reframed recently, meaning that the roof is probably about 20 years old.

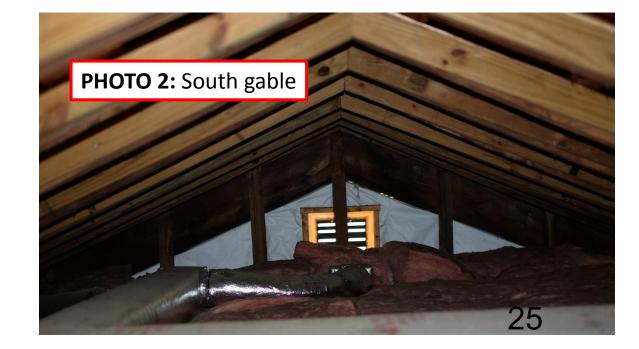
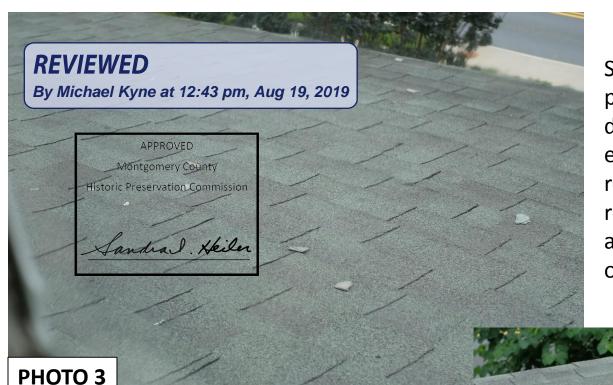
PHOTO 4

New framing can be seen paralleling older beams.
Oriented strand board is visible as the roof decking.
At gable ends the original support timbers are visible.

Safe access to the roof for clear pictures of damage *in situ* is difficult as we do not own a tall enough ladder. Four different roof contractors inspected the roof in order to provide a quote and all expressed degradation of the slates.

However, evidence of damaged and broken slate can be seen on the porch roof below the slate roof (picture taken from interior of second floor room). (The front porch is currently asphalt shingle.)

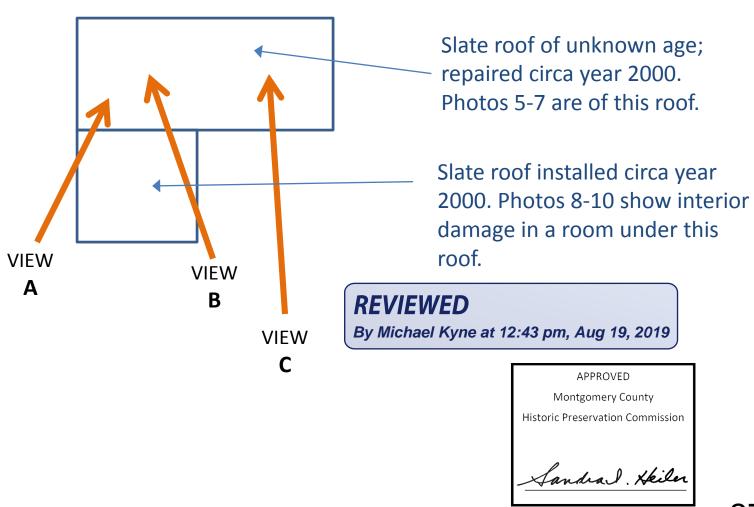
Plan view of lines-of-sight for photos on following pages.

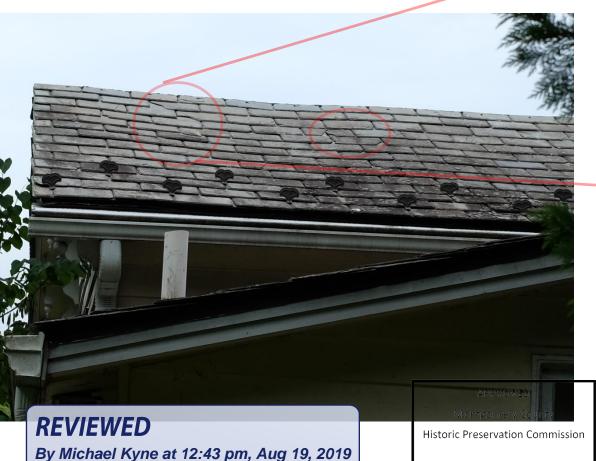
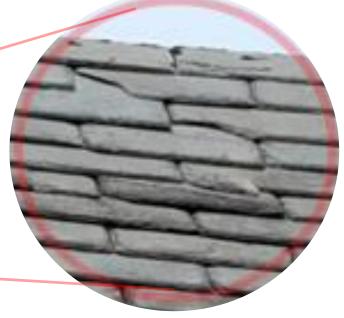
PHOTO 5:

Cracked and broken slates: some examples indicated by red circles.

- The back roof is less than 20 years old and is already leaking into the interior. The pitch is too shallow for any tiled roofing systems, according to professional roofing associations.
- The front roof is shedding slate pieces, possibly already causing leaks. The pitch is at the minimum of recommended slate roof tiles.
- The front porch is currently asphalt shingle, which is not in keeping with the historic character of the home.

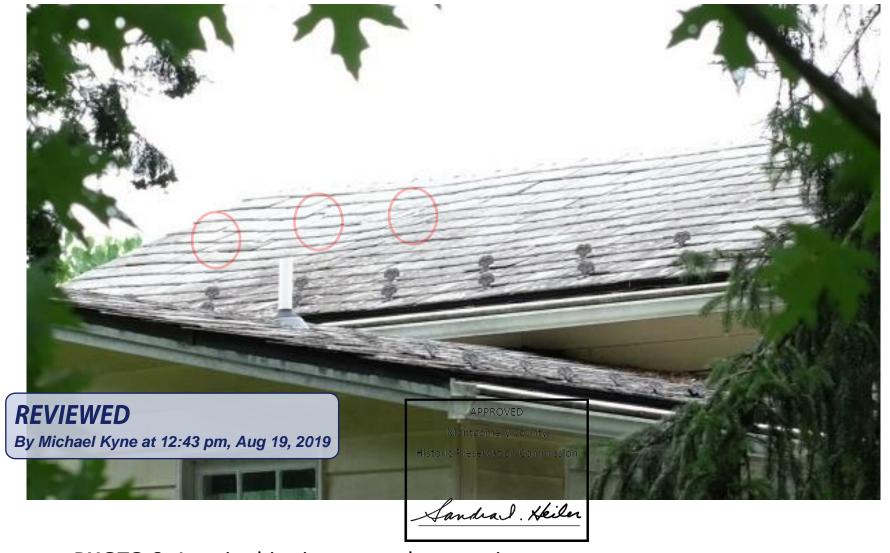
Also note unevenness in ridgeline on the left.

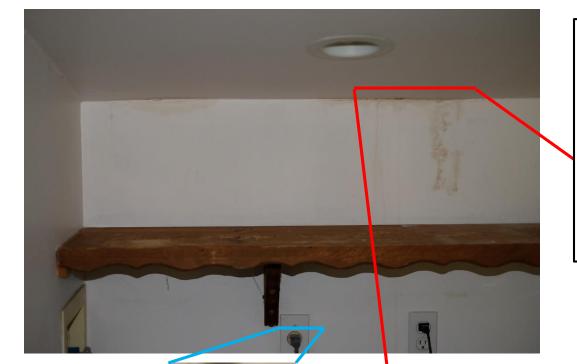
PHOTO 8:

Leaks in roof have allowed water to flow under the slate, causing bulging of ceiling and intrusion where roof meets wall. Water is no doubt flowing down through the wall as well.

Leak emanating from electrical receptacle

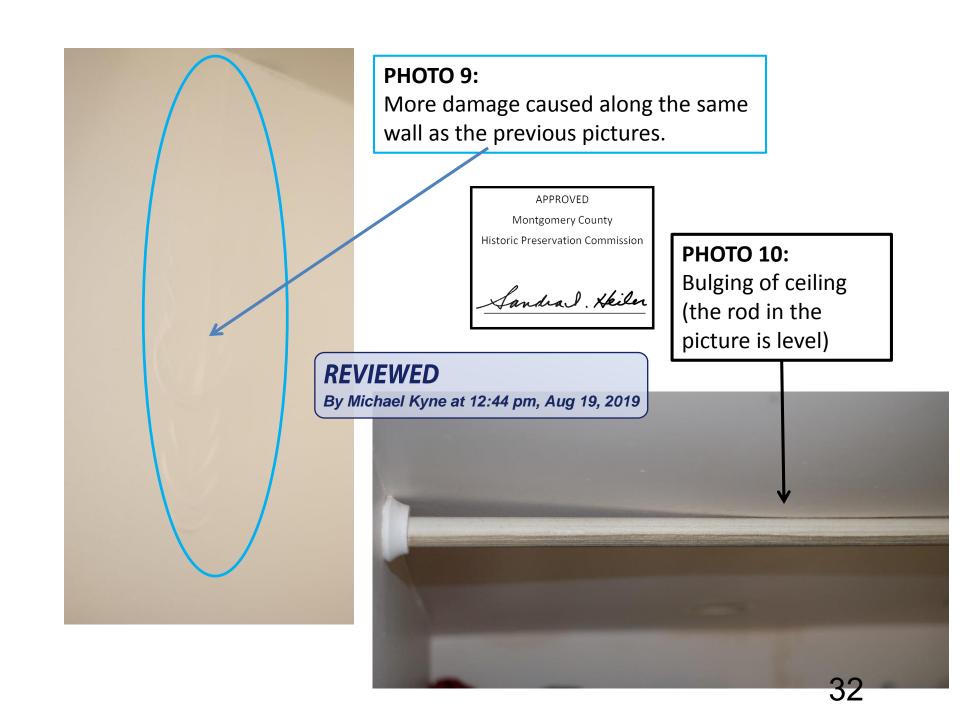
Staining from repeated leaking along north edge of roof
