3940 Washington St.  
Kensington

SUBJECT: Historic Area Work Permit #550801—roof replacement

<b>Address:</b>	3940 Washington Street, Kensington	<b>Meeting Date:</b>	1/12/11
<b>Applicant:</b>	James Foy (Stephen Foy, Agent)	<b>Report Date:</b>	1/5/11
<b>Resource:</b>	Primary-One Resource Kensington Historic District	<b>Public Notice:</b>	12/29/10
<b>Review:</b>	HAWP	<b>Tax Credit:</b>	None
<b>Case Number:</b>	31/6-10G	<b>Staff:</b>	Anne Fothergill
<b>PROPOSAL:</b>	Slate roof replacement

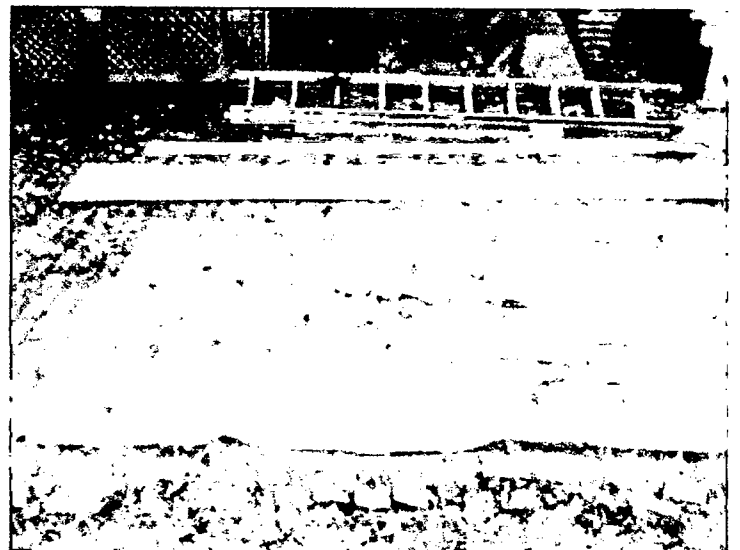
2nd Floor Water Damage

The applicants are proposing to remove the existing original Bangor slate roof on the house and replace it with asphalt shingles. The applicants have repaired the roof many times and done some replacement with Buckingham slate. The roof continues to leak and there is water damage on the second floor (see exterior and interior photos in Circles 10-20).

There is water damage in the attic and on the second floor. Repairs to the attic and second floor cannot begin until the roof is secured.

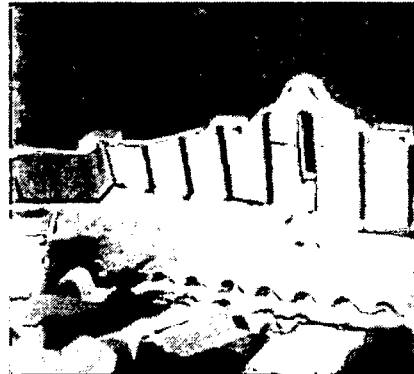
Replacement of damaged clay tile roof.

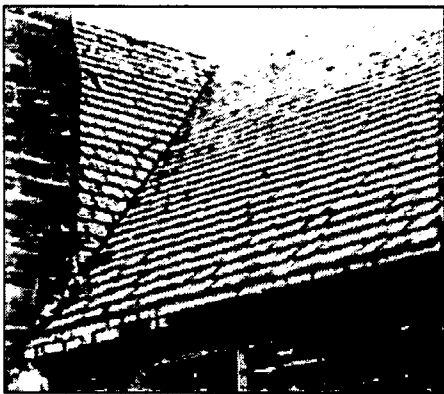
Valleys are formed at the internal angle of two roofing slopes. Flashing is often placed under the slate to increase moisture protection at this vulnerable joint. Photo: Jeffrey S. Levine.

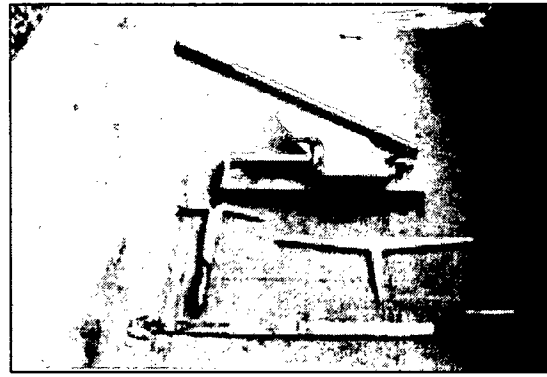
These traditional slater's tools are used to cut and trim, hammer, measure, and rip out nails. Photo: Jeffrey S. Levine.

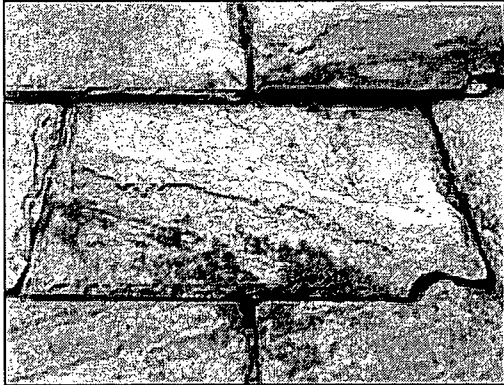
Paper thin lamination can be seen flaking off this weathered, 120 year piece of Pennsylvania Hard-Vein slate. Photo: Jeffrey S. Levine.

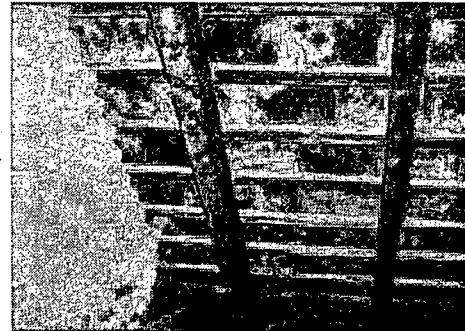
View of these slates laid on open sheathing shows that delamination and flaking are just as bad or worse on the underside of slates as on the exposed surface. This is why most slates cannot be flipped over for reuse. Photo: Jeffrey S. Levine.

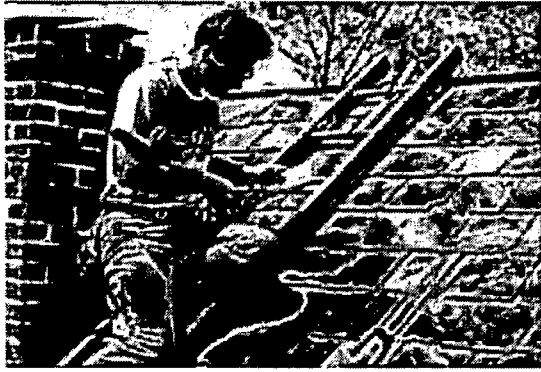
After removing the deteriorated slate and sliding the new slate into place, it is secured with a copper nail. A copper bib (shown here) is formed to protect the newly created nail hole. Finally, a slate hammer is used to push the bib in place over the nail head. Photo: Jeffrey S. Levine.
