Baltzley Castle: 5415 Mohican Road

Written Description of Work: Condition Assessment

MARYLAND DEPARTMENT OF PLANNING
MARYLAND HISTORICAL TRUST
MARYLAND SUSTAINABLE COMMUNITIES
REHABILITATION TAX CREDIT APPLICATION
PART 2 – DESCRIPTION OF REHABILITATION
HOMEOWNER APPLICATION

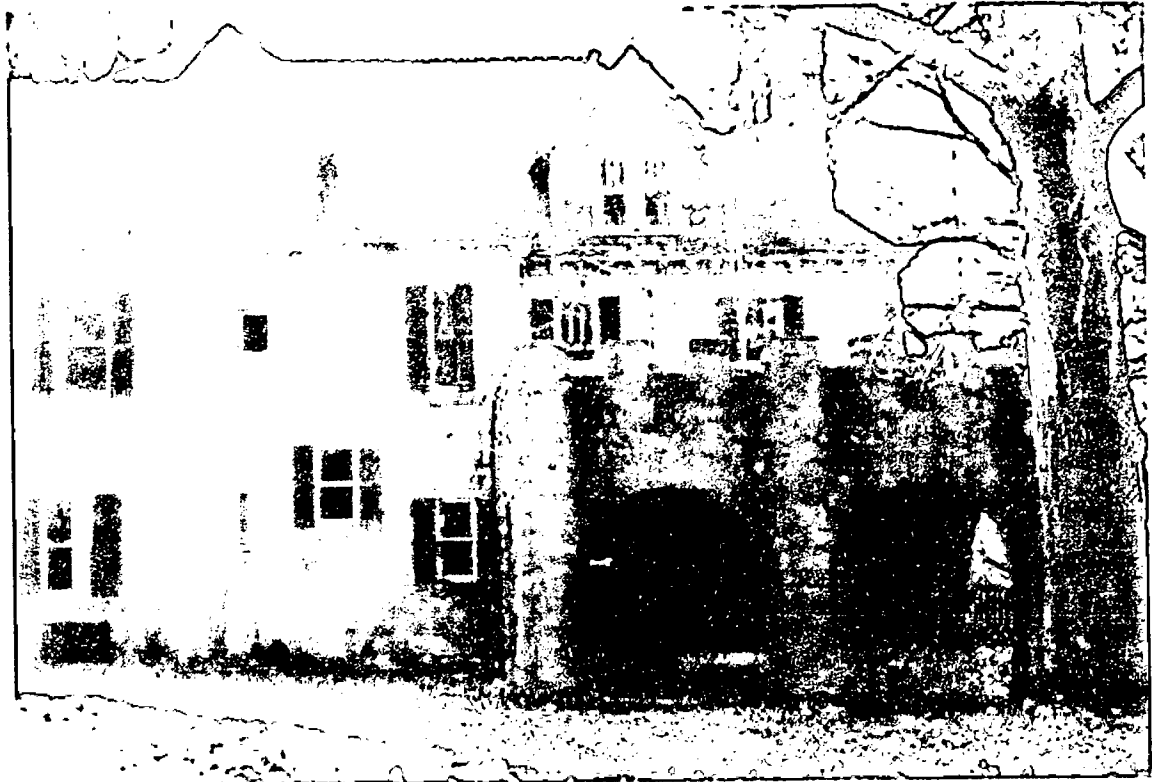
5415 Mohican Road, Bethesda North view

north view

Number 1	Architectural feature: <u>slate roof, stone building</u> Approximate Date of feature: <u>1890</u>	Describe work and impact on existing feature: replace roof, repair stone, remove wooden structure above squared bay
Describe existing feature and its condition: southwest elevation		
Photo #: <u>1</u> Drawing #: _____		
Number 2	Architectural feature: <u>slate roof, stone building</u> Approximate Date of feature: <u>1890</u>	Describe work and impact on existing feature: replace roof, repair stone
Describe existing feature and its condition: northwest view		
Photo #: <u>2</u> Drawing #: _____		
Number 3	Architectural feature: <u>slate roof, stone building</u> Approximate Date of feature: <u>1890</u>	Describe work and impact on existing feature: replace roof, repair stone
Describe existing feature and its condition:

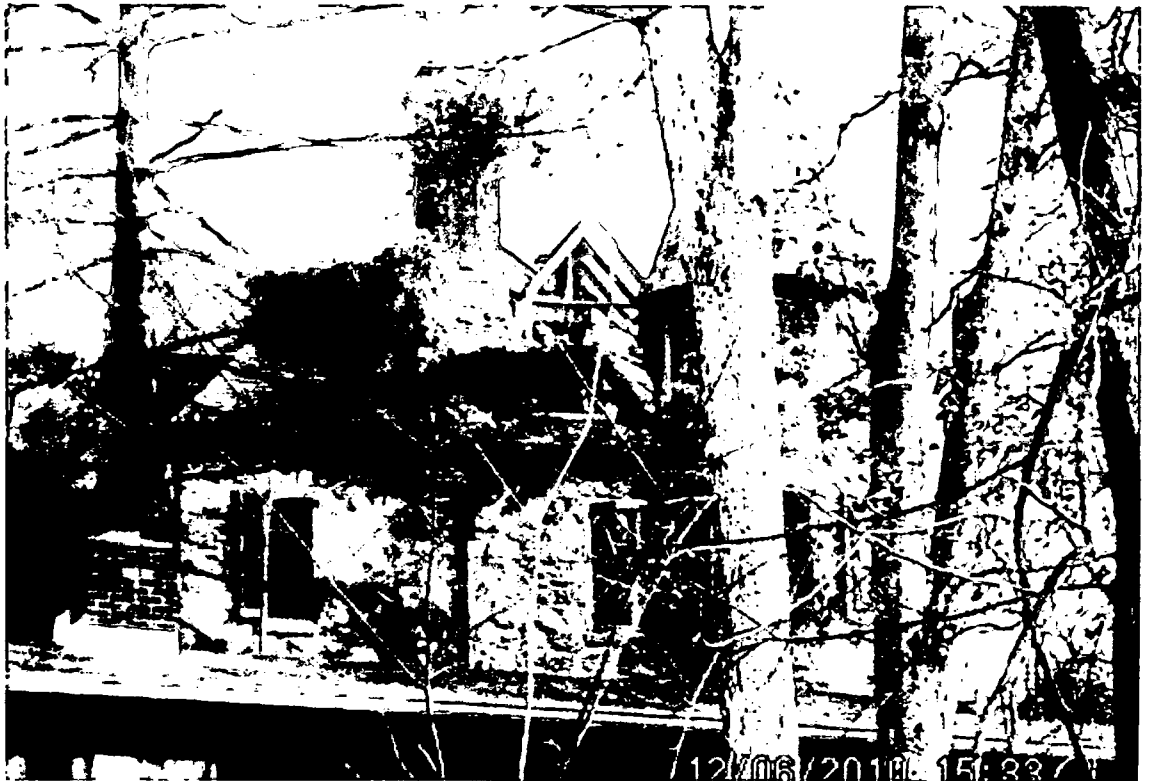
6

5415 Mohican Road, Bethesda

West view

Describe existing feature and its condition:
west view

Describe work and impact on existing feature:
replace roof, repair stone, build cricket at glass structure

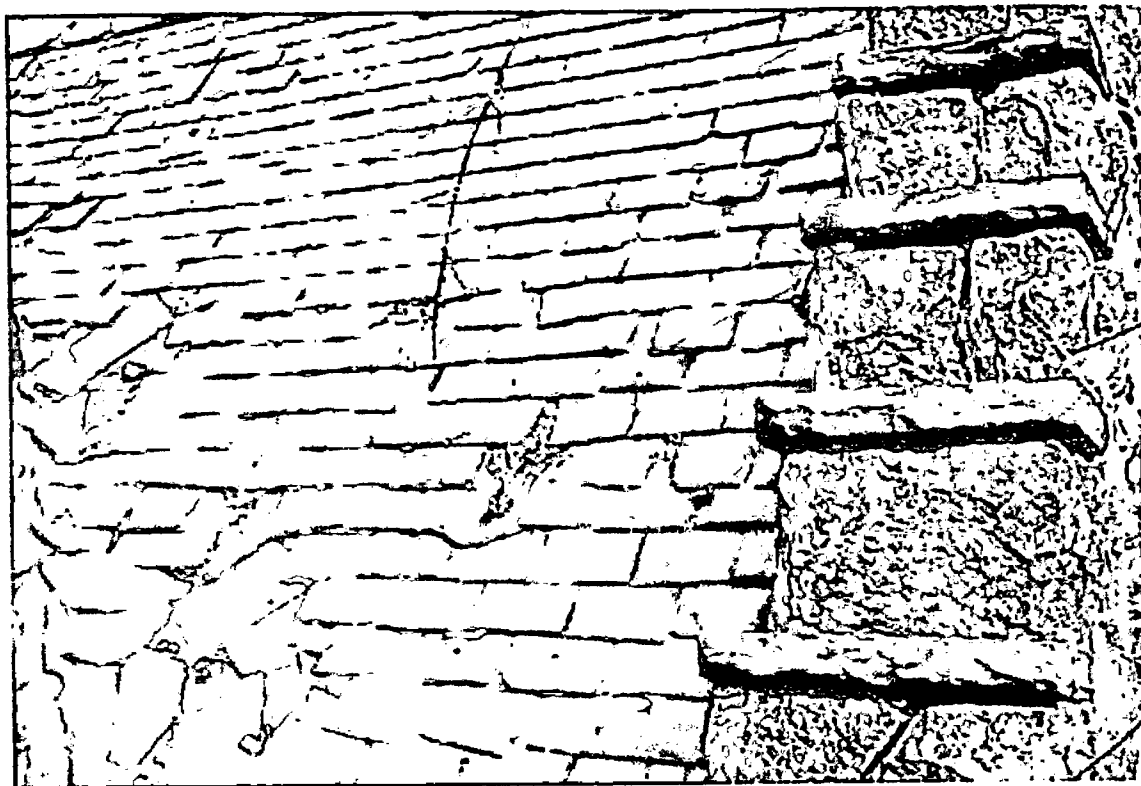
5415 Mohican Road, Bethesda
Roof damage

South view

slate roof in poor condition

An immediate concern is the integrity of the roof. The roof leaks and has caused tremendous damage to the finishes and to some framing elements of the house. The copper built-in gutters, valley, step and chimney flashing's need to be replaced. There are many broken, missing red roof slates, and the felt has completely deteriorated.

The roof needs to be completely replaced. This will involve carefully removing the red slate, ornamental trim elements, stripping all underlayment, flashing and plywood sheathing. We will need to replace damaged framing and sheathing and install snow and ice shield, titanium underlayment, copper built-in gutters / flashing and the red slate roof. The existing slate is from two periods. The original slate is 1880 vintage. Slate was added during a 1958 renovation. The two vintages of red slate are a close match in color, but the original 1880 slate is too old to be reused. We have located two suppliers of a red slate called Vermont Red (actually from New York). Vermont Red is a very close match in color, size and thickness to the existing slate on the roof.

Describe work and impact on existing feature:
replace roof, repair stone, flash roof
