TO: Rabbiah Sabbakhan  
Department of Permitting Services  
FROM: Laura DiPasquale  
Historic Preservation Section  
Maryland-National Capital Park & Planning Commission  
SUBJECT: Historic Area Work Permit #1166076 – Partial demolition, fenestration alterations, and installation of mechanical equipment

Applicant: Fabiana Abreu  
Address: 19821 Darnestown Road, Beallsville

# Abreu Residence

19821 Darnestown Rd., Bealsville, MD 20839

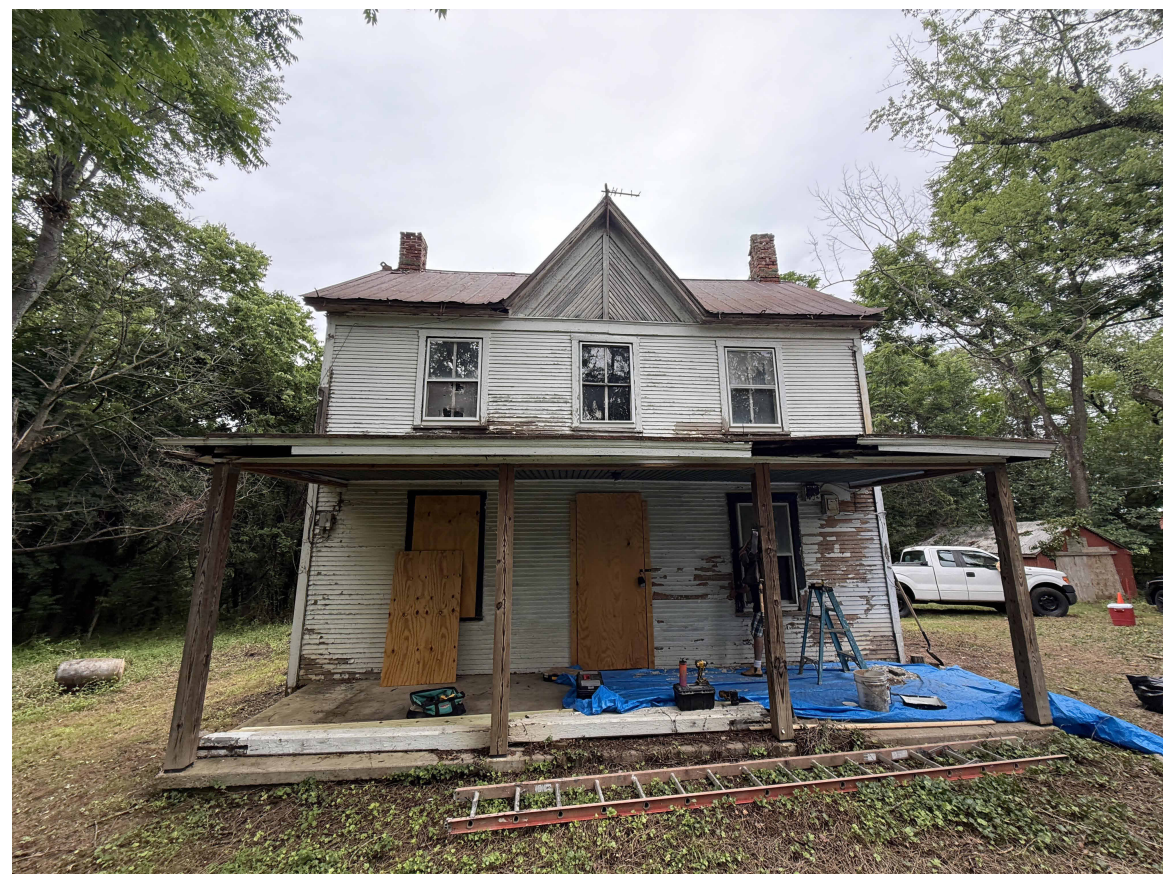
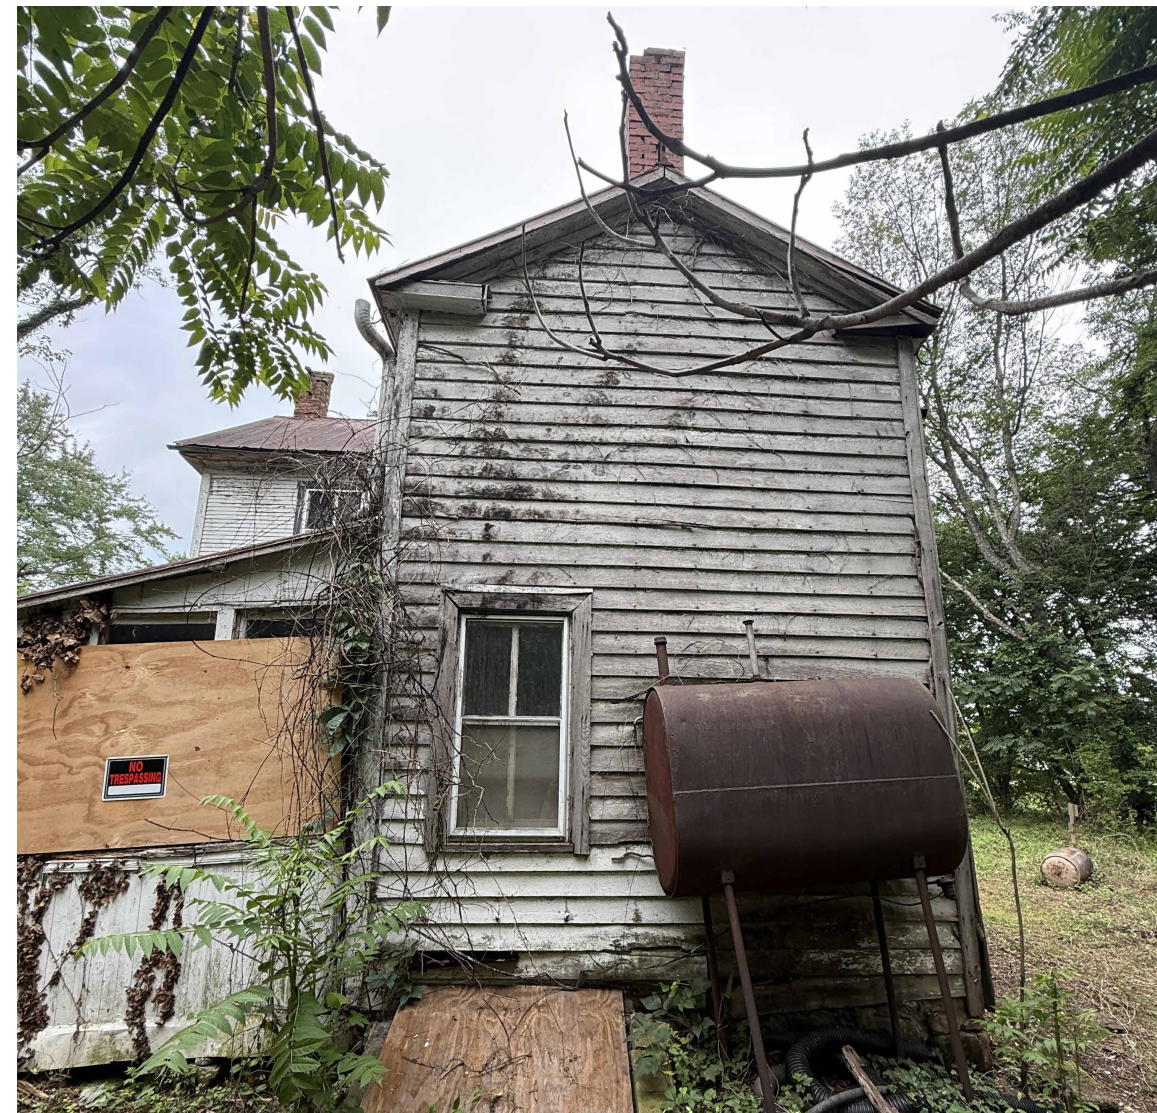
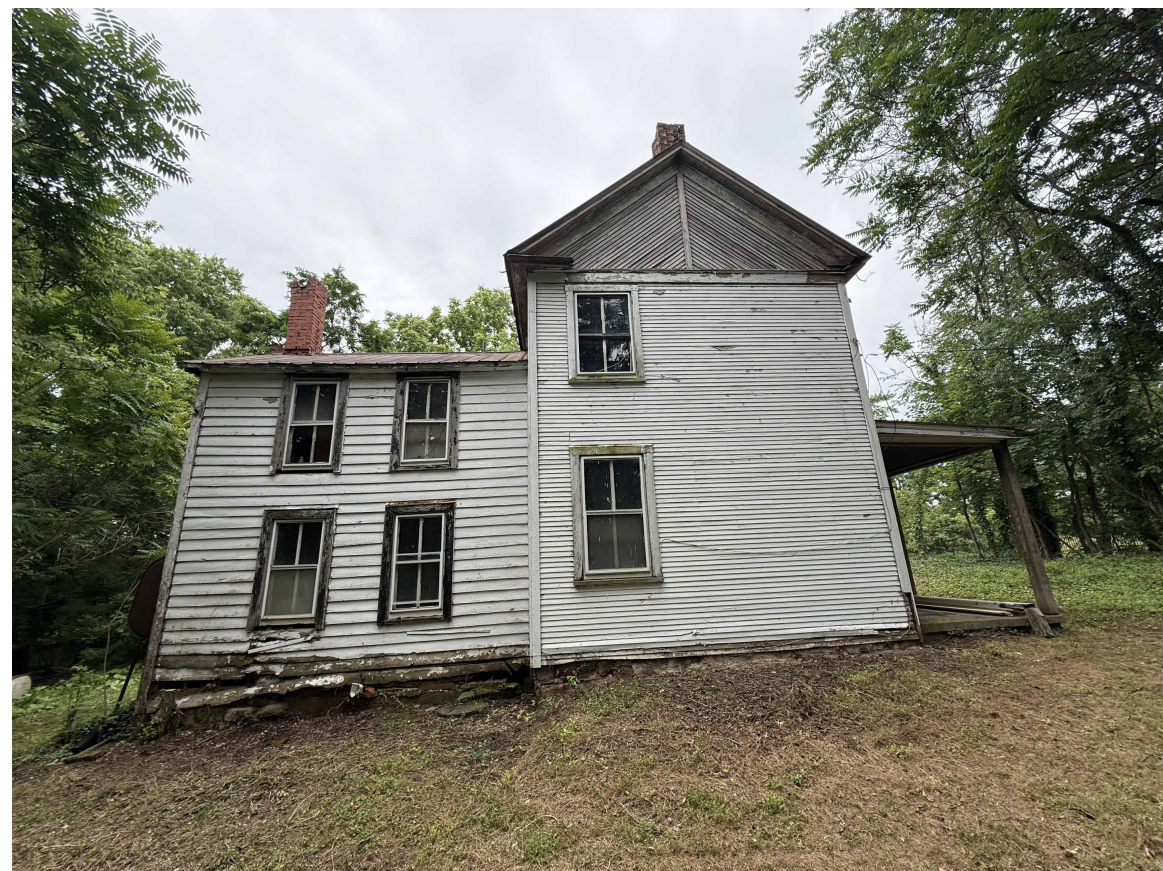
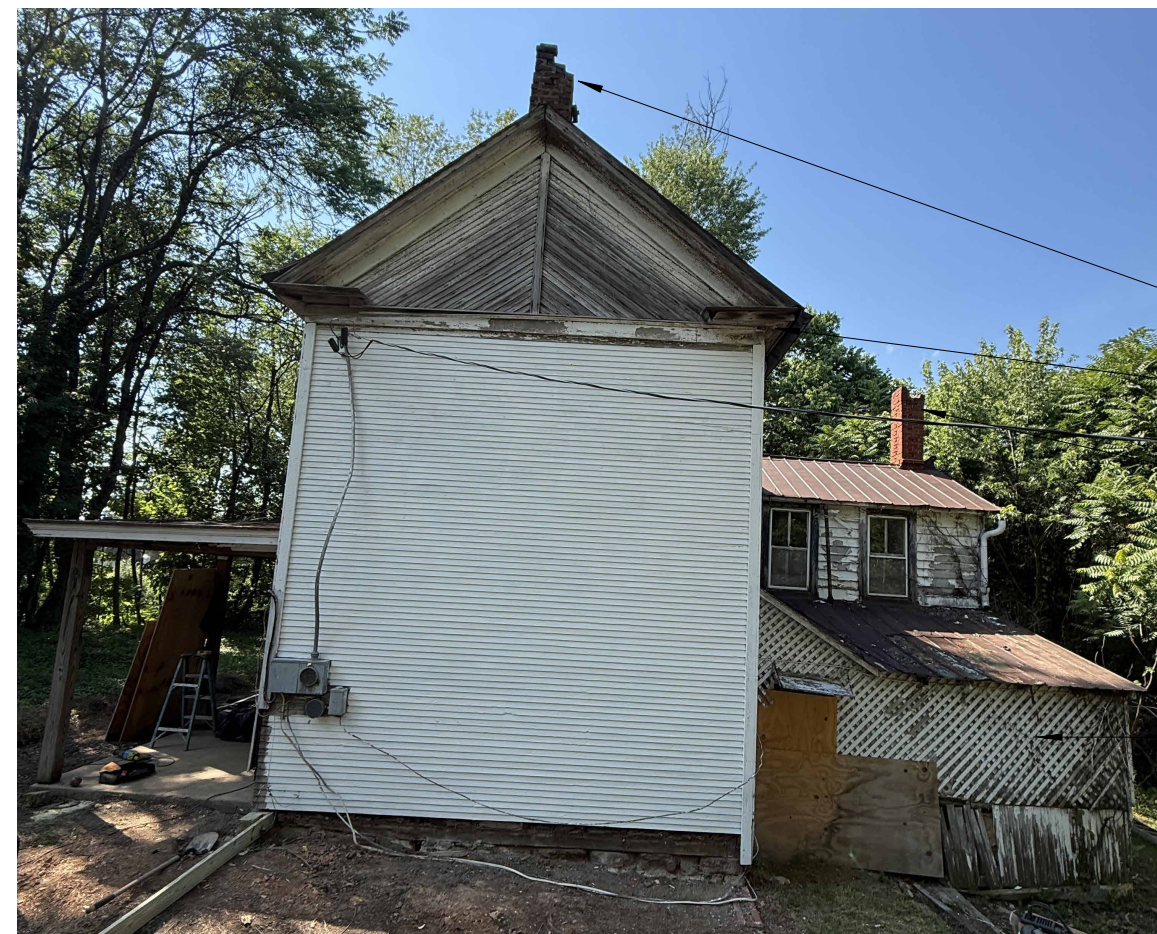
A-100

EXISTING EXTERIOR CONDITION HAS SEVERAL ELEMENTS THAT NEED REPAIR/REPLACEMENT AS DEMONSTRATED BELOW:

1 - EXTERIOR:

**Front** - Several boards are deteriorated beyond repair across the front elevation at the bottom where it is mostly exposed to moisture and just above the front porch roof.

Part of the corner boards will need to be replaced at the bottom as well. Fascia boards will need replacement as most of them are missing pieces.

**Left and Right** - Repair/replace some boards closer to ground due to deterioration beyond repair.  
Scrape windows and paint. Any pieces replaced to match existing.  
Point up the two chimneys using the appropriate mortar mix for the type. Replace missing bricks. Create a new chimney cap with rain guard.

Rear - Repair/replace damaged siding, repair/replace damaged fascia boards in kind.

1 - Rear Fireplace Chimney - This chimney is at the most rear wall and serves no fireplace nor any furnace. The elimination of this chimney will help save the bricks and reused most of them on the two remaining chimneys on the main structure which has many missing bricks above the roof line. This change will also, help the configuration of the new kitchen allowing for uninterrupted cabinetry.

2 - Window at Kitchen rear wall - We propose the reduction in height of this window to allow more cabinets in the new configured kitchen (see proposed rear elevation).

3 - Right Side Entry Enclosure - This structure is not part of the original home and must have been added a later time. It is unsafe and blocks the original side entry door and (3) three other windows. We proposed the demolition of this enclosure.

— REPLACE MISSING BRICKS, INSTALL RAIN CAP

REPAIR/REPLACE MISSING WOOD IN KIND

- PROPOSED CHIMNEY TO BE DEMOLISHED  
(SAVE BRICKS TO REPLACE MISSING BRICKS  
ON THE OTHER TWO CHIMNEYS)

— PROPOSED STRUCTURE TO BE DEMOLISHED

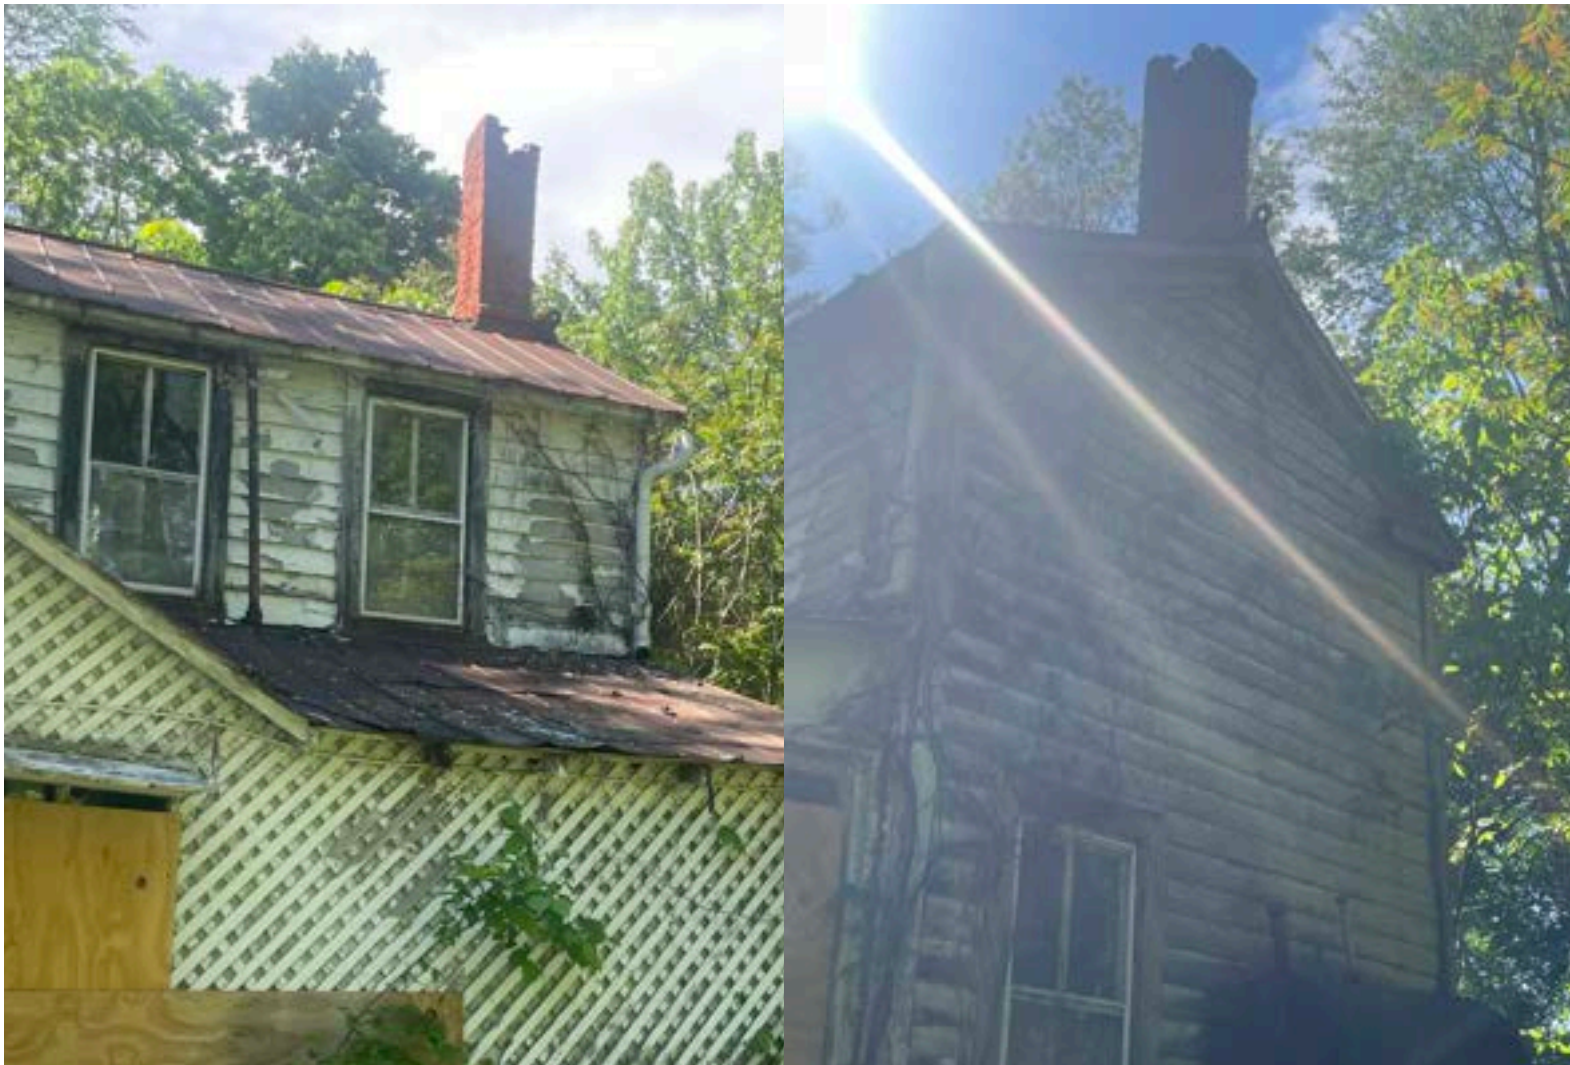
### Removal of Kitchen Chimney

- Remove kitchen Chimney. It seems that it has been added later on to the property. It takes a large space inside the kitchen area and is on a bad condition. Also, its not visible from the front of the home since the roof of this part of the house is much lower than the roof of the front of the home.

Chimney: The upper portion of the chimney is missing bricks and mortar, indicating significant deterioration. The chimney is no longer plumb and is leaning toward the rear of the building.

Removal/Demolition: The kitchen chimney appears to be a later addition to the original structure rather than part of the historic construction. It occupies a significant amount of floor space within the kitchen and is in poor condition. Because the roof over this portion of the house is substantially lower (approximately 8 feet) than the main roof, the chimney is not visible from the front elevation of the home. Its removal would improve the functionality of the kitchen without affecting the historic appearance of the property's primary façade.

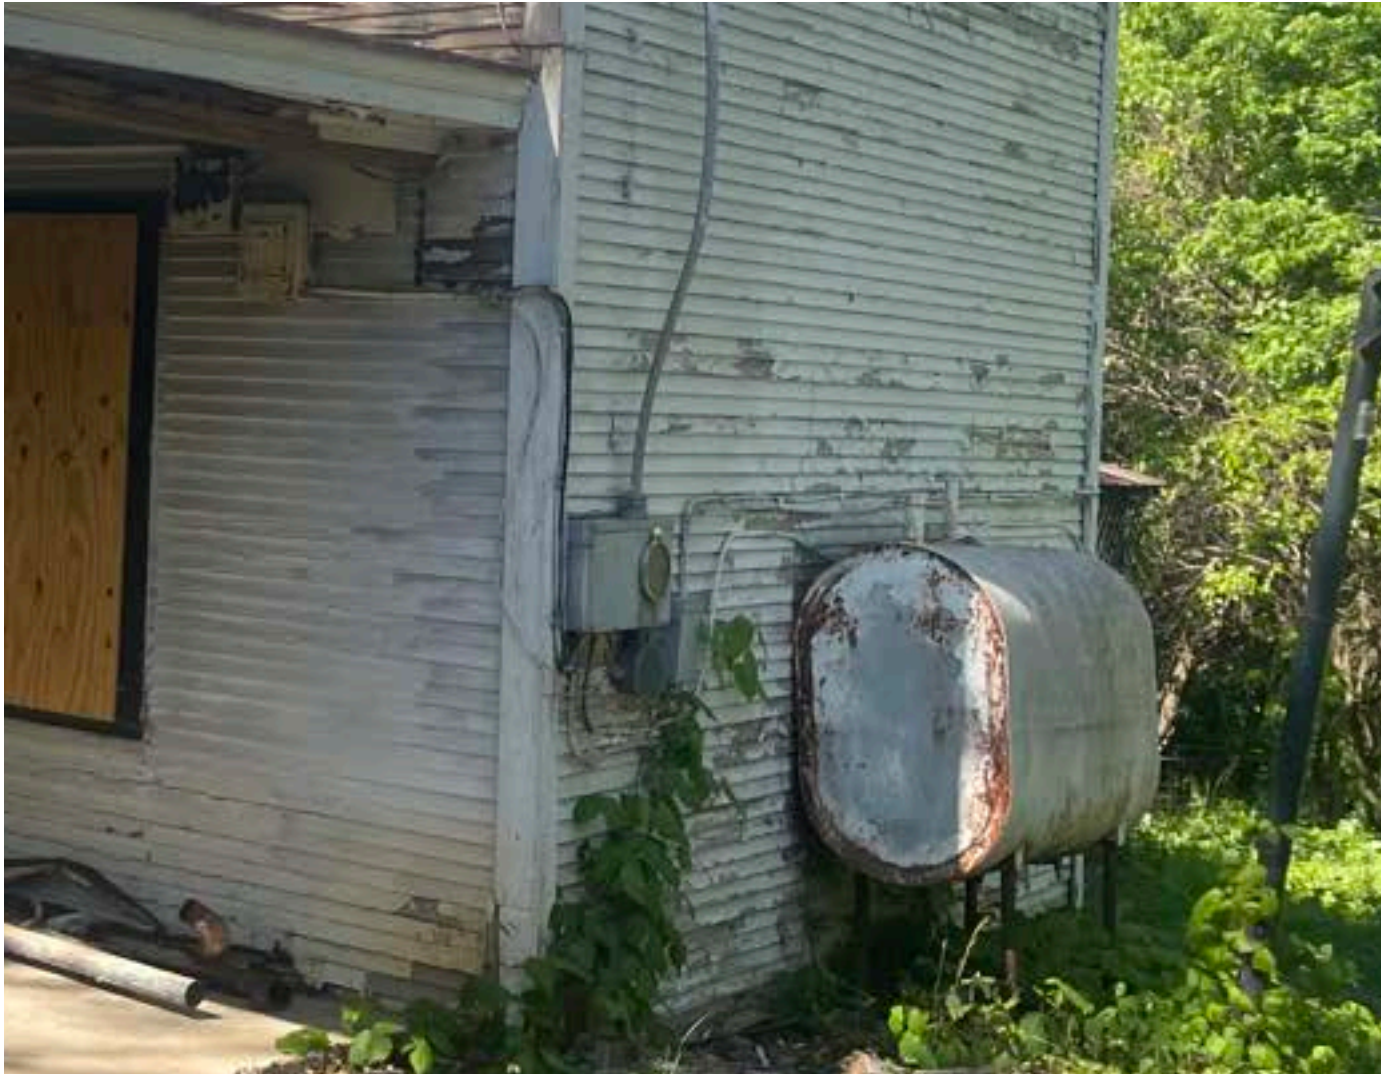
## Relocation of the Electrical Metter

- Remove the electrical meter and wire connections from the front side of the house to the back of the house where they won't be as visible as they are now.

- Electrical Meter: The electrical meter is located on the front exterior of the home. The meter assembly consists of several metal enclosures that appear to have been installed or modified at different times, suggesting multiple additions or alterations over the years.

- Electrical Service Relocation: Relocate the electrical meter and associated service equipment and wiring from the front elevation of the house to the rear of the property. This relocation will reduce the visual impact of the electrical equipment and improve the overall appearance of the front façade.

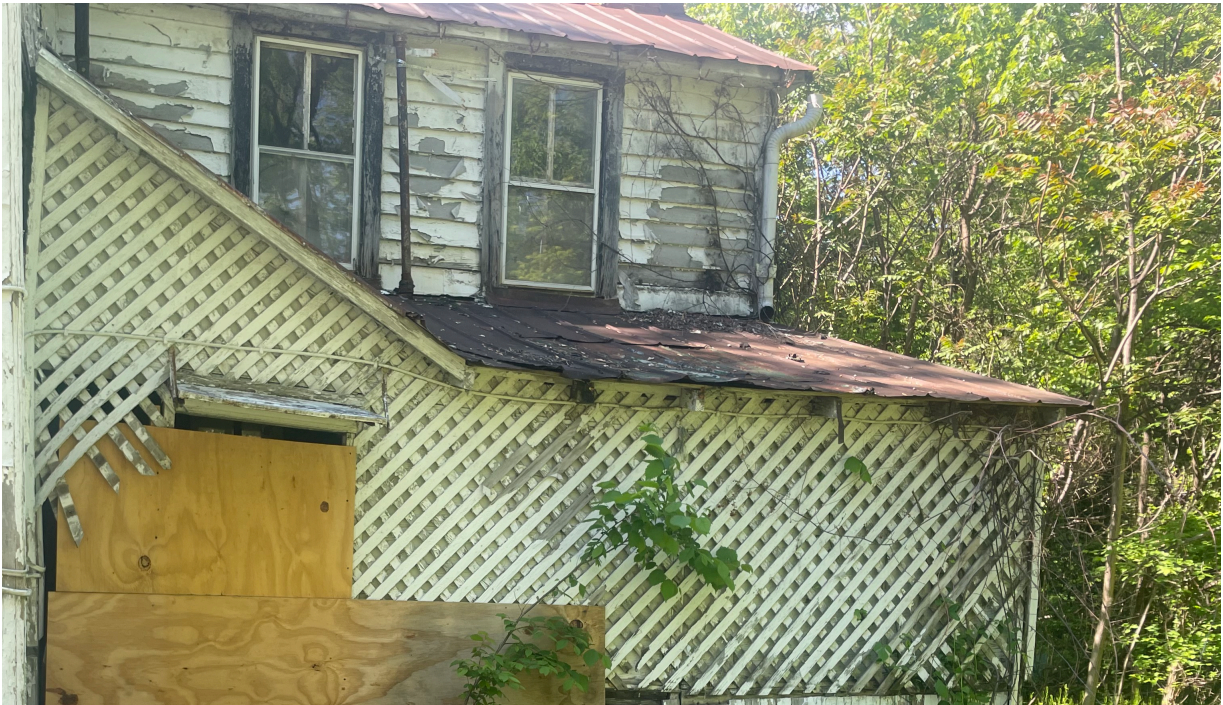
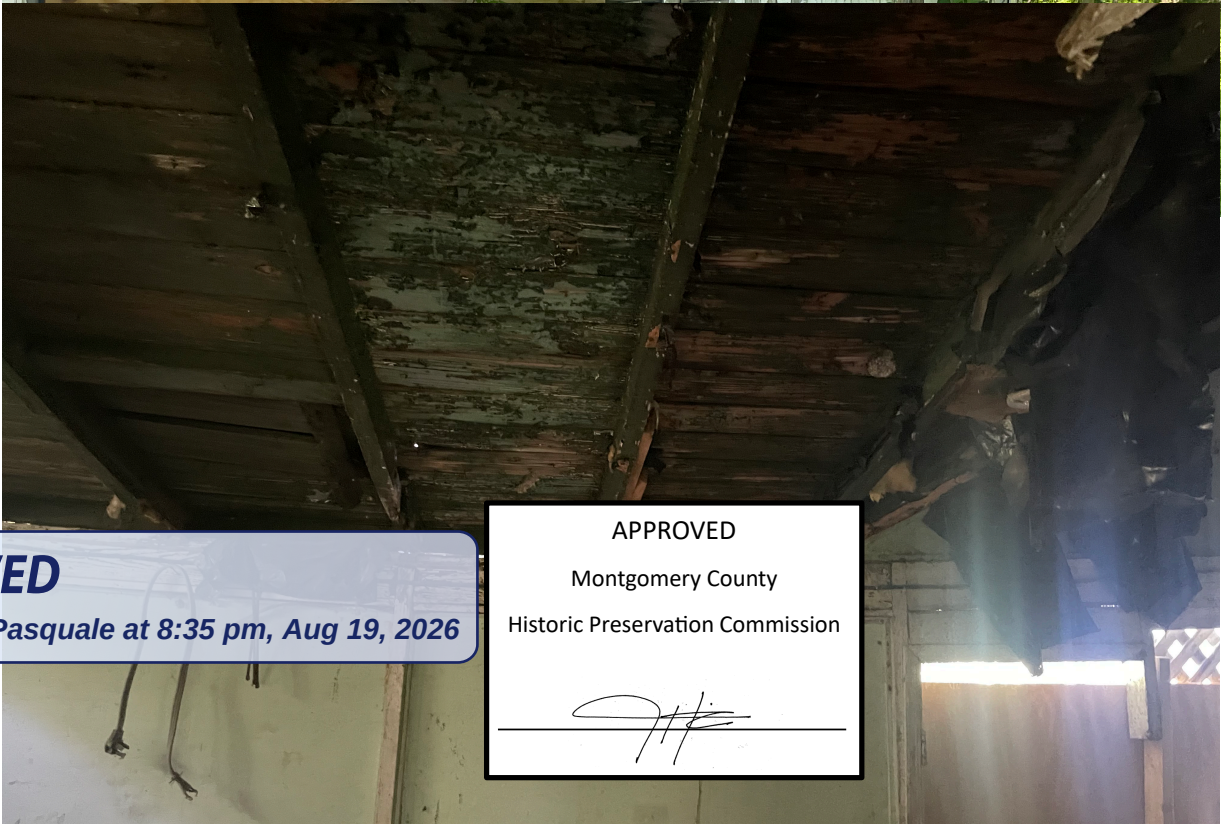
## Side Porch Demolition

Enclosed porch/addition on the back side of the property:

- Remove it. It's in in a very bad condition. It appears that it has been added to the house later on since the used wood are regular 2x4 (1.5"x 3.5") wood and recent construction material .

The structure is in very poor condition and is in the process of collapsing. Although it appears to have been constructed relatively recently, it has deteriorated significantly and is no longer structurally sound.

Removal/Demolition: The structure is in very poor condition and is recommended for removal. It appears to have been constructed as a later addition to the original house, as evidenced by the use of modern dimensional lumber (nominal 2×4s, approximately 1.5 × 3.5 inches) and other contemporary construction materials. Its condition has deteriorated to the point that it is no longer considered structurally sound.

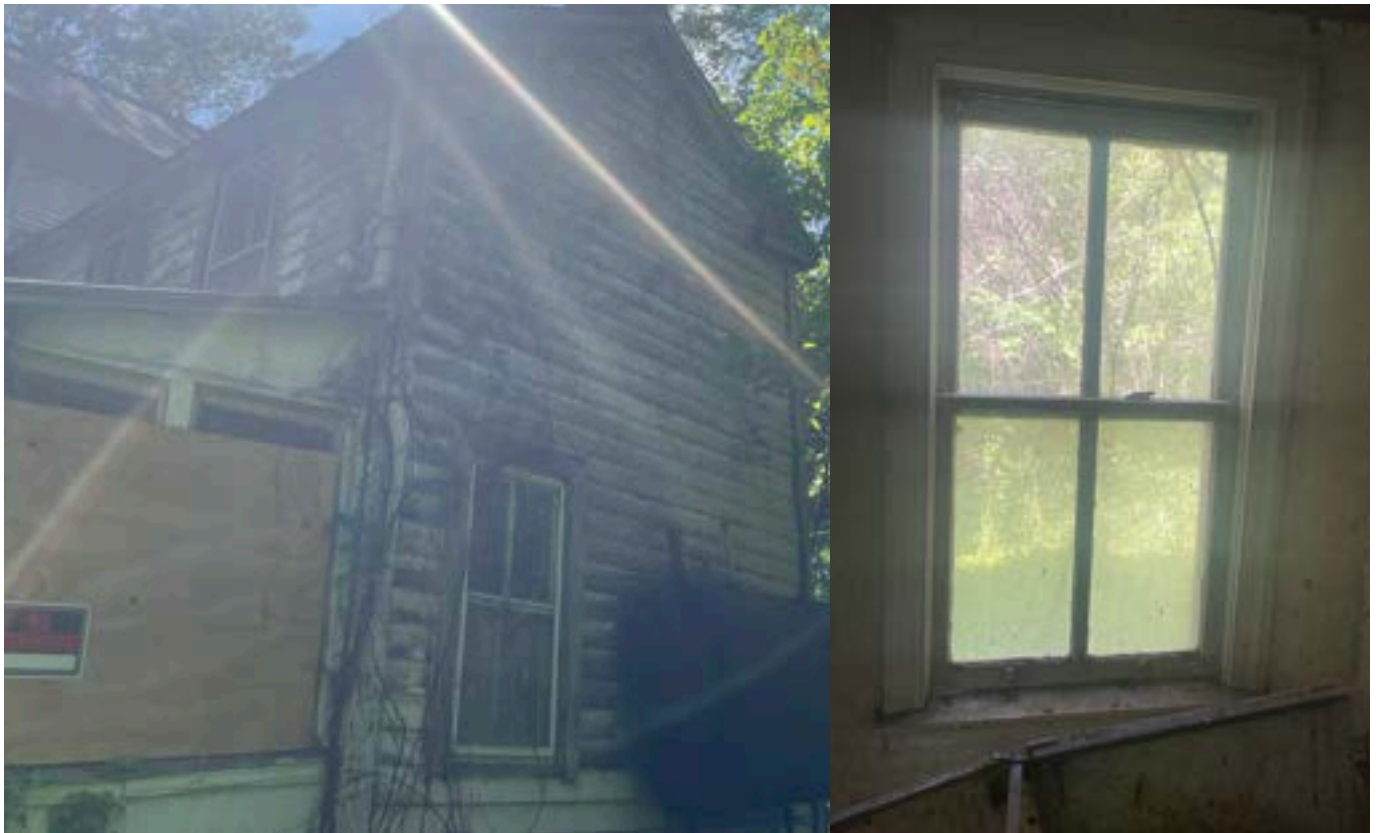
## Kitchen Window Modification

### Kitchen Window (Back of the house):

- Remove and replace this window for a smaller window. Window will be made with the same material, using the top sash of the existing window.
