24/19-1-90A

15120 Turkey Foot Road,  
Gaitheersburg

- E. Darnestown Presbyterian Church, at 15120 Turkey Foot Road, Darnestown (HPC Case No. 24/19-1-90A)

24/19-1 Darnestown  
Presbyterian  
Church

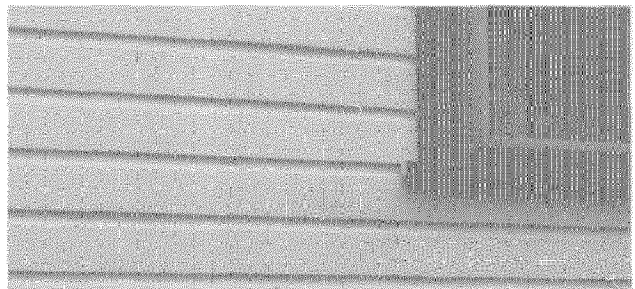
*Historic wood sidings exhibit rich and varied surface textures. They range from hand-split clapboards of short lengths with feather-edged ends, to pit or mill sawn boards which can be beveled, rabbeted, milled, or beaded.*

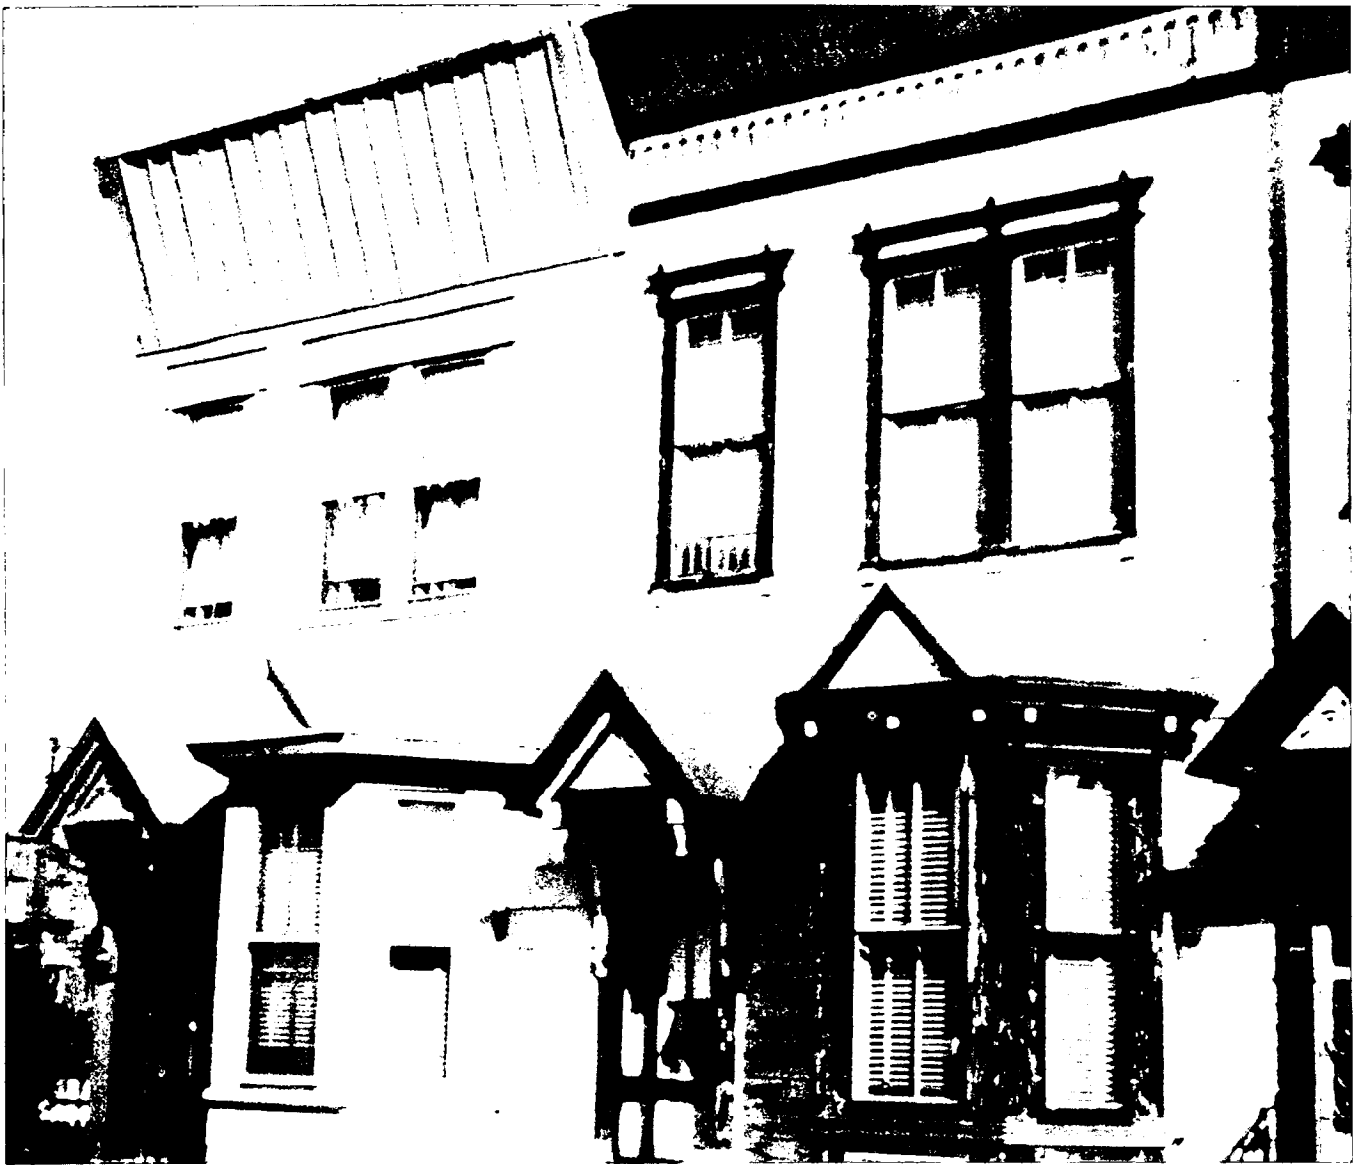
When a building is in need of maintenance, such as the house on the right which needs painting, some owners consider installing aluminum or vinyl siding. The result, like the house on the left, can be a complete loss of architectural character due to the covering of details (cornice), the removal of features (window trim), and a change of scale due to inappropriate siding dimensions.

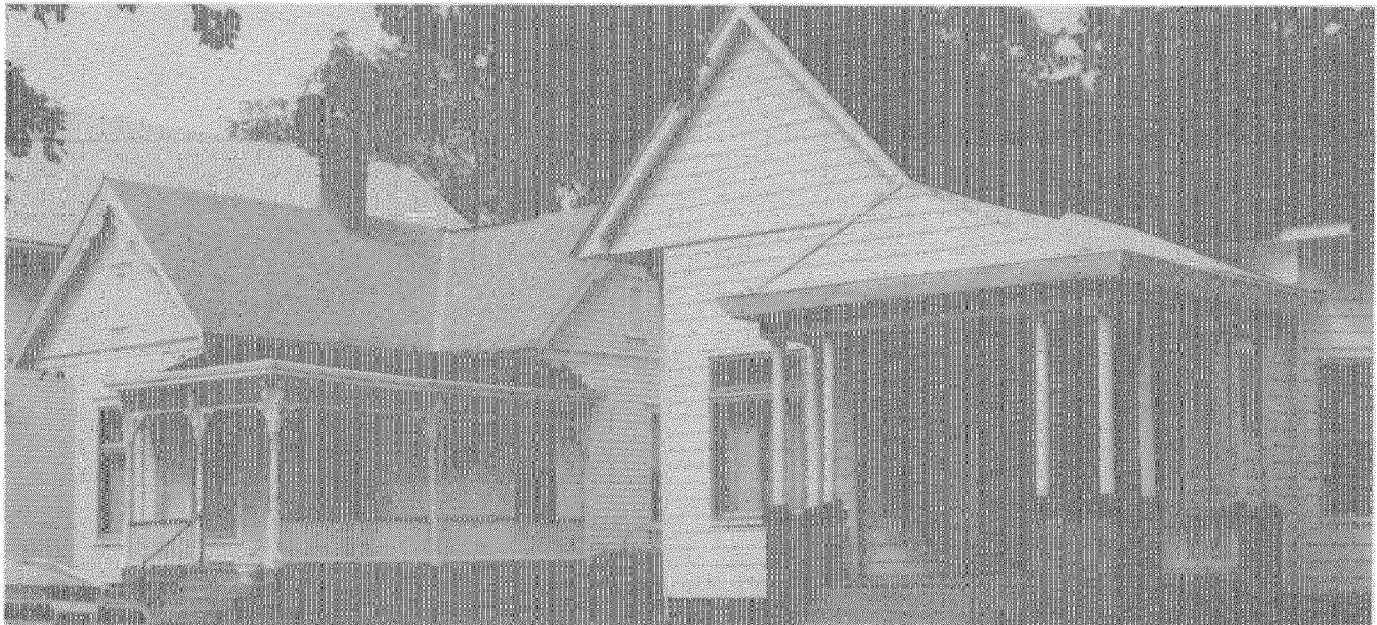
*Two originally similar houses. When aluminum was installed on the house on the right, the barge boards, scrollwork, columns, and railings were removed. The distinctive shingled gable and attic vent were covered, further compromising the building's architectural integrity.*

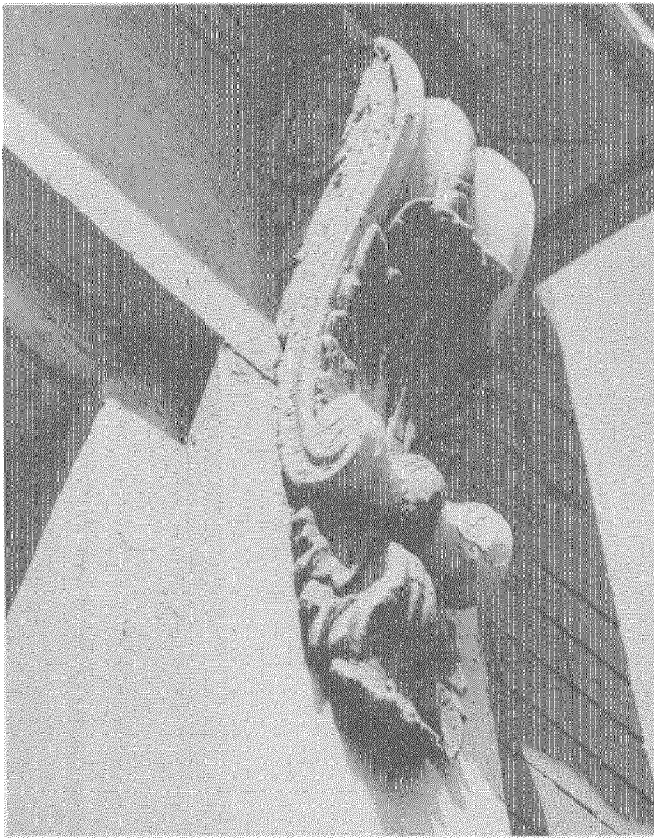
Fig. 1 Excessive paint build-up on architectural details such as this ornamental bracket does not in itself justify total paint removal. If paint is cracked and peeling down to bare wood, however, it should be removed using the gentlest means possible. Photo: David W. Look, AIA.

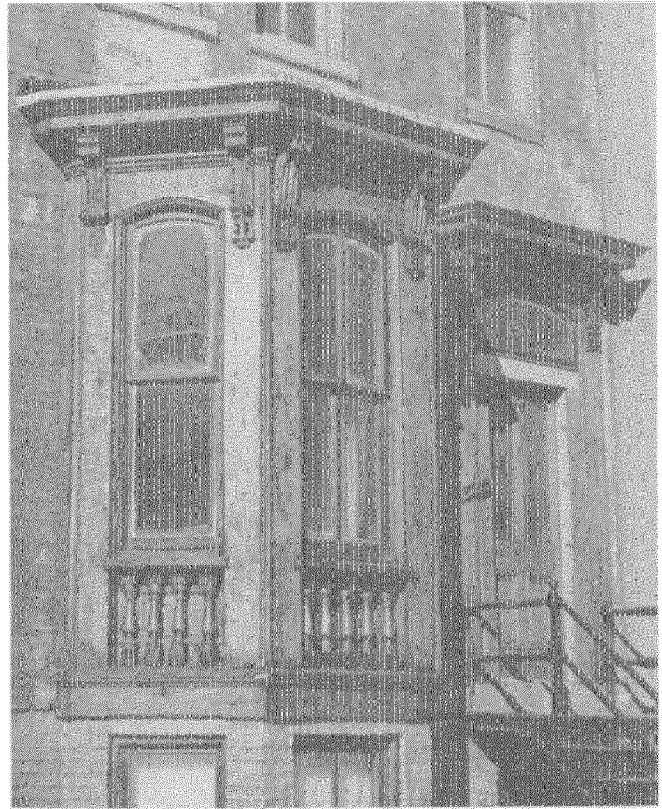
Fig. 2 A traditionally painted bay window has been stripped to bare wood, then varnished. In addition to being historically inaccurate, the varnish will break down faster as a result of the sun's ultraviolet rays than would primer and finish coats of paint. Photo: David W. Look, AIA.

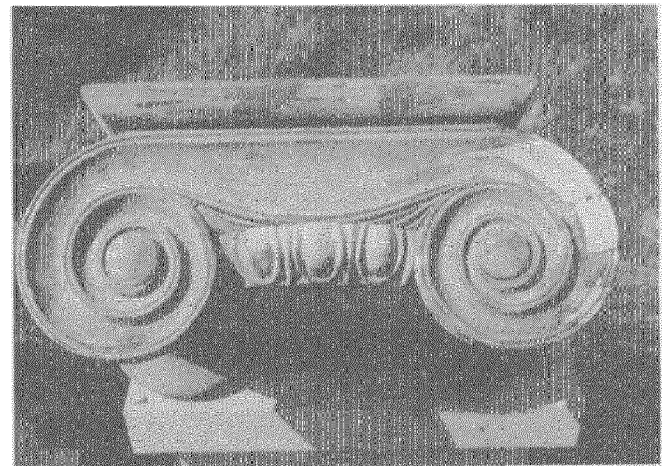
Fig. 3 If damage to parts of a wooden element is severe, new sections of wood will need to be pieced-in. When such piecing is required, paint on the adjacent woodwork should be removed so that the old and new woods will make a smooth profile when joined. After repainting, the repair should be virtually impossible to detect. Photo: Morgan W. Phillips.

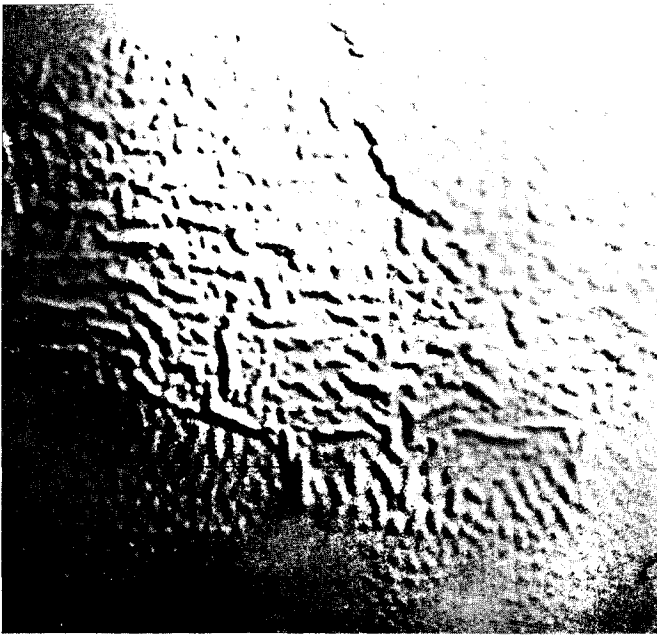
Fig. 7 Wrinkled layers can generally be removed by scraping and sanding as opposed to total paint removal. Following manufacturers' application instructions is the best way to avoid this surface condition. Photo: Courtesy, National Decorating Products Association.

The wrinkled layer can be removed by scraping followed by hand or mechanical sanding to provide as even a surface as possible, then repainted following manufacturer's application instructions.

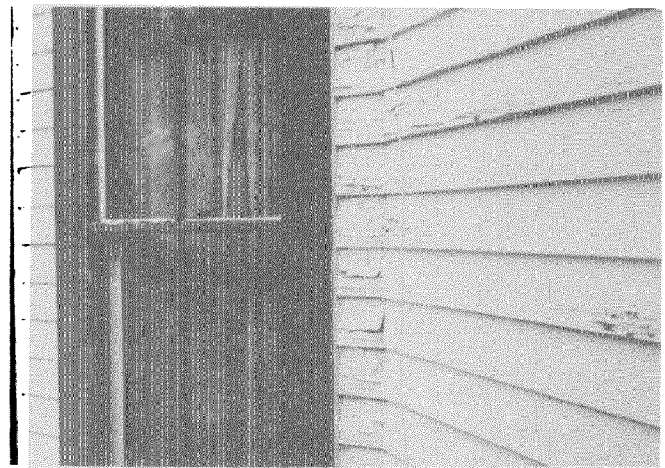
Fig. 8 Peeling to bare wood—one of the most common types of paint failure—is usually caused by an interior or exterior moisture problem. Photo: Anne E. Grimmer.

There is no sense in repainting before dealing with the moisture problems because new paint will simply fail. Therefore, the first step in treating peeling is to locate and remove the source or sources of the moisture, not only because moisture will jeopardize the protective coating of paint but because, if left unattended, it can ultimately cause permanent damage to the wood. Excess interior moisture should be removed from the building through installation of exhaust fans and vents. Exterior moisture should be eliminated by correcting the following conditions prior to repainting: faulty flashing; leaking gutters; defective roof shingles; cracks and holes in siding and trim; deteriorated caulking in joints and seams; and shrubbery growing too close to painted wood. After the moisture problems have been solved, the wood must be permitted to dry out thoroughly. The damaged paint can then be scraped off with a putty knife, hand or mechanically sanded, primed, and repainted.

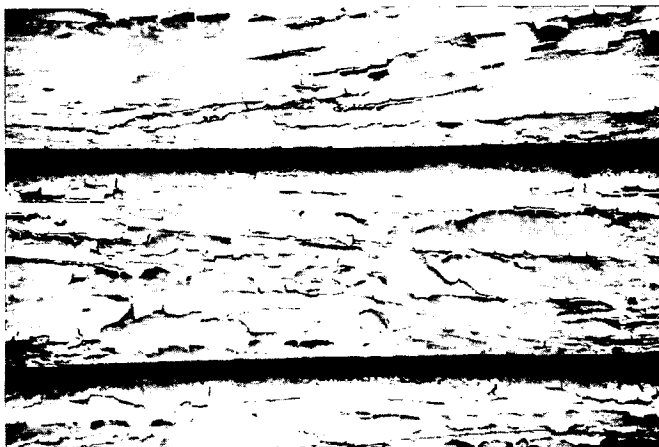
Fig. 9 Cracking, alligatoring, and flaking are evidence of long-term neglect of painted surfaces. The remaining paint on the clapboard shown here can be removed with an electric heat plate and wide-bladed scraper. In addition, unsound wood should be replaced and moisture problems corrected before primer and top coats of paint are applied. Photo: David W. Look, AIA.

bare wood and the paint has begun to flake, it will need to be totally removed. Methods include scraping or paint removal with the electric heat plate, electric heat gun, or chemical strippers, depending on the particular area involved. Bare wood should be primed within 48 hours, then repainted.

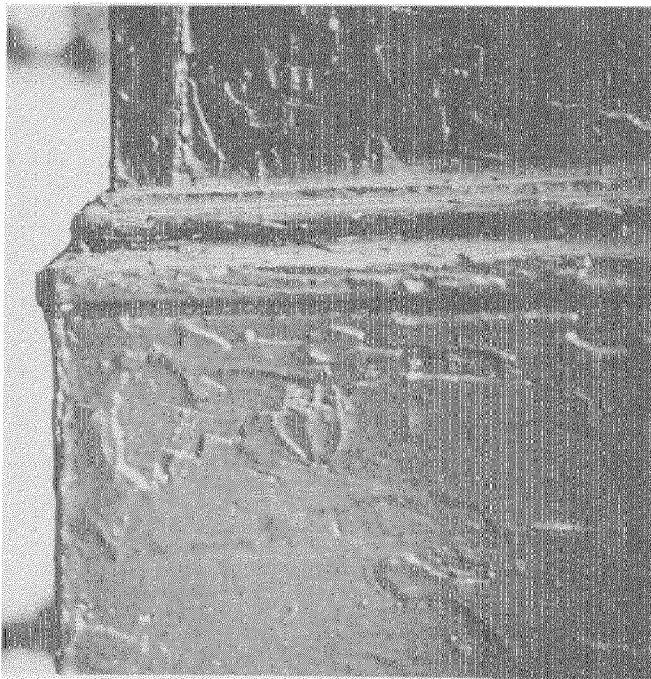
Fig. 10 An excellent example of inadequate scraping before repainting, the problems here are far more than cosmetic. This improperly prepared surface will permit moisture to get behind the paint film which, in turn, will result in chipping and peeling. Photo: Baird M. Smith, AIA.

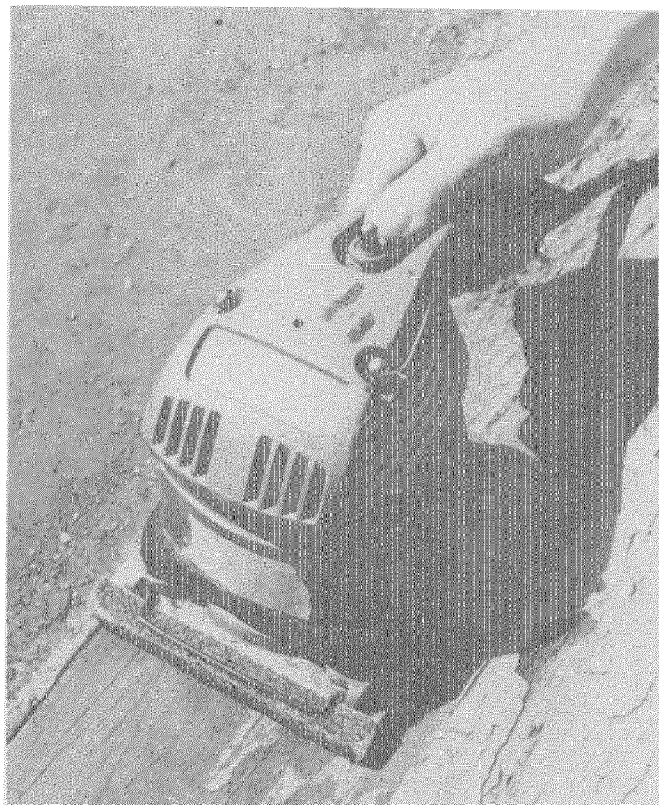
Fig. 11 The orbital sander can be used for limited paint removal, i.e., for smoothing flat surfaces after the majority of deteriorated paint has already been scraped off. Photo: Charles E. Fisher, III.

in this case, the abrasive surface is a continuous belt of sandpaper that travels at high speeds and consequently offers much less control than the orbital sander. Because of the potential for more damage to the paint or the wood, use of the belt sander (also with a medium grit sandpaper) should be limited to flat surfaces and only skilled operators should be permitted to operate it within a historic preservation project.

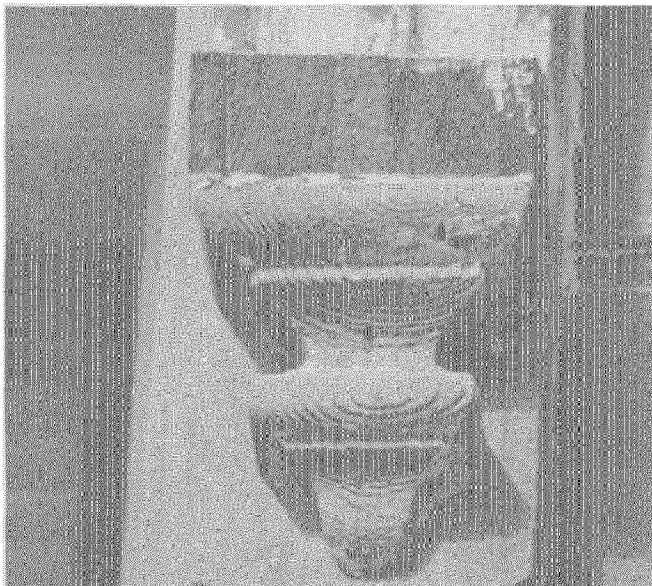
Fig. 12 Sandblasting has permanently damaged this ornamental bracket. Even paint will not be able to hide the deep erosion of the wood. Photo: David W. Look, AIA.

*Sandblasting:* Finally—and undoubtedly most vehemently “not recommended”—sandblasting painted exterior woodwork will indeed remove paint, but at the same time can scar wooden elements beyond recognition. As with rotary wire strippers, sandblasting erodes the soft porous fibers (spring wood) faster than the hard, dense fibers (summer wood), leaving a pitted surface with ridges and valleys. Sandblasting will also erode projecting areas of carvings and moldings before it removes paint from concave areas (see figure 12). Hence, this abrasive method is potentially the most damaging of all possibilities, even if a contractor promises that blast pressure can be controlled so that the paint is removed without harming the historic exterior woodwork. (For Additional Information, See Preservation Briefs 6, “Dangers of Abrasive Cleaning to Historic Buildings”.)

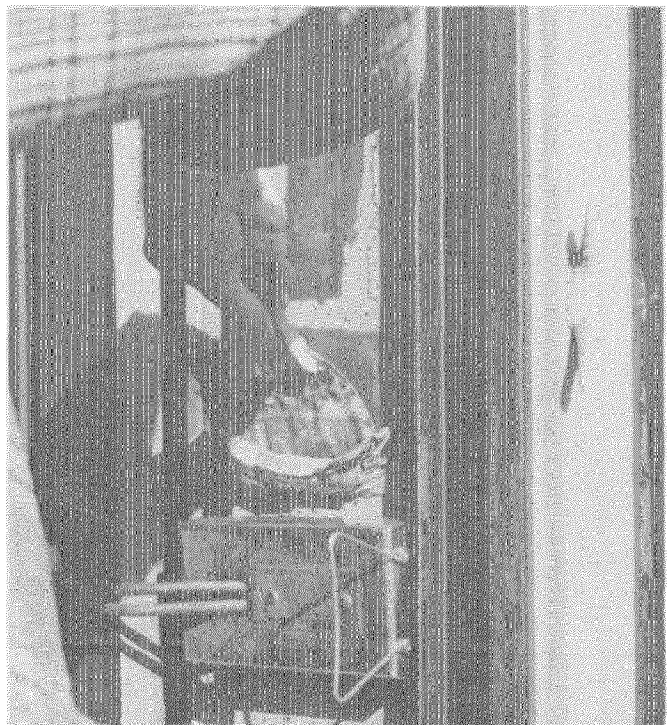
Fig. 13 The electric heat plate (with paint scraper) is particularly useful for removing paint down to bare wood on flat surfaces such as doors, window frames, and siding. After scraping, some light sanding will probably be necessary to smooth the surface prior to application of primer and top coats. Photo: David W. Look, AIA.

*Electric heat plate:* The electric heat plate (see figure 13) operates between 500 and 800 degrees Fahrenheit (not hot enough to vaporize lead paint), using about 15 amps of power. The plate is held close to the painted exterior surface until the layers of paint begin to soften and blister, then moved to an adjacent location on the wood while the softened paint is scraped off with a putty knife (it should be noted that the heat plate is most successful when the paint is very thick!). With practice, the operator can successfully move the heat plate evenly across a flat surface such as wooden siding or a window sill or door in a continuous motion, thus lessening the risk of scorching the wood in an attempt to reheat the edge of the paint sufficiently for effective removal. Since the electric heat plate’s coil is “red hot,” extreme caution should be taken to avoid igniting clothing or burning the skin. If an extension cord is used, it should be a heavy-duty cord (with 3-prong grounded plugs). A heat plate could overload a circuit or, even worse, cause an electrical fire; therefore, it is recommended that this implement be used with a single circuit and that a fire extinguisher always be kept close at hand.

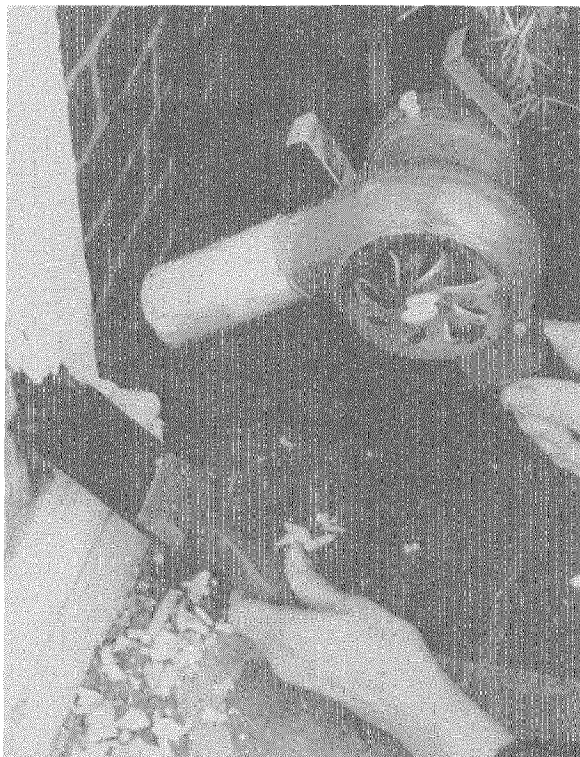
Fig. 14 The nozzle on the electric heat gun permits hot air to be aimed into cavities on solid decorative elements such as this applied column. After the paint has been sufficiently softened, it can be removed with a profiled scraper. Photo: Charles E. Fisher, III.

Although the heat gun is heavier and more tiring to use than the heat plate, it is particularly effective for removing paint from detail work because the nozzle can be directed at curved and intricate surfaces. Its use is thus more limited than the heat plate, and most successfully used in conjunction *with* the heat plate. For example, it takes about two to three hours to strip a paneled door with a heat gun, but if used in combination with a heat plate for the large, flat area, the time can usually be cut in half. Although a heat gun seldom scorches wood, it can cause fires (like the blow torch) if aimed at the dusty cavity between the exterior sheathing and siding and interior lath and plaster. A fire may smolder for hours before flames break through to the surface. Therefore, this thermal device is best suited for use on solid decorative elements, such as molding, balusters, fretwork, or "gingerbread."

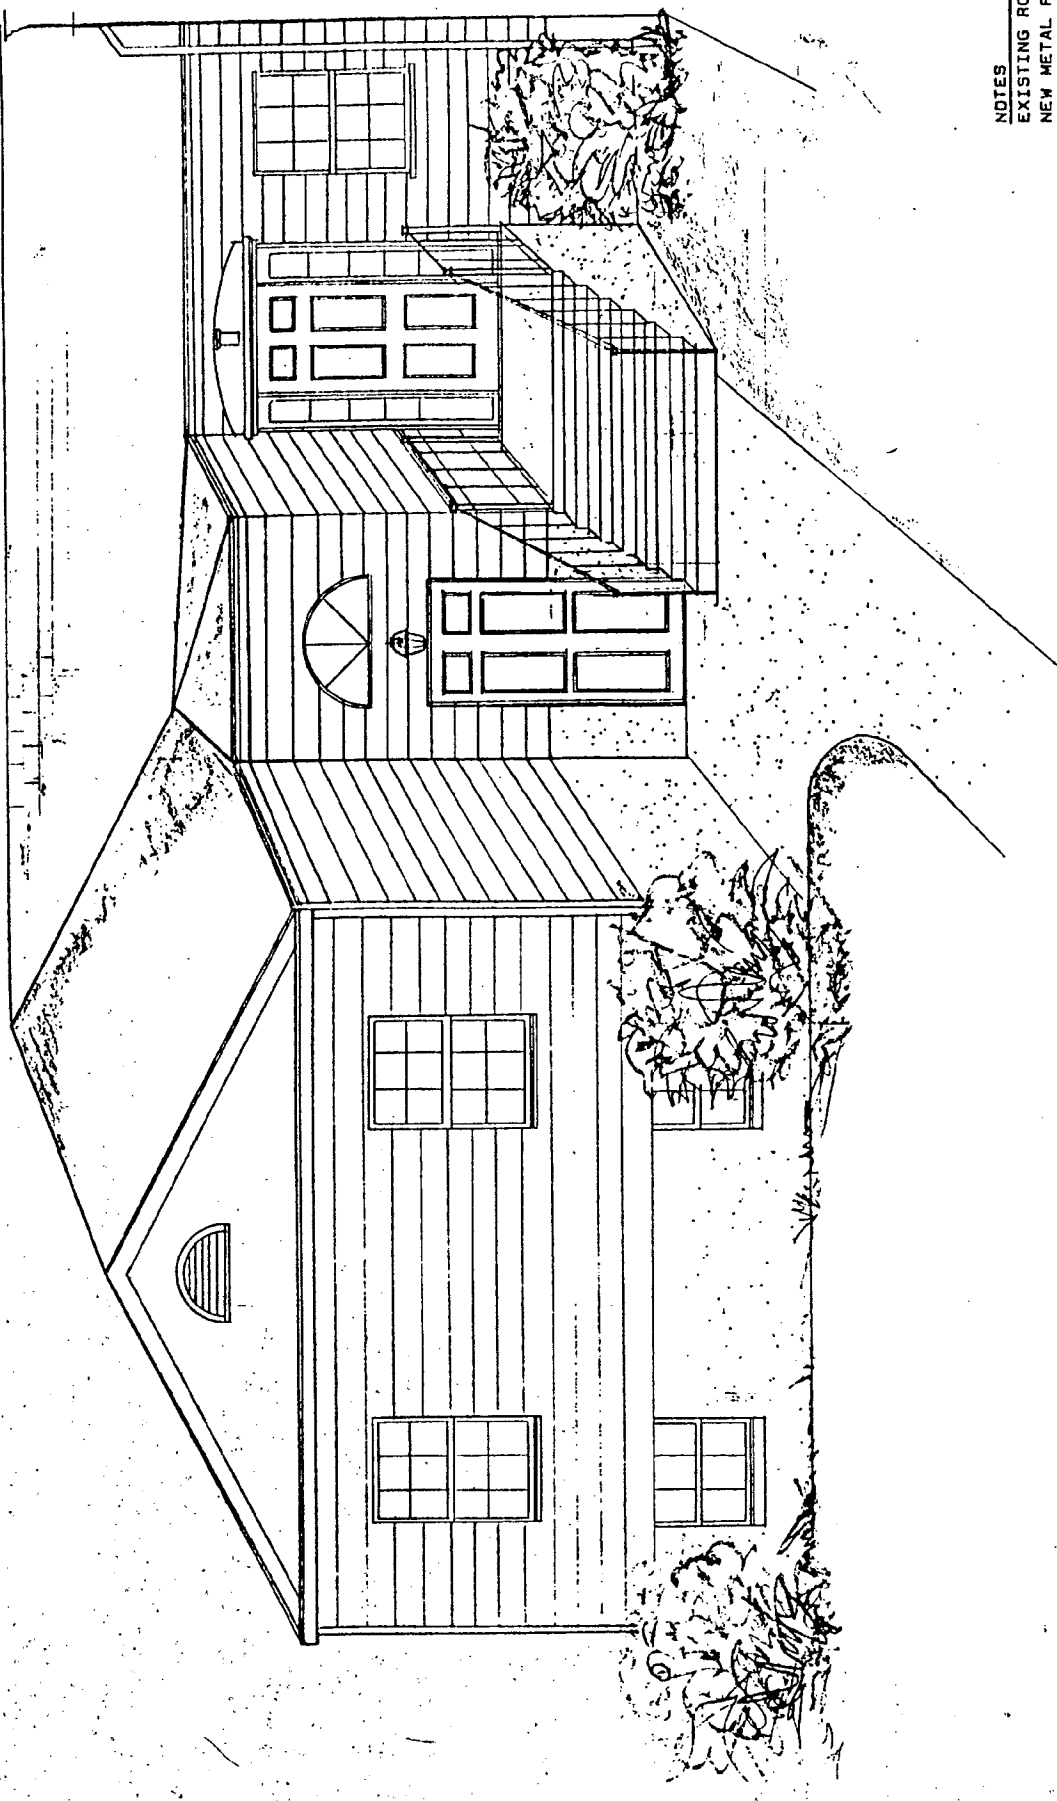
New Enclosure for Handi-Cap Elevator

NOTES  
EXISTING ROOF TO REMAIN  
NEW METAL ROOF ON HANDI-CAP ENC  
SIDING TO MATCH EXISTING

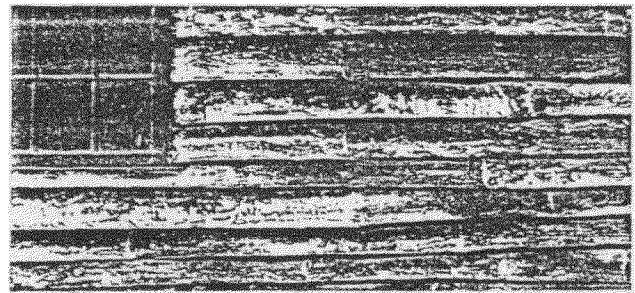
Historic wood sidings exhibit rich and varied surface textures. They range from hand-split clapboards of short lengths with feather-edged ends, to pit or mill sawn boards which can be beveled, rabbeted, milled, or beaded.

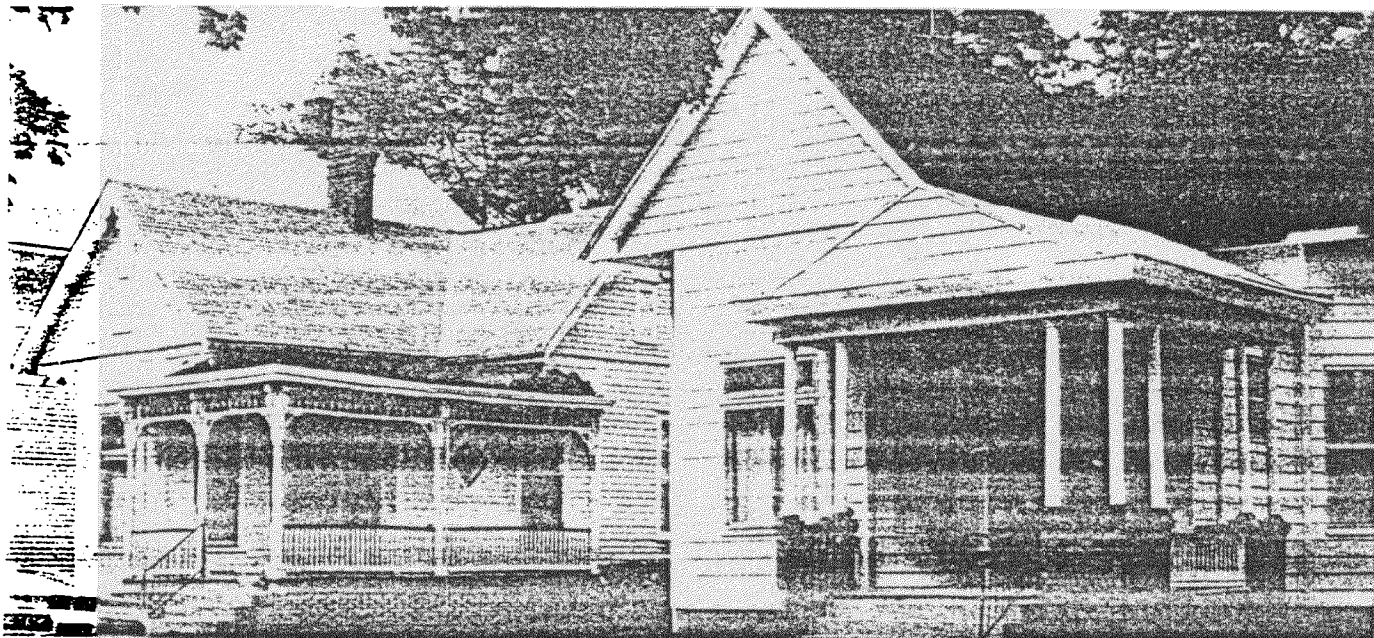
Two originally similar houses. When aluminum was installed on the house on the right, the barge boards, scrollwork, columns, and railings were removed. The distinctive shingled gable and attic vent were covered, further compromising the building's architectural integrity.
