19801 Darnestown Road, Beallsville

HPC Case No. 17/01-09A

Beallsville Historic District

SUBJECT: Historic Area Work Permit #^{513027 JS 3/9/11}506356, building stabilization

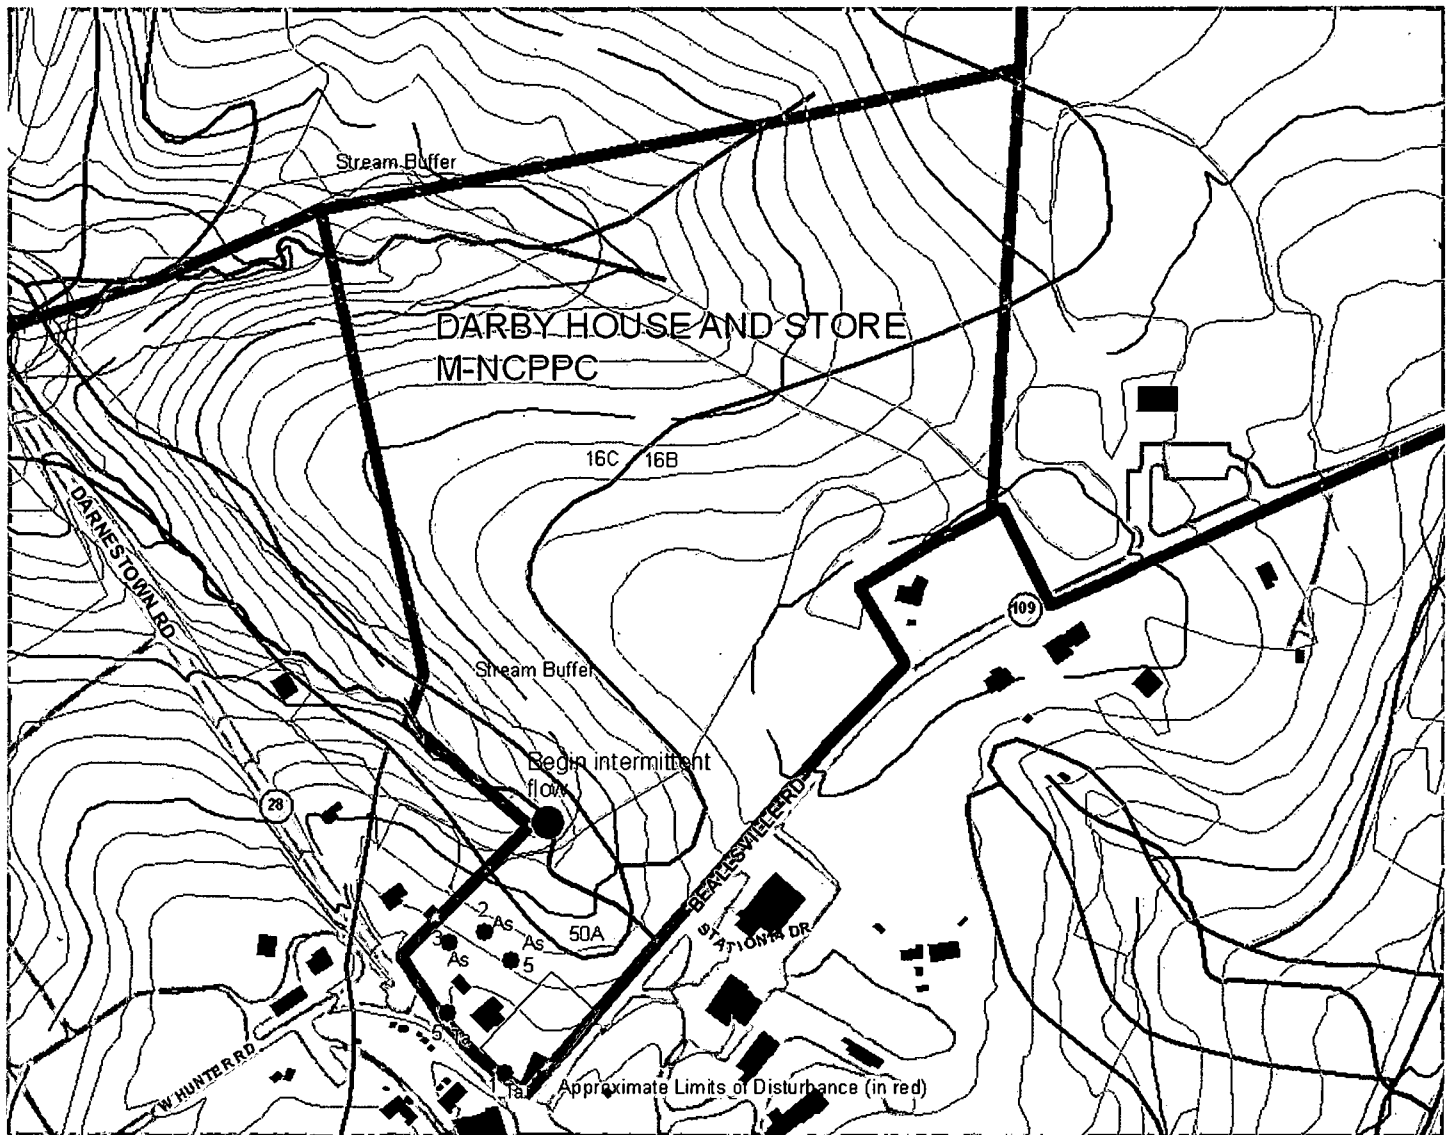
Specimen Tree List and TREE PROTECTION DETAILS			
#	DBH "	Tree Species	Comments
1	36"	Basswood (<i>Tilia americana</i>)	Good Health, Tree Protection is necessary: bollards are necessary to eliminate potential at grade access from Darnestown Road.
2	26"	Silver Maple (<i>Acer saccharinum</i>)	Good Health
3	37"	Silver Maple (<i>Acer saccharinum</i>)	Good Health
4	40"	Silver Maple (<i>Acer saccharinum</i>)	Good Health
5	40"	Basswood (<i>Tilia americana</i>)	Good Health, excellent Specimen, boundary tree

Darby House and Store Location of Specimen trees, Streams, Soil types, forest, buildings and topography (5' contours), stream buffers, 1" = approximately 300', N[^].

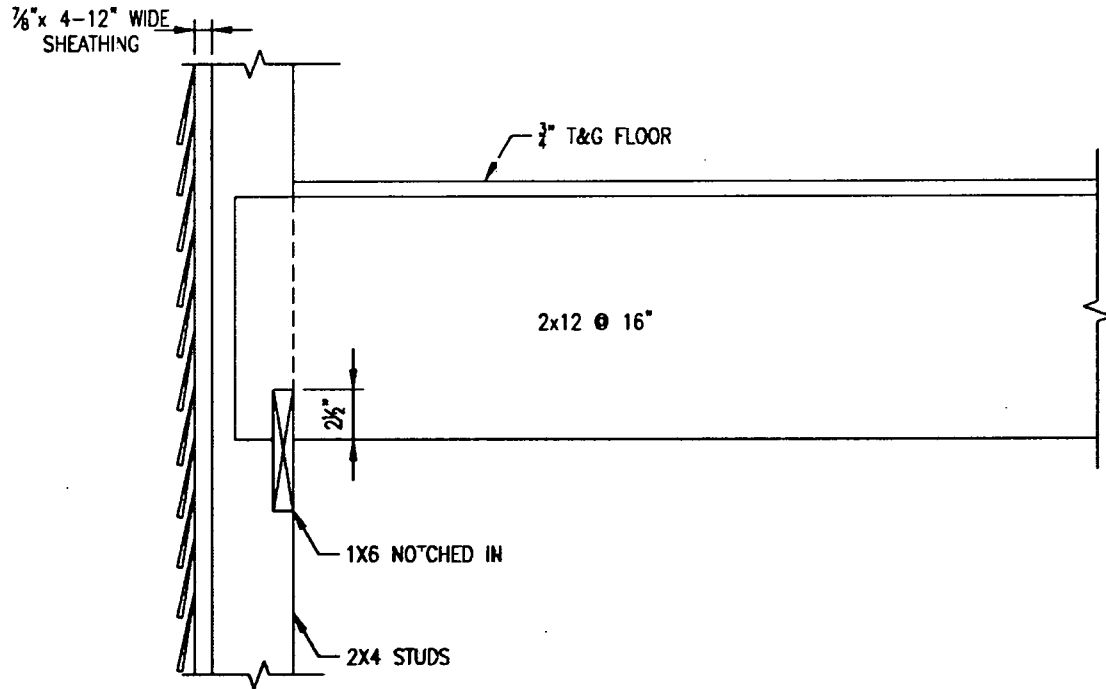
The second floor framing consists of 2-inch by 12-inch joists spaced 16 inches on center. A portion of the second floor framing is covered with the existing original tin ceiling shown in Figure 4 therefore not all joists can be seen. The integrity of the end connection of the joists also cannot be seen because the original bead-board covers the interior wall. However, the connection detail was determined looking down from the second floor which is shown in Figure 5. The second floor only contains a wearing surface which was severely deteriorated in certain spots where leaks had occurred shown in Figure 6. In addition the joists at these locations are either completely deteriorated or the top 2-4 inches are rotting. The second floor joists span the entire floor from east to west with third point bridging.

Figure 5: Connection detail for second floor framing

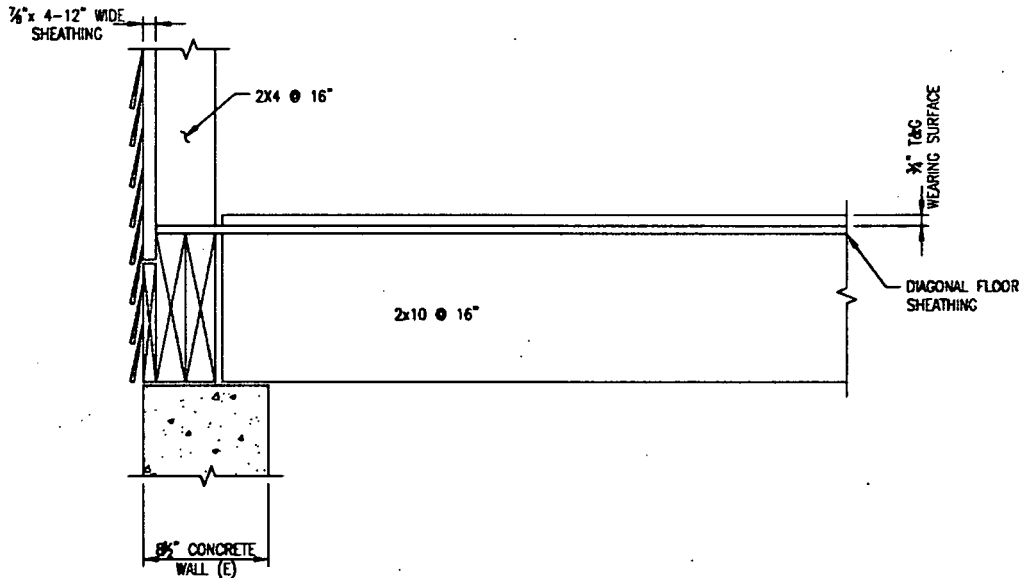
The walls are framed with 2-inch by 4-inch studs spaced 16 inches on center. The studs are continuous from the first floor up to the roof rafters and are braced by the second floor framing. At the first floor the studs do not extend to the sill but rather are toenailed to the subfloor. The connection detail is shown in Figure 7. The studs are not visible from the first floor because the built-in finishes (shelves and bead board) are intact. Diagonal sheathing (4-12" wide x 7/8" thick) extends over the entire exterior surface of the building below the exterior cladding, and is extremely important in stabilizing the structure. This can be seen from inside the building on the second floor where studs have completely deteriorated.

Figure 7: Connection detail for first floor framing

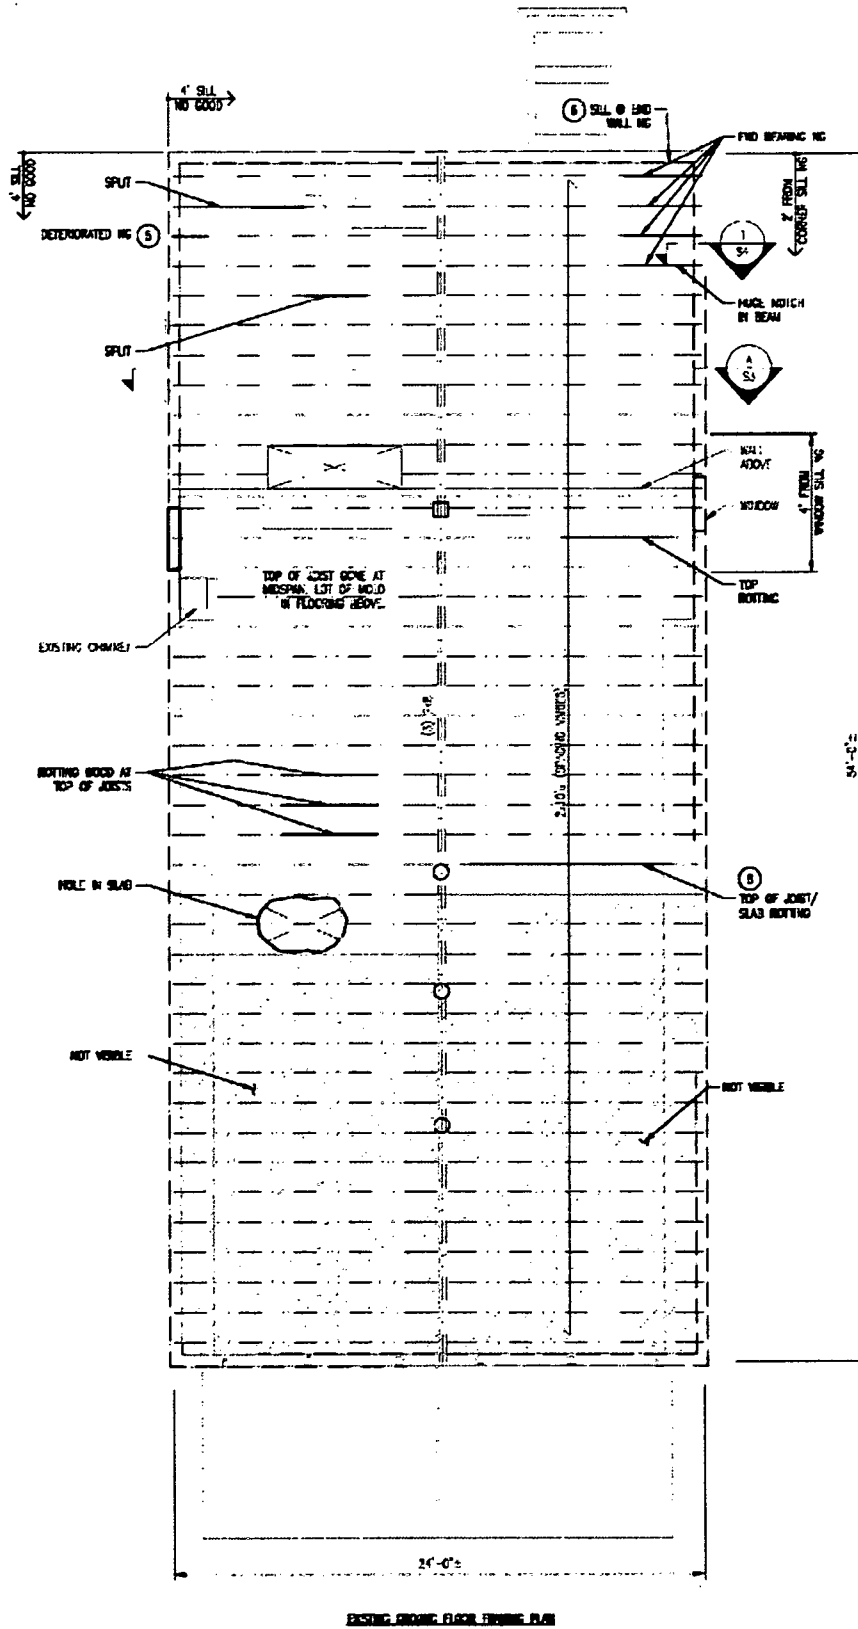
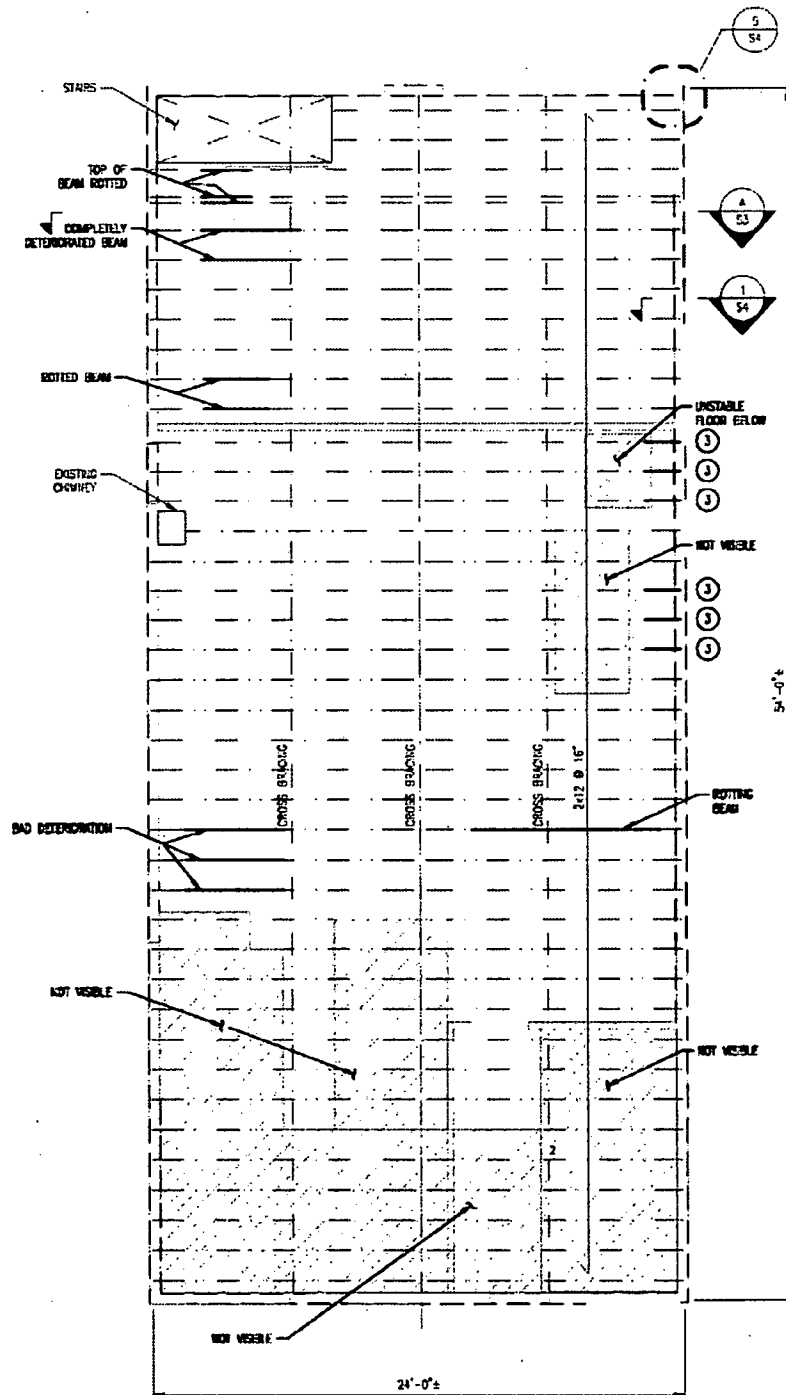
EXISTING FLOOR FRAMING PLAN

Appendix A shows each floor framing plan which identifies areas of observed structural deficiencies. These areas will need to be addressed when stabilization occurs.

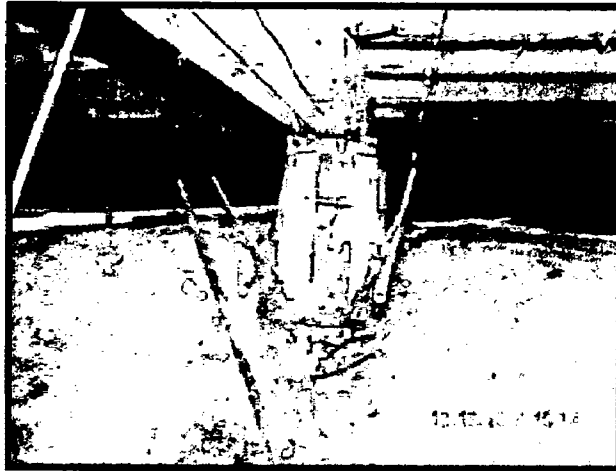
Within the basement, a heavily deflected girder runs north-south through the length of the building. The first floor joists, therefore, are not continuous. It was assumed that the girder would be replaced and its condition was not assessed. Since the building is being moved, the unique construction details of the basement, such as the use of wooden barrels for concrete footing forms will be lost and should be documented prior to demolition (Figure 22).

Figure 22. Wooden barrel that was used as the form for pouring the concrete footing for the center girder in the crawl space.

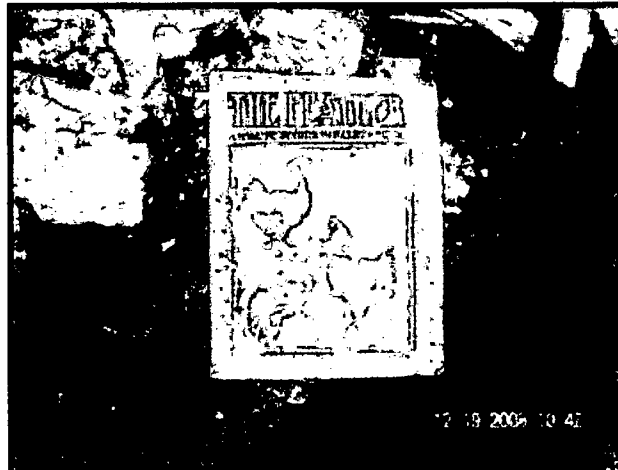
Figure 29. A wealth of historical material culture can be found in the store.

The exterior condition of the windows could not be determined because they were boarded over; however, based on the interior conditions, the windows appear to be in good, repairable condition (Figure 28). The Store itself contains a number of cultural artifacts that may be significant to the Darby family and/or the history of Beallsville (Figure 29). While the materials are contributing to some of the deterioration problems within the building, if possible, the materials should be assessed by a historian or historical archaeologist before being removed or discarded.

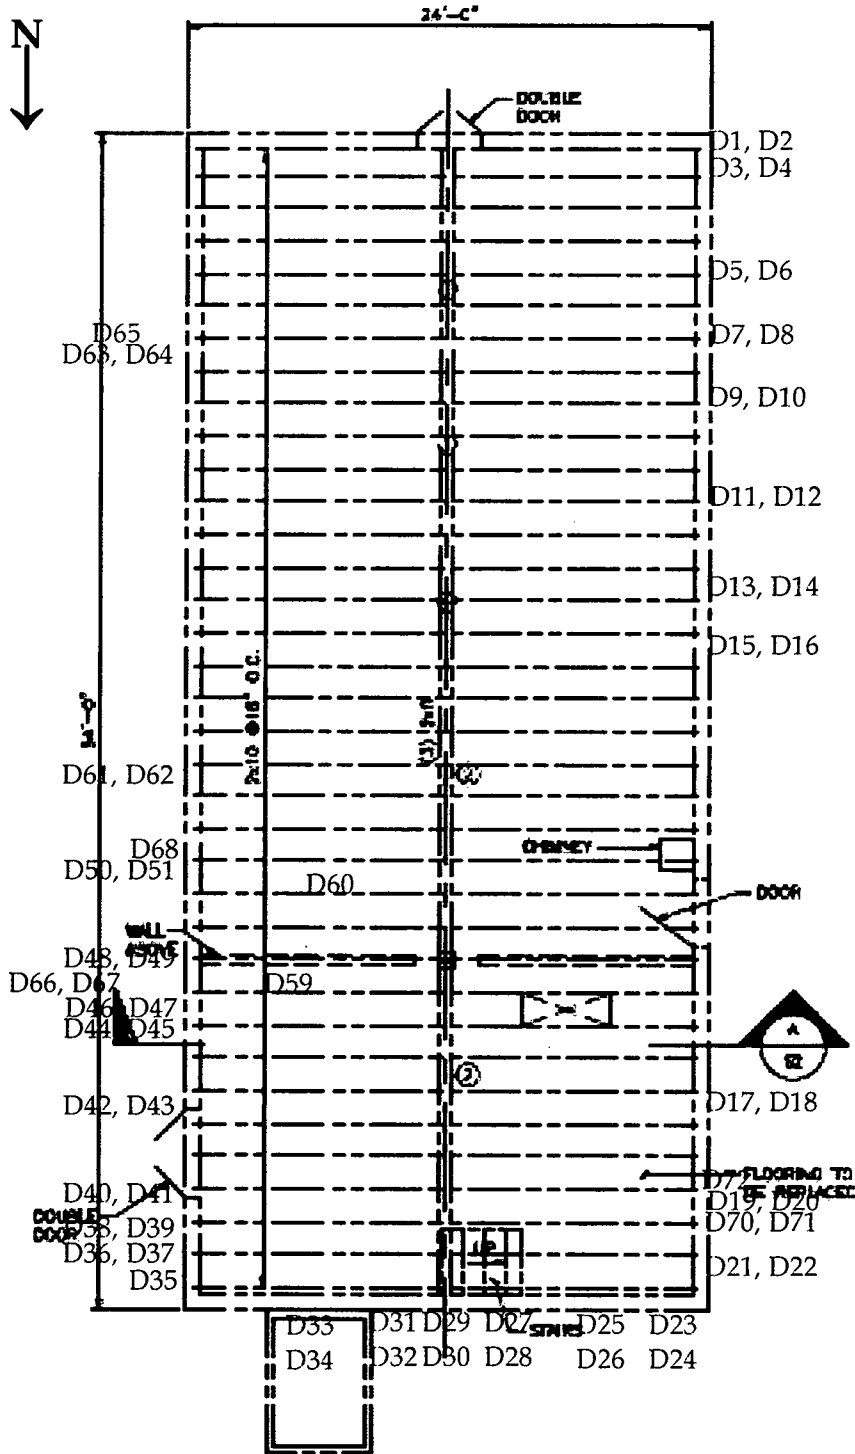
Figure A-1. Resistance Drilling Locations, First Floor and Exterior

Drilling Number	Location	Member ID	Location Description	Comments
D66	east elevation	stud	208" from NE corner, below window	no stud or missed stud
D67	east elevation	stud	248" from NE corner, 35" above concrete foundation	no voids found
D68	east elevation	stud	316" from NE corner, 21" above concrete foundation	no voids found
D69	west elevation	stud	Not labeled	
D70	west elevation	stud	56" from NW corner, 13" above concrete foundation	no stud or missed stud
D71	west elevation	stud	57" from NW corner, 20" above concrete foundation	no stud or missed stud
D72	west elevation	stud	70" from NW corner, 13" above concrete foundation	no voids found
