Mount Carmel
MP site 12/22

From: Fothergill, Anne
Sent: Wednesday, May 11, 2011 2:36 PM
Subject: 5/11 staff item #3

SUBJECT: Historic Area Work Permit #554485—roof replacement, garage construction, barn demolition,
and other alterations

**HISTORIC PRESERVATION FOR:
 MOUNT CARMEL
 DICKERSON, MD 20842**

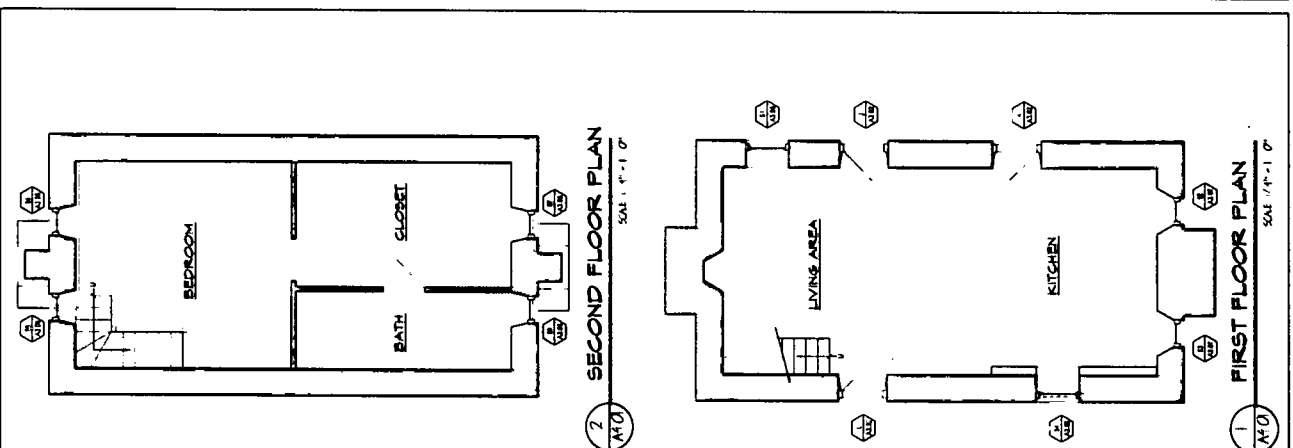
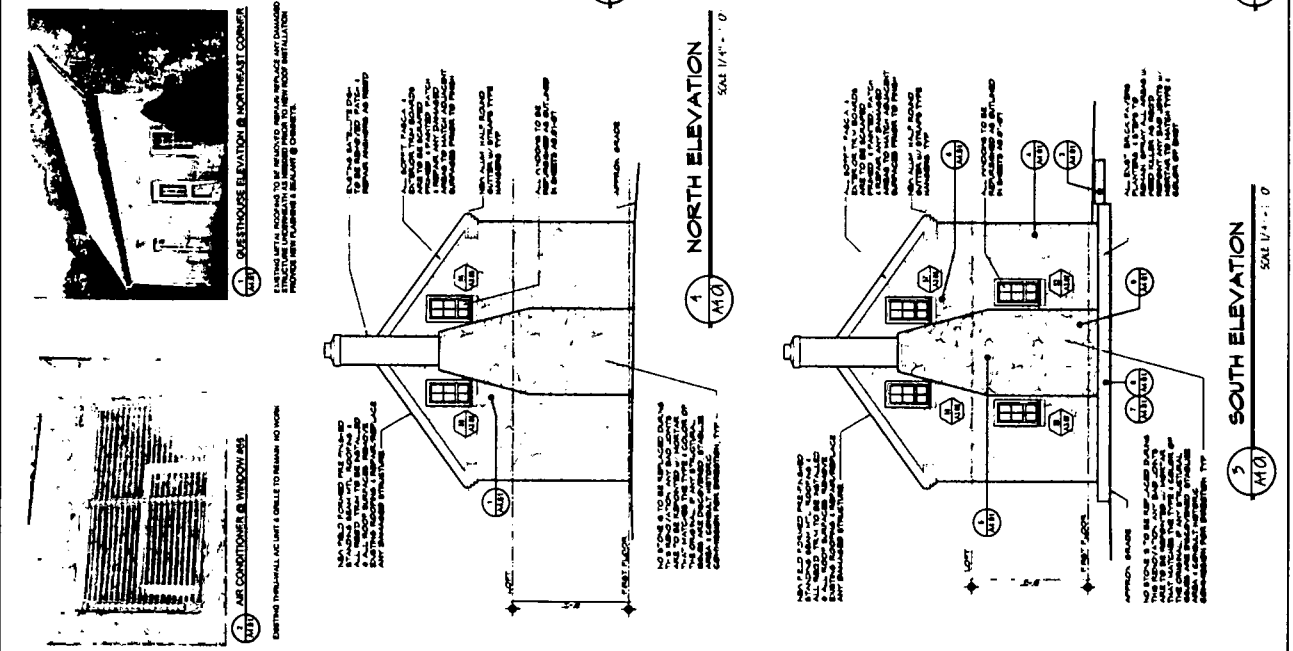
1 **AIR CONDITIONER & WINDOW AW**
 EXISTING THROUGH AIR UNIT & WINDOW TO REMAIN. NO WORK.

2 **OUTHOUSE ELEVATION @ NORTHEAST CORNER**
 EXISTING MATERIALS TO BE REPAIRED. REPAIRS TO BE MADE IN PLACE AND DAMAGED STRUCTURE UNDERLAINING TO BE REPAIRED TO SUPPORT EXISTING ROOF. REPAIRS TO BE MADE IN PLACE AND DAMAGED STRUCTURE UNDERLAINING TO BE REPAIRED TO SUPPORT EXISTING ROOF.

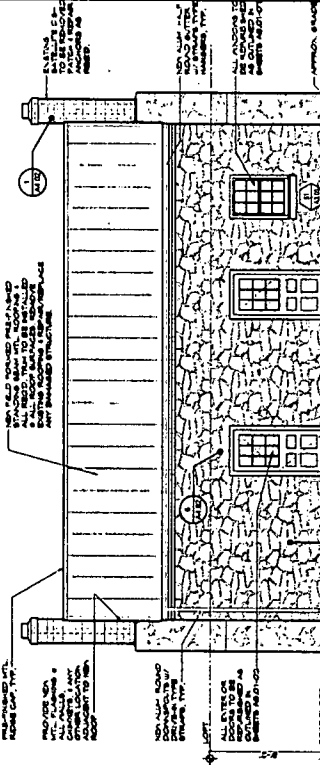
STONE DETAIL
 NO WORK REQUIRED - STONE REPORTING AND JOINTS AS NEEDED - MATCH TYPE & COLOR OF EXISTING.

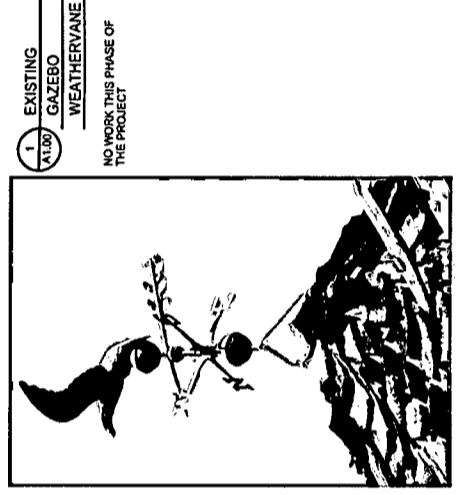
1 EXISTING GAZEBO ELEVATION
 NO WORK THIS PHASE OF THE PROJECT

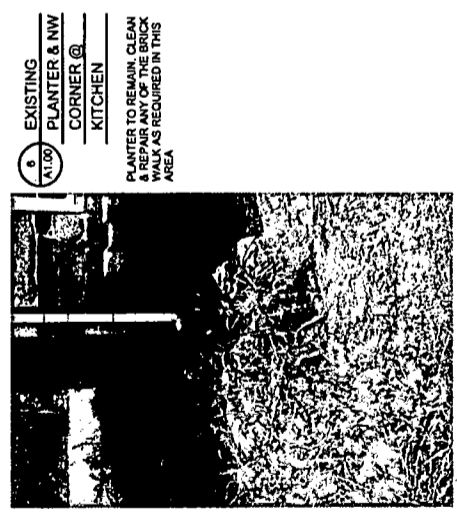
5 EXISTING BRICK PLANTER
 EXISTING PLANTER TO REMAIN. CLEAN & REPOINT ANY BAD JOINTS AS REQUIRED.

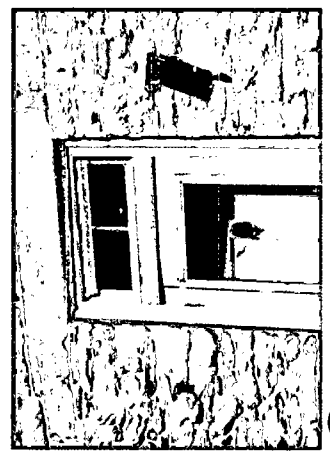
1 PARTIAL ELEVATION @ DOOR 'B'
 A2.03

- EXISTING DAMAGED SCREEN DOOR TO BE REMOVED AND A NEW SCREEN DOOR & HARDWARE IS TO BE INSTALLED. FOR ADDITIONAL WORK AT THIS DOOR, SEE SHEET A2.01
- REPAIR LIGHT FIXTURES & PROVIDE (2) NEW FIXTURES, (1) FOR EACH SIDE OF DOOR. NEW FIXTURES SHALL MATCH THE PERIOD OF THE HOUSE.

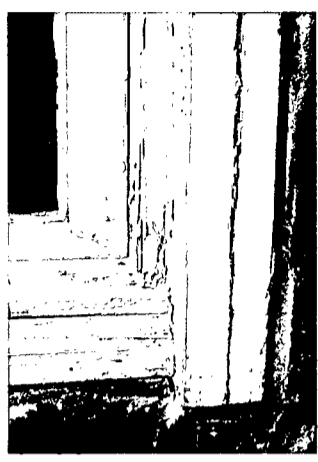
CONNECTION PINS IN WINDOW SASH CAN BE SEEN COMING LOOSE. REPAIR AS REQUIRED @ THIS WINDOW AS WELL AS ANY OTHER WHERE THIS CONDITION OCCURS.

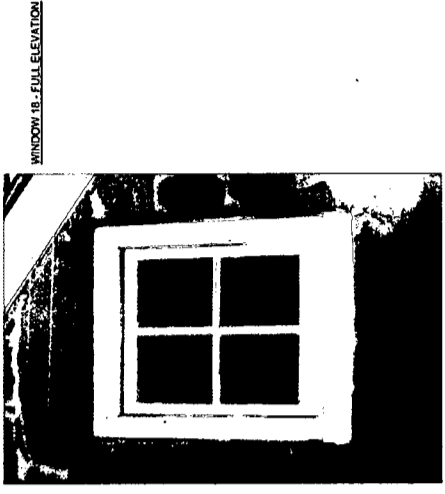
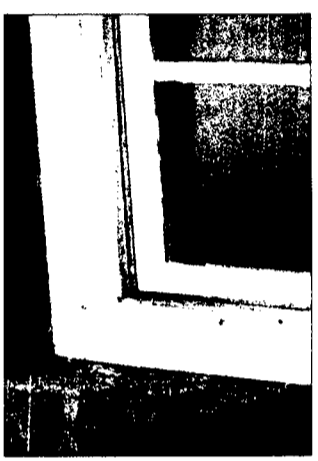
CONNECTION PINS IN WINDOW SASH CAN BE SEEN COMING LOOSE. REPAIR AS REQUIRED @ THIS WINDOW AS WELL AS ANY OTHER WHERE THIS CONDITION OCCURS.

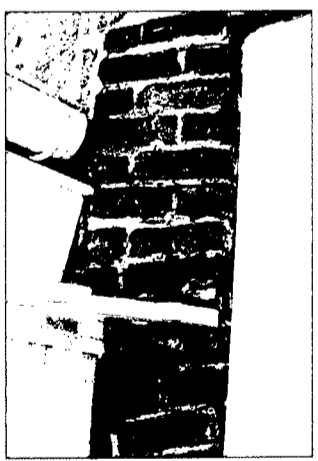
EXISTING WEATHERSTRIPPING IS VISIBLE. REMOVE & REPLACE AS INDICATED.

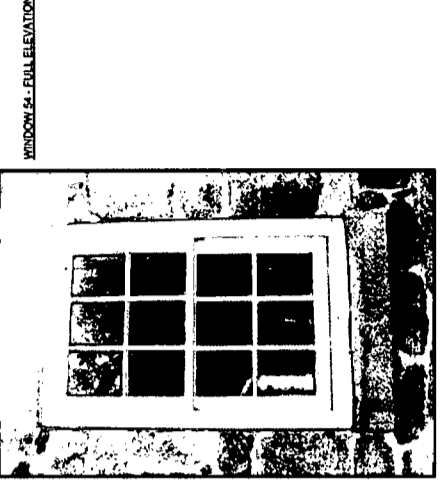
WINDOW 54 - FULL ELEVATION

WINDOW 54 - LINTEL
 NO STONE IS TO BE REPLACED AT THIS TIME. ONLY REPOINTING OF JOINTS AS REQUIRED. HOWEVER, VERIFY CONDITION OF STONE AROUND WINDOW, ESPECIALLY AT LINTEL. POSSES NO STRUCTURAL ISSUE. IF ADDITIONAL WORK IS DETERMINED TO BE NECESSARY, STABILIZE CONDITION AND CONSULT HISTORIC COMMISSION FOR DETAILS ON HOW TO PROCEED.

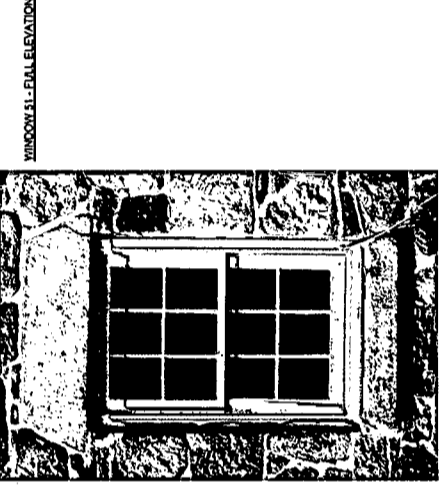
WINDOW 51 - FULL ELEVATION

WINDOW 51 - LINTEL
 NO STONE IS TO BE REPLACED AT THIS TIME. ONLY REPOINTING OF JOINTS AS REQUIRED. HOWEVER, VERIFY CONDITION OF STONE AROUND WINDOW, ESPECIALLY AT LINTEL. POSSES NO STRUCTURAL ISSUE. IF ADDITIONAL WORK IS DETERMINED TO BE NECESSARY, STABILIZE CONDITION AND CONSULT HISTORIC COMMISSION FOR DETAILS ON HOW TO PROCEED.

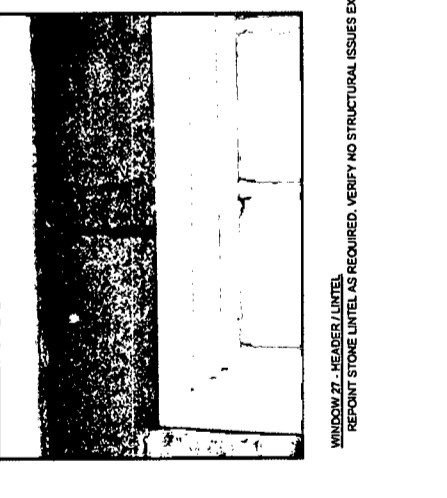
WINDOW 27 - HEADER / LINTEL
 REPOINT STONE LINTEL AS REQUIRED. VERIFY NO STRUCTURAL ISSUES EXIST.

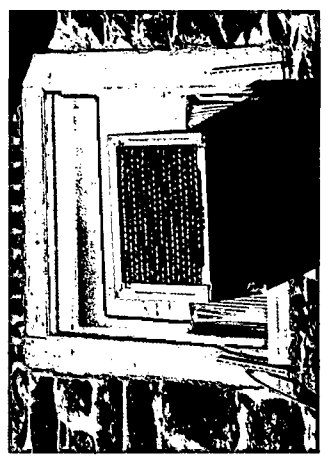
WINDOW 32 - FULL ELEVATION
 EXISTING AIR CONDITIONER & PLYWOOD FILLER PANEL ARE TO BE REMOVED. PREP FRAME OPENING AS REQUIRED & INSTALL A NEW WINDOW TO MATCH WINDOW #30 ADJACENT.

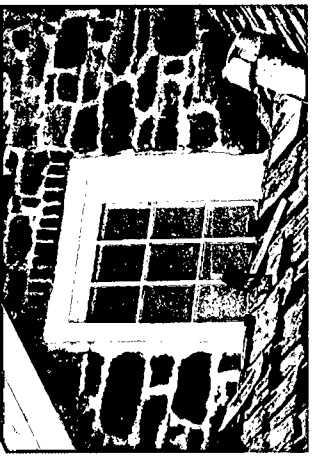
WINDOW 40 - FULL ELEVATION
 NO STONE IS TO BE REPLACED AT THIS TIME. ONLY REPOINTING OF JOINTS AS REQUIRED. HOWEVER, VERIFY CONDITION OF STONE AND MORTAR ESPECIALLY AT SILL POSSES NO STRUCTURAL ISSUE. IF ADDITIONAL WORK IS DETERMINED TO BE NECESSARY, STABILIZE CONDITION AND CONSULT HISTORIC COMMISSION FOR DETAILS ON HOW TO PROCEED.

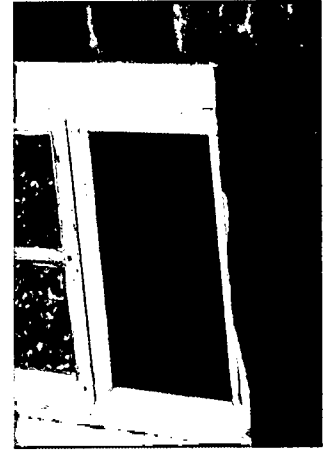
WINDOW 56 - FULL ELEVATION

WINDOW 56 - SILL
 NO STONE IS TO BE REPLACED AT THIS TIME. ONLY REPOINTING OF JOINTS AS REQUIRED. HOWEVER, VERIFY CONDITION OF STONE AROUND WINDOW, ESPECIALLY AT SILL POSSES NO STRUCTURAL ISSUE. IF ADDITIONAL WORK IS DETERMINED TO BE NECESSARY, STABILIZE CONDITION AND CONSULT HISTORIC COMMISSION FOR DETAILS ON HOW TO PROCEED.
