APPLICATION FOR HISTORIC AREA WORK PERMIT
HISTORIC PRESERVATION COMMISSION
301.563.3400

Our proposed work will restore and repair our property's two-story front porch.

**Representative Name:** Roxanne Fulcher Roxy@pheared.net 301-270-5151  
**Location of Project:** 7102-04 Maple Avenue  
**Proposed Scope of Work:** Repair 2-story front porch

Scope of Work Restore two-story front porch.

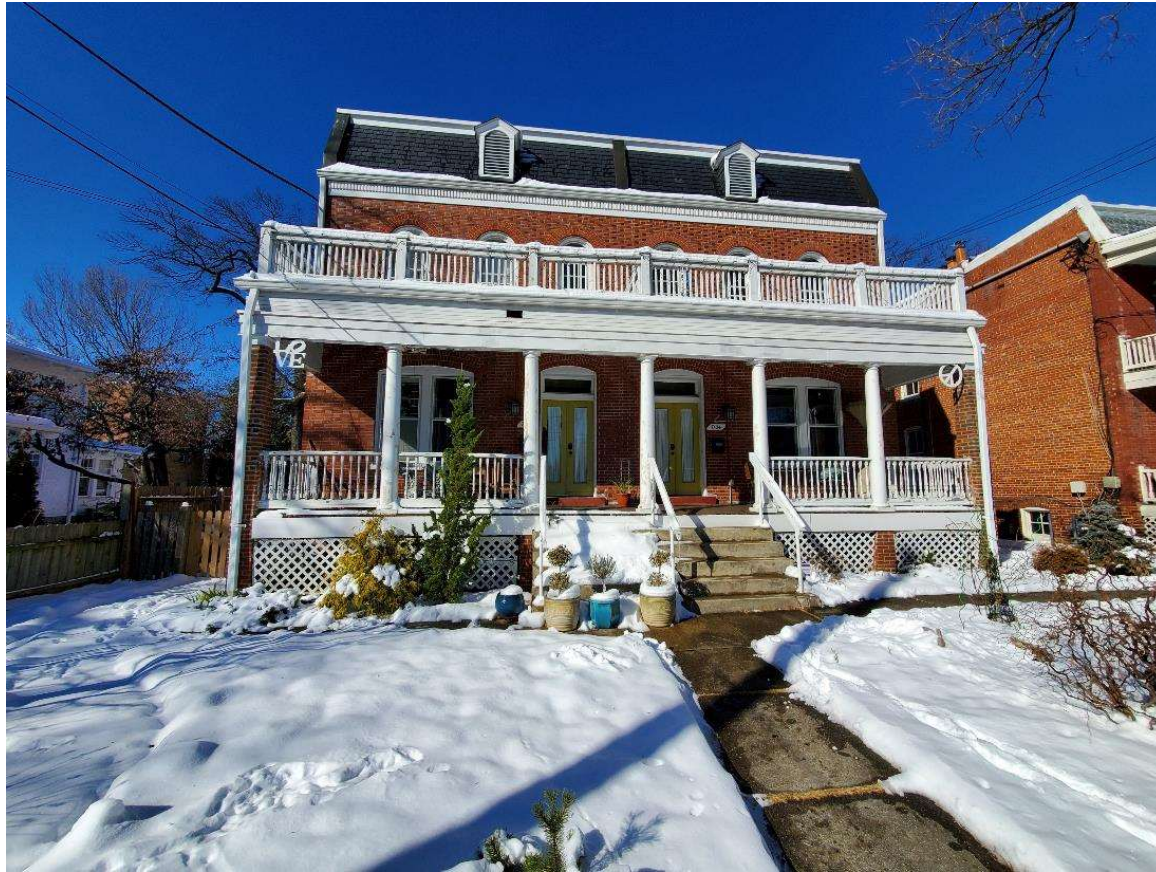
**Photo A - 7102 Maple Ave – Front Elevation**

<p>removed (shortened by ~3'), fascia was made to provide some structural support: 2x4s were installed behind the fascia, which were connected to the two horizontal beams. (Photo A, 1)</p> <p>(8) Roofing materials (tar paper, asphalt, flashing, etc.), not intended to withstand heavy foot traffic or the placement of furniture, were installed over the OSB plywood (that had been installed over and in areas where T&amp;G was missing). (Photo 6,7)</p> <p>(9) The original balustrades have been replaced, Existing are made from pressure treated 2x4s and 5/4" decking materials. Some are tagged <i>Hechinger</i>. Installed without structural support, all wobble. All are deteriorating. Balusters are square, which is the appropriate architectural style for the house and its construction period. (Photo A,7)</p>	
--	--

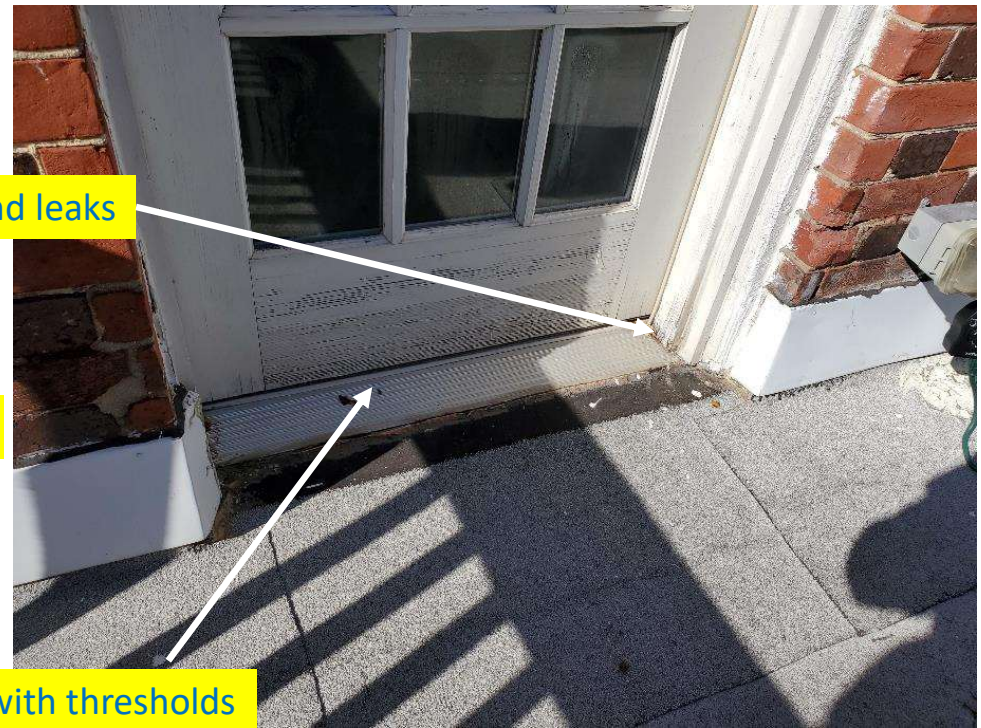
**Photo 9 - 7102 Maple Ave – Upper porch doorways**

- (2) One-inch thick OSB plywood was installed on top of the remaining T&G as well as over the area where T&G was removed.
- (3) An original slope on the upper-floor causing water to move away from the house was eliminated when OSB was installed level with the thresholds of two doors. This alteration resulted in watering puddling on the floor as well as leaking through the doors into the house. (Photo 6,9)
