37/3-96WW 7112 Sycamore Avenue
(Takoma Park Historic District)

Sumner Patch
7112 Sycamore Avenue
HPC 12/18/96.

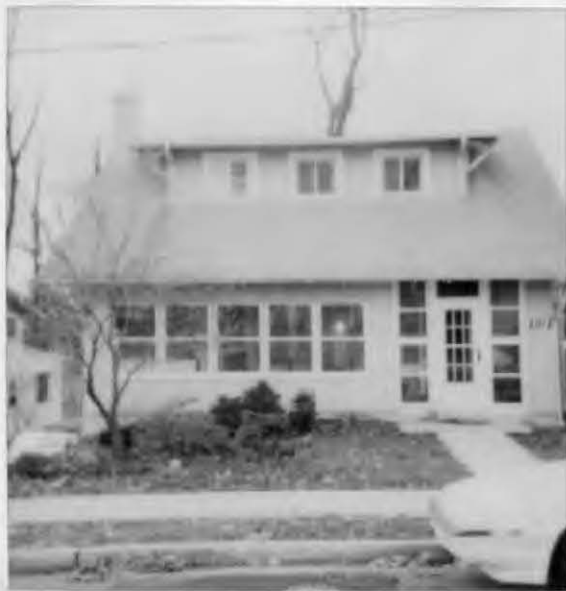
Patch, 7112 Sycamore Ave, TP
front view

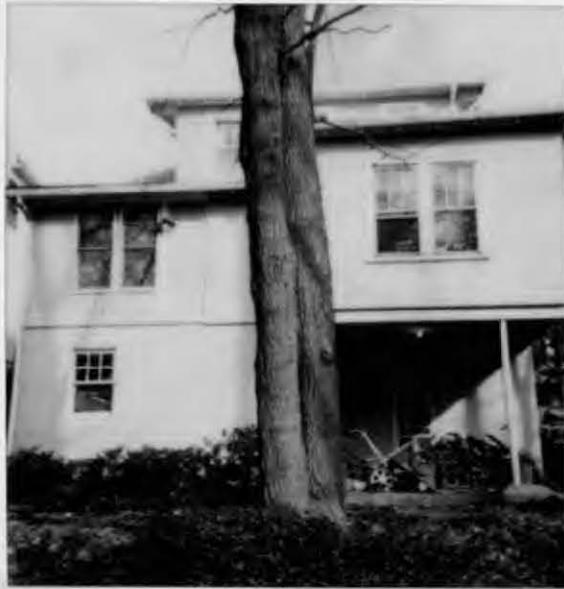
Patch - 7112 Sycamore Ave TP
rear view

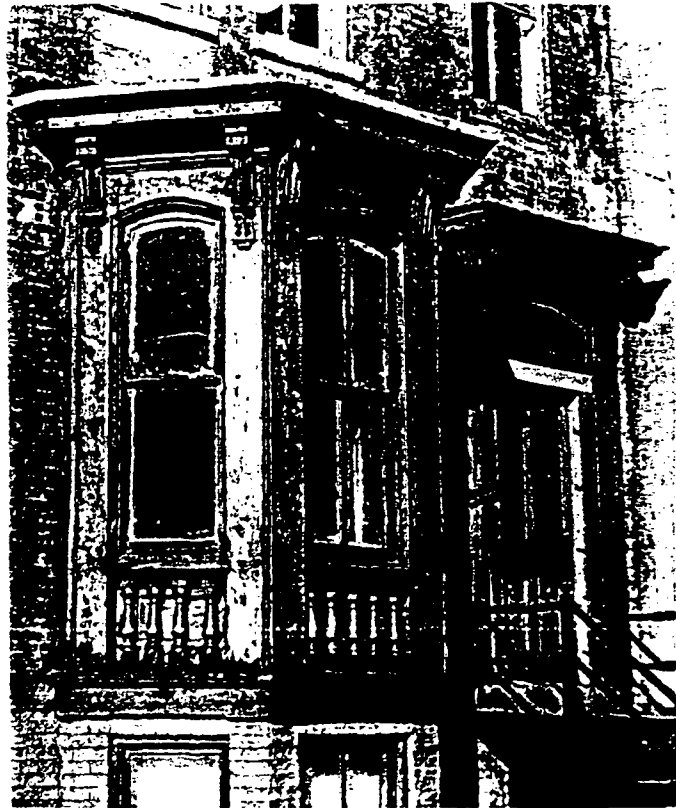
Fig. 2 A traditionally painted bay window has been stripped to bare wood, then varnished. In addition to being historically inaccurate, the varnish will break down faster as a result of the sun's ultraviolet rays than would primer and finish coats of paint. Photo: David W. Look, AIA.

been identified, the general approach should be to remove paint to the next sound layer using the gentlest means possible, then to repaint (see figure 2). Practically speaking as well, paint can adhere just as effectively to existing paint as to bare wood, providing the previous coats of paint are also adhering uniformly and tightly to the wood and the surface is properly prepared for repainting—cleaned of dirt and chalk and dulled by sanding. But, if painted exterior wood surfaces display continuous patterns of deep cracks or if they are extensively blistering and peeling so that bare wood is visible, then the old paint should be completely removed before repainting. The only other justification for removing all previous layers of paint is if doors, shutters, or windows have literally been "painted shut," or if new wood is being pieced-in adjacent to old painted wood and a smooth transition is desired (see figure 3).

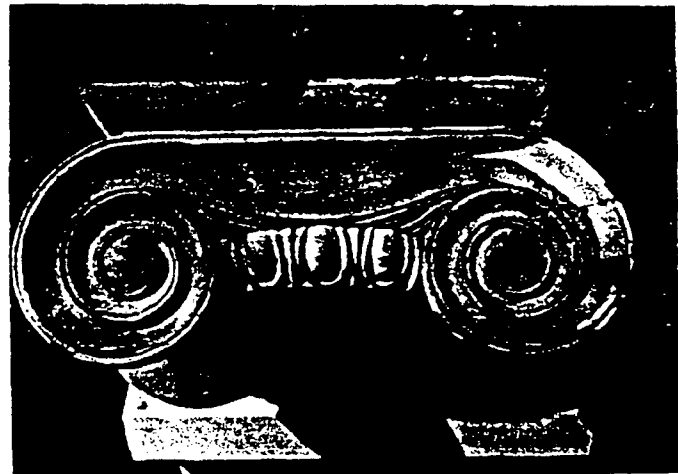
Fig. 3 If damage to parts of a wooden element is severe, new sections of wood will need to be pieced-in. When such piecing is required, paint on the adjacent woodwork should be removed so that the old and new woods will make a smooth profile when joined. After repainting, the repair should be virtually impossible to detect. Photo: Morgan W. Phillips

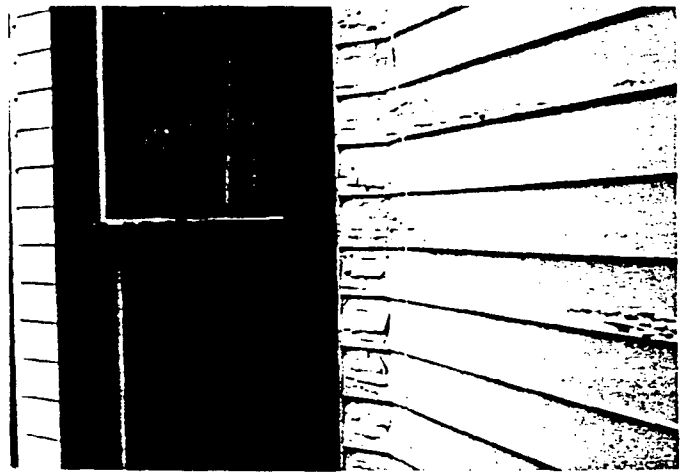
film, thus impairing adhesion (see figure 8). Generally beginning as blisters, cracking and peeling occur as moisture causes the wood to swell, breaking the adhesion of the bottom layer.

Fig. 8 Peeling to bare wood—one of the most common types of paint failure—is usually caused by an interior or exterior moisture problem. Photo: Anne E. Grimmer.

There is no sense in repainting before dealing with the moisture problems because new paint will simply fail. Therefore, the first step in treating peeling is to locate and remove the source or sources of the moisture, not only because moisture will jeopardize the protective coating of paint but because, if left unattended, it can ultimately cause permanent damage to the wood. Excess interior moisture should be removed from the building through installation of exhaust fans and vents. Exterior moisture should be eliminated by correcting the following conditions prior to repainting: faulty flashing; leaking gutters; defective roof shingles; cracks and holes in siding and trim; deteriorated caulking in joints and seams; and shrubbery growing too close to painted wood. After the moisture problems have been solved, the wood must be permitted to dry out thoroughly. The damaged paint can then be scraped off with a putty knife, hand or mechanically sanded, primed, and repainted.

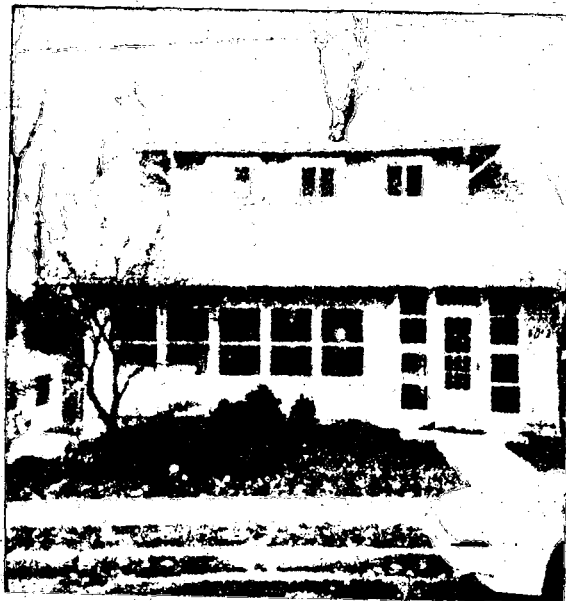
Patch, 7112 Sycamore Ave, TP
front view

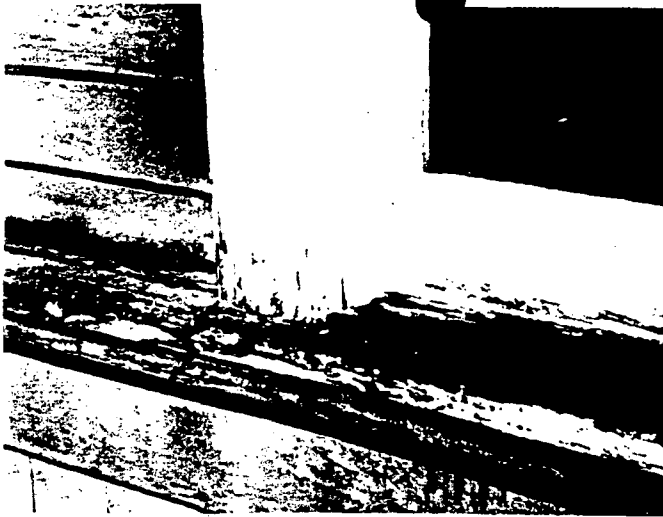
Figure 3. Deterioration of poorly maintained windows usually begins on horizontal surfaces and at joints where water can collect and saturate the wood. The problem areas are clearly indicated by paint failure due to moisture. Photo: Baird M. Smith, AIA

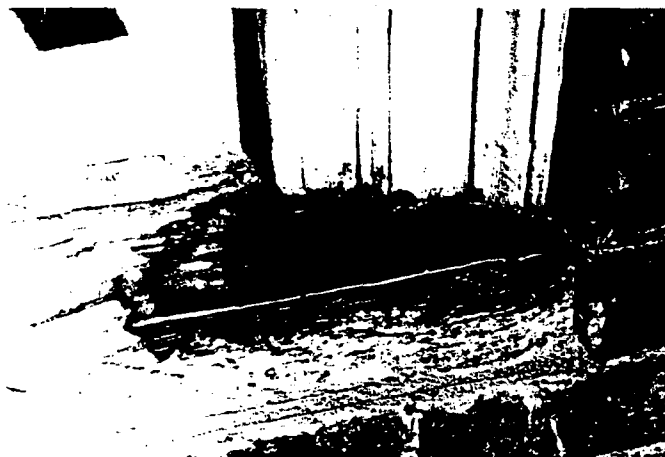
Figure 5. This illustrates a two-part epoxy patching compound used to fill the surface of a weathered sill and rebuild the missing edge. When the epoxy cures, it can be sanded smooth and painted to achieve a durable and waterproof repair. Photo: John H. Myers

Wood may also be strengthened and stabilized by consolidation, using semi-rigid epoxies which saturate the porous decayed wood and then harden. The surface of the consolidated wood can then be filled with a semi-rigid epoxy patching compound, sanded and painted (see figure 5). Epoxy patching compounds can be used to build up

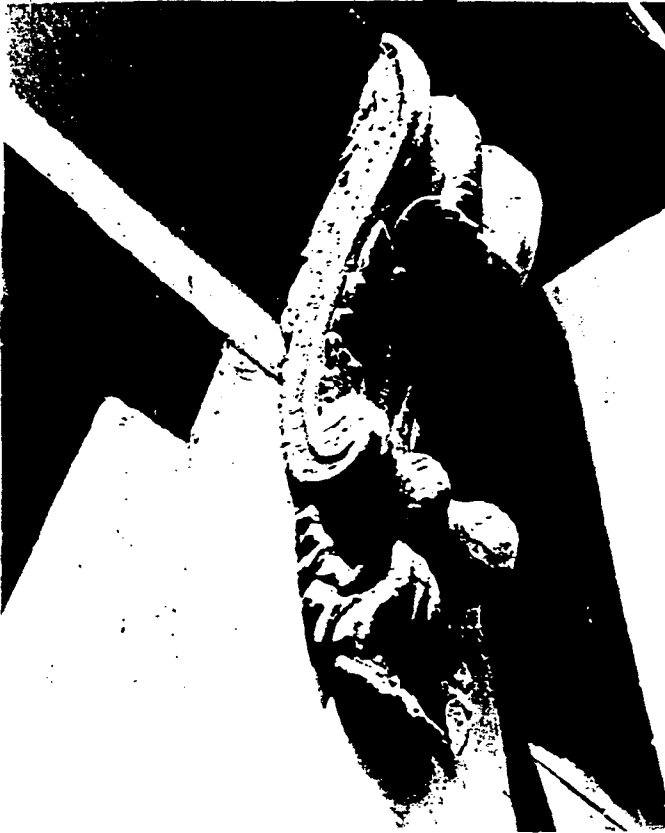
Fig. 1 Excessive paint build-up on architectural details such as this ornamental bracket does not in itself justify total paint removal. If paint is cracked and peeling down to bare wood, however, it should be removed using the gentlest means possible. Photo: David W. Look, AIA.

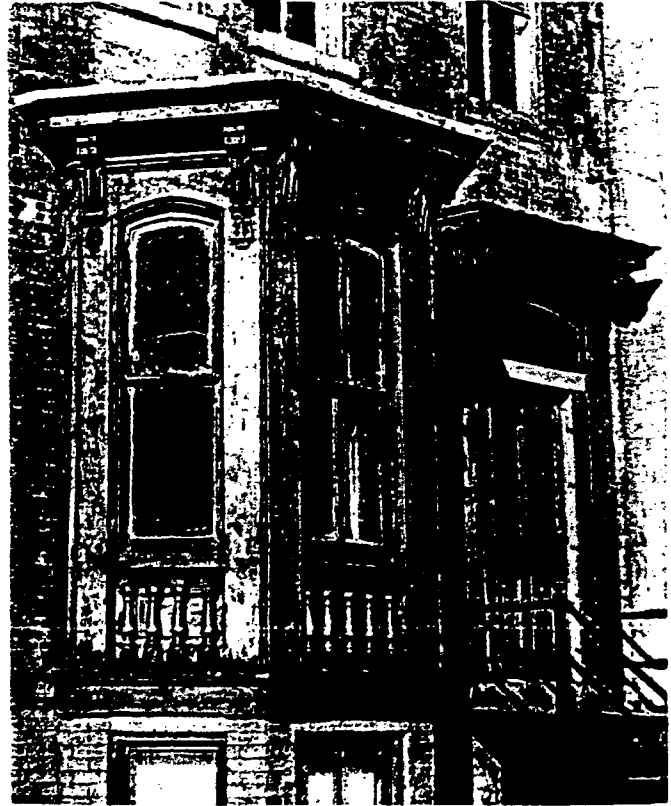
Fig. 2 A traditionally painted bay window has been stripped to bare wood, then varnished. In addition to being historically inaccurate, the varnish will break down faster as a result of the sun's ultraviolet rays than would primer and finish coats of paint. Photo: David W. Look, AIA.

been identified, the general approach should be to remove paint to the next sound layer using the gentlest means possible, then to repaint (see figure 2). Practically speaking as well, paint can adhere just as effectively to existing paint as to bare wood, providing the previous coats of paint are also adhering uniformly and tightly to the wood and the surface is properly prepared for repainting—cleaned of dirt and chalk and dulled by sanding. But, if painted exterior wood surfaces display continuous patterns of deep cracks or if they are extensively blistering and peeling so that bare wood is visible, then the old paint should be completely removed before repainting. The only other justification for removing all previous layers of paint is if doors, shutters, or windows have literally been "painted shut," or if new wood is being pieced-in adjacent to old painted wood and a smooth transition is desired (see figure 3).

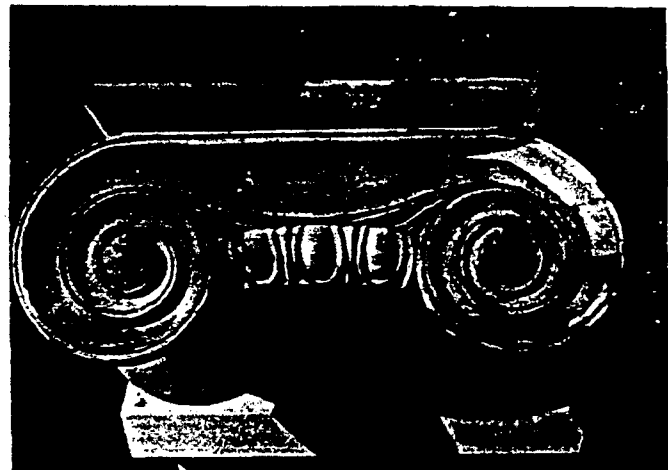
Fig. 3 If damage to parts of a wooden element is severe, new sections of wood will need to be pieced-in. When such piecing is required, paint on the adjacent woodwork should be removed so that the old and new woods will make a smooth profile when joined. After repainting, the repair should be virtually impossible to detect. Photo: Morgan W. Phillips.

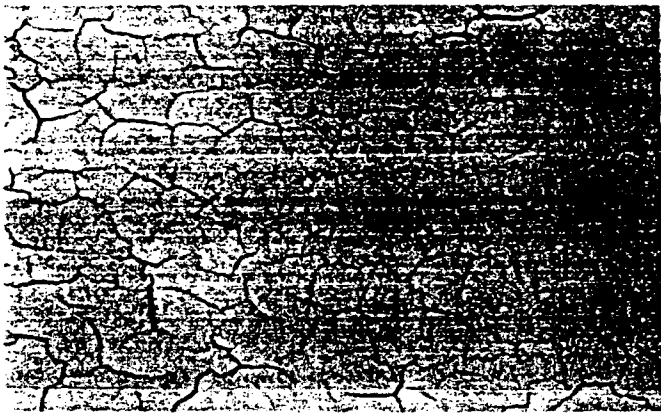
Crazing—fine, jagged interconnected breaks in the top layer of paint—results when paint that is several layers thick becomes excessively hard and brittle with age and is consequently no longer able to expand and contract with the wood in response to changes in temperature and humidity (see figure 5). As the wood swells, the bond between paint layers is broken and hairline cracks appear. Although somewhat more difficult to detect as opposed to other more obvious paint problems, it is well worth the time to scrutinize all surfaces for crazing. If not corrected, exterior moisture will enter the crazed surface, resulting in further swelling of the wood and, eventually, deep cracking and alligatoring, a Class III condition which requires total paint removal.

Fig. 5 Crazing—or surface cracking—is an exterior surface condition which can be successfully treated by sanding and painting. Photo: Courtesy, National Decorating Products Association.

Crazing can be treated by hand or mechanically sanding the surface, then repainting. Although the hairline cracks may tend to show through the new paint, the surface will be protected against exterior moisture penetration.

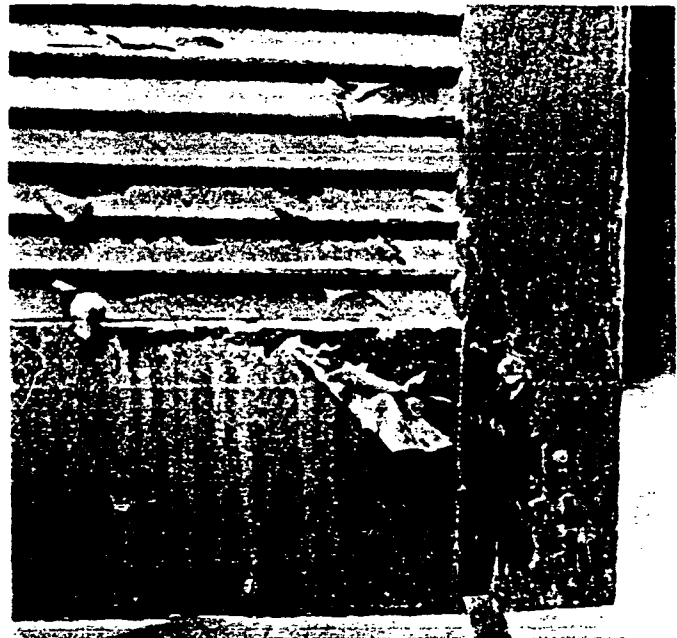
Another common cause of intercoat peeling is incompatibility between paint types (see figure 6). For example, if oil paint is applied over latex paint, peeling of the top

Fig. 6 This is an example of intercoat peeling. A latex top coat was applied directly over old oil paint and, as a result, the latex paint was unable to adhere. If latex is being used over oil, an oil-base primer should be applied first. Although much of the peeling latex paint can be scraped off, in this case, the best solution may be to chemically dip strip the entire shutter to remove all of the paint down to bare wood, rinse thoroughly, then repaint. Photo: Mary L. Oehrlein, AIA.

Where peeling was the result of using incompatible paints, the peeling top coat should be scraped and hand or mechanically sanded. Application of a high quality oil type exterior primer will provide a surface over which either an oil or a latex topcoat can be successfully used.

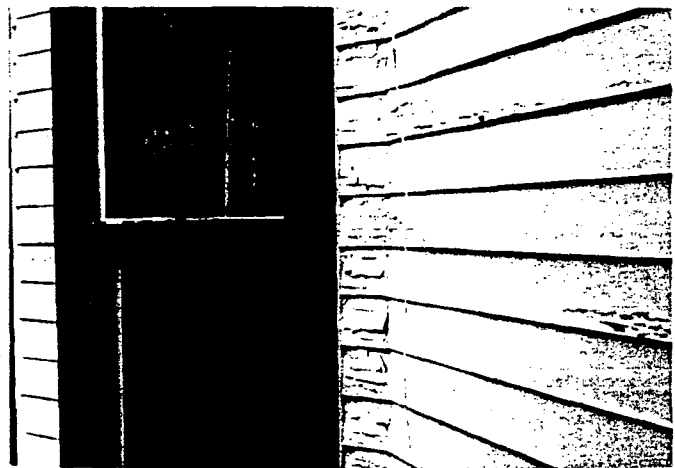
film, thus impairing adhesion (see figure 8). Generally beginning as blisters, cracking and peeling occur as moisture causes the wood to swell, breaking the adhesion of the bottom layer.

Fig. 8 Peeling to bare wood—one of the most common types of paint failure—is usually caused by an interior or exterior moisture problem. Photo: Anne E. Grimmer.

There is no sense in repainting before dealing with the moisture problems because new paint will simply fail. Therefore, the first step in treating peeling is to locate and remove the source or sources of the moisture, not only because moisture will jeopardize the protective coating of paint but because, if left unattended, it can ultimately cause permanent damage to the wood. Excess interior moisture should be removed from the building through installation of exhaust fans and vents. Exterior moisture should be eliminated by correcting the following conditions prior to repainting: faulty flashing; leaking gutters; defective roof shingles; cracks and holes in siding and trim; deteriorated caulking in joints and seams; and shrubbery growing too close to painted wood. After the moisture problems have been solved, the wood must be permitted to dry out thoroughly. The damaged paint can then be scraped off with a putty knife, hand or mechanically sanded, primed, and repainted.

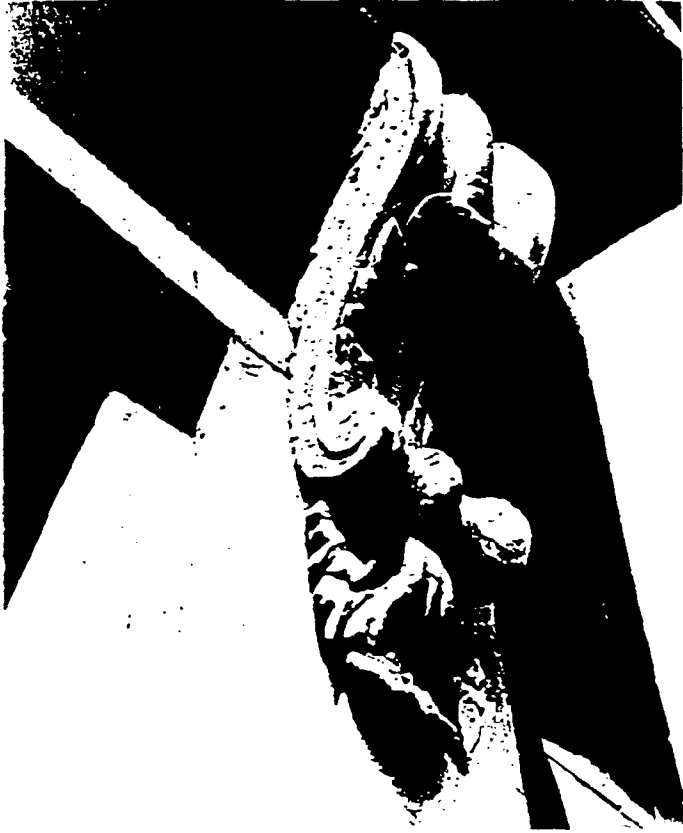
Fig. 1 Excessive paint build-up on architectural details such as this ornamental bracket does not in itself justify total paint removal. If paint is cracked and peeling down to bare wood, however, it should be removed using the gentlest means possible. Photo: David W. Look. AIA.

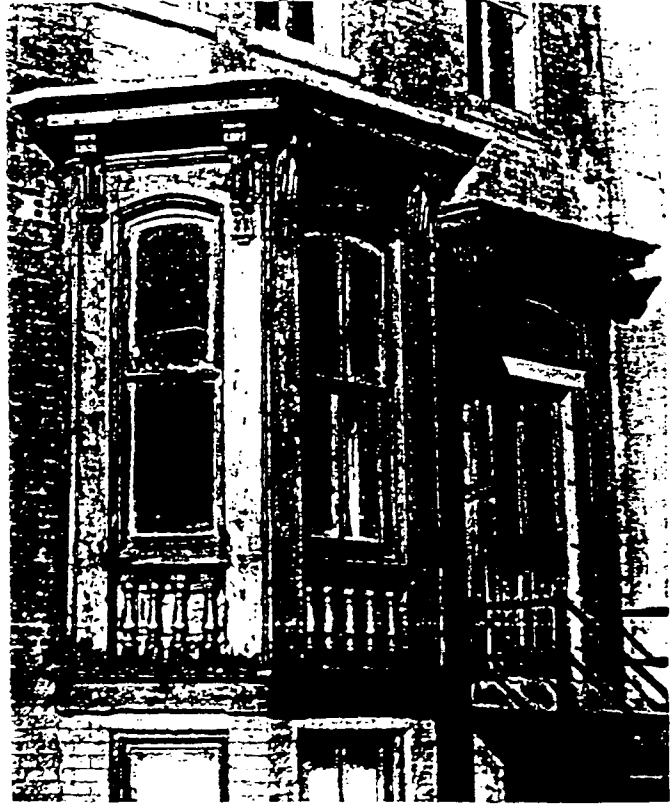
Fig. 2 A traditionally painted bay window has been stripped to bare wood, then painted in an attempt to being historically inaccurate. The finish will break down faster as a result of the sun's ultraviolet rays than would primer and finish coats of paint. Photo: David W. Look. AIA.

been identified, the general approach should be to remove paint to the next sound layer using the gentlest means possible, then to repaint (see figure 2). Practically speaking as well, paint can adhere just as effectively to existing paint as to bare wood, providing the previous coats of paint are also adhering uniformly and tightly to the wood and the surface is properly prepared for repainting—cleaned of dirt and chalk and dulled by sanding. But, if painted exterior wood surfaces display continuous patterns of deep cracks or if they are extensively blistering and peeling so that bare wood is visible, then the old paint should be completely removed before repainting. The only other justification for removing all previous layers of paint is if doors, shutters, or windows have literally been "painted shut," or if new wood is being pieced-in adjacent to old painted wood and a smooth transition is desired (see figure 3).

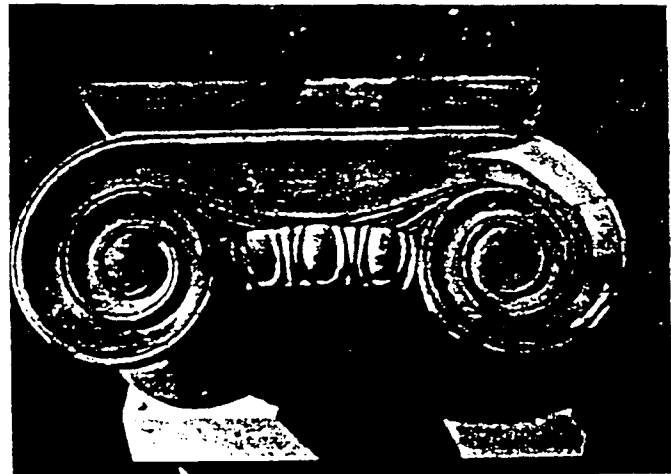
Fig. 3 If damage to parts of a wooden element is severe, new sections of wood will need to be pieced-in. When such piecing is required, paint on the adjacent woodwork should be removed so that the old and new woods will make a smooth profile when joined. After repainting, the repair should be virtually impossible to detect. Photo: Margaret W. Phillips.
