31/6-91B 3934 Baltimore Street,
Kensington

Re: Removal of White Pine
tree

On Friday, October 21, 1994, I conducted a Hazard Tree evaluation on the 32" DBH White Pine (*Pinus strobus*) in the rear of your property. This letter will serve as my report.

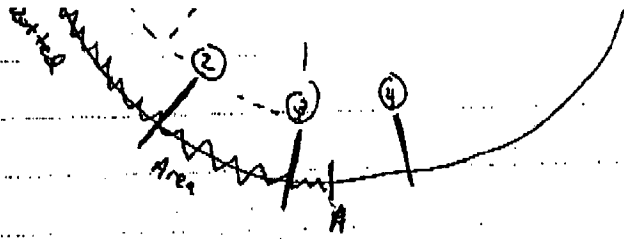
At 6" above grade a total of 9 holes were bored into the trunk. Four of these holes were bored directly into the face of the rotted area (39 inches wide). The rot extends at least 9 inches into the trunk (the length of the bit). The other five sites yielded 9 inches of normal looking wood. I suspect that the rotted area here resembles a wedge shape.

- ② 9" OK
- ③ 9" OK
- ④ 9" OK
